## 1. 도곡2교

## 손상현황 사진

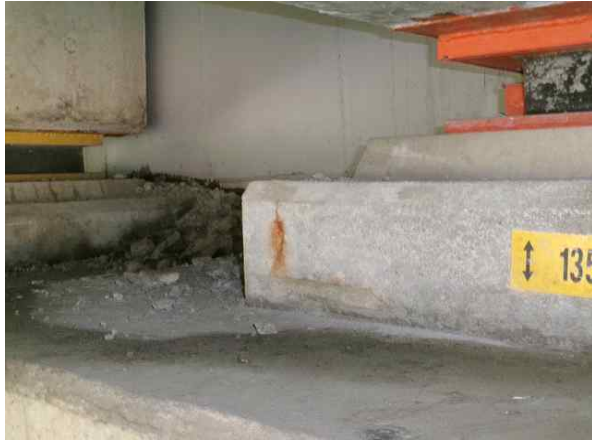
A1-SH5 받침콘크리트 파손(1.0×0.5)

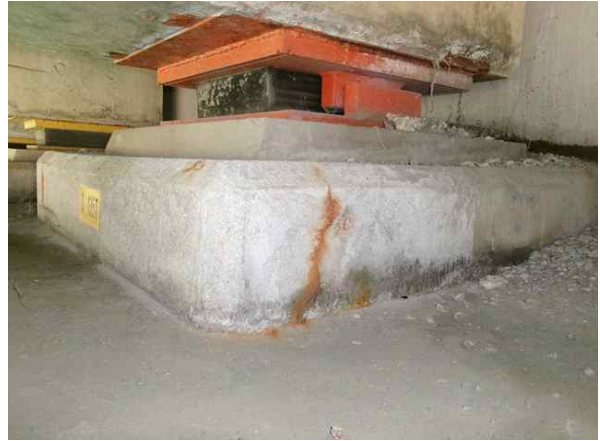
A1-SH5 받침콘크리트 파손(1.0×0.5)

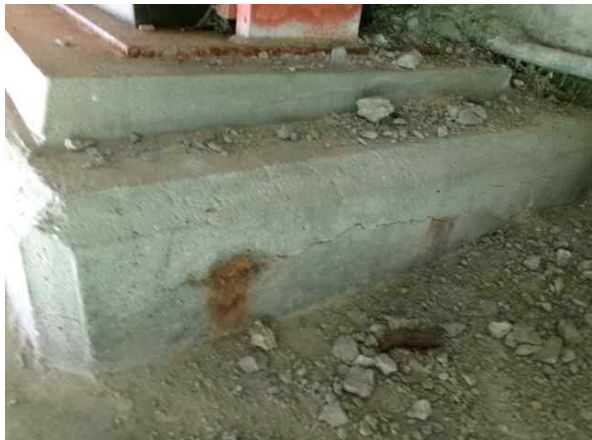
A1-SH5 받침콘크리트 균열(0.3mm/0.4m)
