### 3. 도 곡 2 교

바닥판하면 손상현황

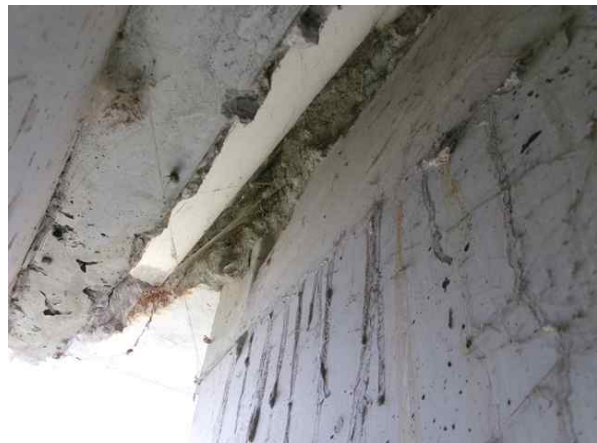
S3 파손 및 철근노출(0.2×1.0)

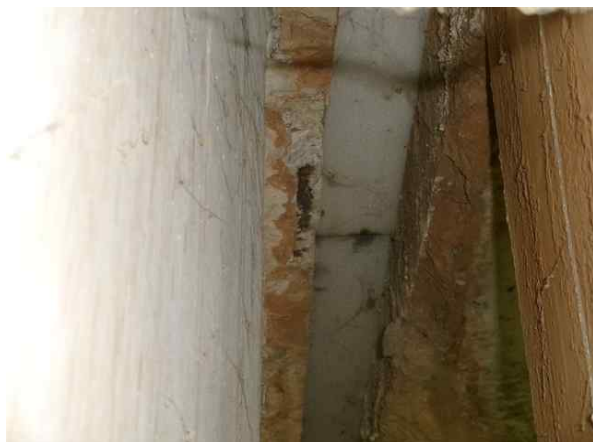
S3 파손 및 철근노출(0.3×1.0)
