### 손상물량표

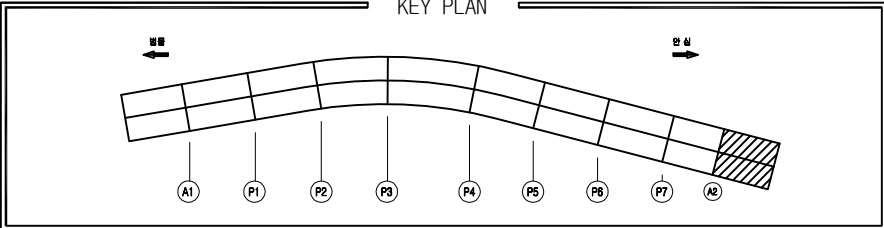
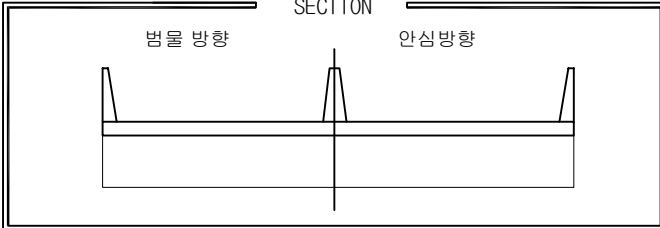
| 번 | 위치 | 손상내용 | 손상물량 | | | | | 비고 |
|---|---|---|---|---|---|---|---|---|
| 1 | 포장부 | 아스콘 균열 | - | 1.2 | 3 | m | 3.60 | |
