# ID : 복정고가교 본선-상행선 box외부(S1)

## 손상물량표

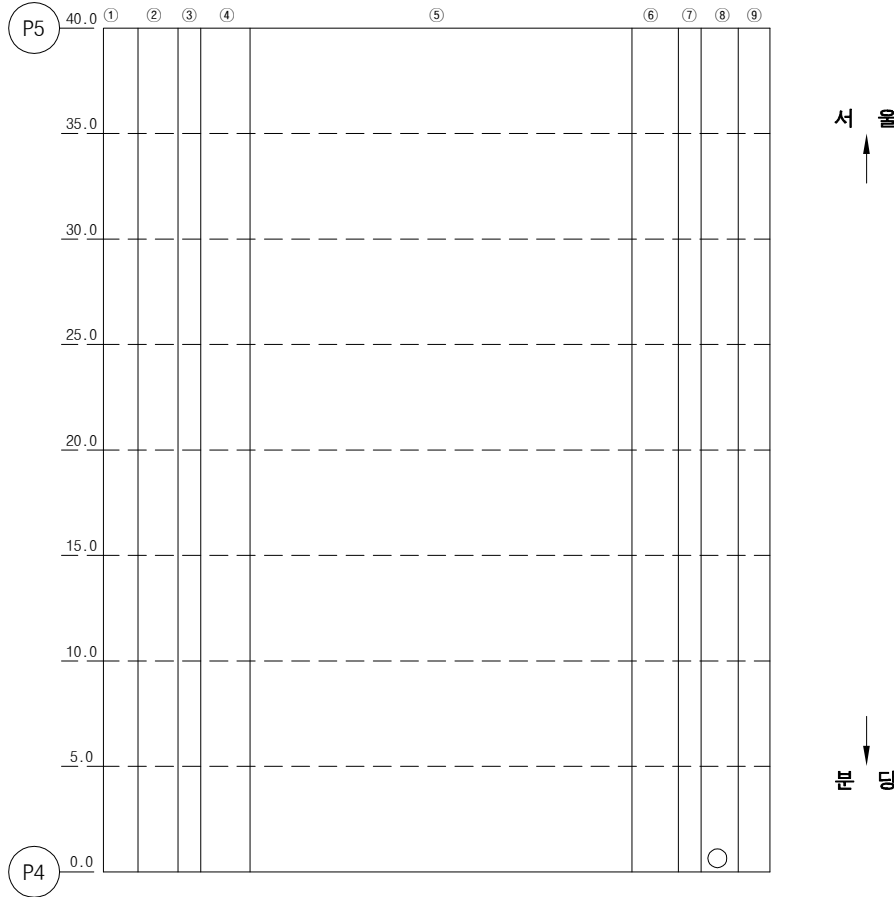
| 용역명 | | 2023년 하반기 복정고가교 정밀안전진단 용역 | | | | | |
|---|---|---|---|---|---|---|--|
| | 누수, 변색 | 배수구 | 포장의 요철 | 기타 | 도면번호 | 135 | |

| 번호 | 손상내용 | 손상물량 | | | | | 비고 |
|---|---|---|---|---|---|---|---|
| 1 | 누수흔적 | 0.20 | 3.00 | 0.60 | m <sup>2</sup> | 1 | |
| 2 | 표면오염(누수흔적) | 0.10 | 3.00 | 0.30 | m <sup>2</sup> | 1 | |
| 3 | 균열부백태 | 0.20 | 0.70 | 0.70 | m | 1 | |
| 5 | 배수관주변누수흔적 | 0.50 | 1.00 | 0.50 | m <sup>2</sup> | 1 | |

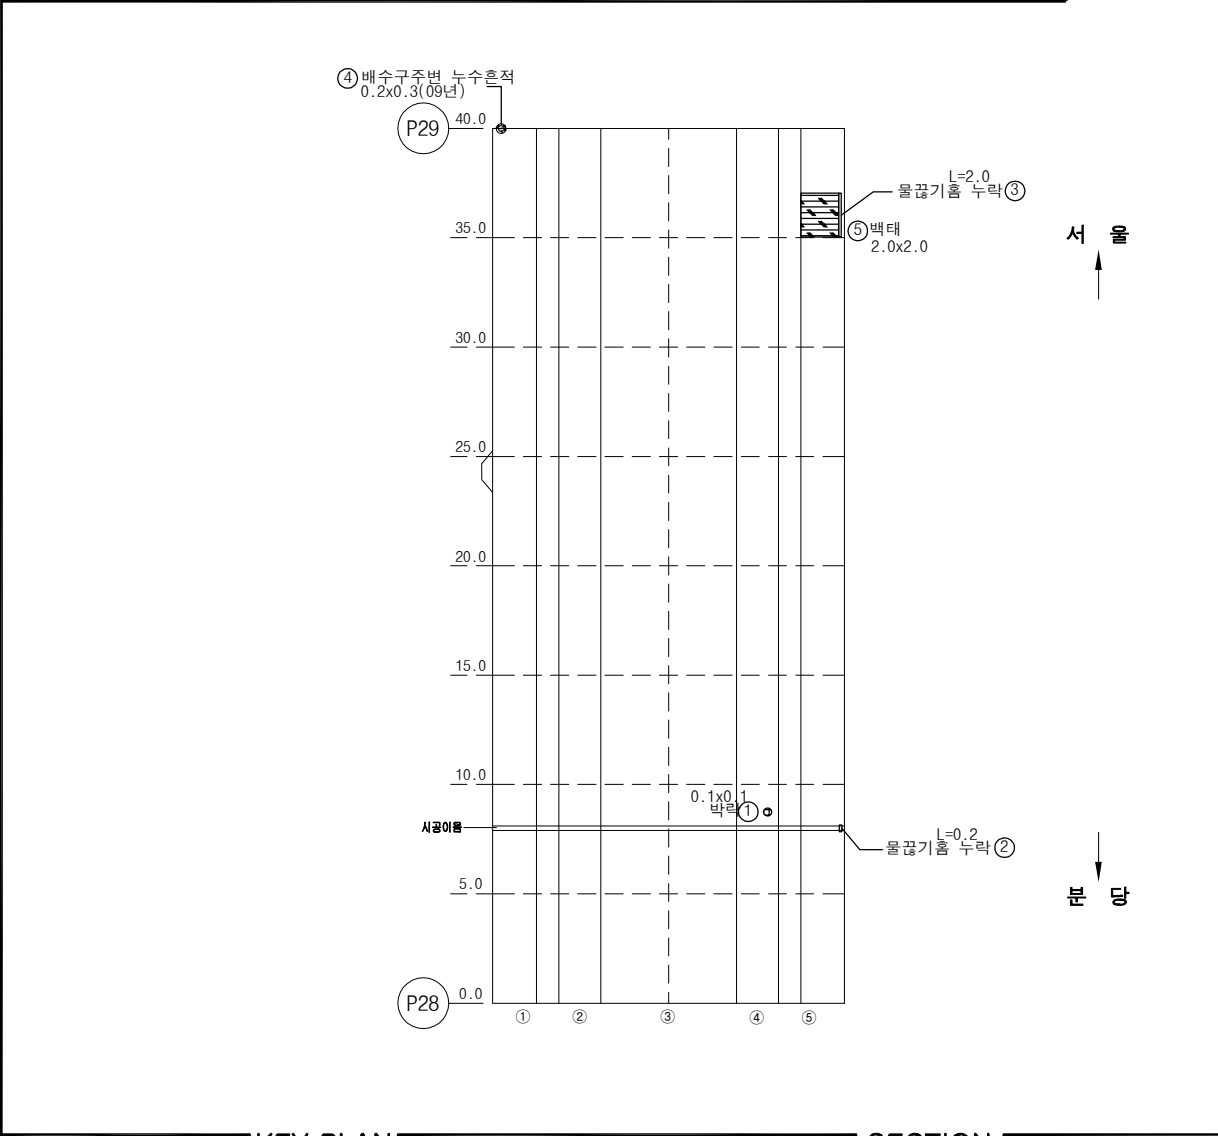
ID : 복정고가교 본선-하행선 box외부(S29)

| 번호 | 손상내용 | 손상물량 | | | | | 비고 |
|---|---|---|---|---|---|---|---|
| 4 | 배수구 주변 누수 흔적 | 0.3 | 0.2 | 0.06 | m² | 1 | |

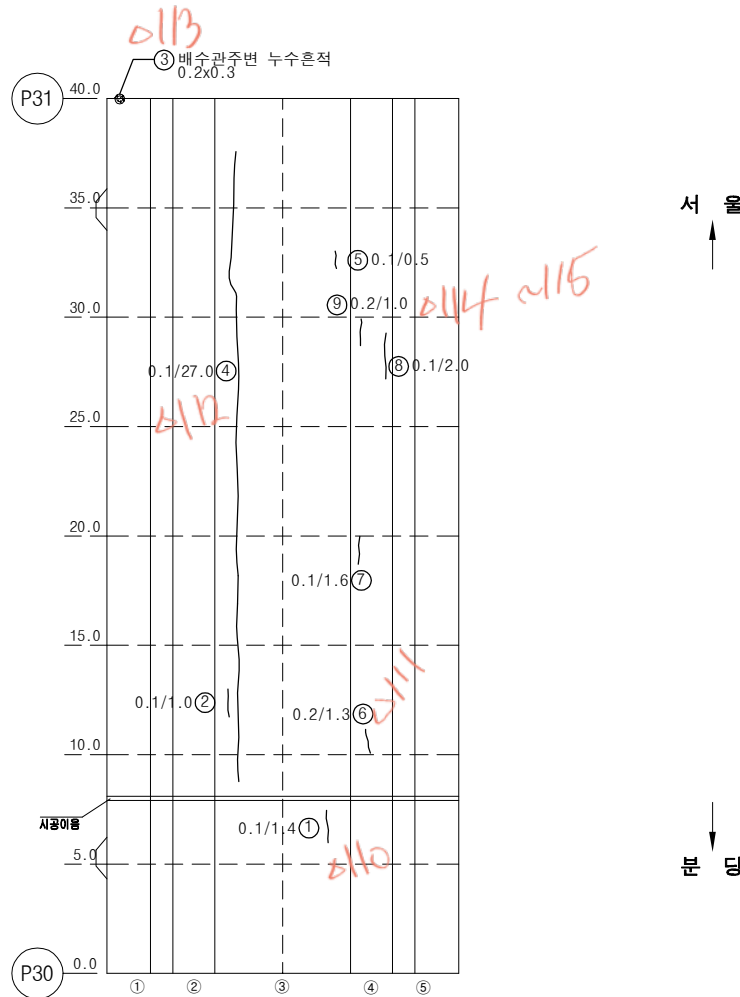
# ID : 복정고가교 본선-하행선 box외부(S31)

| 번호 | 손상내용 | 손상물량 | | | | | 비고 |
|---|---|---|---|---|---|---|---|
| 1 | 균열(0.1mm) | 0.1 | 1.4 | 1.40 | m | 1 | |
| 3 | 배수관 주변 누수흔적 | 0.3 | 0.25 | 0.08 | m <sup>2</sup> | 1 | |
| 4 | 균열(0.1mm) | 0.1 | 27 | 27.00 | m | 1 | |
| 6 | 균열(0.2mm) | 0.2 | 1.3 | 1.30 | m | 1 | |

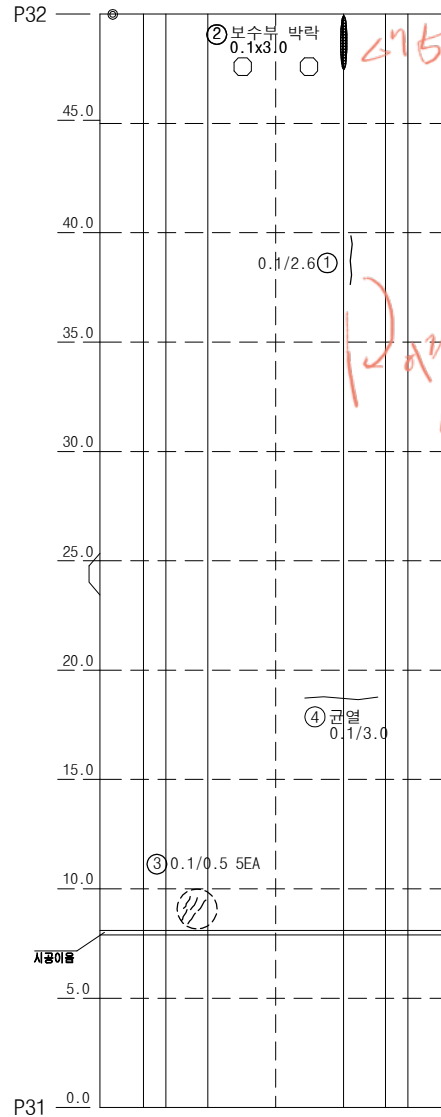
# ID : 복정고가교 본선-하행선 box외부(S32)

| 번호 | 손상내용 | 손상물량 | | | | | 비고 |
|---|---|---|---|---|---|---|---|
| 1 | 균열(0.1mm) | 0.1 | 2.6 | 2.60 | m | 1 | |
| 3 | 균열(0.1mm) | 0.1 | 0.5 | 2.50 | m | 5 | |
| 4 | 균열(0.1mm) | 0.1 | 3 | 3.00 | m | 1 | |

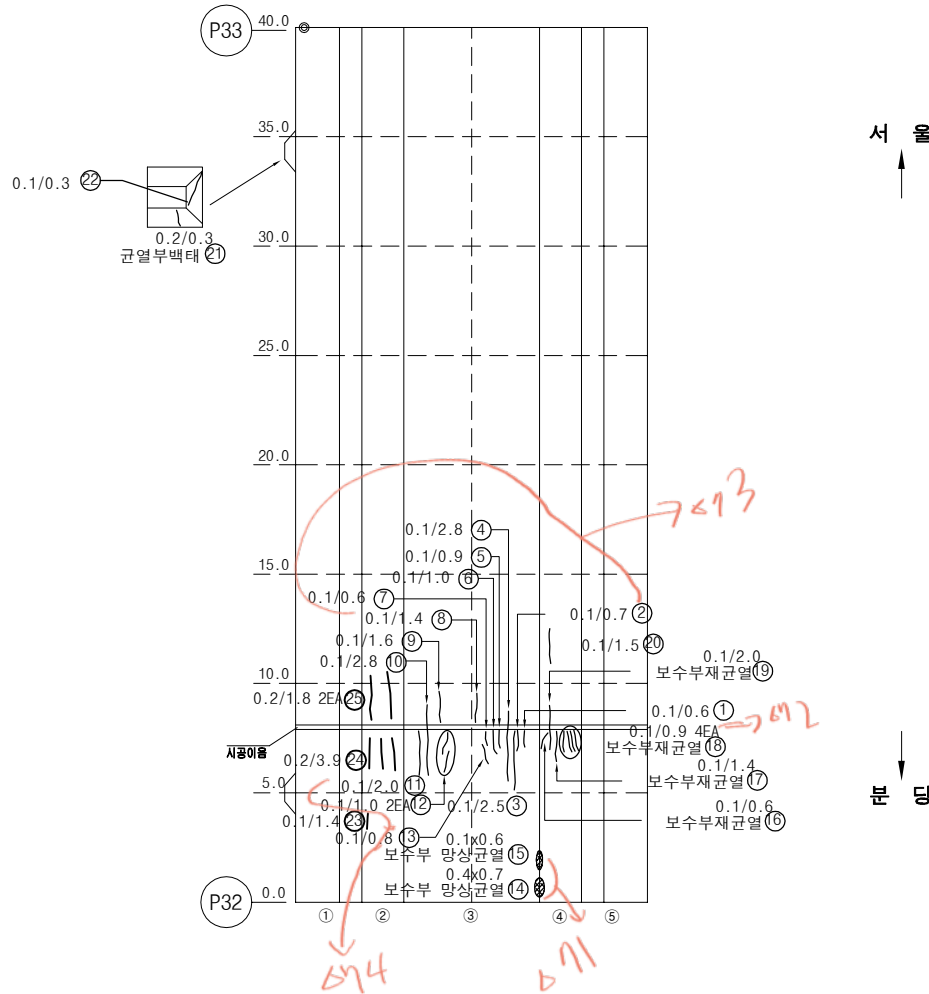
| 번호 | 손상내용 | 손상물량 | | | | | 비고 |
|---|---|---|---|---|---|---|---|
| 1 | 균열(0.1mm) | 0.1 | 0.6 | 0.60 | m | 1 | |
| 14 | 보수부망상균열 | 0.6 | 0.1 | 0.06 | m² | 1 | |
| 15 | 보수부망상균열 | 0.7 | 0.4 | 0.28 | m² | 1 | |
| 21 | 균열부백태 | 0.2 | 0.3 | 0.30 | m | 1 | |
| 24 | 균열(0.2mm) | 0.2 | 3.9 | 3.90 | m | 1 | |
| 25 | 균열(0.2mm) | 0.2 | 1.8 | 3.60 | m | 2 | |

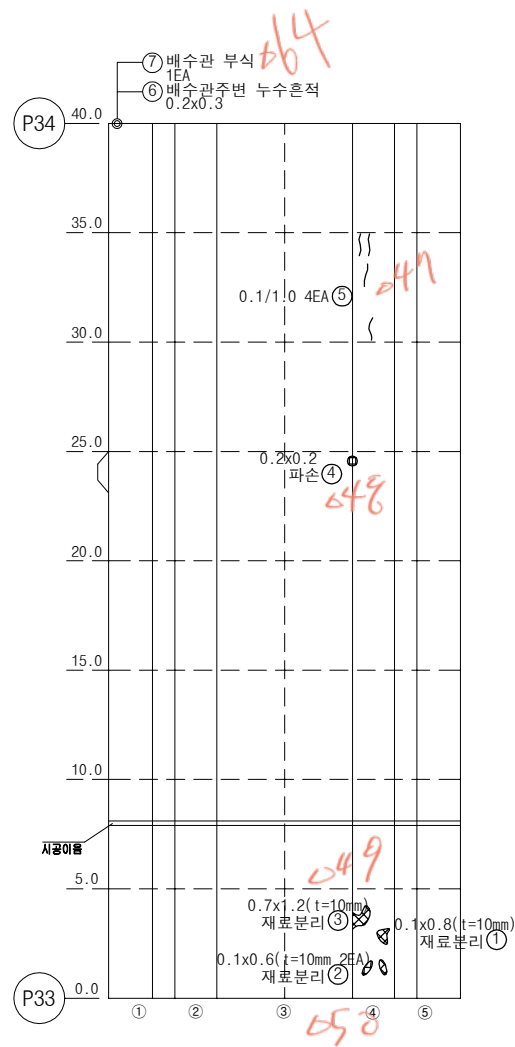
| 번호 | 손상내용 | 손상물량 | | | | | 비고 |
|---|---|---|---|---|---|---|---|
| 5 | 균열(0.1mm) | 0.1 | 1 | 4.00 | m | 4 | |
| 6 | 배수관부식 | | | 1 | EA | 1 | |
| 7 | 배수관 주변 누수흔적 | 0.2 | 0.3 | 0.06 | m <sup>2</sup> | 1 | |
