삼정천교(울산) 교면포장 S1

손 상 물 량 표

| 용역명 | | 2023년 부산울산고속도로 정밀안전점검 및 성능평가용역 | | | |

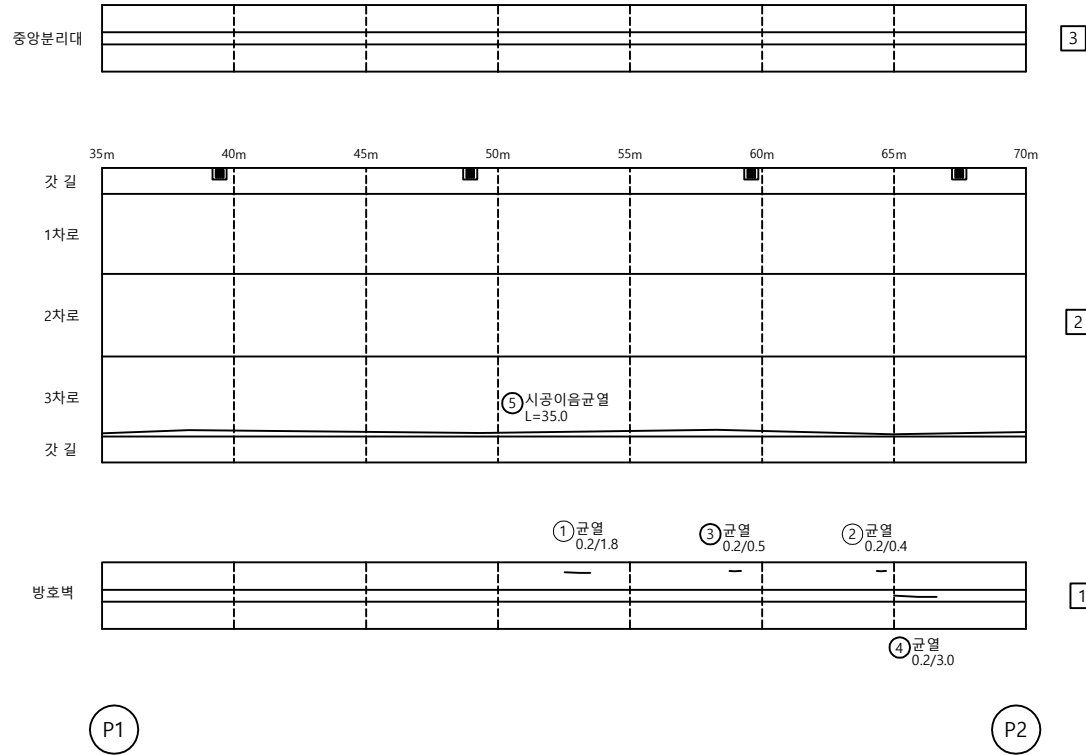
| 번호 | 선/구 | 부재명 | 손 상 현 황 | 손 상 규 모 | | | | | 비고 |
|---|---|---|---|---|---|---|---|---|---|
| 1 | 구 | 교면포장 | 시공이음 균열 | 1.0 | 10.0 | | 3 | m | 30.00 |
| 2 | 구 | 교면포장 | 시공이음 균열 | 1.0 | 35.0 | | 1 | m | 35.00 |
| 3 | 구 | 방호벽 | 균열 | 0.2 | 15.0 | | 1 | m | 15.00 |
| 4 | 신 | 방호벽 | 균열 | 0.2 | 0.5 | | 2 | m | 1.00 |

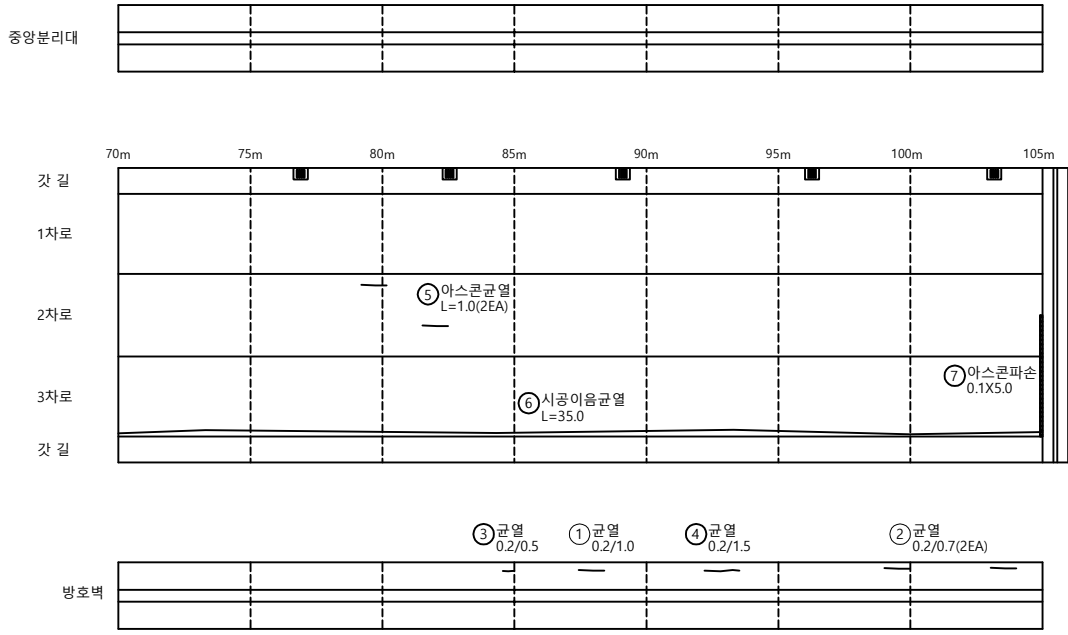
| 번호 | 신/구 | 부재명 | 손 상 현 황 | 손 상 규 모 | | | | | | 비고 |
|---|---|---|---|---|---|---|---|---|---|---|
| 1 | 구 | 교면포장 | 시공이음 균열 | 1.0 | 35.0 | | 1 | m | 35.00 | |
| 2 | 구 | 교면포장 | 시공이음 균열 | 1.0 | 2.0 | | 1 | m | 2.00 | |
| 3 | 신 | 방호벽 | 균열 | | 2.0 | 0.5 | 1 | m | 1.00 | |
| 4 | 신 | 교면포장 | 포장균열 | 1.0 | 5.0 | | 1 | m | 5.00 | |

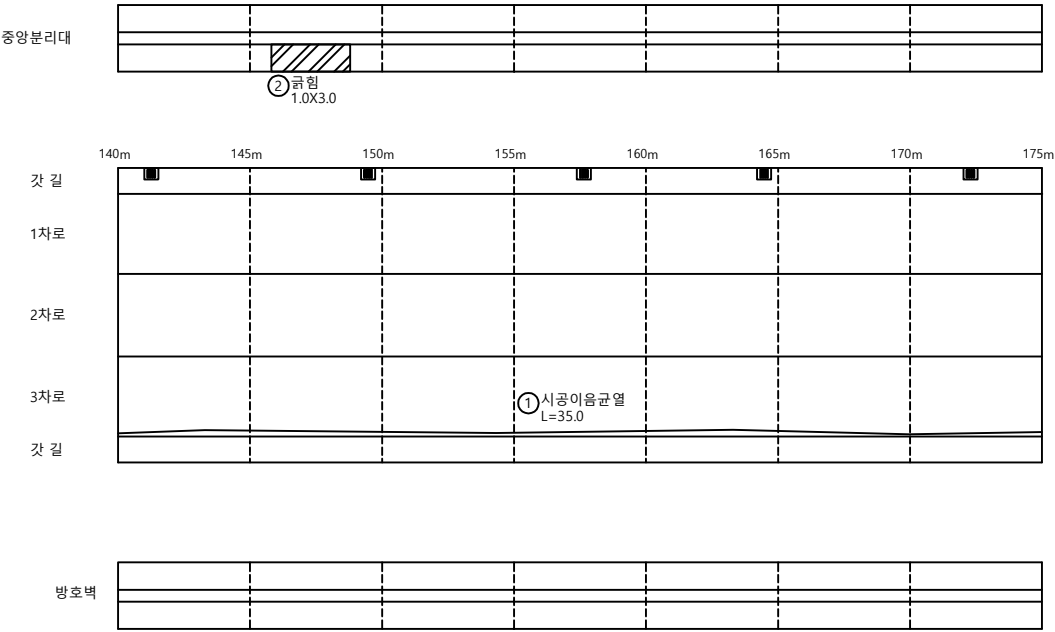
| 번호 | 신/구 | 부재명 | 손 상 현 경 | 손 상 규 모 | | | | | 비 고 |
|---|---|---|---|---|---|---|---|---|---|
| 1 | 구 | 교면포장 | 시공이음균열 | 1.0 | 35.0 | | 1 | m | 35.00 |

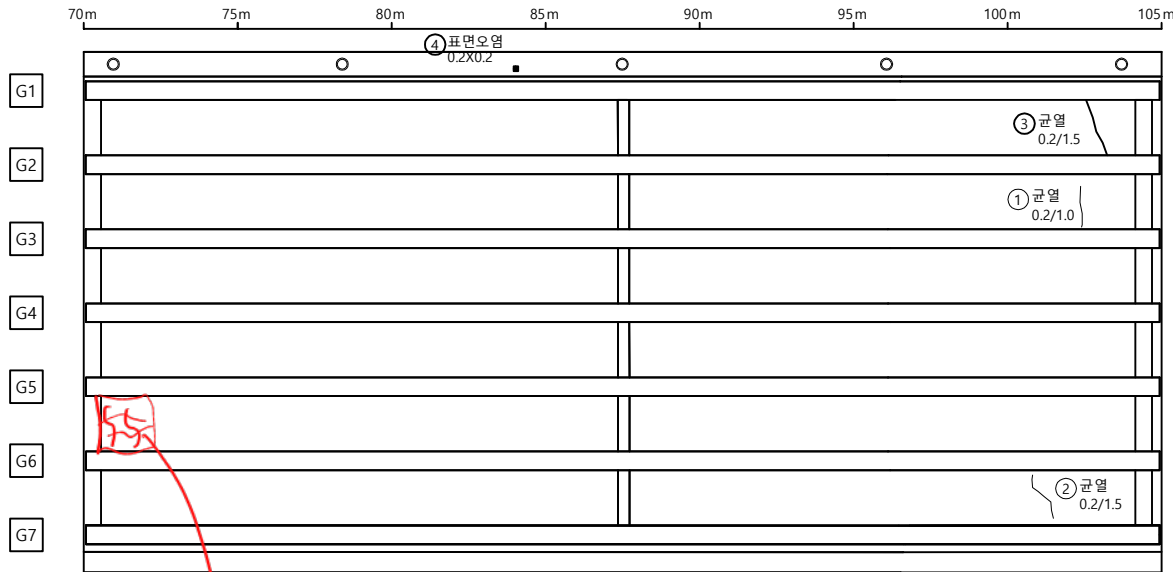
CCV=0.2mm  
1.0x1.0 0.311

| 번호 | 선/구 | 부재명 | 손 상 현 황 | 손 상 규 모 | | | | | 비고 |
|---|---|---|---|---|---|---|---|---|---|
| 1 | 구 | 배덕판 | 평상균열 | 0.2 | 2.0 | 2.0 | 1 | m | 4.00 |
| 2 | 구 | 배덕판 | 균열 | 0.2 | 2.0 | | 1 | m | 2.00 |
| 3 | 구 | 배덕판 | 균열 | 0.2 | 1.0 | | 1 | m | 1.00 |
| 4 | 구 | 배덕판 | 균열 | 0.2 | 0.5 | | 1 | m | 0.50 |
| 9 | 구 | 배덕판 | 보수부 재균열 | 0.2 | 2.0 | | 1 | m | 2.00 |
| 10 | 구 | 배덕판 | 평상균열 | 0.2 | 1.0 | 1.0 | 1 | m <sup>2</sup> | 1.00 |
| 11 | 구 | 배덕판 | 균열 | 0.2 | 1.0 | | 1 | m | 1.00 |
| 13 | 신 | 배덕판 | 평상균열 | 0.2 | 1.5 | 1.5 | 1 | m <sup>2</sup> | 2.25 |

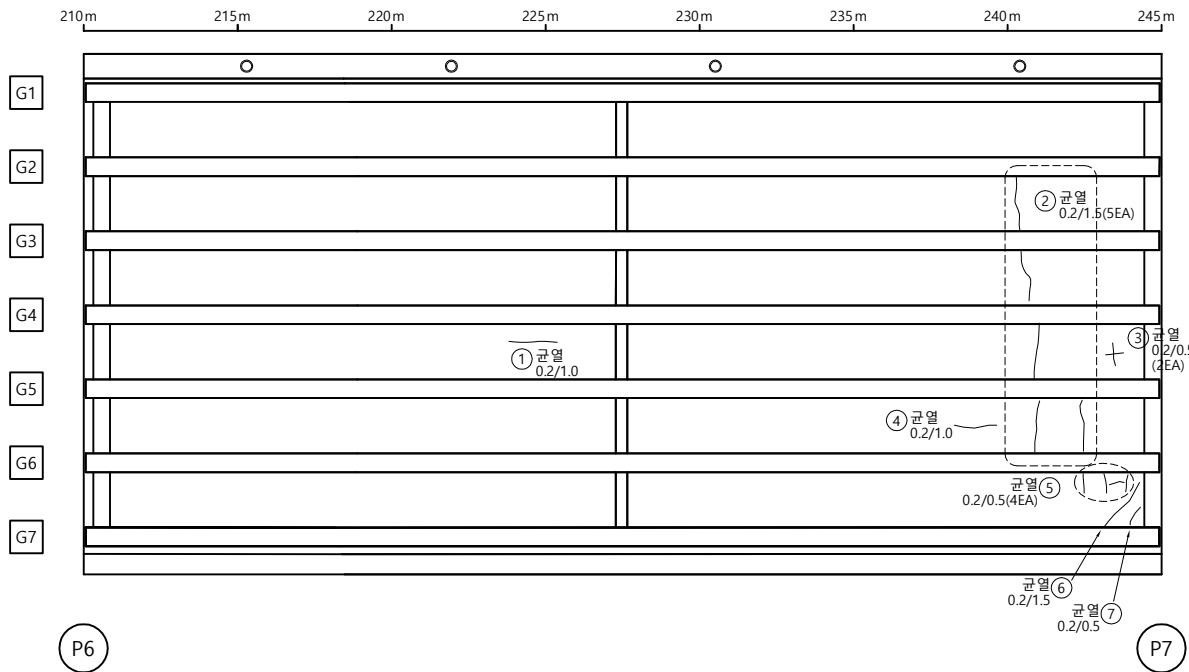
| 번호 | 선/구 | 부재명 | 손상현황 | 손상규모 | | | | | | 비고 |
|---|---|---|---|---|---|---|---|---|---|---|
| 1 | 구 | 바닥판 | 균열 | 0.2 | 1.0 | | 1 | m | 1.00 | |
| 2 | 구 | 바닥판 | 균열 | 0.2 | 1.5 | | 5 | m | 7.50 | |
| 3 | 구 | 바닥판 | 균열 | 0.2 | 0.5 | | 2 | m | 1.00 | |
| 4 | 구 | 바닥판 | 균열 | 0.2 | 1.0 | | 1 | m | 1.00 | |
| 5 | 구 | 바닥판 | 균열 | 0.2 | 0.5 | | 4 | m | 2.00 | |
| 6 | 구 | 바닥판 | 균열 | 0.2 | 1.5 | | 1 | m | 1.50 | |

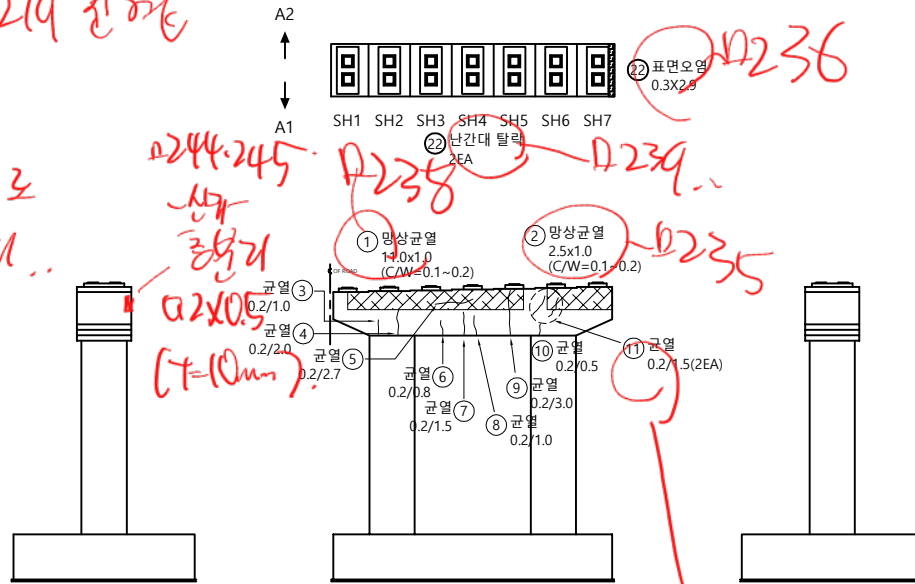
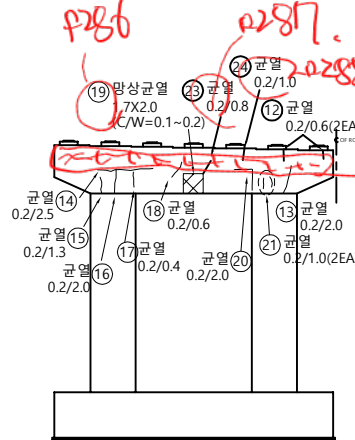
보수부망상관변  
(C/W=0.1mm)  
15.0x1.0 상대

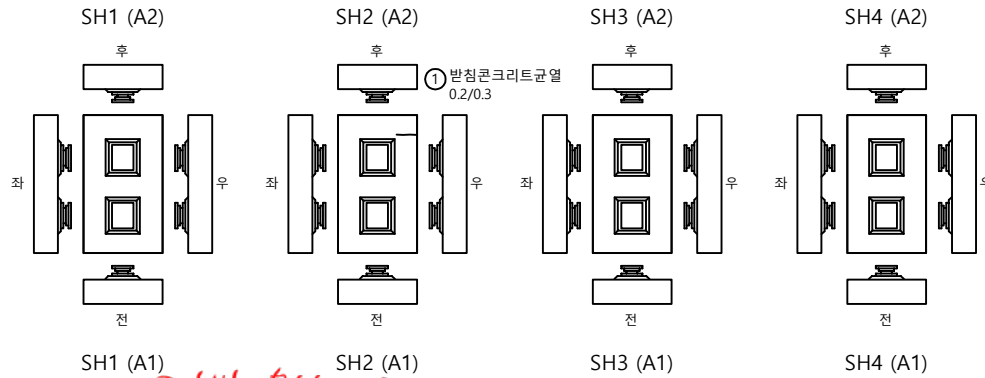
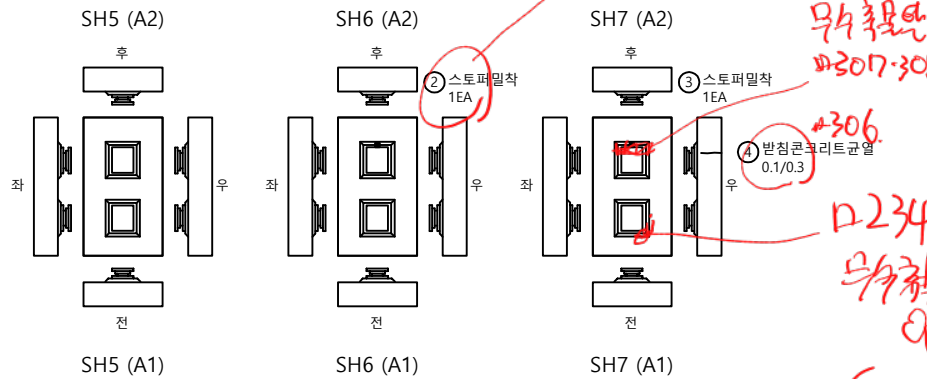
삼정천교(울산) 받침장치 P2

0.2X0.5  
무사철강방식 (CW=0.1mm)  
0307~308  
0306  
0234  
무사철강방식  
0.2X0.2 - 신주  
(CW=0.1mm)

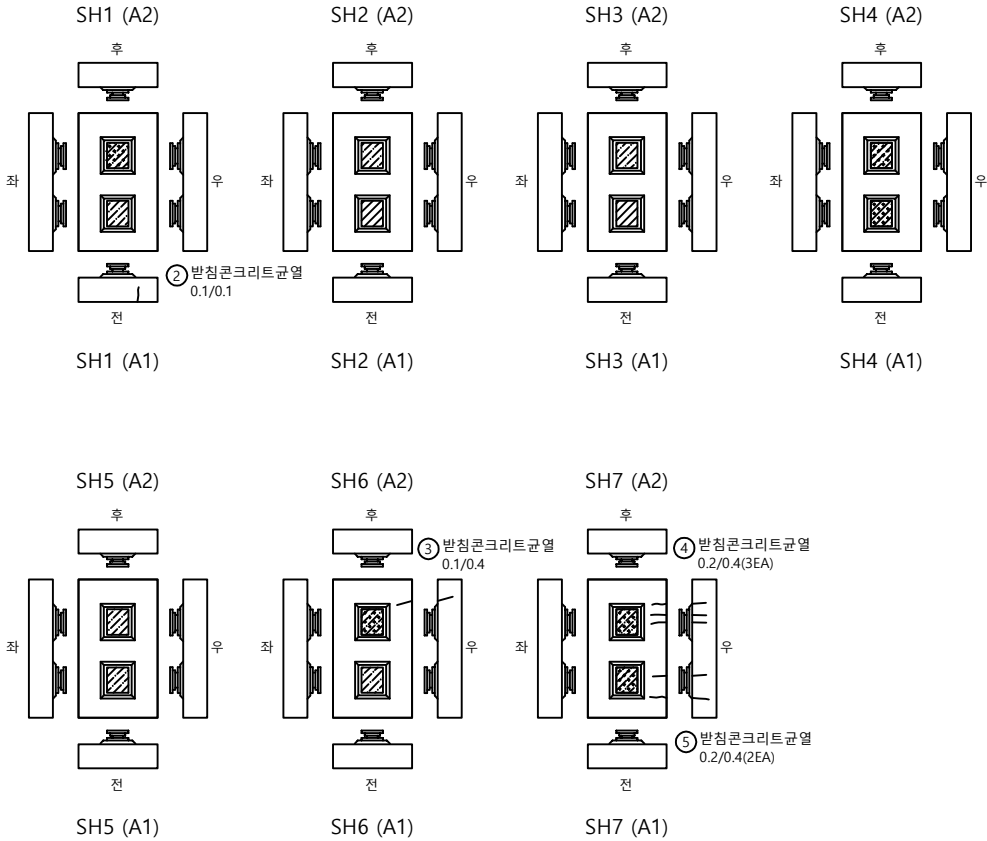
- ① 받침본체밀림  
14EA  
⑥ 플레이트부식  
6EA

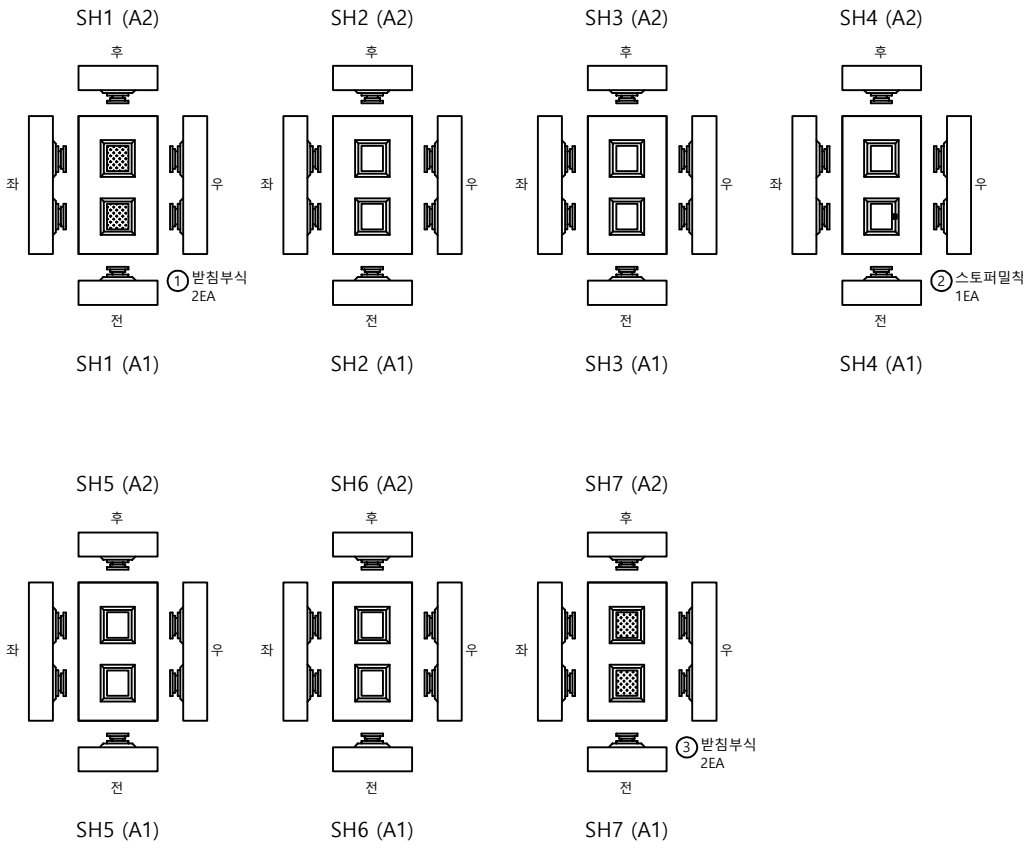
| 받침장치 | | | | | | | | | |

| 받침장치 | | | | | | | | | |
|---|---|---|---|---|---|---|---|---|---|
| 1 | 구 | 교량받침 | 플레이트 부식 | | | | 2 | EA | 2.00 |
| 3 | 구 | 교량받침 | 플레이트 부식 | | | | 2 | EA | 2.00 |

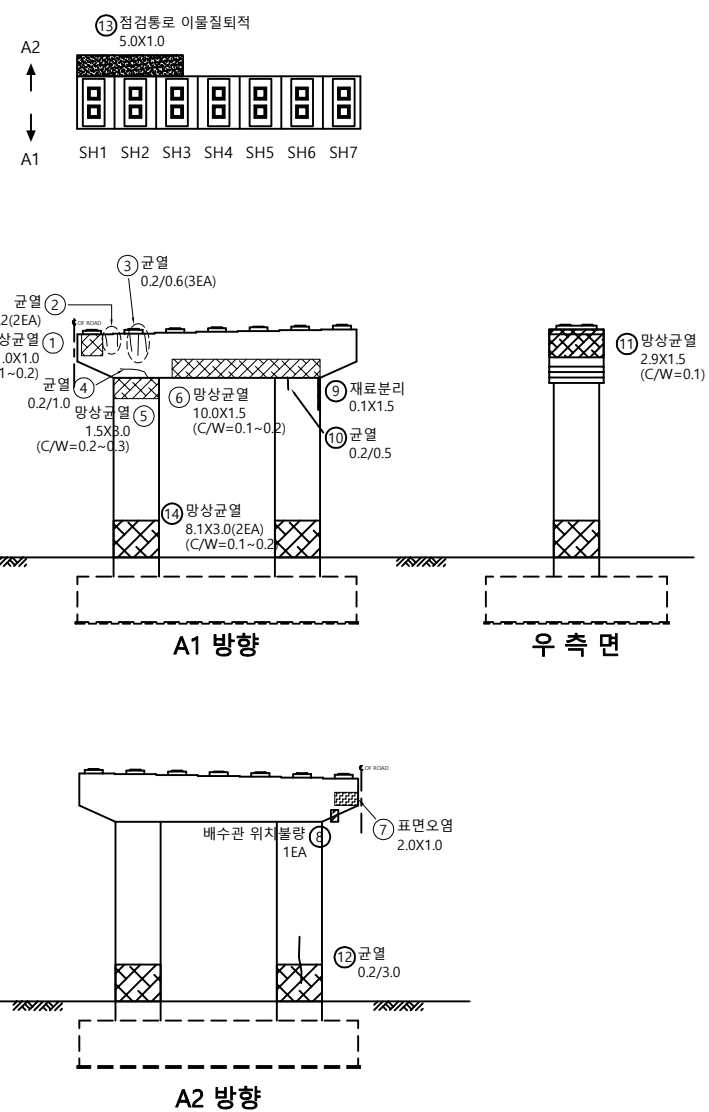
| 교각<br>P7 | | | | | | | | | |

| 교각<br>P7 | | | | | | | | | |
|---|---|---|---|---|---|---|---|---|---|
| 1 | 구 | 교각 | 망상균열 | 0.2 | 1.0 | 1.0 | 1 | m | 1.00 |
| 2 | 구 | 교각 | 균열 | 0.1 | 0.2 | | 2 | m | 0.40 |
| 3 | 구 | 교각 | 균열 | 0.2 | 0.6 | | 3 | m | 1.80 |
| 4 | 구 | 교각 | 균열 | 0.2 | 1.0 | | 1 | m | 1.00 |
| 5 | 구 | 교각 | 망상균열 | 0.2 | 3.0 | 1.5 | 1 | m | 4.50 |
| 6 | 구 | 교각 | 망상균열 | 0.2 | 10.0 | 1.5 | 1 | m | 15.00 |
| 10 | 구 | 교각 | 균열 | 0.2 | 0.5 | | 1 | m | 0.50 |
| 11 | 구 | 교각 | 망상균열 | 0.2 | 2.9 | 1.5 | 1 | m | 4.35 |
| 12 | 구 | 교각 | 균열 | 0.2 | 3.0 | | 1 | m | 3.00 |
| 14 | 신 | 교각 | 망상균열 | 0.2 | 8.1 | 3.0 | 2 | m | 48.60 |

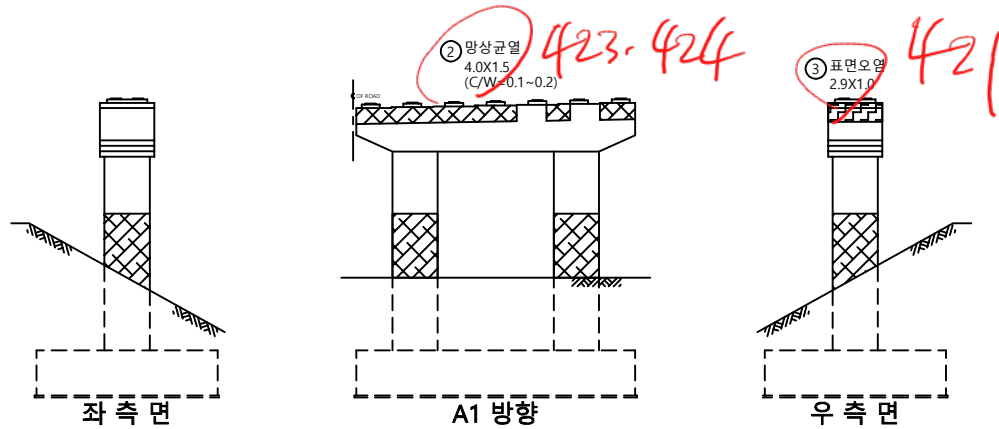
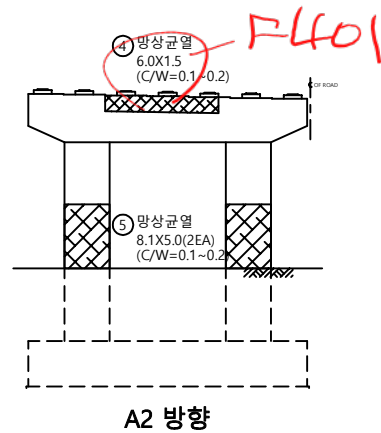
| 교각 P8 | | | | | | | | | |

| 교각 P8 | | | | | | | | | |
|---|---|---|---|---|---|---|---|---|---|
| 1 | 구 | 교각 | 균열 | 0.2 | 0.1 | | 4 | m | 0.40 |
| 2 | 구 | 교각 | 망상균열 | 0.2 | 4.0 | 1.5 | 1 | m <sup>2</sup> | 6.00 |
| 4 | 구 | 교각 | 망상균열 | 0.2 | 6.0 | 1.5 | 1 | m <sup>2</sup> | 9.00 |
| 5 | 구 | 교각 | 망상균열 | 0.2 | 8.1 | 5.0 | 2 | m <sup>2</sup> | 81.00 |

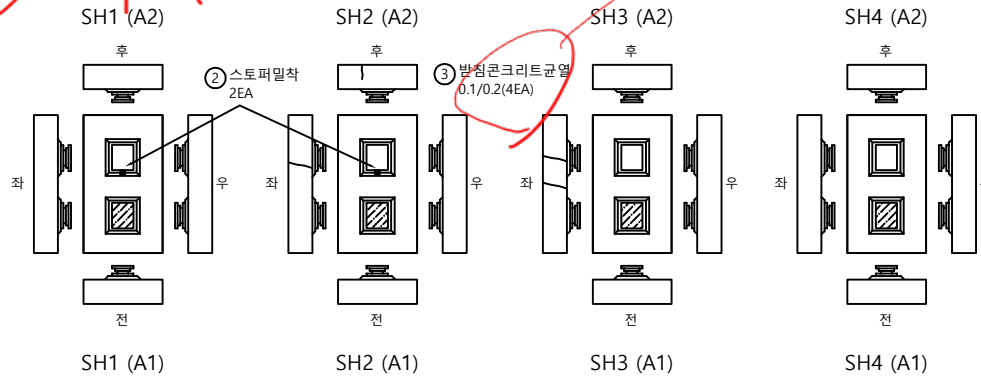
D402~415 P8-911~7(A2)

① 고무재밀림 7EA
