# 용소교(부산) 교면포장 S1

| 용역명 | | 2023년 부산울산고속도로 정밀안전점검 및 성능평가용역 | | | |

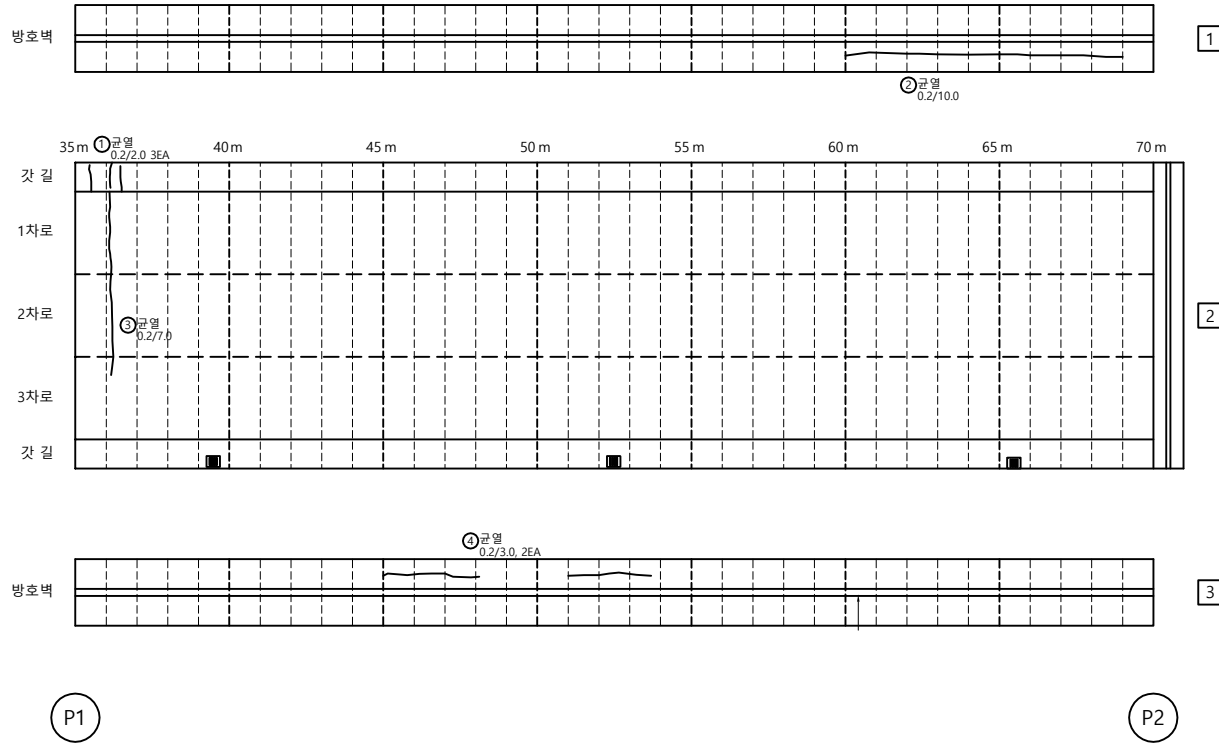
## 손 상 물 량 표

| 교면포장 | | | | | | | | | |
|---|---|---|---|---|---|---|---|---|---|
| 1 | 구 | 교면포장 | 모장균열 | 0.2 | 2.0 | | 3 | m | 6.00 |
| 2 | 구 | 방호벽 | 균열 | 0.2 | 10.0 | | 1 | m | 10.00 |
| 3 | 구 | 교면포장 | 모장균열 | 0.2 | 7.0 | | 1 | m | 7.00 |
| 4 | 구 | 방호벽 | 균열 | 0.2 | 3.0 | | 2 | m | 6.00 |

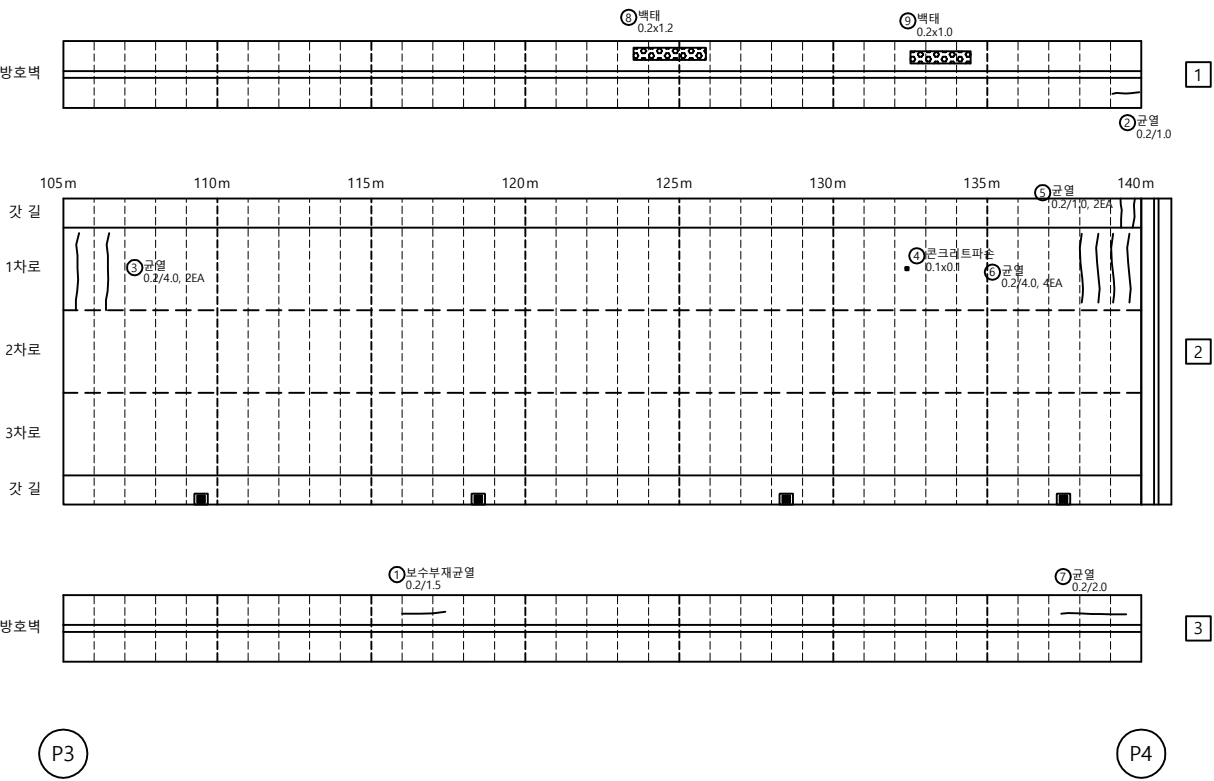
| 변호 | 신/구 | 부재명 | 손 상 현 황 | 손 상 규 모 | | | | | 비고 |
|---|---|---|---|---|---|---|---|---|---|
| 1 | 구 | 방호벽 | 보수부재균열 | 0.2 | 1.5 | | 1 | m | 1.50 |
| 2 | 구 | 방호벽 | 균열 | 0.2 | 1.0 | | 1 | m | 1.00 |
| 3 | 구 | 교면포장 | 포장균열 | 0.2 | 4.0 | | 2 | m | 8.00 |
| 5 | 구 | 교면포장 | 포장균열 | 0.2 | 1.0 | | 2 | m | 2.00 |
| 6 | 구 | 교면포장 | 포장균열 | 0.2 | 4.0 | | 4 | m | 16.00 |
| 7 | 구 | 방호벽 | 균열 | 0.2 | 2.0 | | 1 | m | 2.00 |

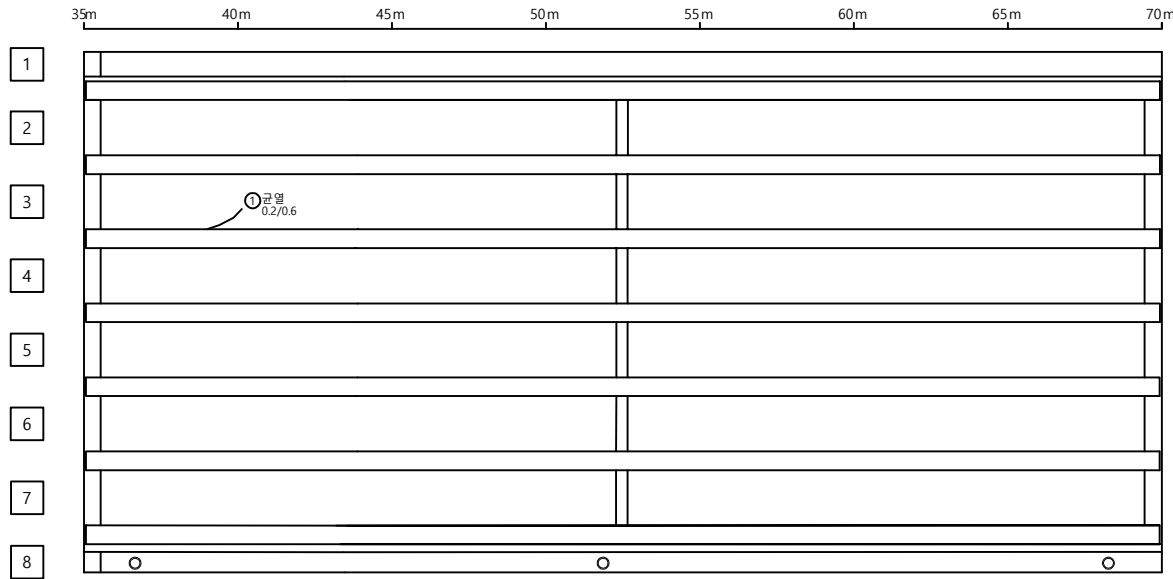
| 번호 | 신/구 | 부재명 | 손 상 현 경 | 손 상 규 모 | | | | | | 비고 |
|---|---|---|---|---|---|---|---|---|---|---|
| 1 | 구 | 바닥판 | 균열 | 0.2 | 0.6 | | 1 | m | 0.60 | |

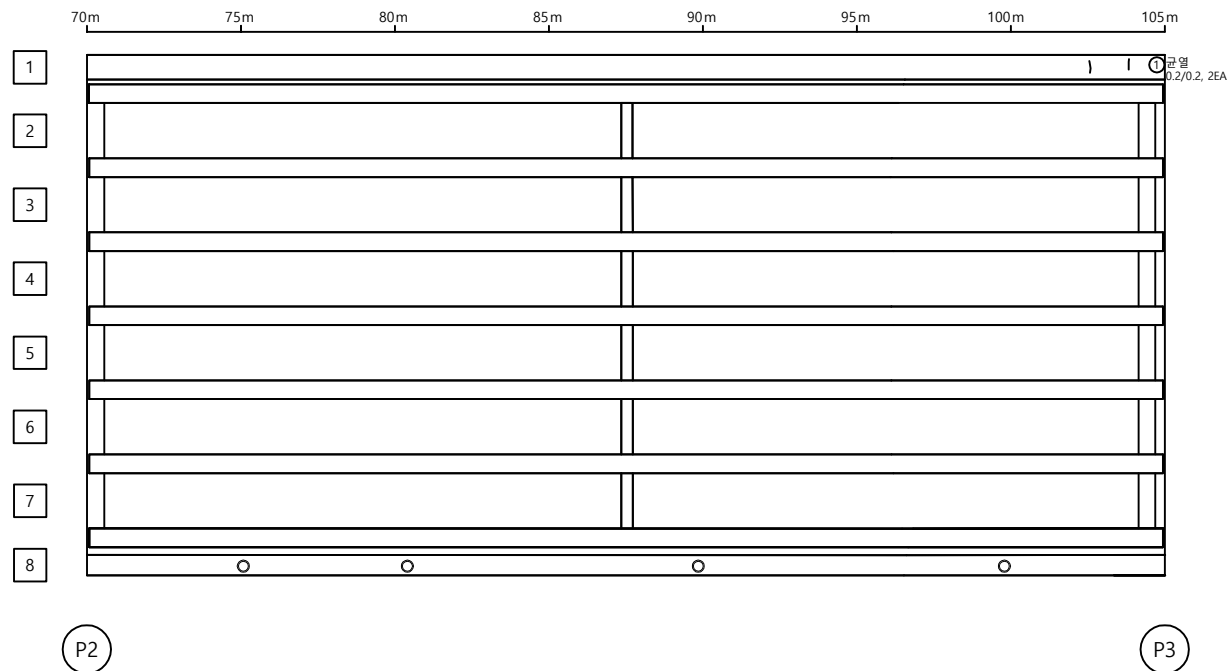
| 번호 | 신/구 | 부재명 | 손 상 현 경 | 손 상 규 모 | | | | | | 비고 |
|---|---|---|---|---|---|---|---|---|---|---|
| 1 | 구 | 바닥판 | 균열 | 0.2 | 0.2 | | 2 | m | 0.40 | |

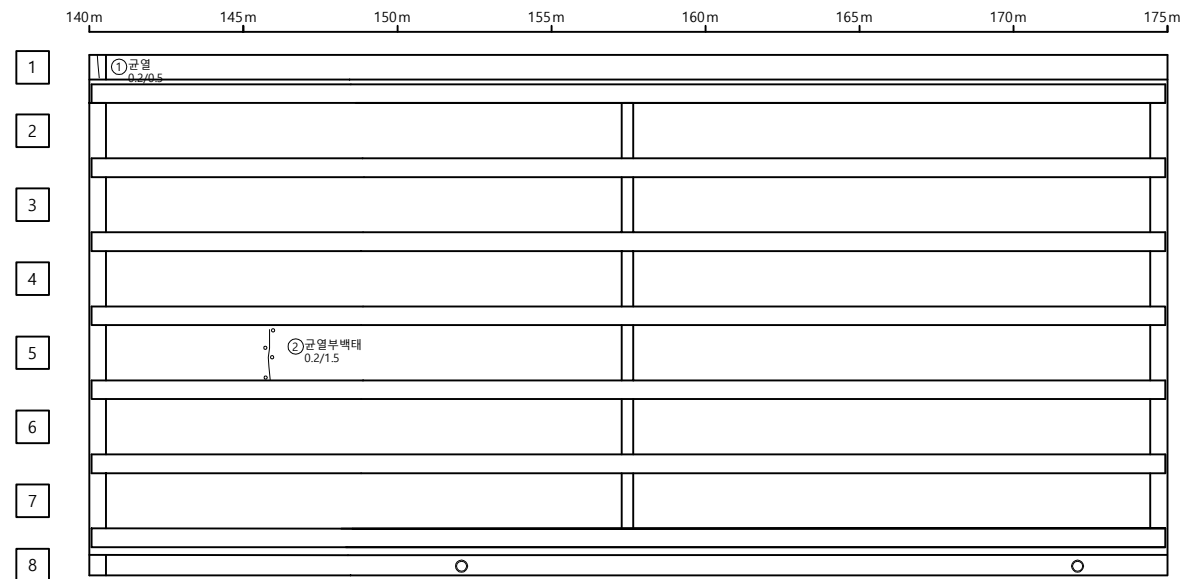
| 번호 | 신/구 | 부재명 | 손 상 전 경 | 손 상 규 모 | | | | | | 비고 |
|---|---|---|---|---|---|---|---|---|---|---|
| 1 | 구 | 바닥판 | 균열 | 0.2 | 0.5 | | 1 | m | 0.50 | |
| 2 | 구 | 바닥판 | 균열부백태 | 0.2 | 1.5 | | 1 | m | 1.50 | |

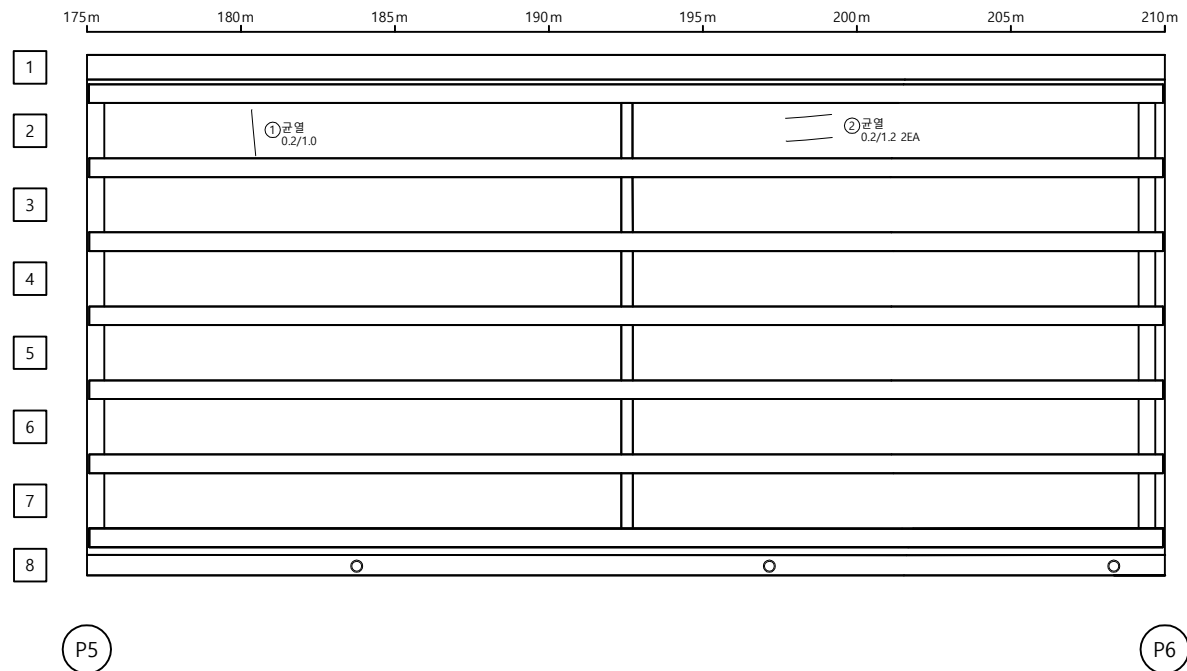
| 바닥판 | | | | | | | | | | |
|---|---|---|---|---|---|---|---|---|---|---|
| 1 | 구 | 배덕판 | 균열 | 0.2 | 1.0 | | 1 | m | 1.00 | |
| 2 | 구 | 배덕판 | 균열 | 0.2 | 1.2 | | 2 | m | 2.40 | |

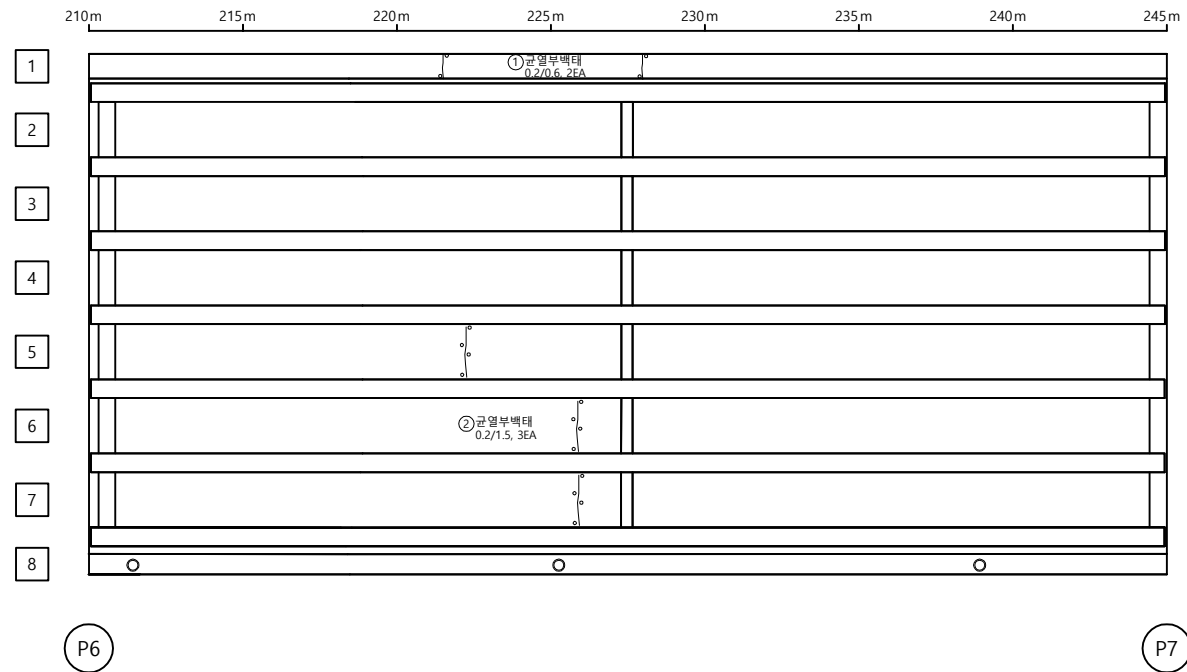
| 바닥판 | | | | | | | | | |
|---|---|---|---|---|---|---|---|---|---|
| 1 | 구 | 바닥판 | 균열부백태 | 0.2 | 0.6 | | 2 | m | 1.20 |
| 2 | 구 | 바닥판 | 균열부백태 | 0.2 | 1.5 | | 3 | m | 4.50 |

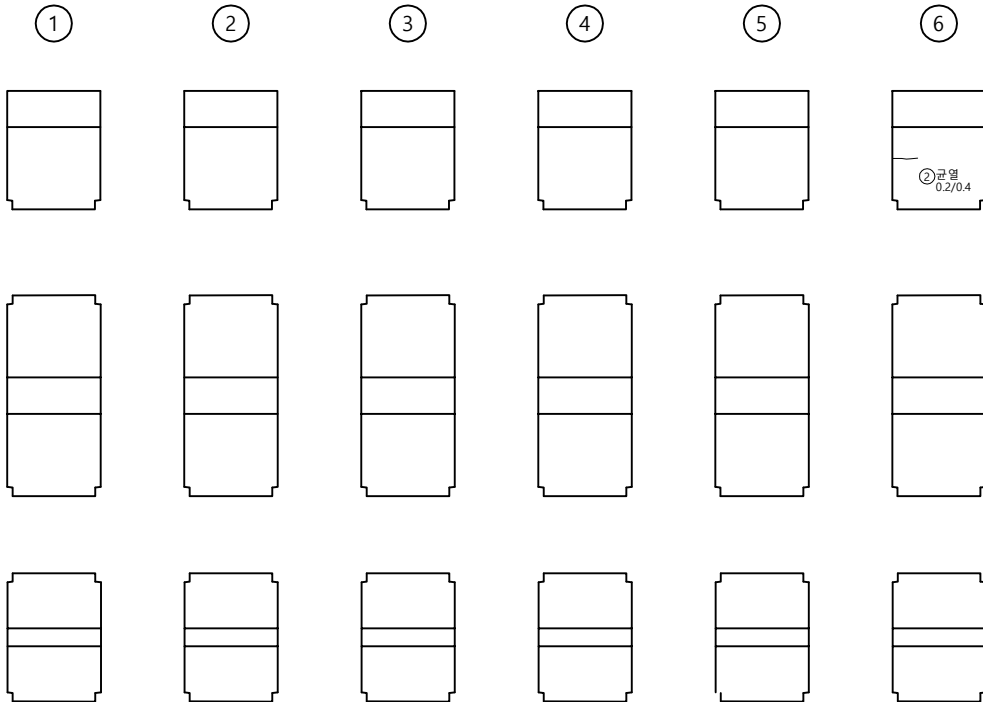
P9

| 번호 | 신/구 | 부재명 | 손 상 현 황 | 손 상 규 모 | | | | | 비고 |
|---|---|---|---|---|---|---|---|---|---|
| 1 | 구 | 가로보 | 균열 | 0.2 | 0.4 | | 1 | m | 0.40 |

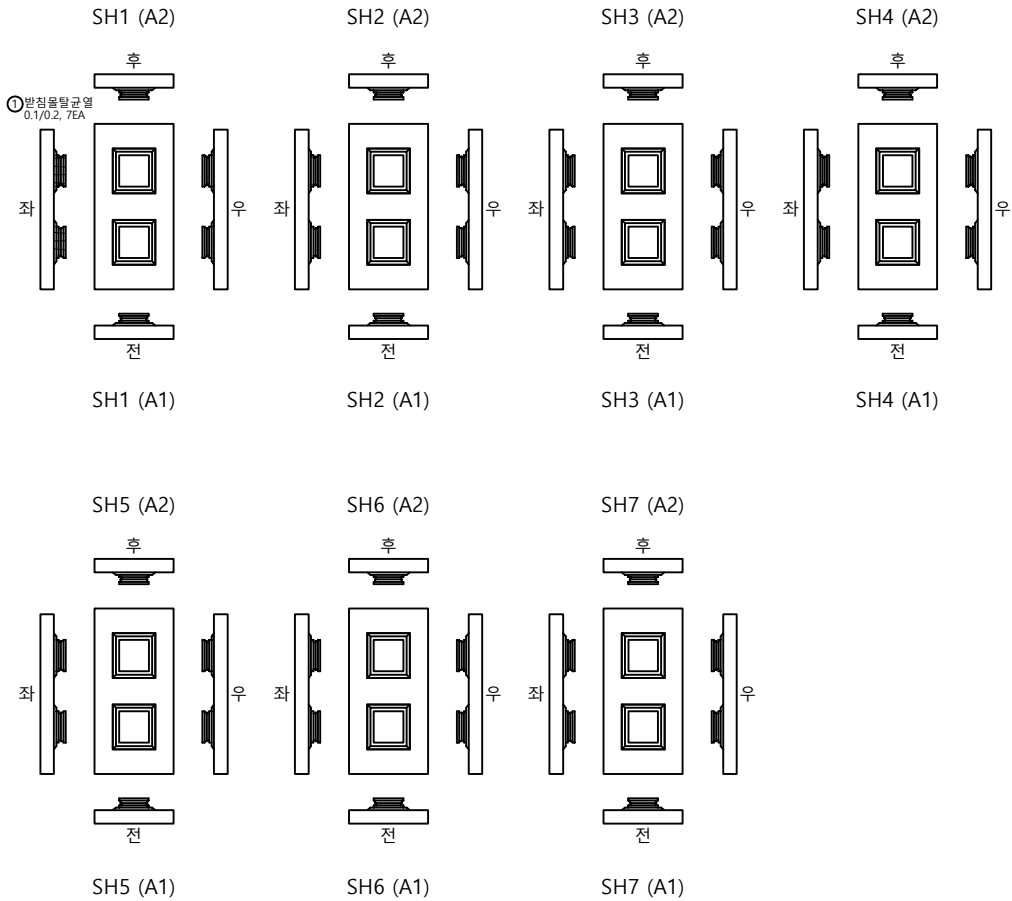
| 번호 | 선/구 | 부재명 | 손 상 현 황 | 손 상 규 모 | | | | | | 비고 |
|---|---|---|---|---|---|---|---|---|---|---|
| 1 | 구 | 교량받침 | 받침물탈 균열 | 0.1 | 0.2 | | 7 | m | 1.40 | |

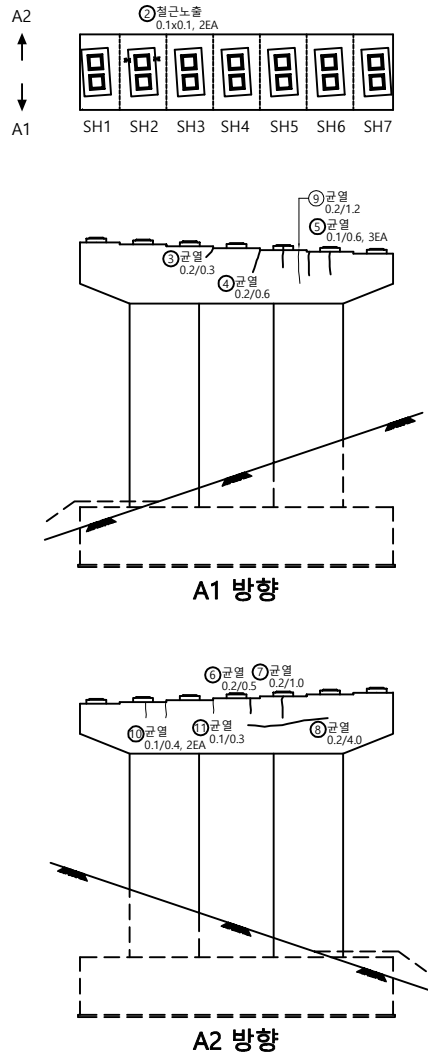
| 교각 | | | | | | | | | | |
|---|---|---|---|---|---|---|---|---|---|---|
| 1 | 구 | 교각 | 균열 | 0.2 | 0.7 | | 2 | m | 1.40 | |
| 3 | 구 | 교각 | 균열 | 0.2 | 0.3 | | 1 | m | 0.30 | |
| 4 | 구 | 교각 | 균열 | 0.2 | 0.6 | | 1 | m | 0.60 | |
| 5 | 구 | 교각 | 균열 | 0.1 | 0.6 | | 3 | m | 1.80 | |
| 6 | 구 | 교각 | 균열 | 0.2 | 0.5 | | 1 | m | 0.50 | |
| 7 | 구 | 교각 | 균열 | 0.2 | 1.0 | | 1 | m | 1.00 | |
| 8 | 구 | 교각 | 균열 | 0.2 | 4.0 | | 1 | m | 4.00 | |
| 9 | 구 | 교각 | 균열 | 0.2 | 1.2 | | 1 | m | 1.20 | |
| 10 | 구 | 교각 | 균열 | 0.1 | 0.4 | | 2 | m | 0.80 | |
| 11 | 구 | 교각 | 균열 | 0.1 | 0.3 | | 1 | m | 0.30 | |

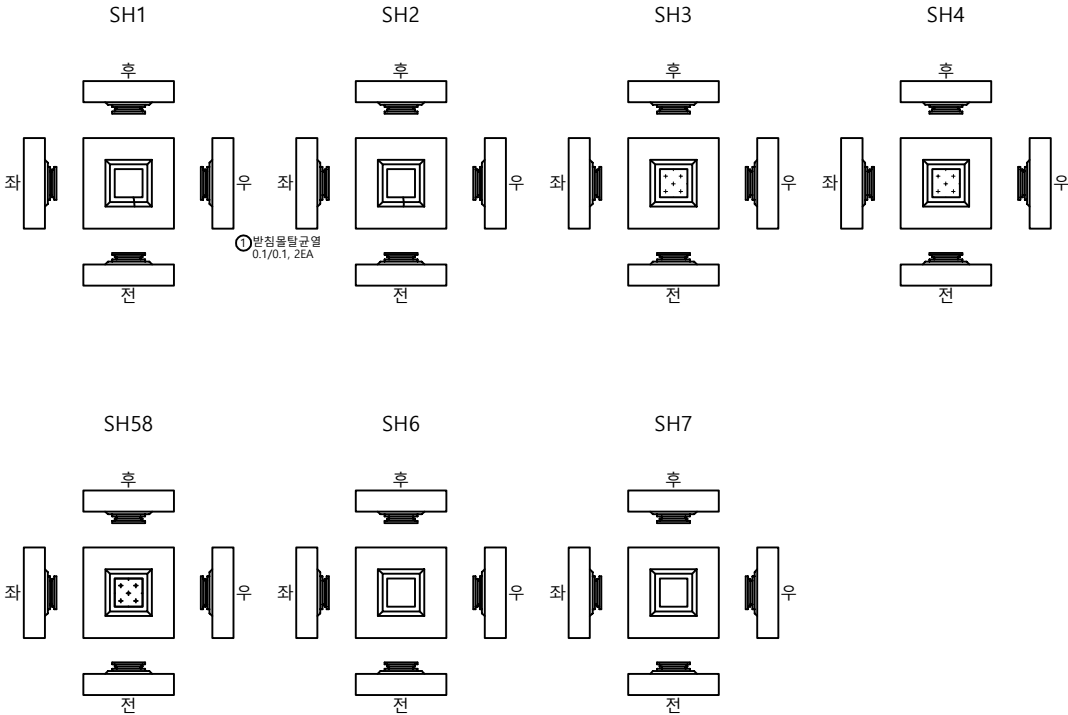
②플레이트 부식  
3EA
