**2017년 상반기 시설물 정기점검 용역**  
**정 기 점 검 사 진 첵**  
**[2종 절토사면 손상현황 사진첩]**

**2017. 06.**

**新 대구부산고속도로주식회사**  
**New DAEGU BUSAN Expressway Co., Ltd.**

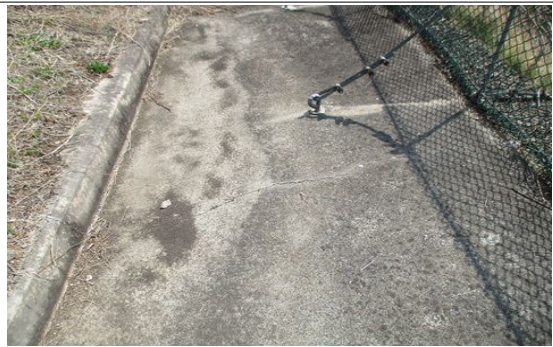
54.21K 1소단배수로 균열

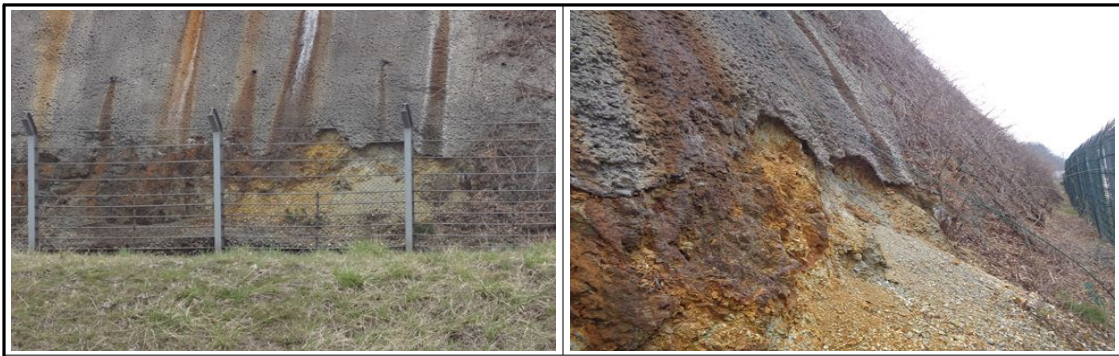
78.13K 1단 숏크리트 파손 및 하부퇴적

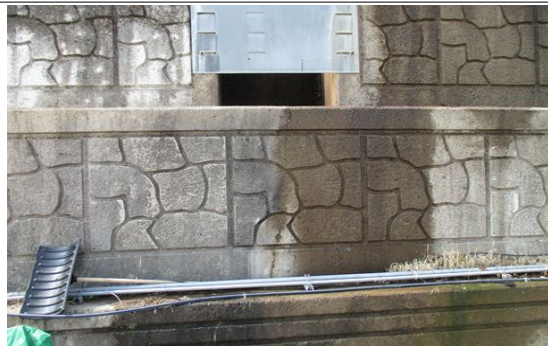
12.85K 계단식옹벽 균열 1.0

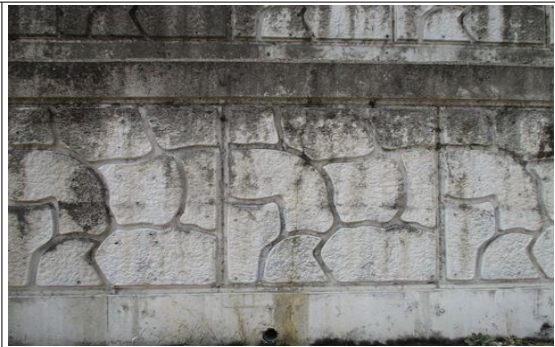
12.91K 계단식옹벽 균열 2.0

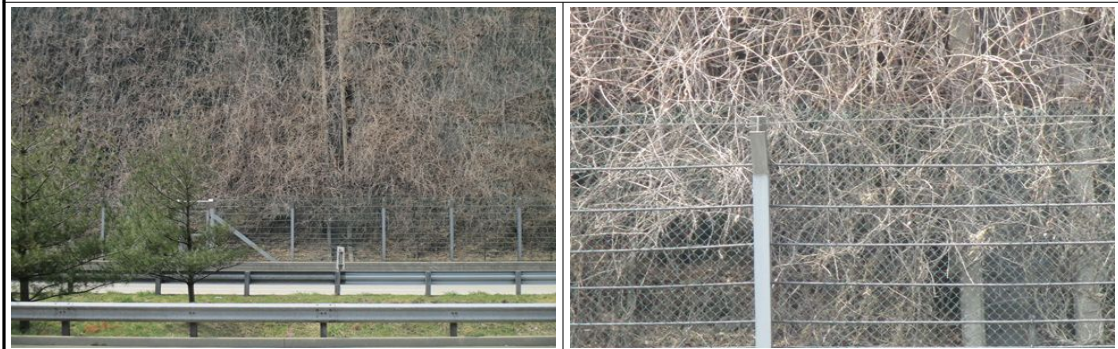
70.77K 1단 슛크리트 파손

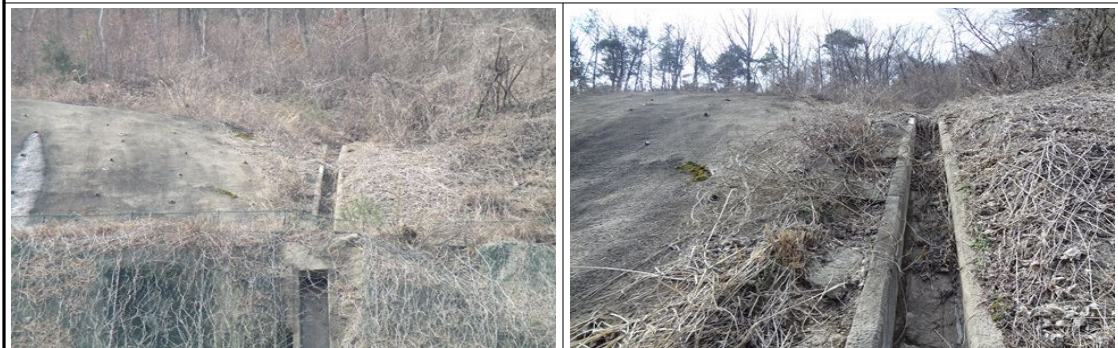
70.77K 2단 슛크리트 파손

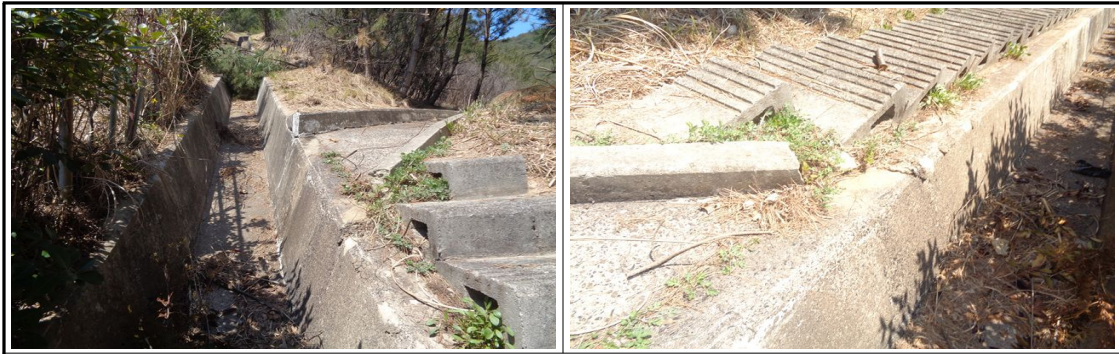
STA.38+450 1소단배수로 파손

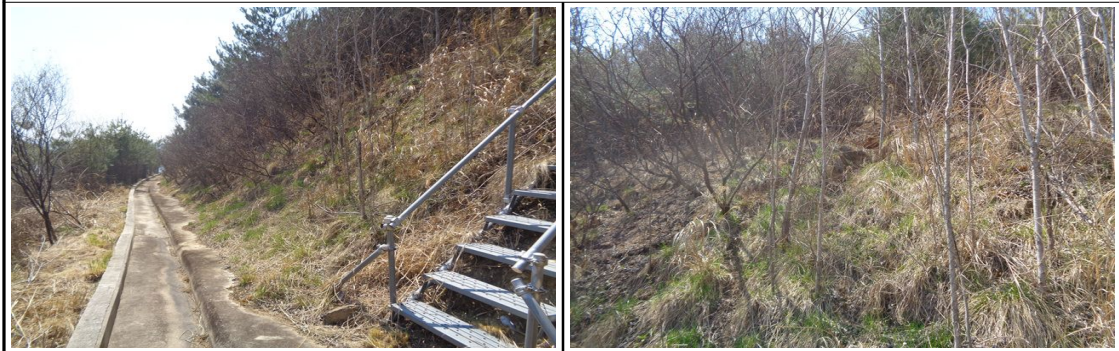
STA.38+540 5~7단 표층유실 및 세굴

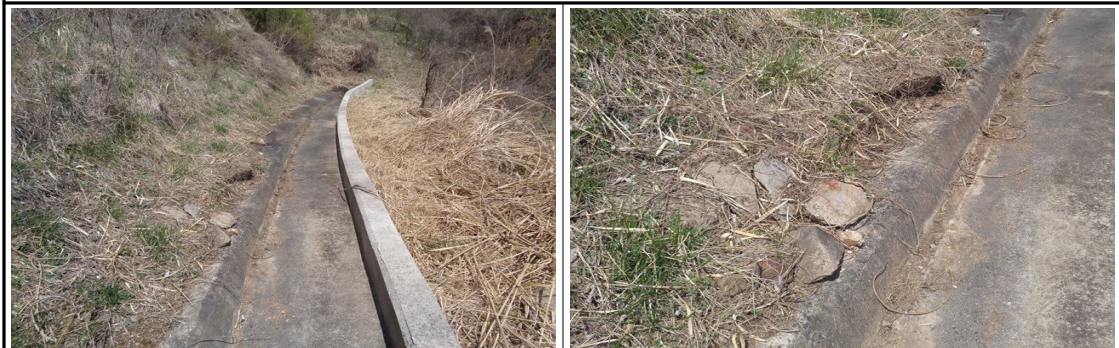
STA.38+570 1소단배수로 낙석퇴적
