# 교 면 포 장

가천교

[주] 우림 종합 엔지니어링

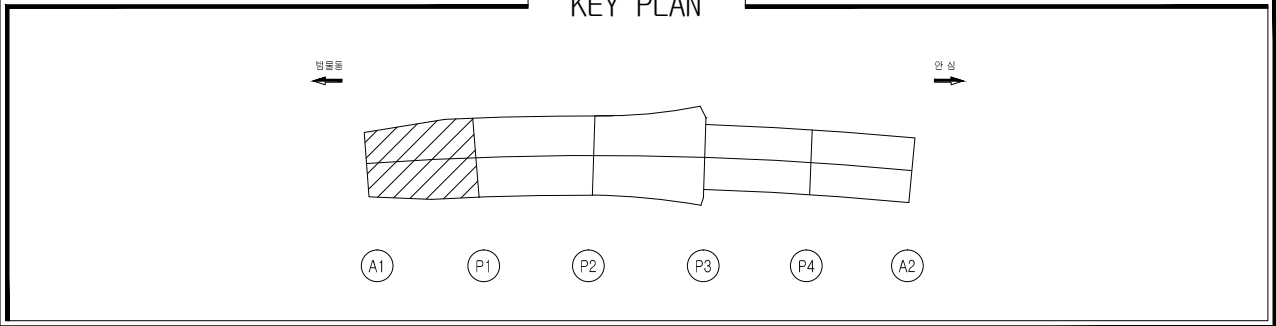
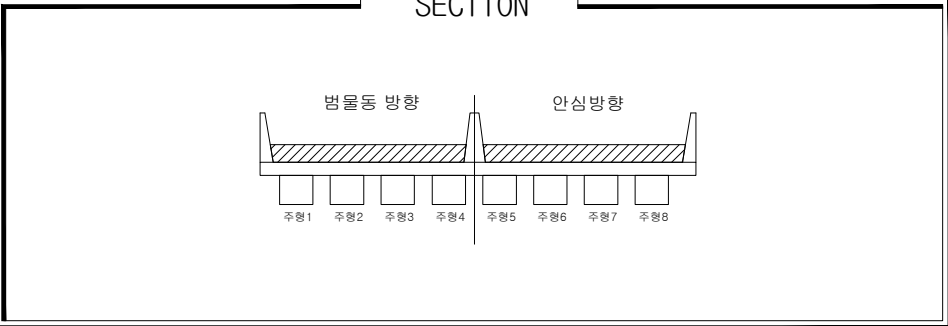
| 일련<br>번호 | 구<br>분 | 부재명<br>(위치) | 결함종류 | 결함규모 | | | | 개소 | 최종보수내역 | | 우선<br>순위 | 비고 |
|---|---|---|---|---|---|---|---|---|---|---|---|---|
| 1 | 구 | 교면포장 | 포장균열 | 2.0 | 2.5 | 2.50 | m | 1 | | | 3 | |
| 2 | 구 | 교면포장 | 포장망상균열 | | 1.0 | 4.0 | 4.00 | ㎡ | 1 | | - | |
| 4 | 구 | 교면포장 | 포장균열 | 1.0 | 2.0 | 2.00 | m | 1 | | | 3 | |
| 5 | 구 | 교면포장 | 포장균열 | 1.0 | 4.0 | 4.00 | m | 1 | | | 3 | |
| 6 | 구 | 교면포장 | 포장균열 | 1.0 | 10.0 | 10.00 | m | 1 | | | 3 | |
| 7 | 신 | 교면포장 | 포장균열 | 1.0 | 4.0 | 4.00 | m | 1 | | | 3 | |

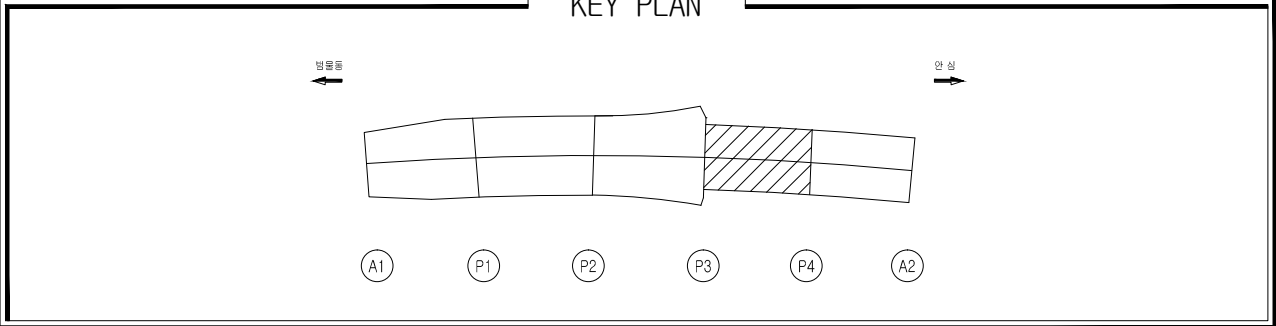
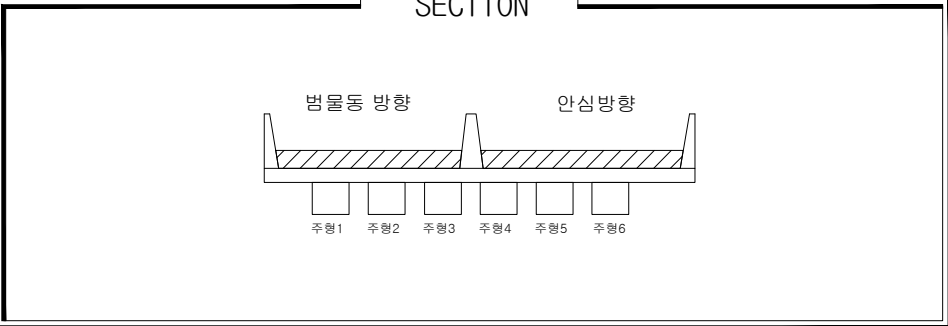
② 포장망상균열  
0.5x56.0 2EA

④포창균열  
1.0/3.0

⑥ 포장균열  
1.0/10.0

⑧포장균열  
3.0/8.0

| 손상물량표 | | | | | | | | | | | |
|---|---|---|---|---|---|---|---|---|---|---|---|
| 1 | 구 | 교면포장 | 포장망상균열 | 0.5 | 50.0 | 50.00 | m | 2 | | | - |

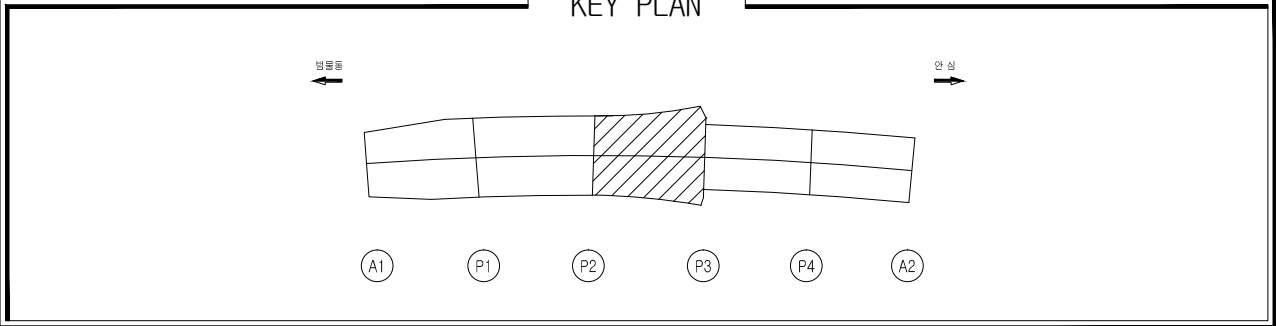
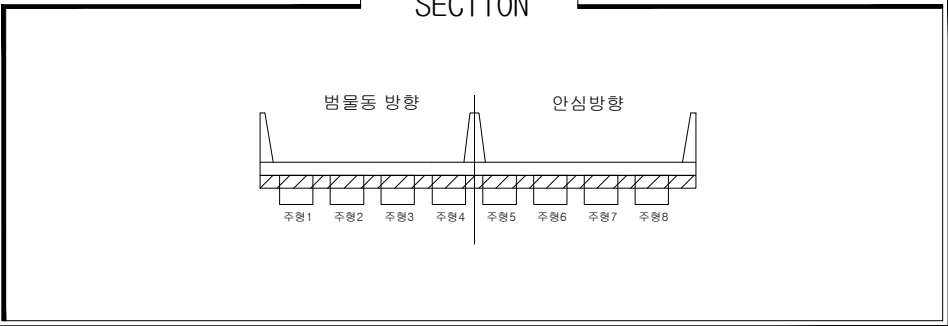
| 일련<br>번호 | 구<br>분 | 부재명<br>(위치) | 결함종류 | 결함 규모 | | | | | 최종보수내역 | | | 우선<br>순위 | 비고 |
|---|---|---|---|---|---|---|---|---|---|---|---|---|---|
| 1 | 신 | 바닥판아면 | 균열 | 0.2 | 1.0 | | 4.00 | m | 4 | | | 3 | |

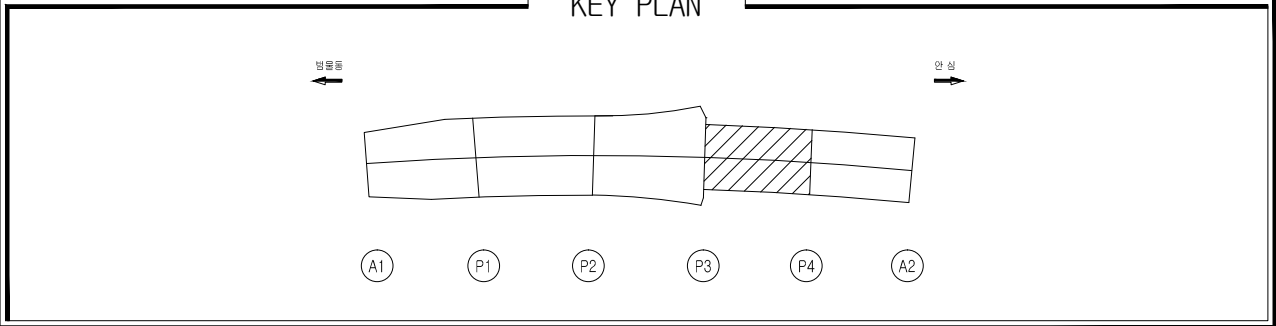
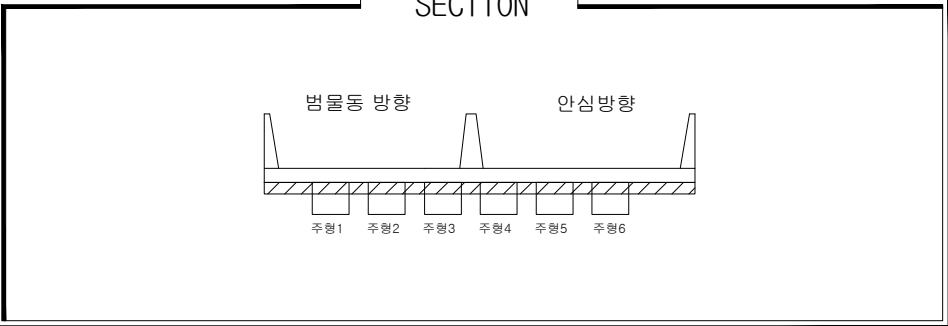
| 일련<br>번호 | 구<br>분 | 부재명<br>(위치) | 결함종류 | 결함구오 | | | | 개소 | 최종보수내역 | | 우선<br>순위 | 비고 |
|---|---|---|---|---|---|---|---|---|---|---|---|---|
| 1 | 구 | 배수시설 | 배수관누수 | | | | 1.00 | ea | 1 | | - | |
| 2 | 신 | 바닥판하면 | 균열 | 0.2 | 1.0 | | 2.00 | m | 2 | | 3 | |

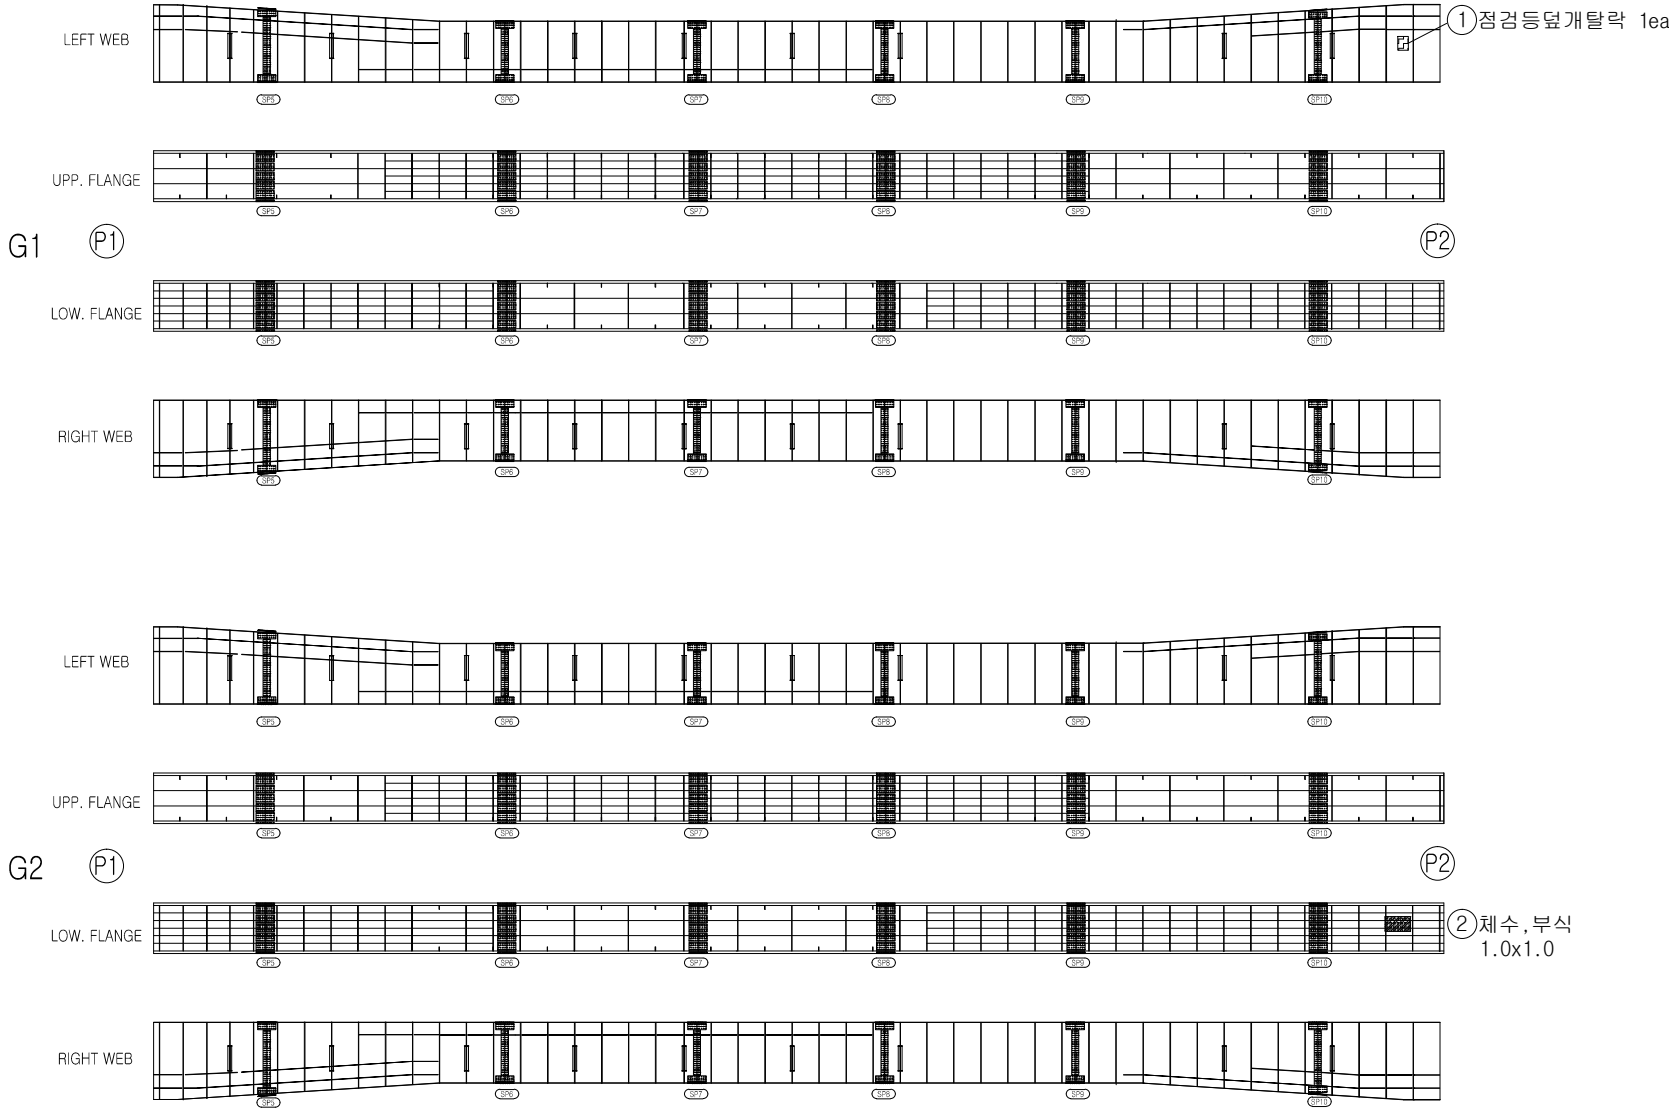
| 일련<br>번호 | 구<br>분 | 부재명<br>(위치) | 결함종류 | 결함규모 | | | | 개소 | 최종보수내역 | | 우선<br>순위 | 비고 |
|---|---|---|---|---|---|---|---|---|---|---|---|---|
| 2 | 신 | 거터내부 | 채수부식 | 1.0 | 1.0 | 1.00 | m² | 1 | | | 1 | |

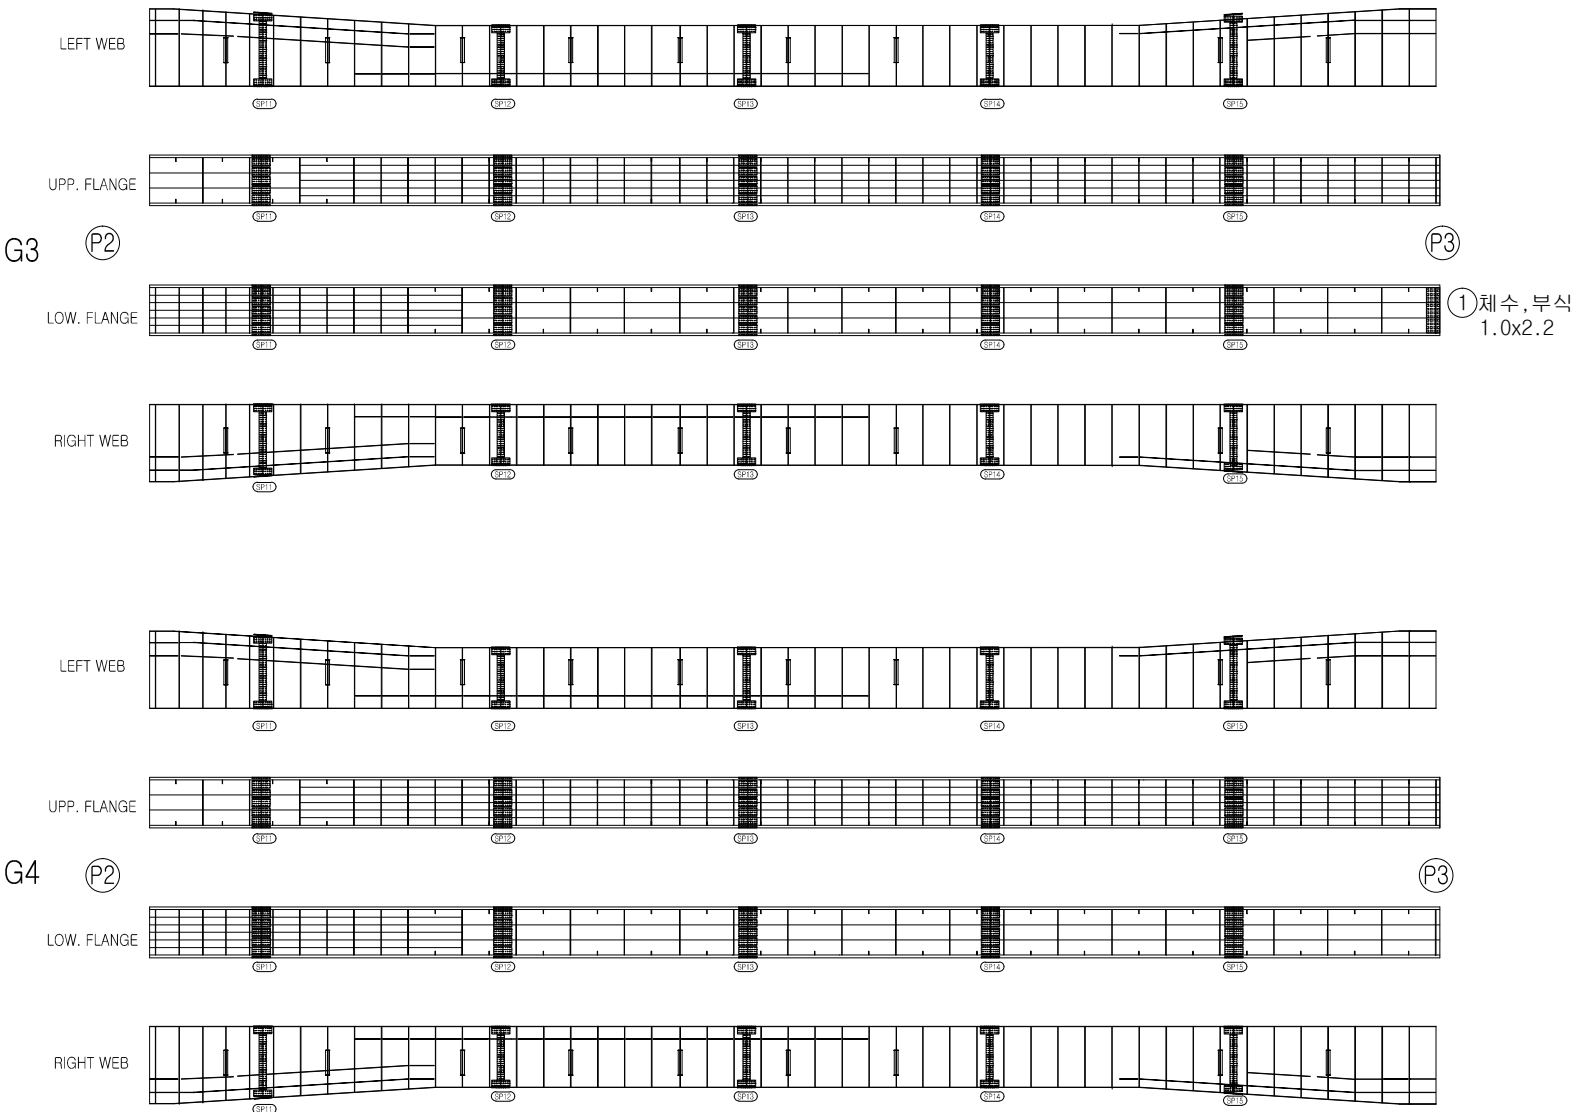
| 일련<br>번호 | 구<br>분 | 부재명<br>(위치) | 결함종류 | 결함 규모 | | | | | 최종보수내역<br>년월 일 | 유선<br>순위 | 비고 |
|---|---|---|---|---|---|---|---|---|---|---|---|
| 1 | 구 | 거터내부 | 채수,부식 | | 1.0 | 2.2 | 2.20 | ㎡ | 1 | | |

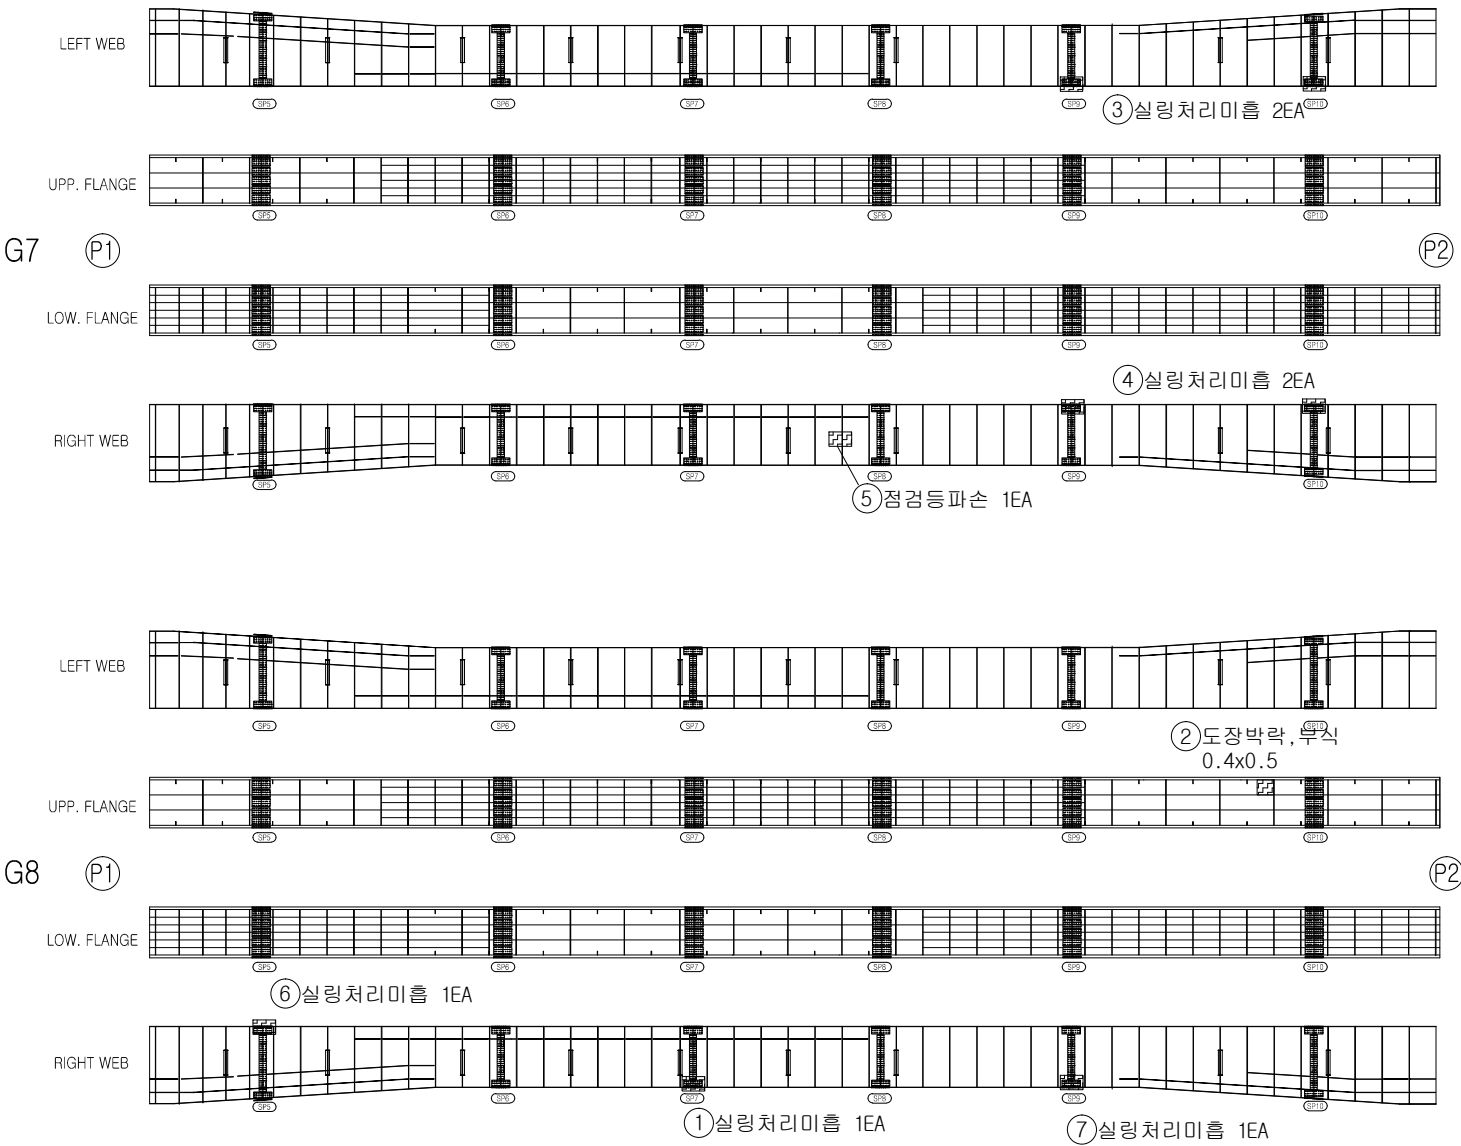
| 일련<br>번호 | 구<br>분 | 부재명<br>(위치) | 결함종류 | 결함규모 | | | | 개소 | 최종보수내역 | | 우선<br>순위 | 비고 |
|---|---|---|---|---|---|---|---|---|---|---|---|---|
| 2 | 구 | 거더내부 | 도장박락,부식 | 0.4 | 0.5 | 0.20 | m <sup>2</sup> | 1 | | | 1 | |

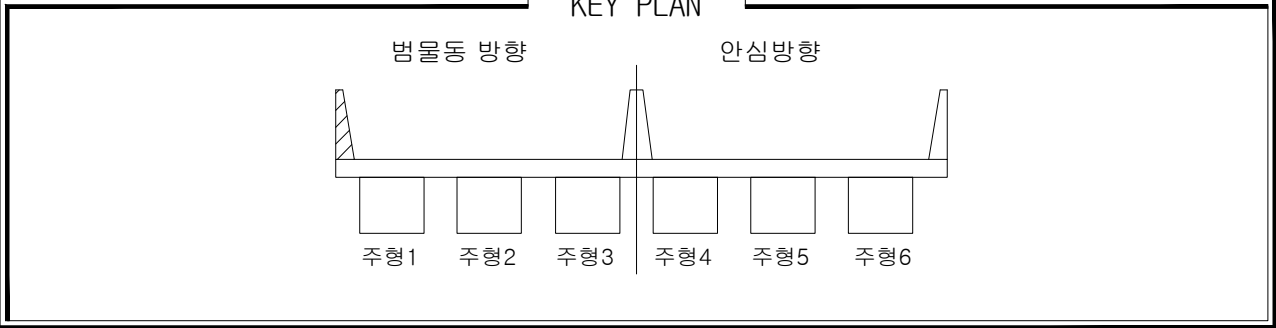
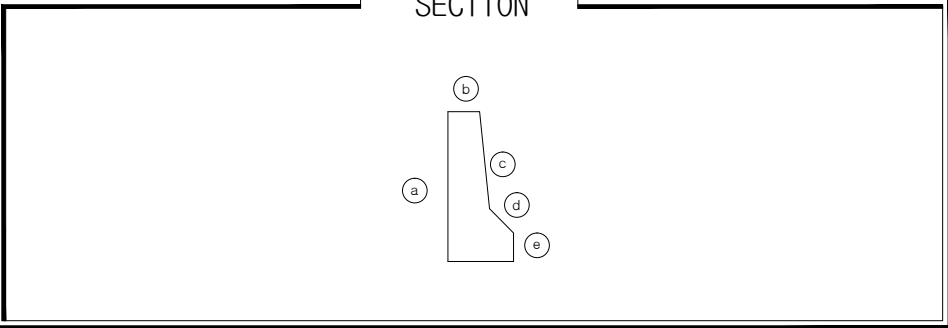
| 일련<br>번호 | 구<br>신 | 부재명<br>(위치) | 결함종류 | 결함규모 | | | | 최종보수내역 | | | 비고 |
|---|---|---|---|---|---|---|---|---|---|---|---|
| 1 | 신 | 방호벽 | 균열 | 0.1 | 1.0 | 1.00 | m | 1 | | | 2 |
| 2 | 신 | 방호벽 | 균열 | 0.2 | 1.0 | 1.00 | m | 1 | | | 2 |
| 6 | 신 | 방호벽 | 균열 | 0.2 | 1.5 | 3.00 | m | 2 | | | 2 |
| 12 | 신 | 방호벽 | 균열 | 0.2 | 0.3 | 1.50 | m | 5 | | | 2 |

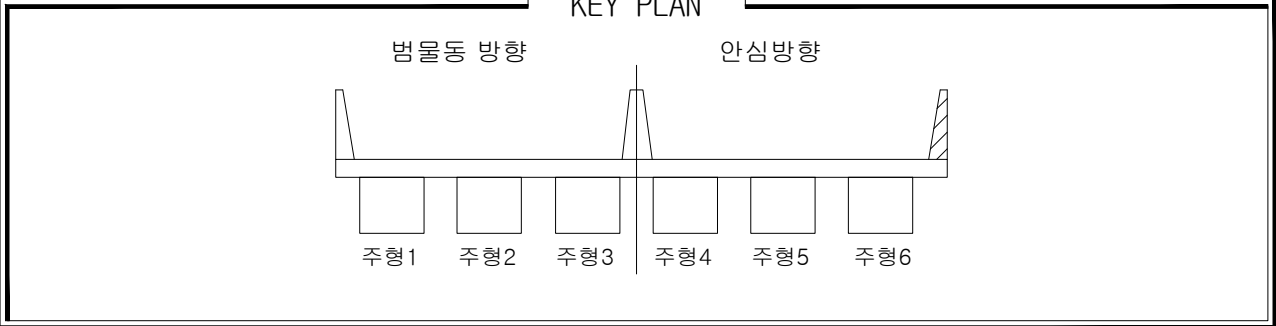
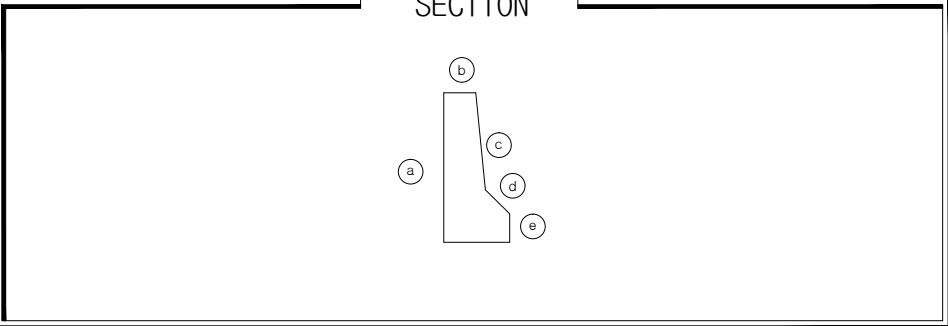
| 일련<br>번호 | 구 | 부재명<br>(위치) | 결함종류 | 결함구호 | | | | | | 최종보수내역 | | | 우선<br>순위 | 비고 |
|---|---|---|---|---|---|---|---|---|---|---|---|---|---|---|
| 1 | 구 | 방호벽 | 균열 | 0.1 | 1.2 | 9.60 | m | 8 | | | | 2 | | |
| 2 | 구 | 방호벽 | 균열 | 0.1 | 1.2 | 12.00 | m | 10 | | | | 2 | | |
| 4 | 구 | 방호벽 | 균열,백태 | 0.2 | 0.5 | 0.50 | m² | 5 | | | | 2 | | |

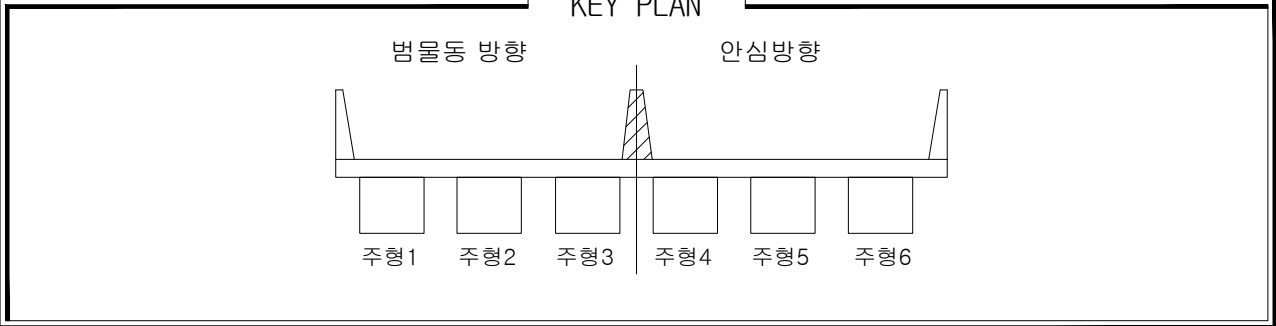
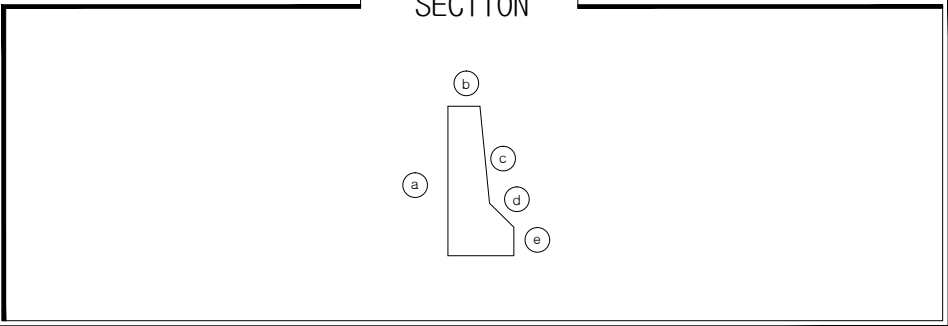
| 손상물량표 | | | | | | | | | | | | |
|---|---|---|---|---|---|---|---|---|---|---|---|---|
| 1 | 신 | 방호벽 | 균열 | 0.3 | 2.0 | 2.00 | m | 1 | | | | 1 |
| 2 | 신 | 방호벽 | 균열 | 0.5 | 2.0 | 12.00 | m | 6 | | | | 1 |
| 3 | 신 | 방호벽 | 균열 | 0.5 | 2.0 | 16.00 | m | 8 | | | | 1 |
| 5 | 신 | 방호벽 | 균열 | 1.0 | 2.0 | 2.00 | m | 1 | | | | 1 |

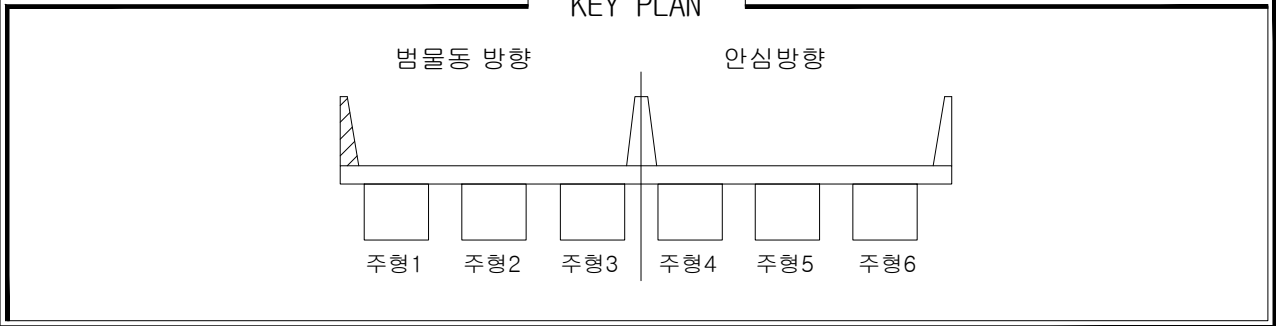
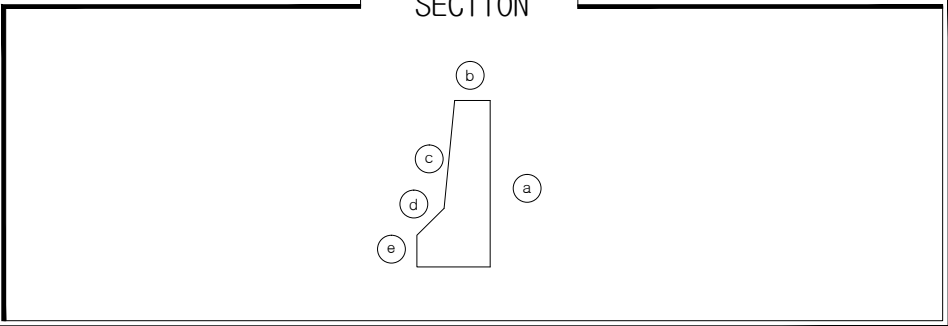
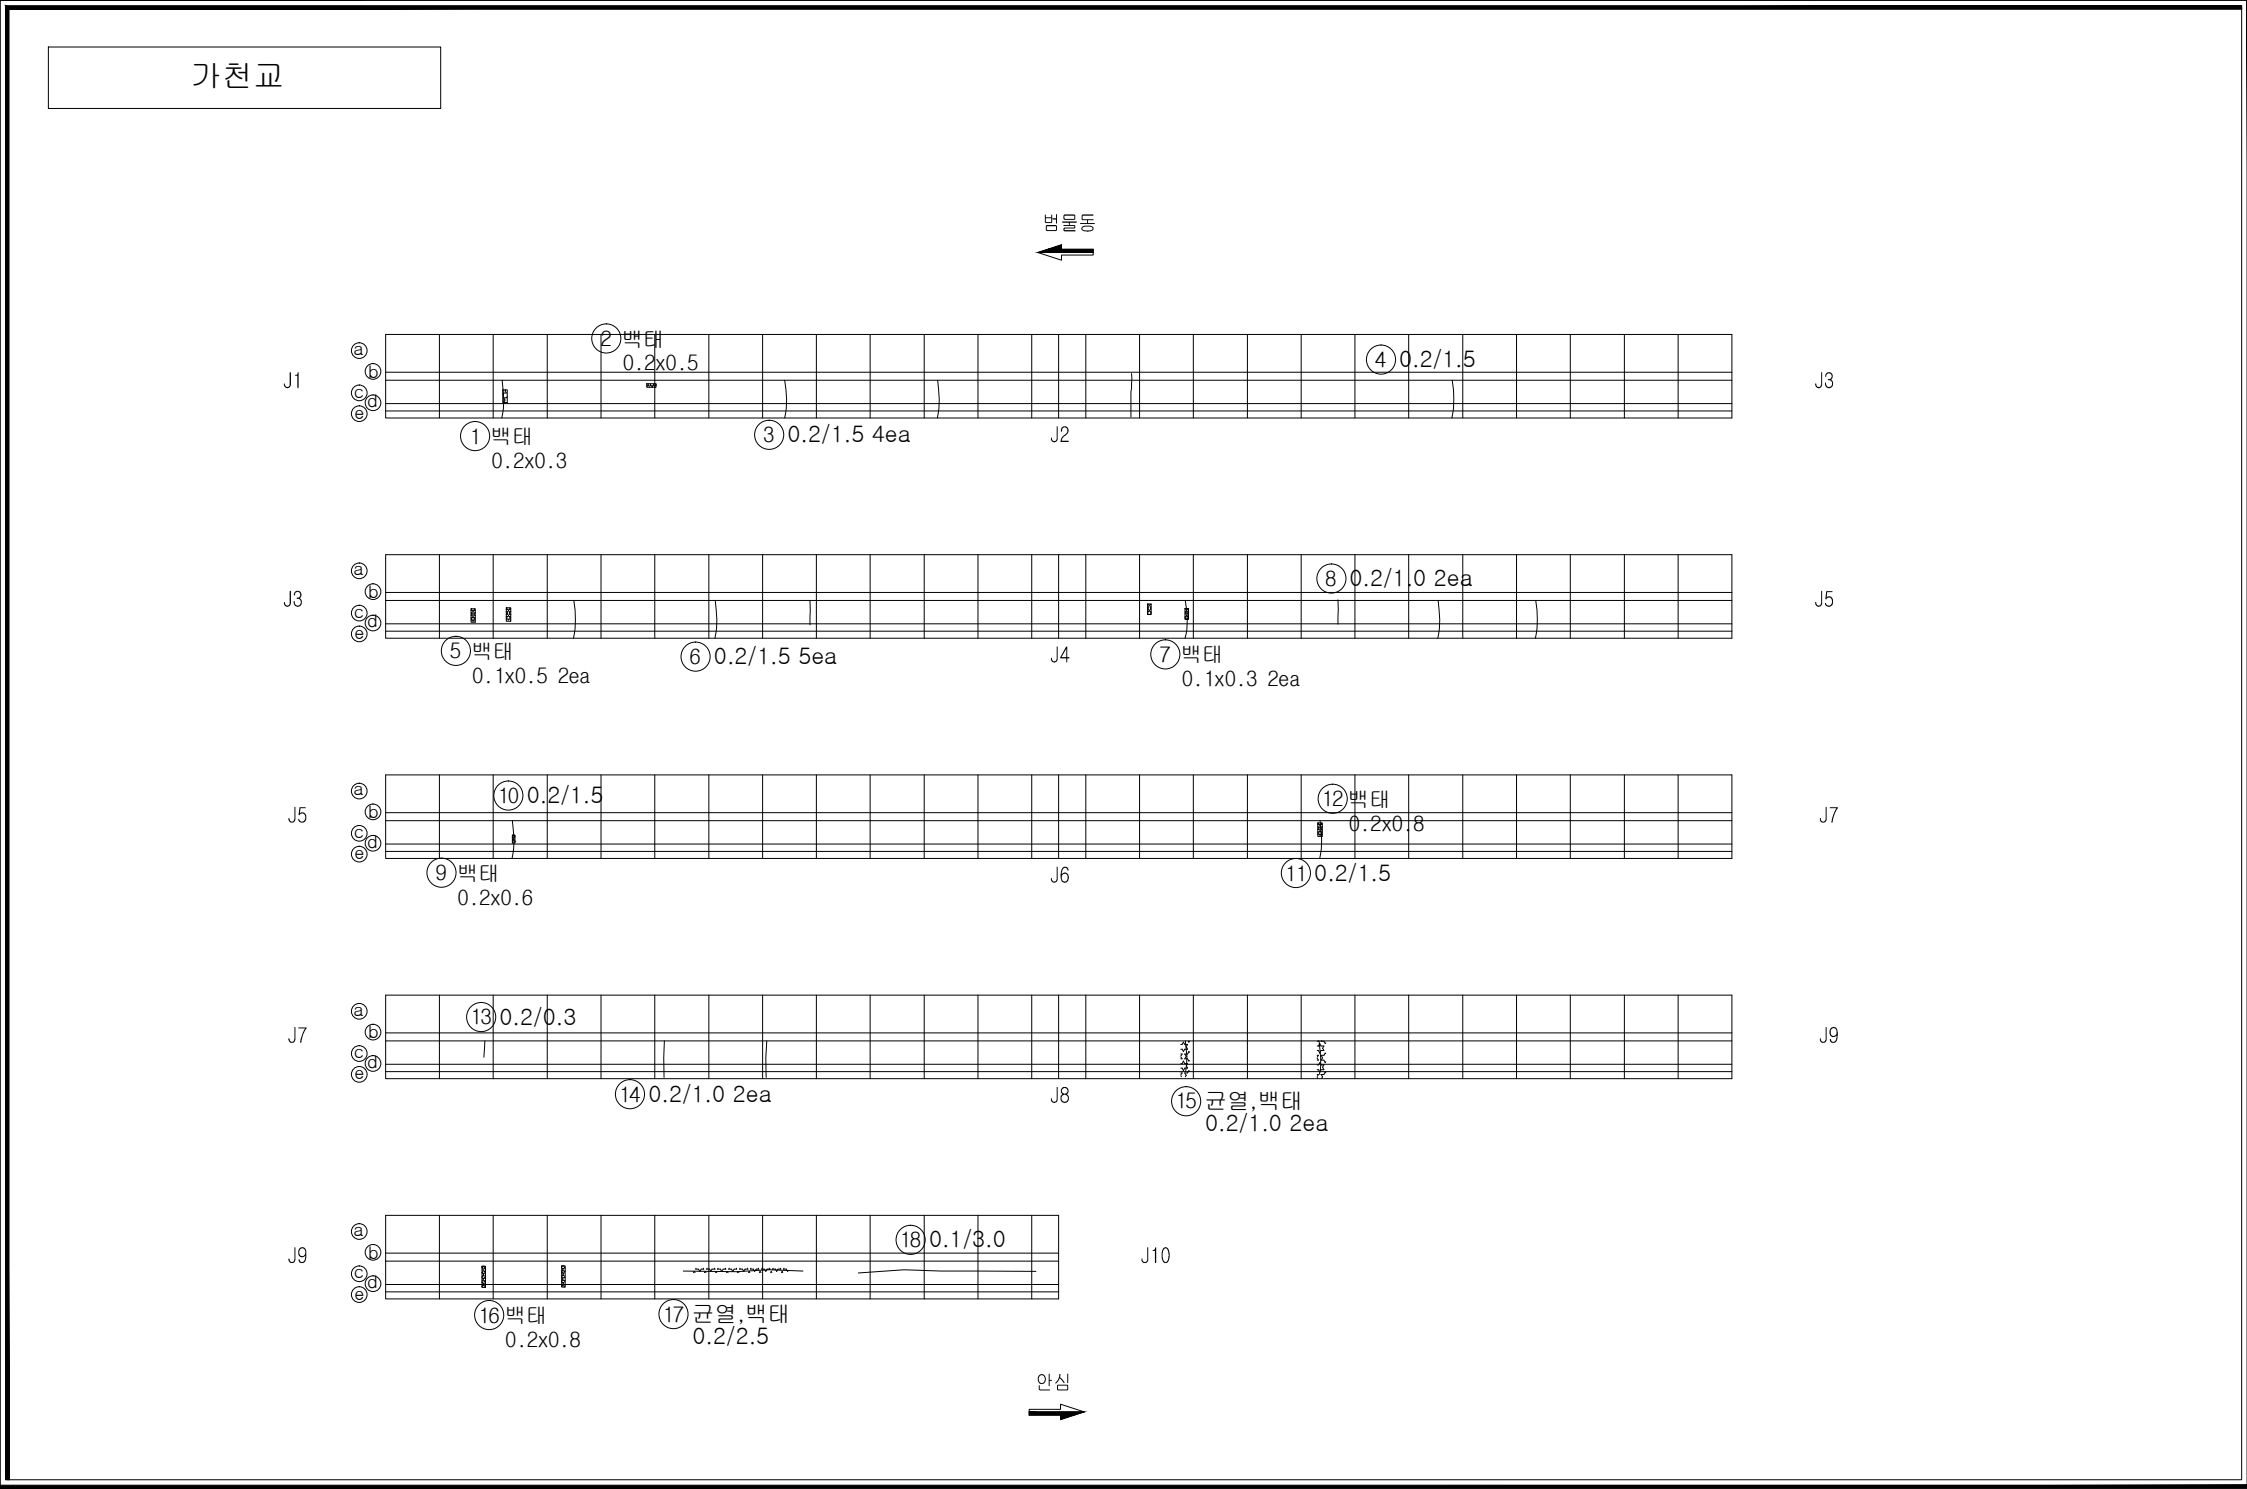
| 손상물량표 | | | | | | | | | | | | |
|---|---|---|---|---|---|---|---|---|---|---|---|---|
| 3 | 신 | 방호벽 | 균열 | 0.2 | 1.5 | 6.00 | m | 4 | | | | 2 |
| 15 | 신 | 방호벽 | 균열,백태 | 0.2 | 1.0 | 0.40 | ㎡ | 2 | | | | 2 |
| 17 | 신 | 방호벽 | 균열,백태 | 0.2 | 2.5 | 0.50 | ㎡ | 1 | | | | 2 |

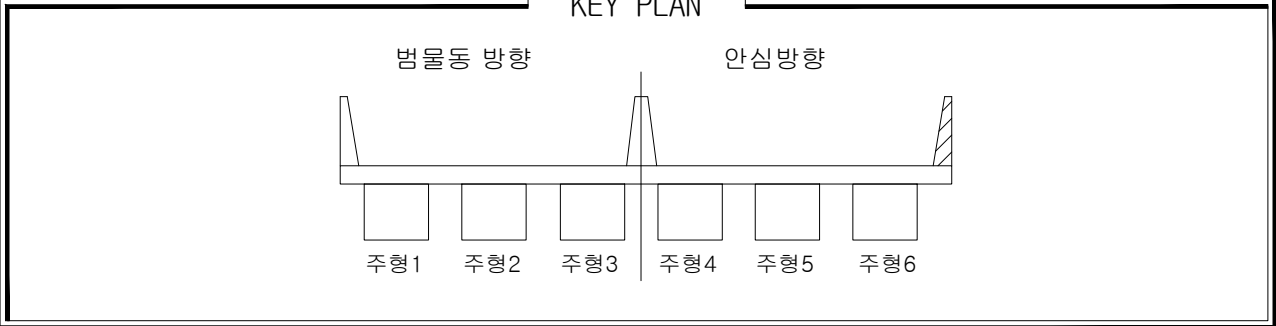
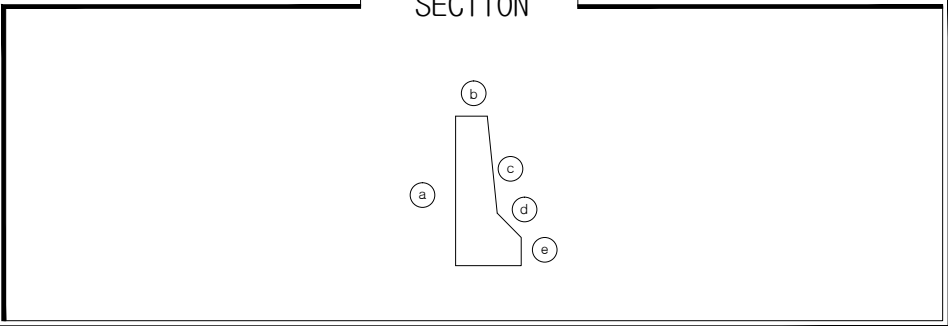
| 일련<br>번호 | 구<br>신 | 부재명<br>(위치) | 결함종류 | 결함규모 | | | | 개소 | 최종보수내역 | | 우선<br>순위 | 비고 |
|---|---|---|---|---|---|---|---|---|---|---|---|---|
| 1 | 신 | 방호벽 | 균열 | 0.3 | 1.3 | 13.00 | m | 10 | | | 1 | |
| 2 | 신 | 방호벽 | 균열 | 0.3 | 1.3 | 10.40 | m | 8 | | | 1 | |
| 3 | 신 | 방호벽 | 균열 | 0.3 | 1.3 | 11.70 | m | 9 | | | 1 | |

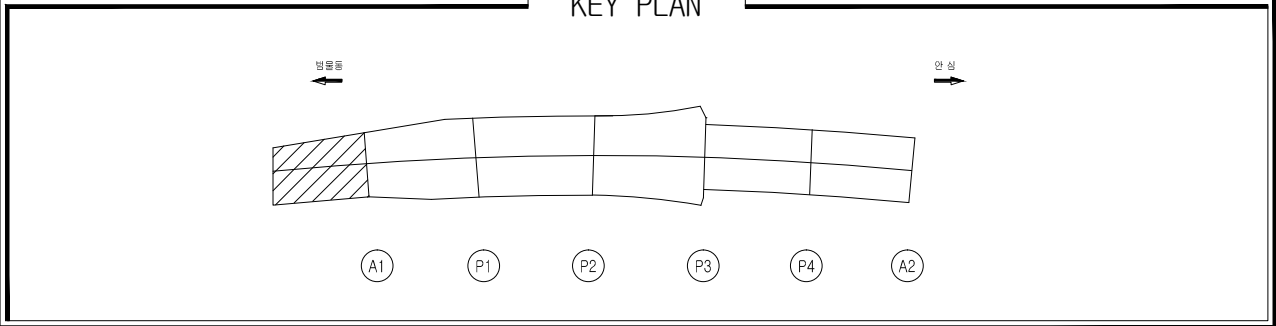
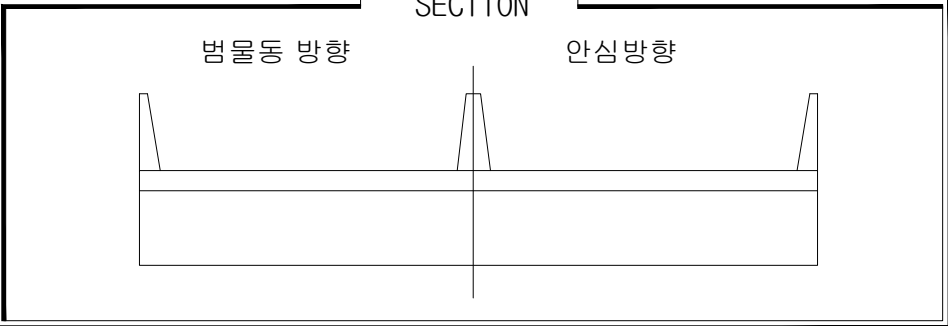
| 일련<br>번호 | 구<br>분 | 부재명<br>(위치) | 결함종류 | 결함 규모 | | | | 최종보수내역 | | | 우선<br>순위 | 비고 |
|---|---|---|---|---|---|---|---|---|---|---|---|---|
| 2 | 신 | 옹벽 | 누수흔적 | 0.3 | 3.0 | 0.90 | ㎡ | 1 | | | | 2 |
| 6 | 신 | 옹벽 | 균열 | 0.3 | 0.2 | 0.20 | m | 1 | | | | 1 |

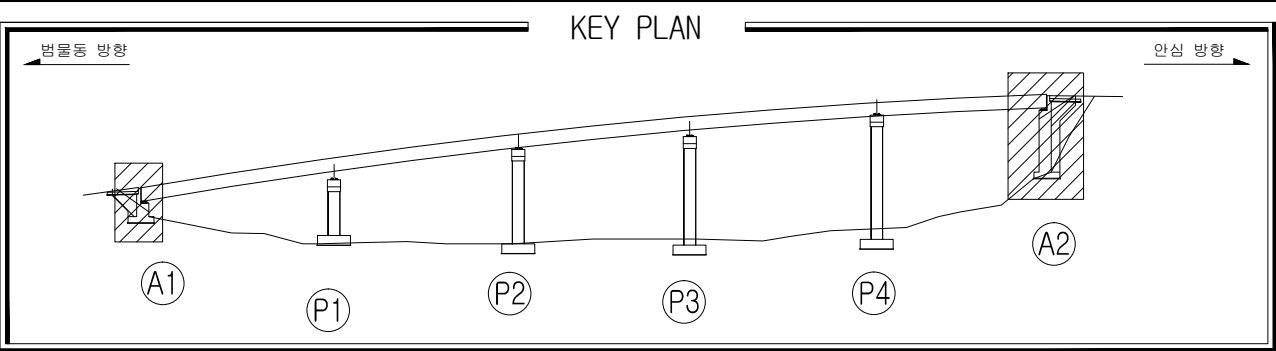
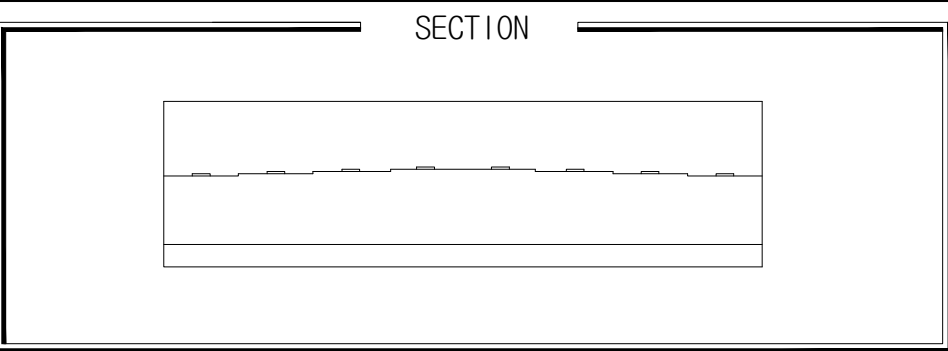
| 일련<br>번호 | 구<br>분 | 부재명<br>(위치) | 결함종류 | 결함구호 | | | | 개소 | 최종보수내역 | | 우선<br>순위 | 비고 |
|---|---|---|---|---|---|---|---|---|---|---|---|---|
| 1 | 신 | 교대 | 균열 | 0.1 | 0.25 | 0.25 | m | 1 | | | 2 | |
| 2 | 신 | 교대 | 균열 | 0.2 | 0.3 | 0.30 | m | 1 | | | 2 | |

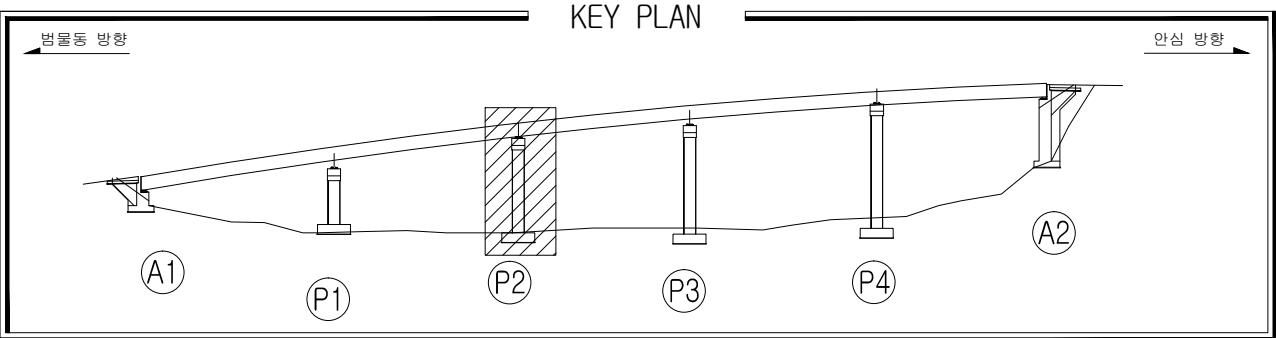
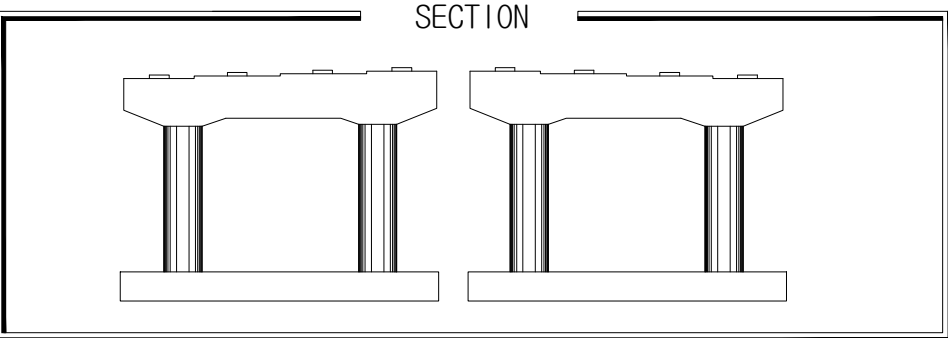
\*교각의 콘크리트 구체 전반에 표면 망상균열(CW=0.1mm)이 간헐적 발생됨

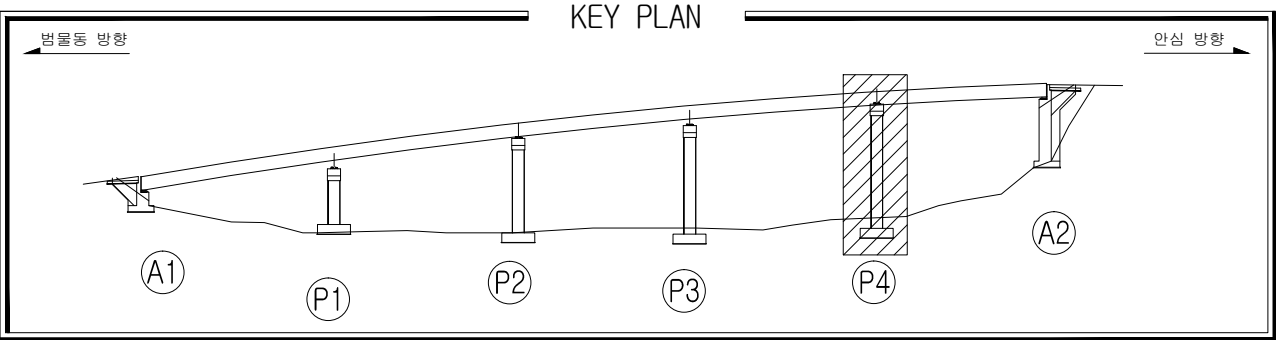
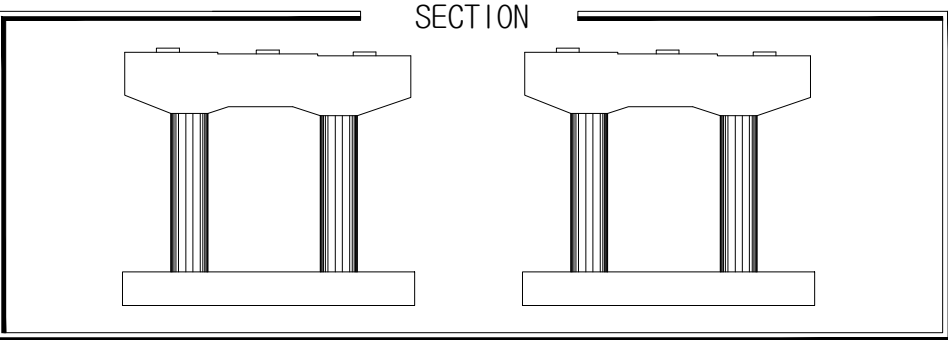
\*교각의 콘크리트 구체 전반에 표면 망상균열(CW=0.1mm)이 간헐적 발생됨
