| 01. 연지교 외관조사망도 |

2019년 상반기 시설물 정기안전점검 기술용역

# 연지교

2019. 06

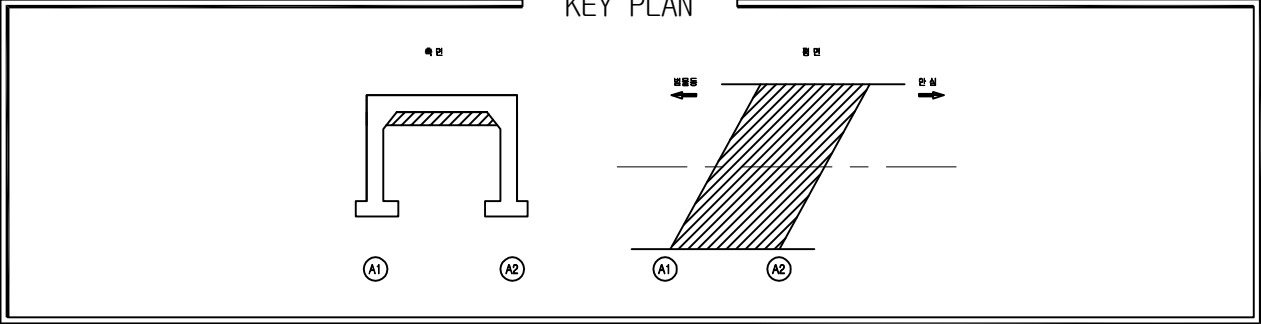
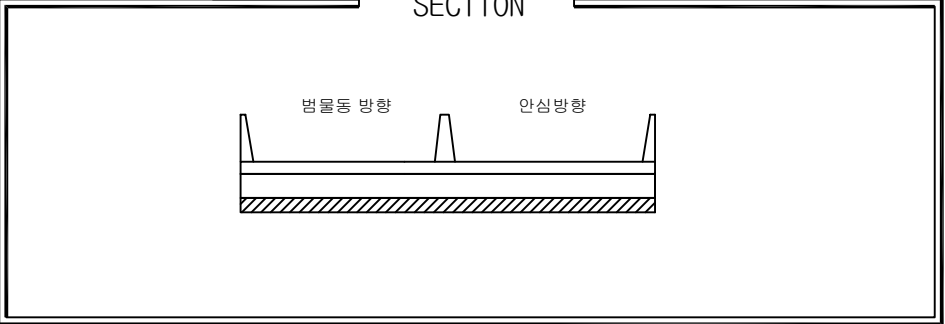
| 번호 | 위치 | 손상내용 | 손상물량 | | | | | 보수보강방안 |
|---|---|---|---|---|---|---|---|---|
| 1 | 포장부 | 포장균열 | - | 2.00 | 1 | m | 2.00 | 주의관찰 |
| 2 | 포장부 | 포장균열 | - | 2.00 | 1 | m | 2.00 | 주의관찰 |
| 3 | 포장부 | 포장균열 | - | 2.00 | 1 | m | 2.00 | 주의관찰 |
| 4 | 포장부 | 포장균열 | - | 1.70 | 1 | m | 1.70 | 주의관찰 |
| 5 | 포장부 | 포장균열 | - | 2.00 | 3 | m | 6.00 | 주의관찰 |
| 6 | 포장부 | 포장 망상균열 | 10.0 | 0.50 | 1 | m <sup>2</sup> | 5.00 | 주의관찰 |
