# 01 남양5배수지(기존)

화성시 맑은물사업소

2023년 화성시 상수도시설물 안전점검용역

남양5배수지(기존) - 유출밸브실

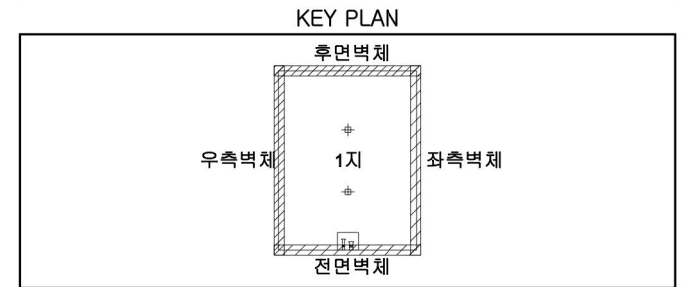
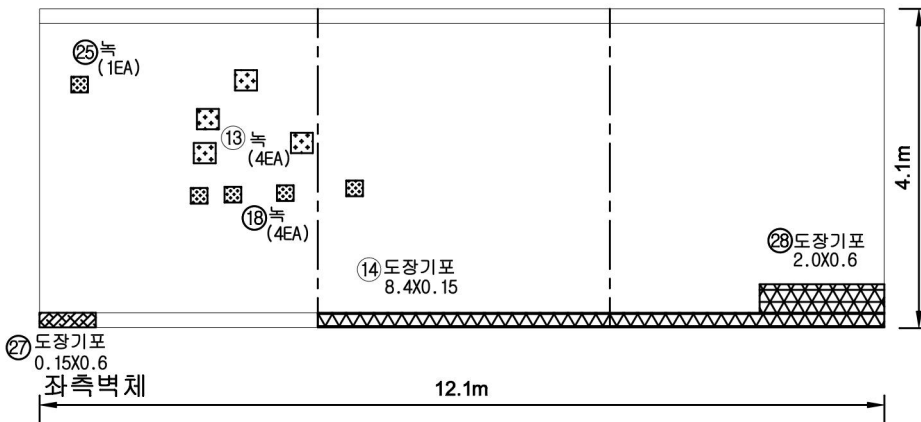
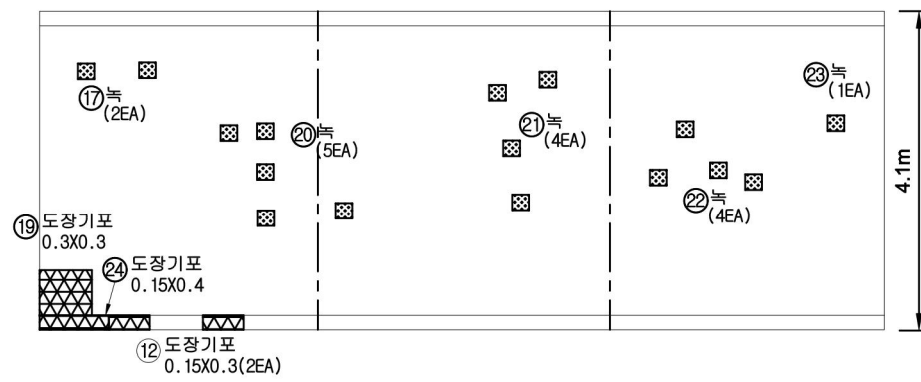
| 번호 | 내용 | 손상규모 | | | | | 비고 |
|---|---|---|---|---|---|---|---|
| 1 | 도장기포 | 2.2 | 2.1 | 1 | 4.62 | m² | 기존 |
| 2 | 도장기포 | 8.0 | 0.15 | 1 | 1.20 | m² | 기존 |
| 3 | 녹 | - | - | 2 | 2.00 | EA | 기존 |
| 4 | 녹 | - | - | 1 | 1.00 | EA | 기존 |
| 5 | 도장기포 | 0.3 | 0.5 | 1 | 0.15 | m² | 기존 |
| 6 | 관부식 | - | - | 1 | 1.00 | EA | 기존 |
| 7 | 관부식 | - | - | 2 | 2.00 | EA | 기존 |

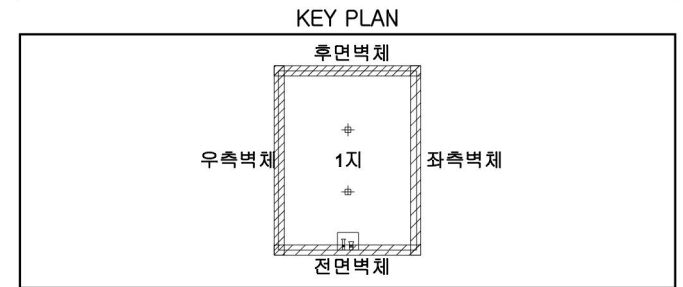
| 번호 | 내 용 | 손 상 규 모 | | | | | 비 고 |
|---|---|---|---|---|---|---|---|
| 26 | 도장기포 | 0.15 | 0.6 | 1 | 0.09 | ㎡ | 기존 |
| 27 | 도장기포 | 2.0 | 0.6 | 1 | 1.20 | ㎡ | 기존 |

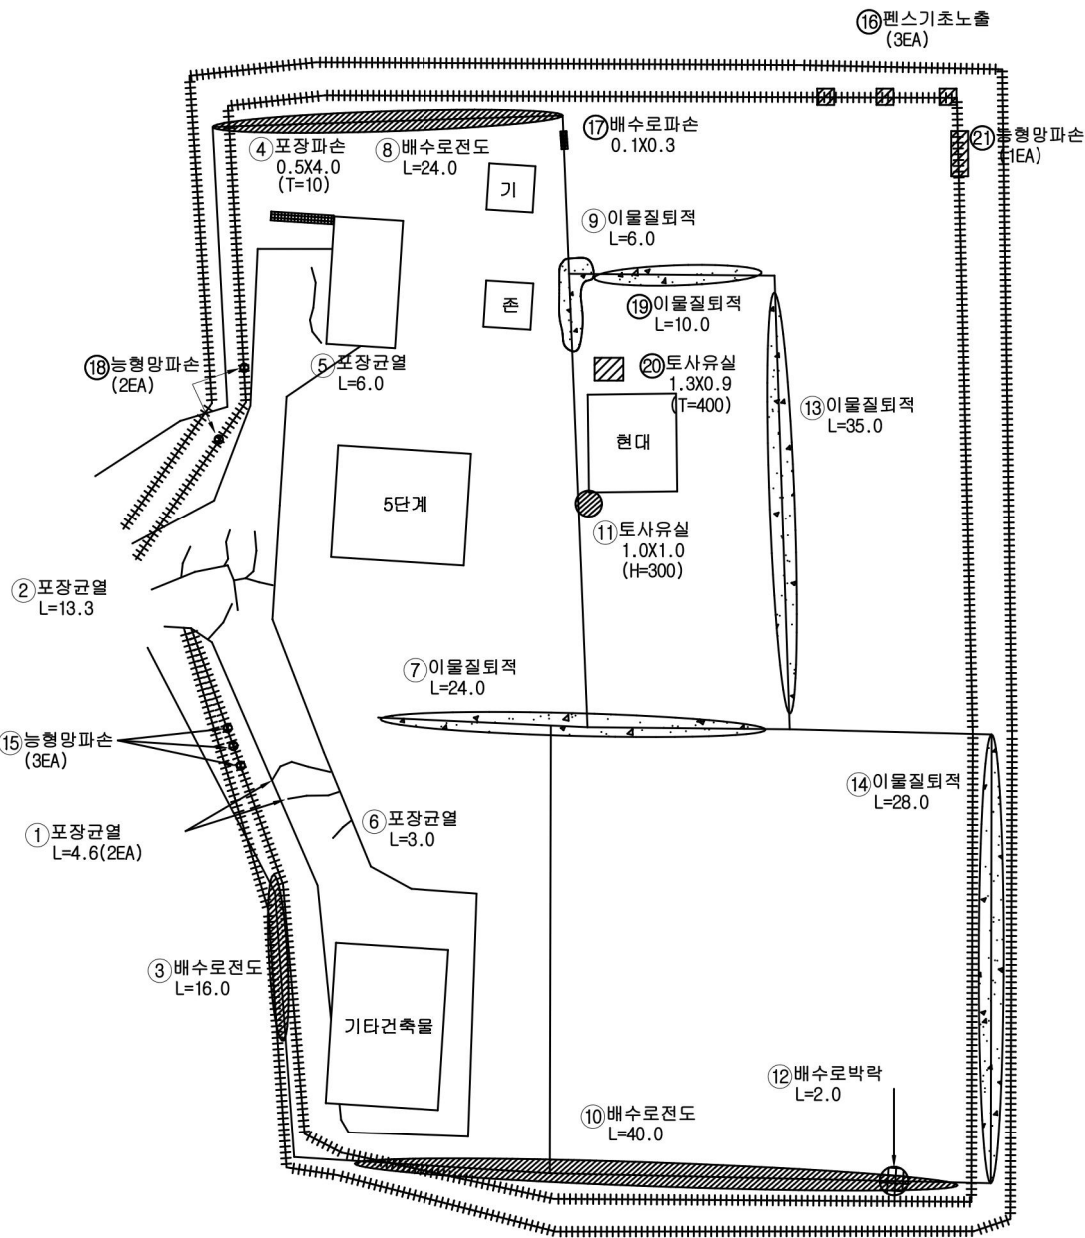
15-1

| 번호 | 내용 | 손상규모 | | | | | 비고 |
|---|---|---|---|---|---|---|---|
| 1 | 포장균열 | - | 4.6 | 2 | 9.20 | m | 기존 |
| 2 | 포장균열 | - | 13.3 | 1 | 13.30 | m | 기존 |
| 5 | 포장균열 | - | 6.0 | 1 | 6.00 | m | 기존 |
| 6 | 포장균열 | - | 3.0 | 1 | 3.00 | m | 기존 |
