## 불 광 천 포 장 부 J40(1K 128) ~ J45(1K 248)

### 손 상 물 량 표

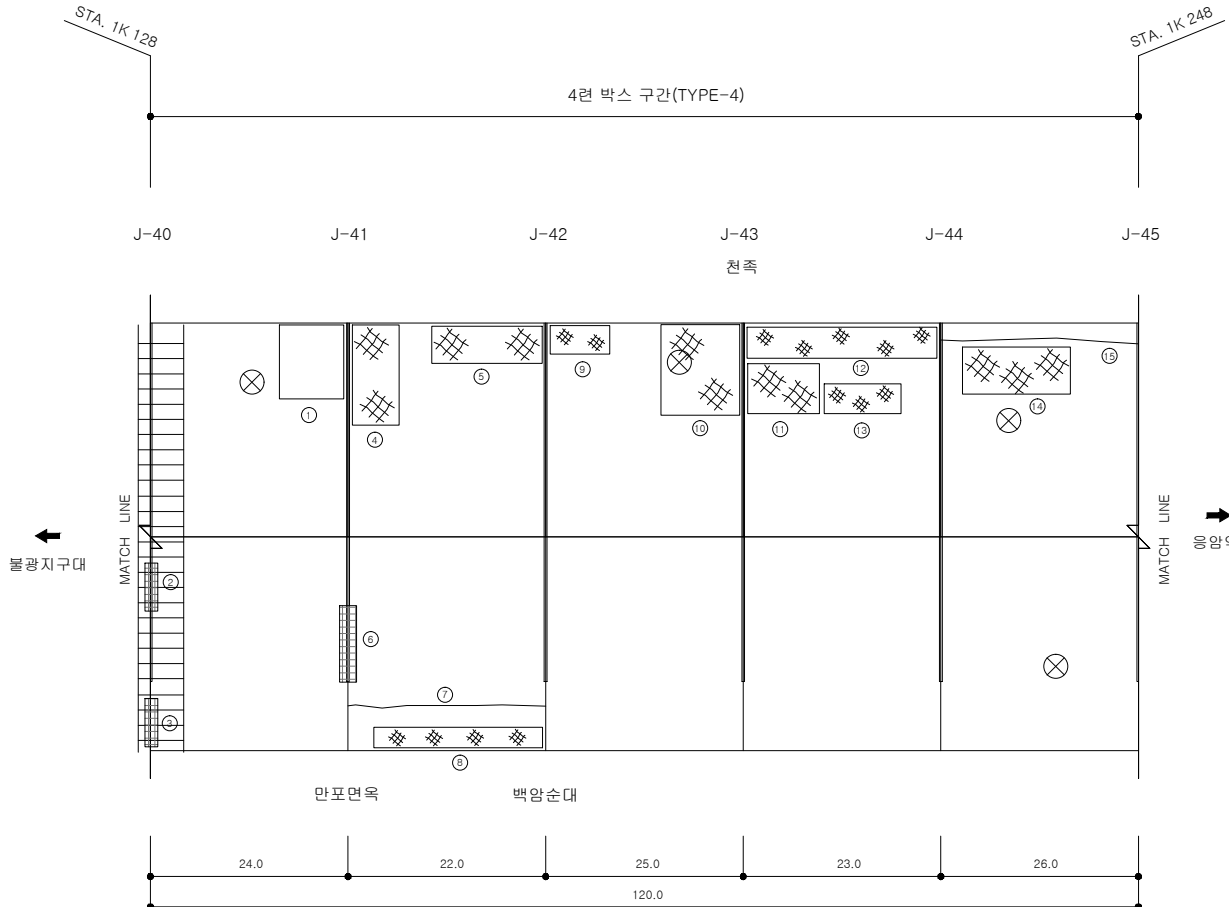
| 번 호 | 손 상 위 치 | 적 출 년 도 | 법 레 | ① - 2013 신 규 | 기 ① - 기 준 손 상 | 결 형 규 모 | | | | 단 위 | 개 소 | 비 고 |
|---|---|---|---|---|---|---|---|---|---|---|---|---|
| 1 | 40~41 | S | 2013 | | | 소성변형 | 6.0 | 6.0 | | ㎡ | 1 | 신규 |
| 2 | 40 | S | 2013 | | | 탄성조인트파손 | 0.8 | 2.5 | | ㎡ | 1 | 신규 |
| 3 | 40 | S | 2013 | | | 탄성조인트파손 | 0.8 | 1.0 | | ㎡ | 1 | 신규 |
| 4 | 41~42 | S | 2013 | | | 망상균열 | 6.0 | 7.0 | | ㎡ | 1 | 신규 |
| 5 | 41~42 | S | 2013 | | | 망상균열 | 9.0 | 3.0 | | ㎡ | 1 | 신규 |
| 6 | 41~42 | S | 2013 | | | 탄성조인트파손 | 0.8 | 2.0 | | ㎡ | 1 | 신규 |
| 7 | 41~42 | S | 2013 | | | 균열 | | 22.0 | | m | 1 | 신규 |
| 8 | 41~42 | S | 2013 | | | 망상균열 | 17.0 | 2.0 | | ㎡ | 1 | 신규 |
| 9 | 42~43 | S | 2013 | | | 망상균열 | 4.5 | 2.0 | | ㎡ | 1 | 신규 |
| 10 | 42~43 | S | 2013 | | | 망상균열 | 6.5 | 6.5 | | ㎡ | 1 | 신규 |
| 11 | 43~44 | S | 2013 | | | 망상균열 | 6.0 | 4.0 | | ㎡ | 1 | 신규 |
| 12 | 43~44 | S | 2013 | | | 망상균열 | 12.5 | 2.0 | | ㎡ | 1 | 신규 |
| 13 | 43~44 | S | 2013 | | | 망상균열 | 3.0 | 5.0 | | ㎡ | 1 | 신규 |
| 14 | 44~45 | S | 2013 | | | 망상균열 | 9.5 | 4.0 | | ㎡ | 1 | 신규 |
| 15 | 44~45 | S | 2013 | | | 균열 | 0.5 | 26.0 | | m | 1 | 신규 |

-1순위 : Type-7~9 (예일여고~역말사거리)  
-2순위 : Type-9~11 (역말사거리~신사오거리) 및 조인트 손상  
-3순위 : Type-1~7 (시점~예일여고) 및 포장균열
