(구)남한강교 외관조사망도 바닥판 하면 S5

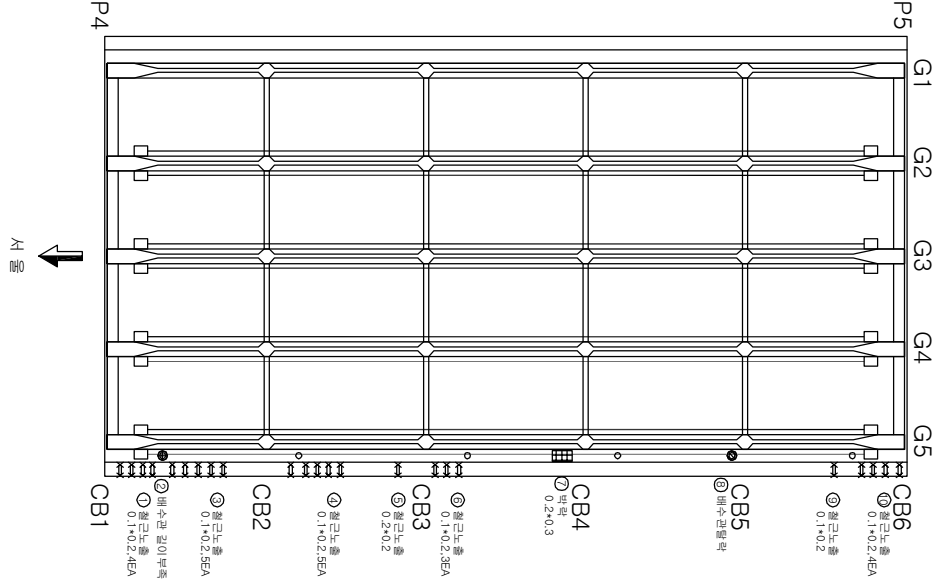
| 번호 | 손상 내용 | 손상 규모 | | | 단위 | 비고 |
|---|---|---|---|---|---|---|
| 1 | 철근노출 | 0.1 | 0.20 | 4 | 0.08 | m <sup>2</sup> |
| 2 | 배수관 길이부족 | | | 1 | 1.00 | ea |
| 3 | 철근노출 | 0.1 | 0.20 | 5 | 0.10 | m <sup>2</sup> |
| 4 | 철근노출 | 0.1 | 0.20 | 5 | 0.10 | m <sup>2</sup> |
| 5 | 철근노출 | 0.2 | 0.20 | 1 | 0.04 | m <sup>2</sup> |
| 6 | 철근노출 | 0.1 | 0.20 | 3 | 0.06 | m <sup>2</sup> |
| 7 | 파손 | 0.2 | 0.30 | 1 | 0.06 | m <sup>2</sup> |
| 8 | 배수관 길이부족 | | | 1 | 1.00 | ea |
| 9 | 철근노출 | 0.1 | 0.20 | 1 | 0.02 | m <sup>2</sup> |
| 10 | 철근노출 | 0.1 | 0.2 | 4 | 0.08 | m <sup>2</sup> |
