## 18. 유정교 토공노반(G55)

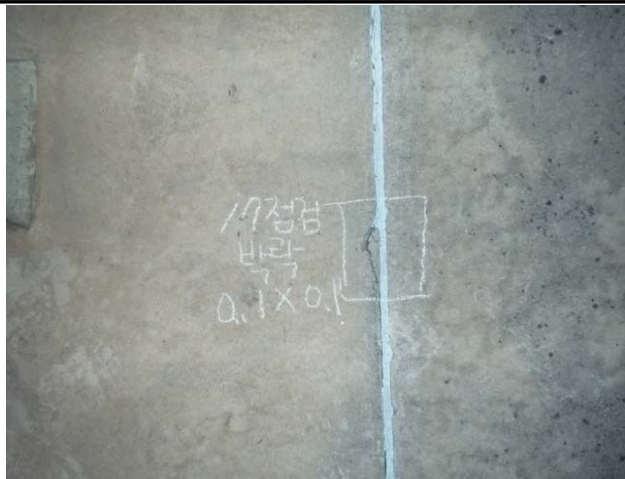
| 위치 | STA. 115K540-550 | | | | 선별 | T1 | | 위치 | TCL | | | | 위치 | STA. 115K600-610 | | | | 선별 | T1 | | 위치 | TCL | |
| 내용 | 박락 | | | | A= 0.2x0.3 | | | | 내용 | 균열 | | | | Cw= 0.6/0.5 | | | | | | | | | |

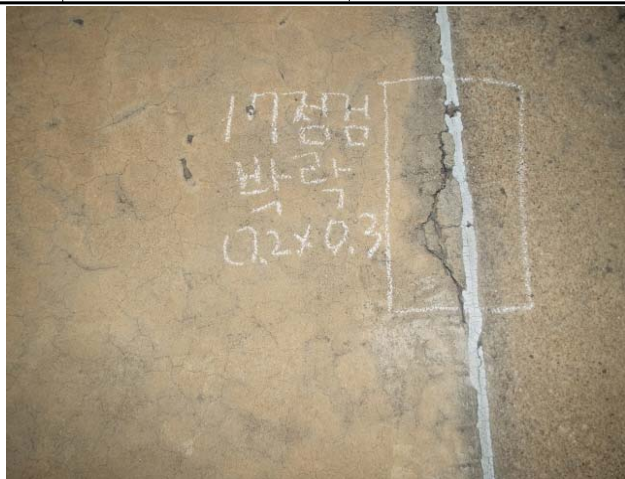
| 위치 | STA. 115K910-920 | | | | 선별 | T1 | | 위치 | HSB | | | | 위치 | STA. 115K910-920 | | | | 선별 | T1 | | 위치 | TLC | |
| 내용 | 파손 | | | | A= 0.2x0.3 | | | | 내용 | 박리 | | | | A= 0.1x0.2 | | | | | | | | | |

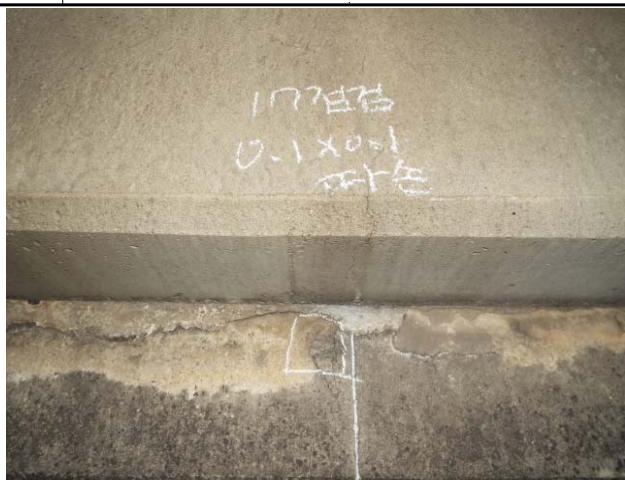
| 위치 | STA. 115K910-920 | | | | 선별 | T2 | | 위치 | TCL | | | | 위치 | STA. 116K910-920 | | | | 선별 | | | 위치 | 채움 | |
| 내용 | 파손 | | | | A= 0.1x0.1 | | | | 내용 | 균열 | | | | Cw= 0.5/1.6 | | | | | | | | | |

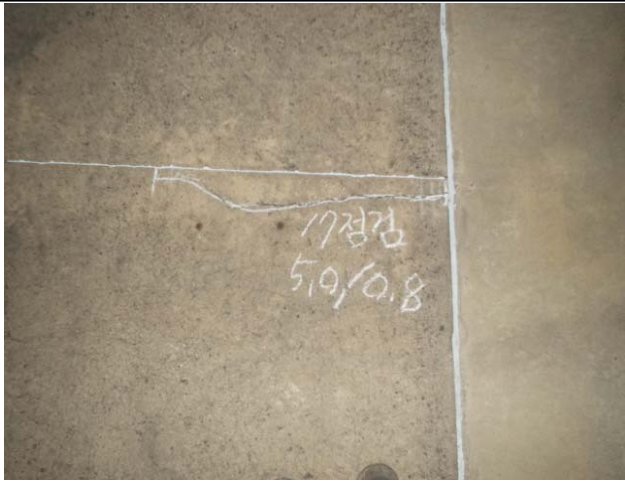
| 위치 | STA. 116K910-920 | 선별 | | 위치 | STA. 116K930-940 | 선별 | |
| 내용 | 균열 | Cw= 0.5/0.8 | | 내용 | 균열 | Cw= 0.5/1.6 | |
