## 17. 죽청터널 (U21)

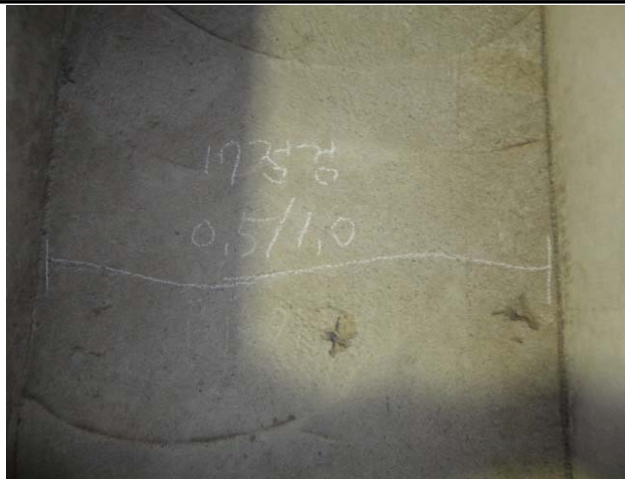
| 위치 | Sta. 152k393-403 | 선별 | T1 | 위치 | 보조 | 위치 | Sta. 152k373-383 | 선별 | T1 | 위치 | 보조 |
| 내용 | 균열 | | Cw= 0.5/1.0 | | | 내용 | 균열 | | Cw= 0.5/1.0 | | |

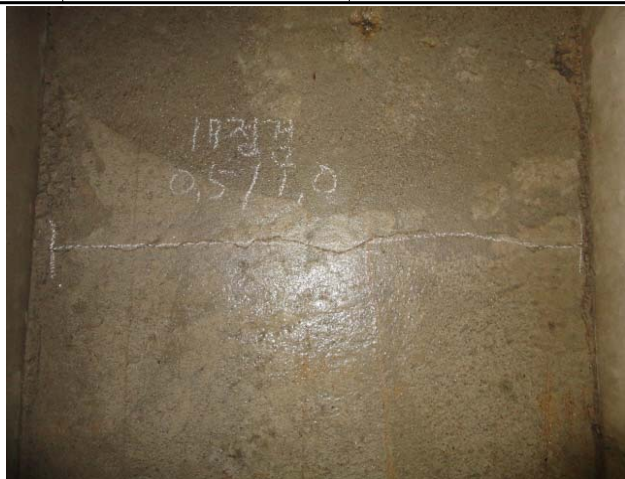
| 위치 | Sta. 152k373-383 | 선별 | T1 | 위치 | 보조 | 위치 | Sta. 152k353-363 | 선별 | T1 | 위치 | 보조 |
| 내용 | 균열 | | Cw= 0.5/1.0 | | | 내용 | 균열 | | Cw= 0.5/1.0 | | |

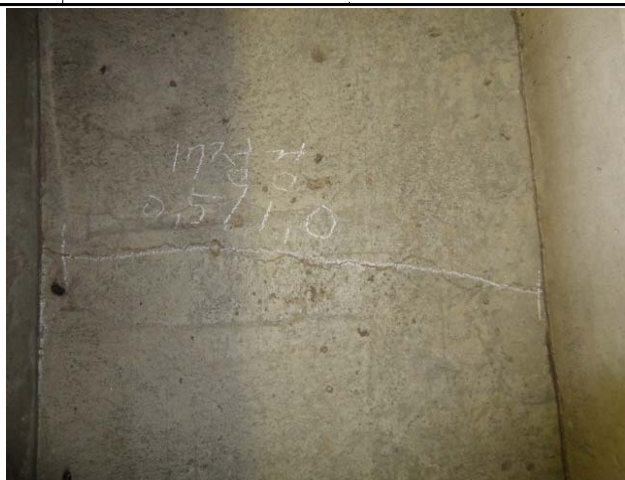
| 위치 | Sta. 152k343-353 | 선별 | T1 | 위치 | 보조 | 위치 | Sta. 152k343-353 | 선별 | T1 | 위치 | 보조 |
| 내용 | 균열 | | Cw= 0.5/1.0 | | | 내용 | 균열 | | Cw= 0.5/1.0 | | |

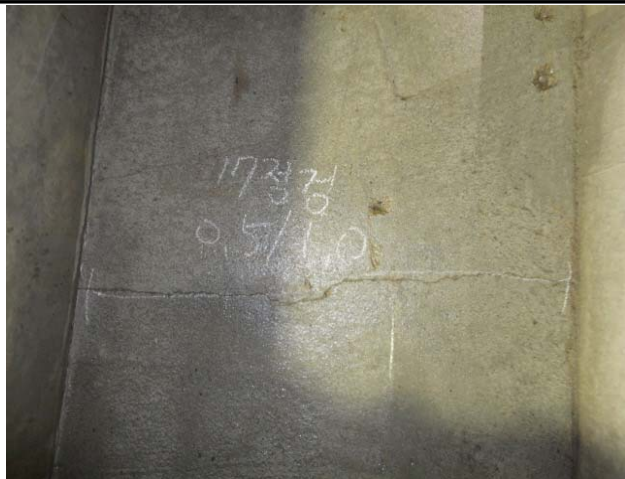
| 위치 | Sta. 152k333-343 | 선별 | T1 | 위치 | 보조 | 위치 | Sta. 152k293-303 | 선별 | T1 | 위치 | 보조 |
| 내용 | 균열 | | Cw= 0.5/1.0 | | | 내용 | 균열 | | Cw= 0.5/1.0 | | |

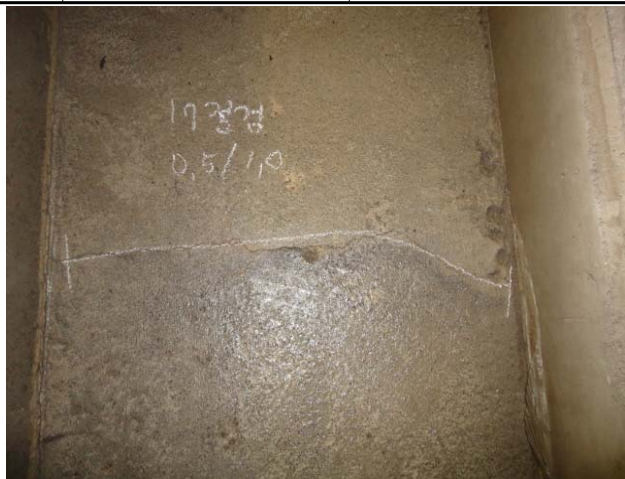
| 위치 | Sta. 152k273-283 | 선별 | T1 | 위치 | 보조 | 위치 | Sta. 152k263-273 | 선별 | T1 | 위치 | 보조 |
| 내용 | 균열 | | Cw= 0.5/1.0 | | | 내용 | 균열 | | Cw= 0.5/1.0 | | |

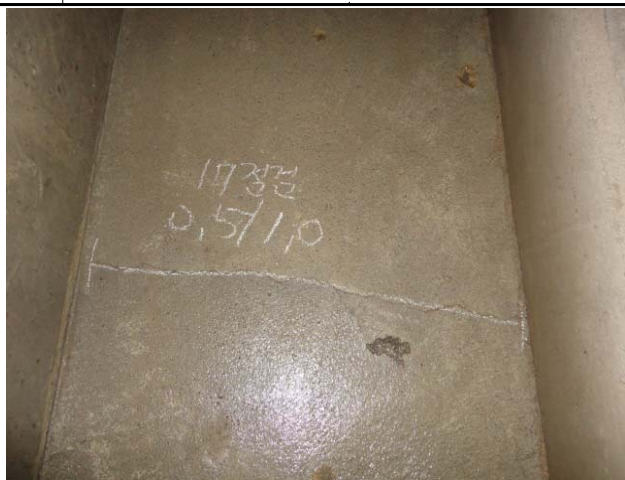
| 위치 | Sta. 152k233-243 | 선별 | T1 | 위치 | 보조 | 위치 | Sta. 152k203-213 | 선별 | T1 | 위치 | 보조 |
| 내용 | 균열 | | Cw= 0.5/1.0 | | | 내용 | 균열 | | Cw= 0.5/1.0 | | |

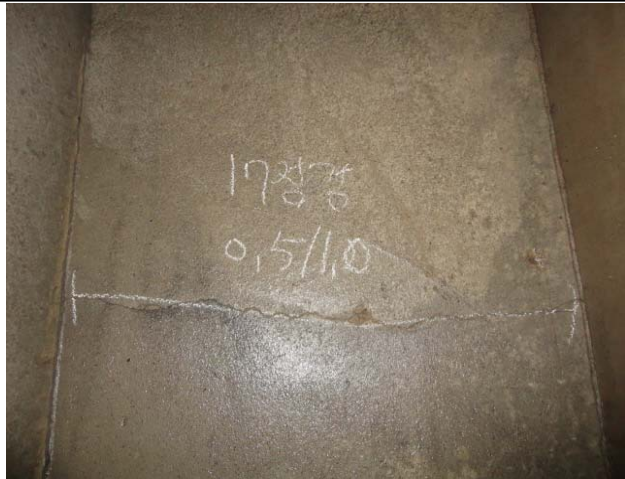
| 위치 | Sta. 151k993-152k003 | 선별 | T1 | 위치 | 보조 | 위치 | Sta. 151k883-893 | 선별 | T1 | 위치 | 보조 |
| 내용 | 균열 | | Cw= 0.5/1.0 | | | 내용 | 균열 | | Cw= 0.5/1.0 | | |

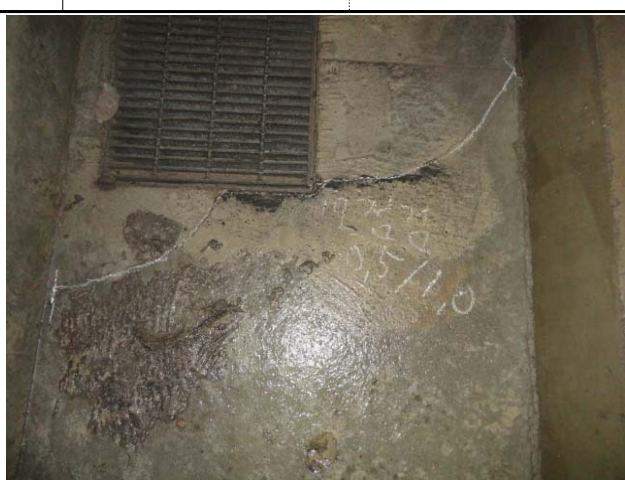
| 위치 | Sta. 151k683-693 | 선별 | T1 | 위치 | 보조 | 위치 | Sta. 151k633-643 | 선별 | T1 | 위치 | 보조 |
| 내용 | 균열 | | Cw= 0.5/1.0 | | | 내용 | 균열 | | Cw= 0.5/1.0 | | |

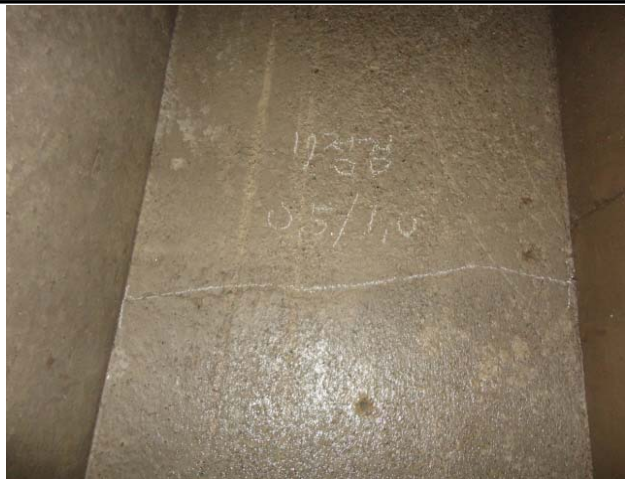
| 위치 | Sta. 151k513-523 | 선별 | T1 | 위치 | 보조 | 위치 | Sta. 151k503-513 | 선별 | T1 | 위치 | 보조 |
| 내용 | 균열 | | Cw= 0.5/1.0 | | | 내용 | 균열 | | Cw= 0.5/1.0 | | |

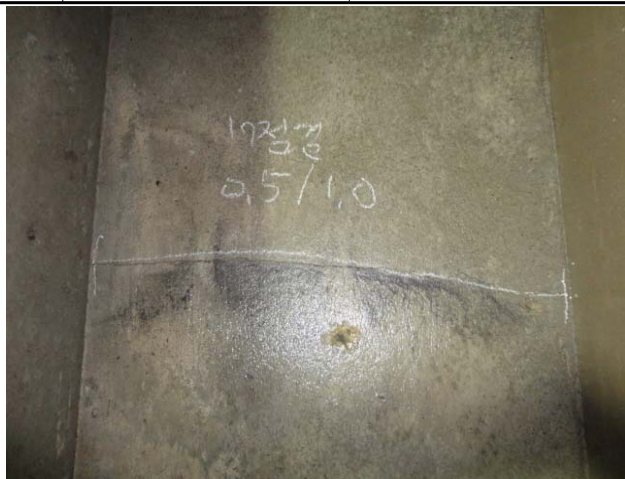
| 위치 | Sta. 151k423-433 | 선별 | T1 | 위치 | 보조 | 위치 | Sta. 151k403-413 | 선별 | T1 | 위치 | 보조 |
| 내용 | 균열 | | Cw= 0.5/1.0 | | | 내용 | 균열 | | Cw= 0.5/0.8 | | |

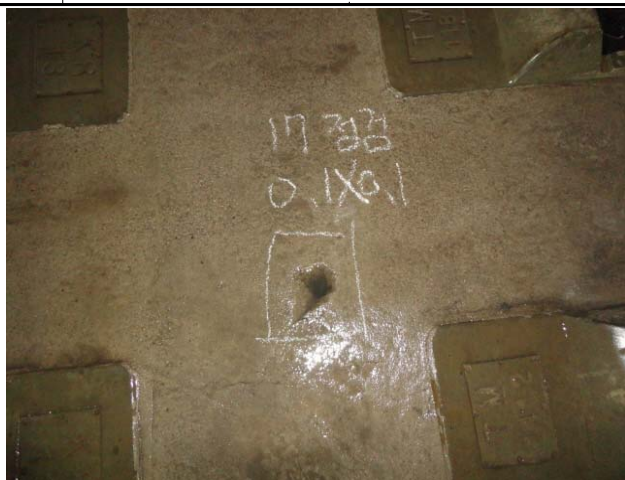
| 위치 | Sta. 151k383-393 | 선별 | T1 | 위치 | TCL | 위치 | Sta. 151k383-393 | 선별 | T1 | 위치 | TCL |
| 내용 | 파손 | | A= 0.1/0.1 | | | 내용 | 균열(보수) | | Cw= 0.6/0.4 | | |

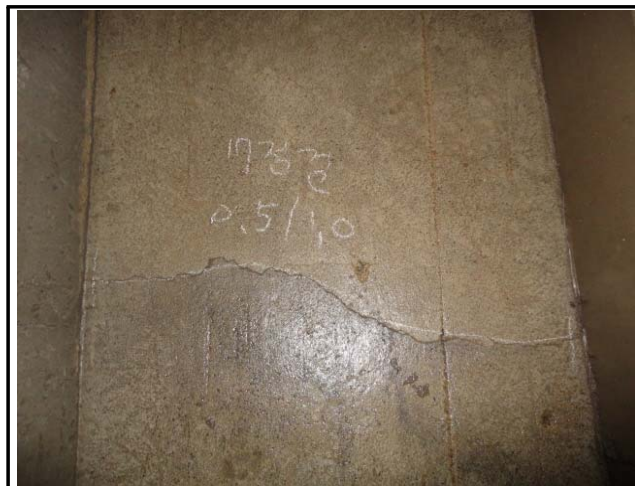
| 위치 | Sta. 151k373-383 | 선별 | T1 | 위치 | 보조 |
| 내용 | 균열 | Cw= 0.5/1.0 | | | |

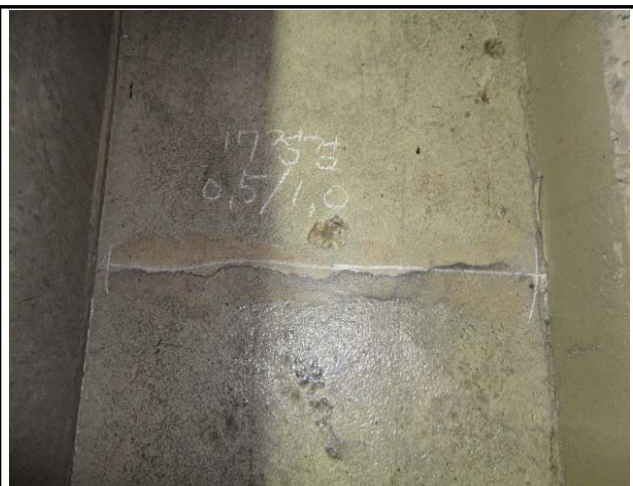
| 위치 | Sta. 151k343-353 | 선별 | T1 | 위치 | 보조 |
| 내용 | 균열 | Cw= 0.5/0.8 | | | |

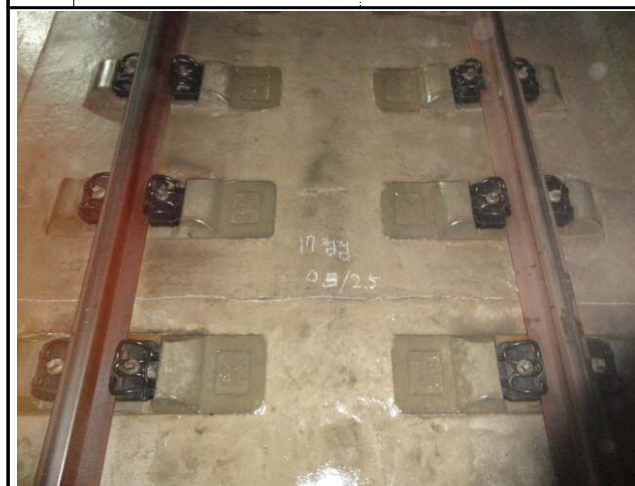
| 위치 | Sta. 151k293-303 | 선별 | T1 | 위치 | TCL |
| 내용 | 균열 | Cw= 0.5/2.5 | | | |

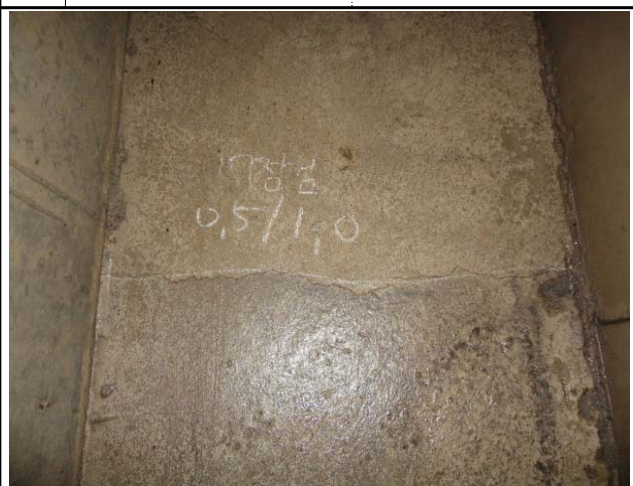
| 위치 | Sta. 151k293-303 | 선별 | T1 | 위치 | 보조 |
| 내용 | 균열 | Cw= 0.5/1.0 | | | |

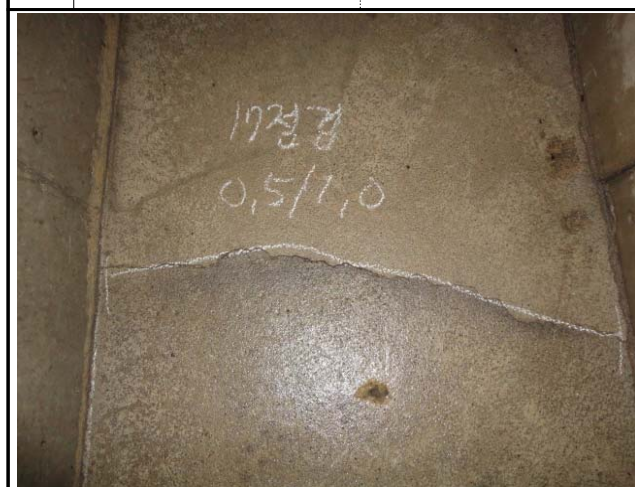
| 위치 | Sta. 151k253-263 | 선별 | T1 | 위치 | 보조 |
| 내용 | 균열 | Cw= 0.5/1.0 | | | |

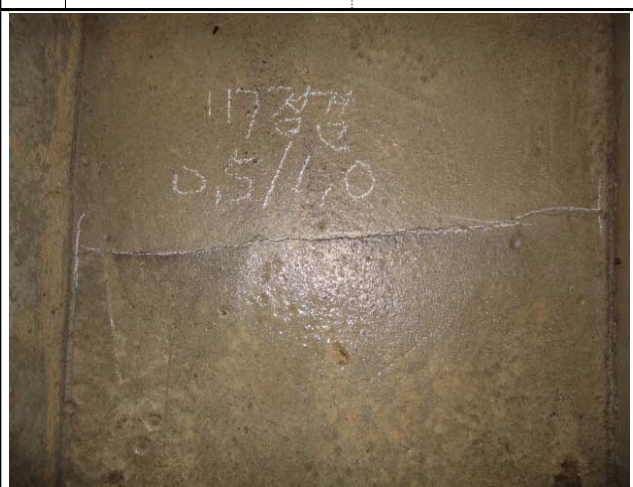
| 위치 | Sta. 151k513-523 | 선별 | T1 | 위치 | 보조 |
| 내용 | 균열 | Cw= 0.5/1.0 | | | |

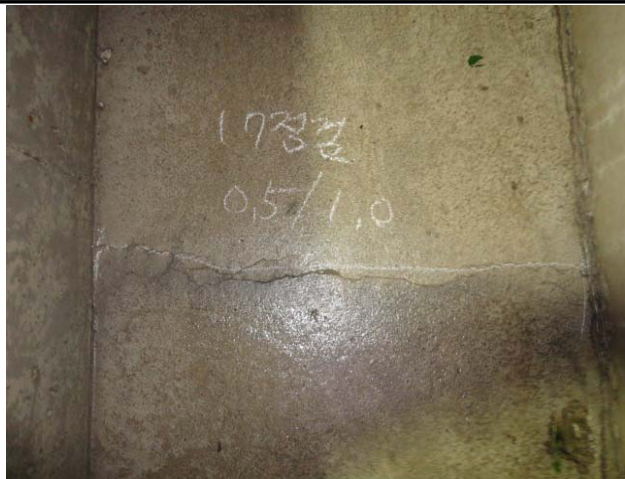
| 위치 | Sta. 151k223-233 | 선별 | T1 | 위치 | 보조 | 위치 | Sta. 151k203-213 | 선별 | T1 | 위치 | 보조 |
| 내용 | 균열 | | Cw= 0.5/1.0 | | | 내용 | 균열 | | Cw= 0.5/1.0 | | |

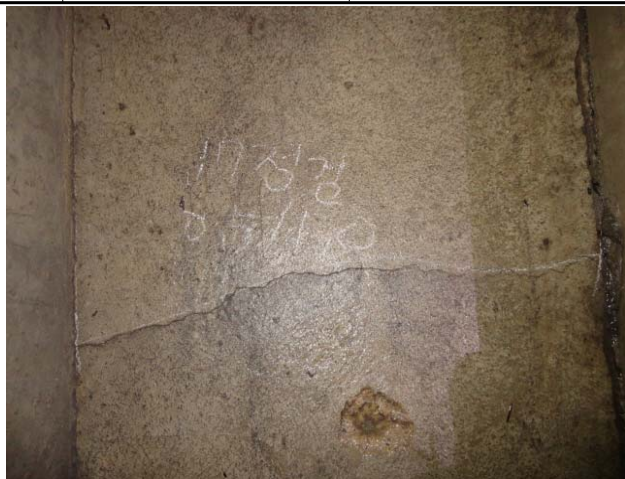
| 위치 | Sta. 151k203-213 | 선별 | T1 | 위치 | 보조 | 위치 | Sta. 151k163-173 | 선별 | T1 | 위치 | 보조 |
| 내용 | 균열 | | Cw= 0.5/1.0 | | | 내용 | 균열 | | Cw= 0.5/1.0 | | |

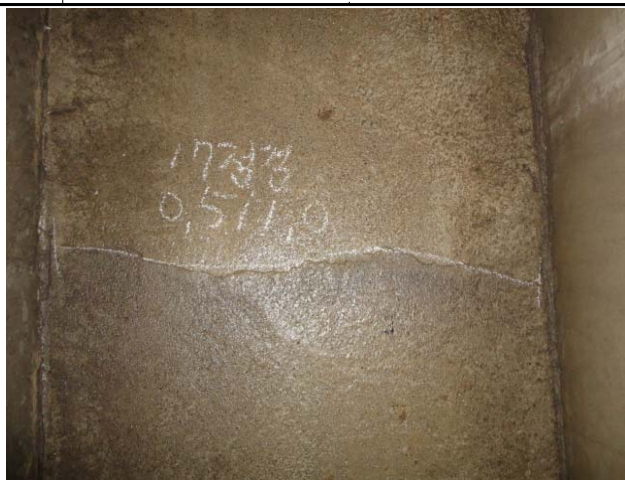
| 위치 | Sta. 151k153-163 | 선별 | T1 | 위치 | 보조 | 위치 | Sta. 151k143-153 | 선별 | T1 | 위치 | 보조 |
| 내용 | 균열 | | Cw= 0.5/1.0 | | | 내용 | 균열 | | Cw= 0.5/1.0 | | |

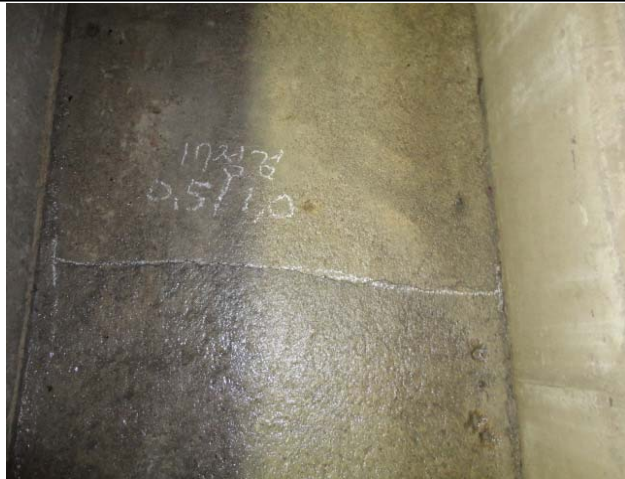
| 위치 | Sta. 151k123-133 | 선별 | T1 | 위치 | 보조 | 위치 | Sta. 151k113-123 | 선별 | T1 | 위치 | TCL |
| 내용 | 균열 | | Cw= 0.5/1.0 | | | 내용 | 균열 | | Cw= 0.5/1.2 | | |

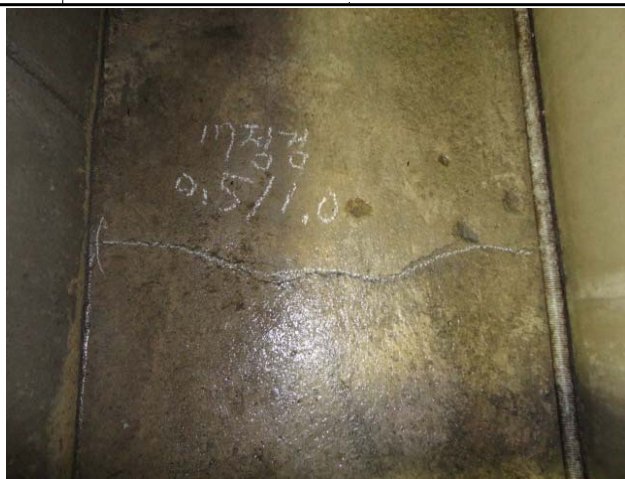
| 위치 | Sta. 151k103-113 | 선별 | T1 | 위치 | 보조 | 위치 | Sta. 151k093-103 | 선별 | T1 | 위치 | 보조 |
| 내용 | 균열 | | Cw= 0.5/1.0 | | | 내용 | 균열 | | Cw= 0.5/1.0 | | |

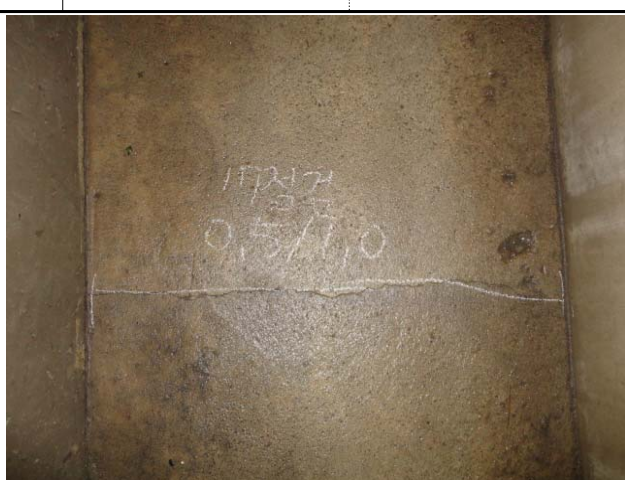
| 위치 | Sta. 151k083-093 | 선별 | T1 | 위치 | 보조 | 위치 | Sta. 151k083-093 | 선별 | T1 | 위치 | 보조 |
| 내용 | 균열 | | Cw= 0.5/1.0 | | | 내용 | 균열 | | Cw= 0.5/1.0 | | |

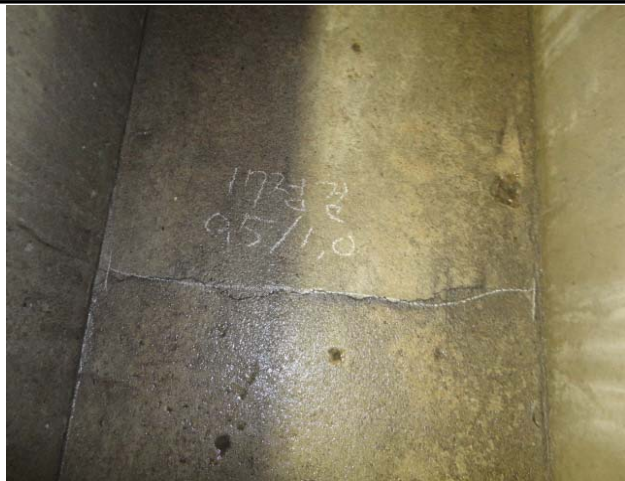
| 위치 | Sta. 151k073-083 | 선별 | T1 | 위치 | 보조 | 위치 | Sta. 151k063-073 | 선별 | T1 | 위치 | 보조 |
| 내용 | 균열 | | Cw= 0.5/1.0 | | | 내용 | 균열 | | Cw= 0.5/1.0 | | |

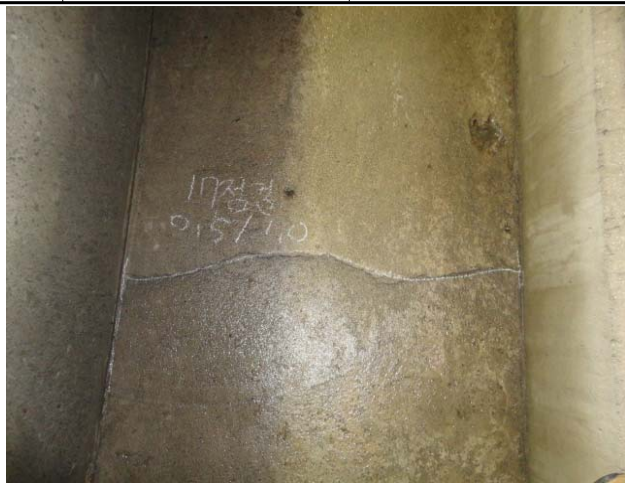
| 위치 | Sta. 151k063-073 | 선별 | T1 | 위치 | 보조 | 위치 | Sta. 151k053-063 | 선별 | T1 | 위치 | 보조 |
| 내용 | 균열 | | Cw= 0.5/1.0 | | | 내용 | 균열 | | Cw= 0.5/1.0 | | |

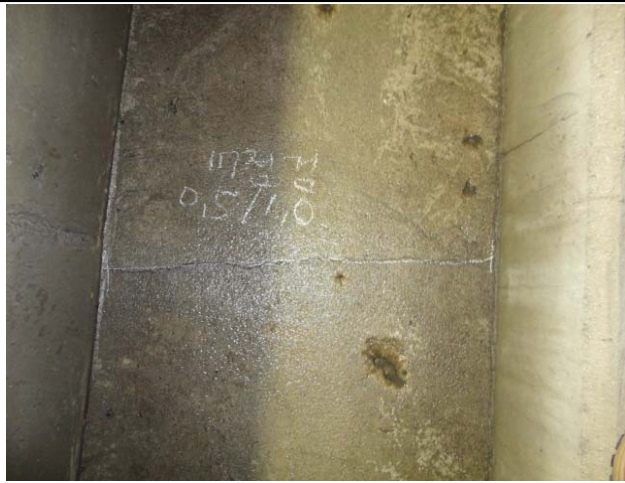
| 위치 | Sta. 151k053-063 | 선별 | T1 | 위치 | 보조 | 위치 | Sta. 151k043-053 | 선별 | T1 | 위치 | 보조 |
| 내용 | 균열 | | Cw= 0.5/1.0 | | | 내용 | 균열 | | Cw= 2.5/1.0 | | |

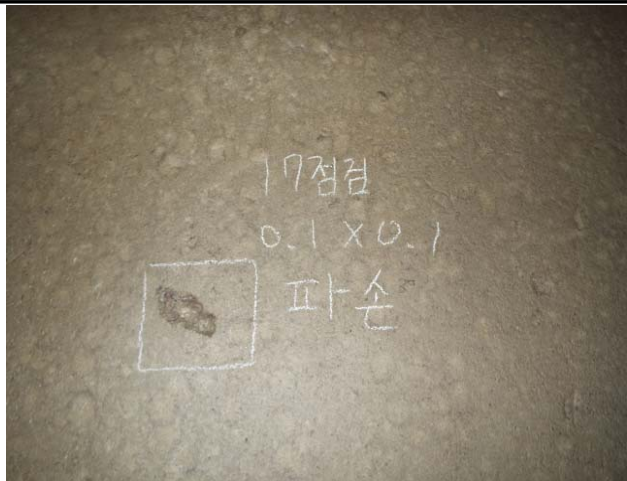
| 위치 | Sta. 152k103-113 | 선별 | T1 | 위치 | 채움 | 위치 | Sta. 151k873-883 | 선별 | T2 | 위치 | TCL |
| 내용 | 파손 | | A= 0.1x0.1 | | | 내용 | 침목도상분리 | | 1EA | | |

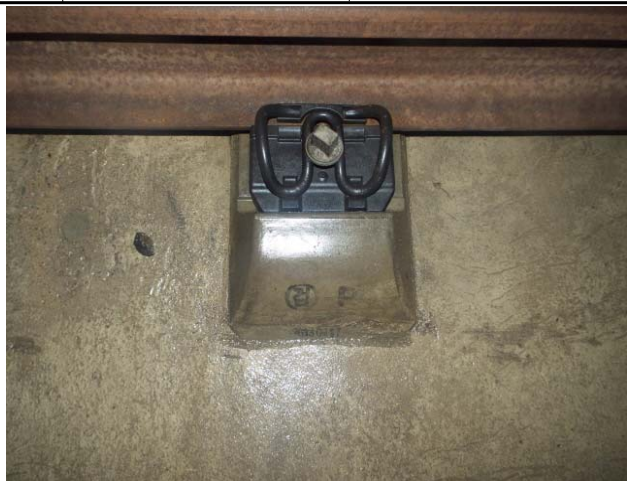
| 위치 | Sta. 151k873-883 | 선별 | T2 | 위치 | TCL | 위치 | Sta. 151k863-873 | 선별 | T2 | 위치 | TCL |
| 내용 | 침목도상분리 | | 1EA | | | 내용 | 침목도상분리 | | 1EA | | |

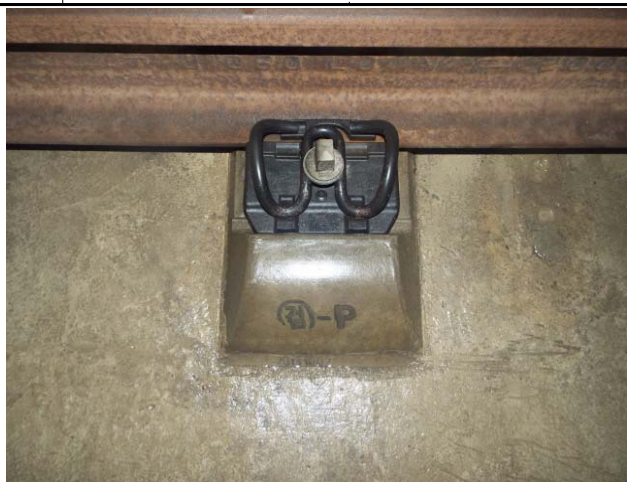
| 위치 | Sta. 151k863-873 | 선별 | T2 | 위치 | TCL | 위치 | Sta. 151k863-873 | 선별 | T2 | 위치 | TCL |
| 내용 | 침목도상분리 | | 1EA | | | 내용 | 침목도상분리 | | 1EA | | |

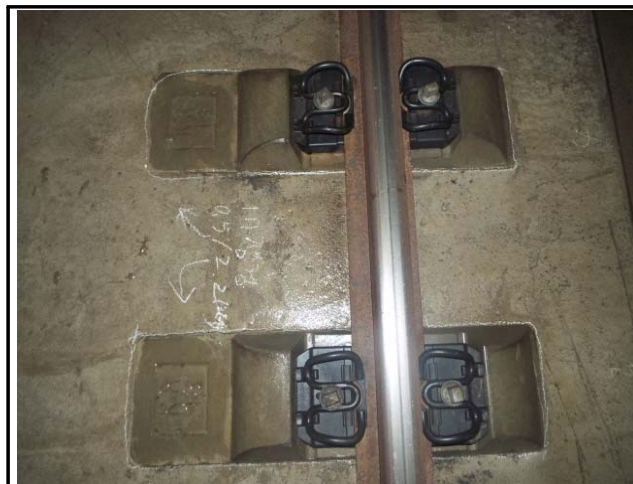
| 위치 | Sta. 151k643-653 | 선별 | T2 | 위치 | TCL |
| 내용 | 경계부 균열 | Cw= 0.5/2.2 (2EA) | | | |

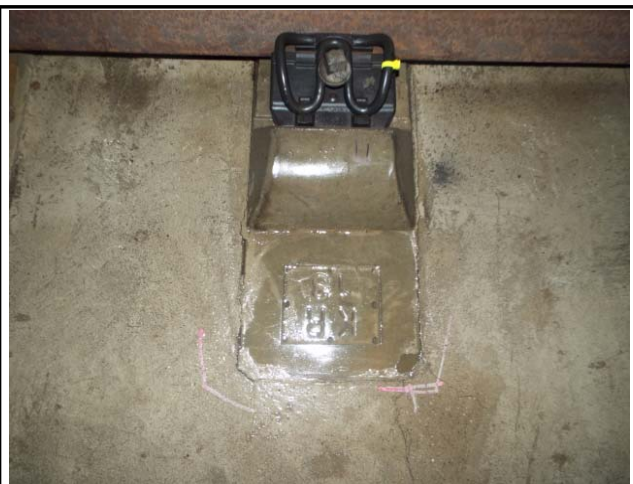
| 위치 | Sta. 151k643-653 | 선별 | T2 | 위치 | TCL |
| 내용 | 침목도상분리 | 1EA | | | |

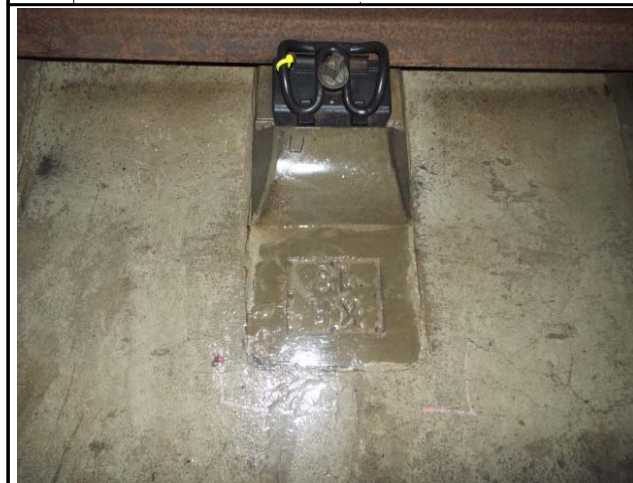
| 위치 | Sta. 151k633-643 | 선별 | T2 | 위치 | TCL |
| 내용 | 침목도상분리 | 1EA | | | |

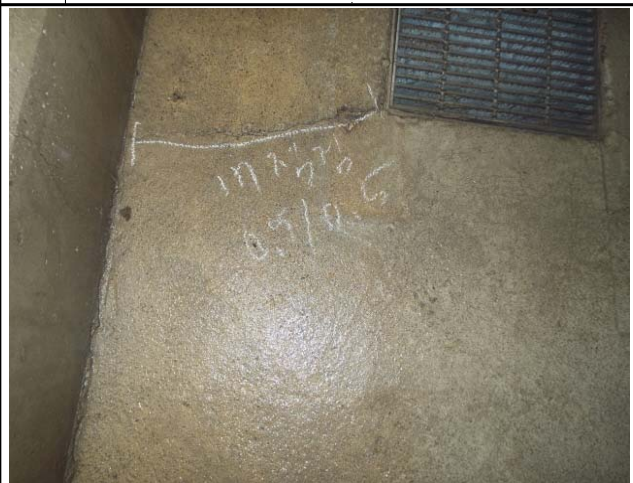
| 위치 | Sta. 151k283-293 | 선별 | T2 | 위치 | 보조 |
| 내용 | 균열 | Cw= 0.5/0.5 | | | |

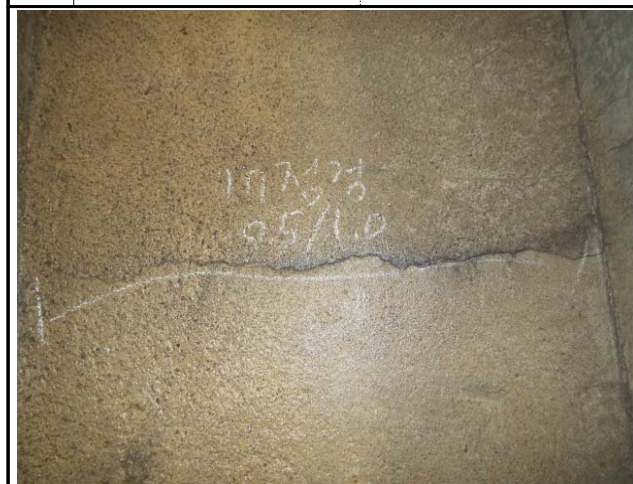
| 위치 | Sta. 151k153-163 | 선별 | T2 | 위치 | 보조 |
| 내용 | 균열 | Cw= 0.5/1.0 | | | |

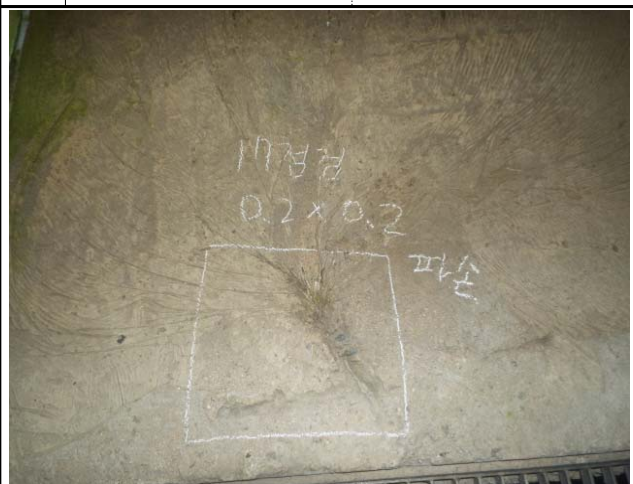
| 위치 | Sta. 151k033-043 | 선별 | T2 | 위치 | 채움 |
| 내용 | 파손 | A= 0.2x0.2 | | | |
