## 59. 신통고가(B64)

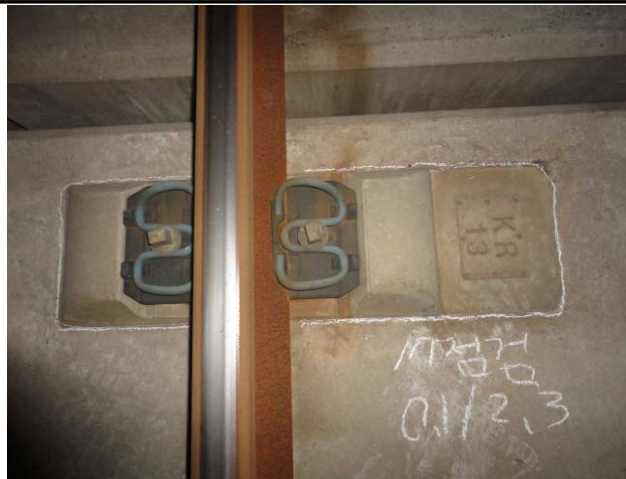
| 위치 | STA. 172K385-393 | | | 선별 | T1 | 위치 | STA. 172K385-393 | | | 선별 | T1 | 위치 | TCL | | | | | | |

| 내용 | 경계부 균열 | | | Cw= 0.1/2.3 | | | 내용 | 균열 | | | Cw= 0.5/1.2 | | | | | | | | |

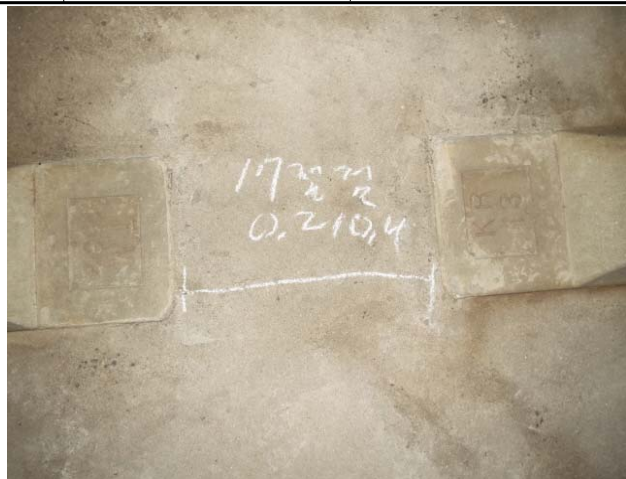
| 위치 | STA. 172K401-409 | | | 선별 | T2 | 위치 | STA. 172K417-425 | | | 선별 | T2 | 위치 | TCL | | | | | | |

| 내용 | 균열 | | | Cw= 0.2/0.4 | | | 내용 | 균열 | | | Cw= 0.2/0.3 | | | | | | | | |

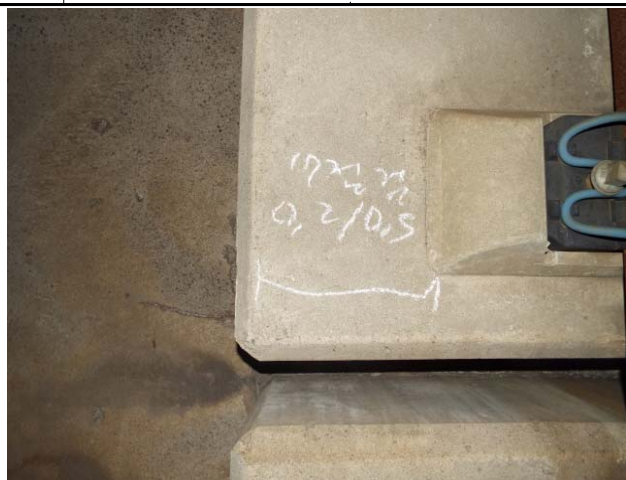
| 위치 | STA. 172K425-433 | | | 선별 | T2 | 위치 | STA. 172K433-441 | | | 선별 | T1 | 위치 | TCL | | | | | | |

| 내용 | 균열 | | | Cw= 0.2/0.5 | | | 내용 | 균열 | | | Cw= 0.2/0.3 | | | | | | | | |

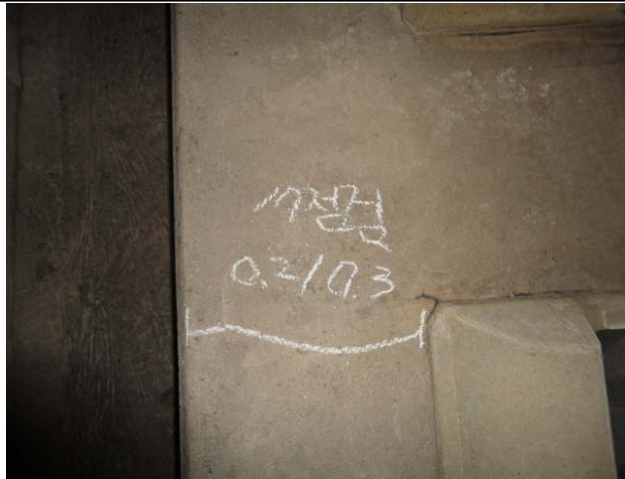
| 내용 | | 균열 | | | | Cw= 0.2/0.3 | | | | | | 내용 | | 균열 | | | | Cw= 0.2/0.3 | | | | | |

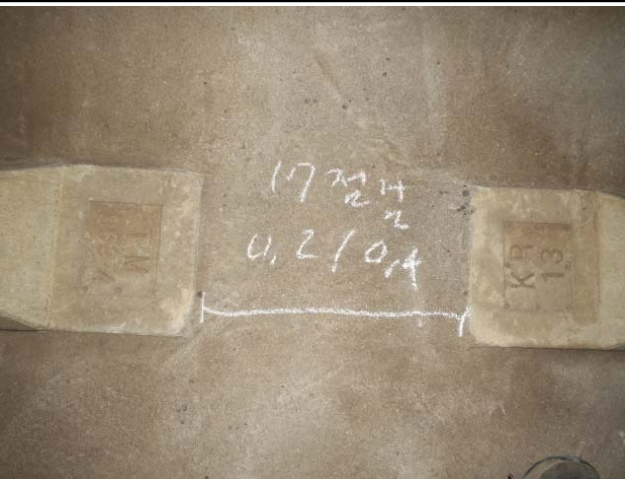
| 내용 | | 균열 | | | | Cw= 0.2/0.4 | | | | | | 내용 | | 균열 | | | | Cw= 0.3/0.4 | | | | | |

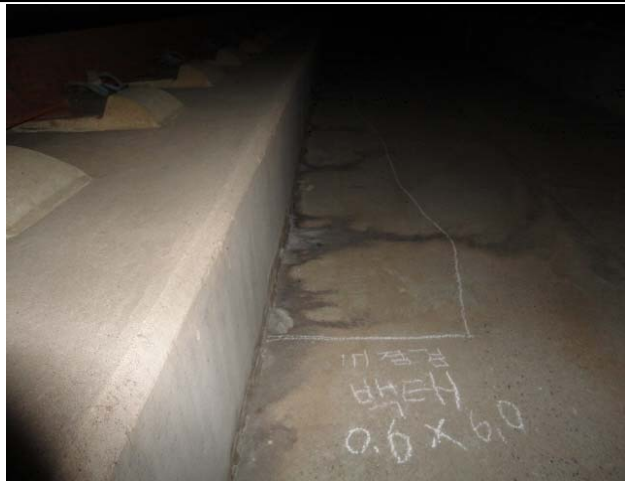
| 내용 | | 백태 | | | | A= 0.6x6.0 | | | | | | 내용 | | 백태 | | | | A= 0.3x10.0 | | | | | |
