호남고속선 오송고가(T1)\_9(1.306~1.314km, S3-5)

| 시 | 행 사 | 영 역 | 영 역 | 영역 | 사 | 과목명 | | 단 | |
|---|---|---|---|---|---|---|---|---|---|
| KORAIL<br>KOREA RAILROAD | 한국철도공사 | 2017년도 호남고속선 오송-광주승정간 콘크리트케도 점검공여 | (주) 한국구조물안전연구원<br>(주) 한국도로안전연구원<br>(재) 한국건설품질연구원 | 이 부 영 | 김 윤 강<br>김 경 기<br>문 은 작 기 | 점 | 0.220 (0.3mm이하 : 흑색) | 참모대상분리 | |

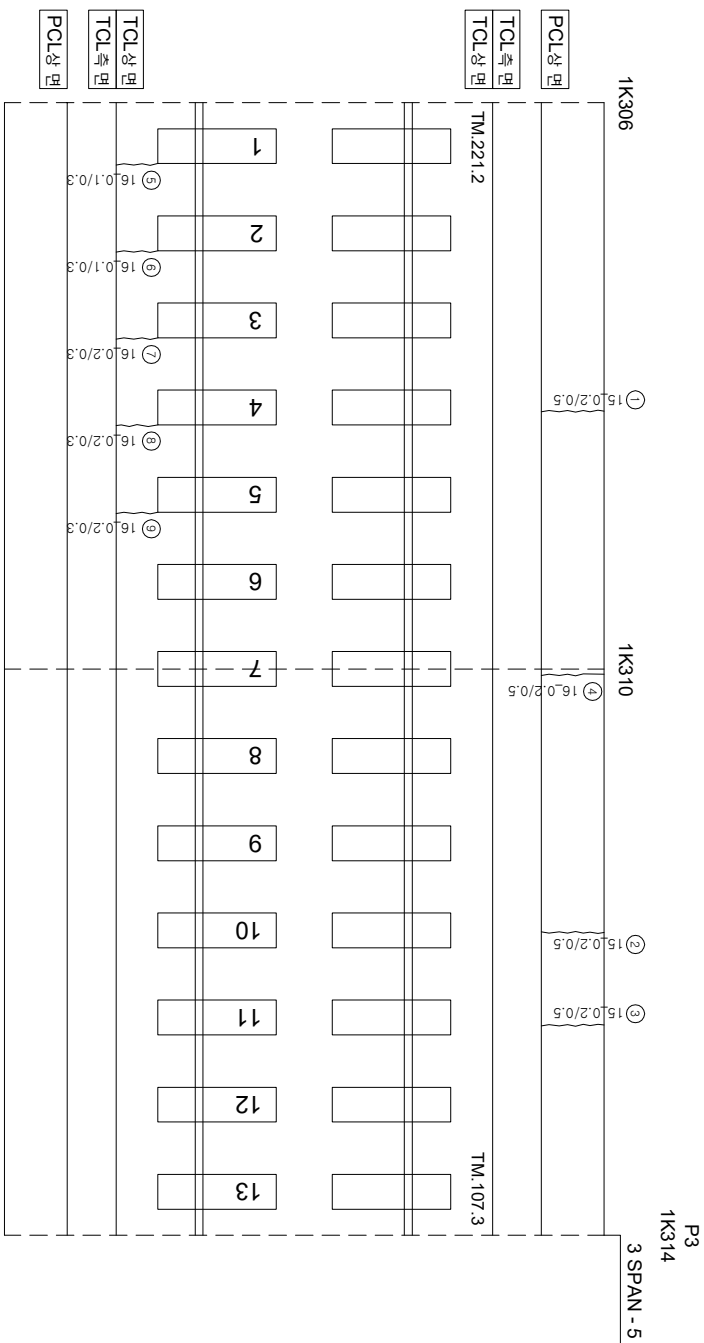
| 연번 | 순상 | 폭 | 연장 | 비고 | 연번 | 순상 | 폭 | 연장 | 비고 |
|---|---|---|---|---|---|---|---|---|---|
| 1 | 균열 | 0.2 | mm | 0.5 | m | 56 | | | |
| 2 | 균열 | 0.2 | mm | 0.5 | m | 57 | | | |
| 3 | 균열 | 0.2 | mm | 0.5 | m | 58 | | | |
| 4 | 균열 | 0.2 | mm | 0.5 | m | 59 | | | |
| 5 | 균열 | 0.1 | mm | 0.3 | m | 60 | | | |
| 6 | 균열 | 0.2 | mm | 0.3 | m | 61 | | | |
| 7 | 균열 | 0.2 | mm | 0.3 | m | 62 | | | |
| 8 | 균열 | 0.2 | mm | 0.3 | m | 63 | | | |
| 9 | 균열 | 0.2 | mm | 0.3 | m | 64 | | | |
