호남고속선 오송고가(T2)\_2(1.210~1.226km, S1-3,S1-4)

| 시 | 행 | 사 | 용 | 여 | 명 | 용 | 여 | 사 | 관 | | | | |
|---|---|---|---|---|---|---|---|---|---|---|---|---|---|
| KORAIL<br>KOREA RAILROAD | 한국철도공사 | 2017년도 호남고속선 오송-광주승정간 코크리트케도 점검용역 | (주)한국구조물안전연구원<br>(주)한국도로안전연구원<br>(제)한국건설품질연구원 | 이복영 | 김문강<br>김경기<br>한은석 | 용 | 〰〰〰 (0.3mm이하 : 흑색) | 0.220 | 천문도상문리 | | 제료문리 | | |

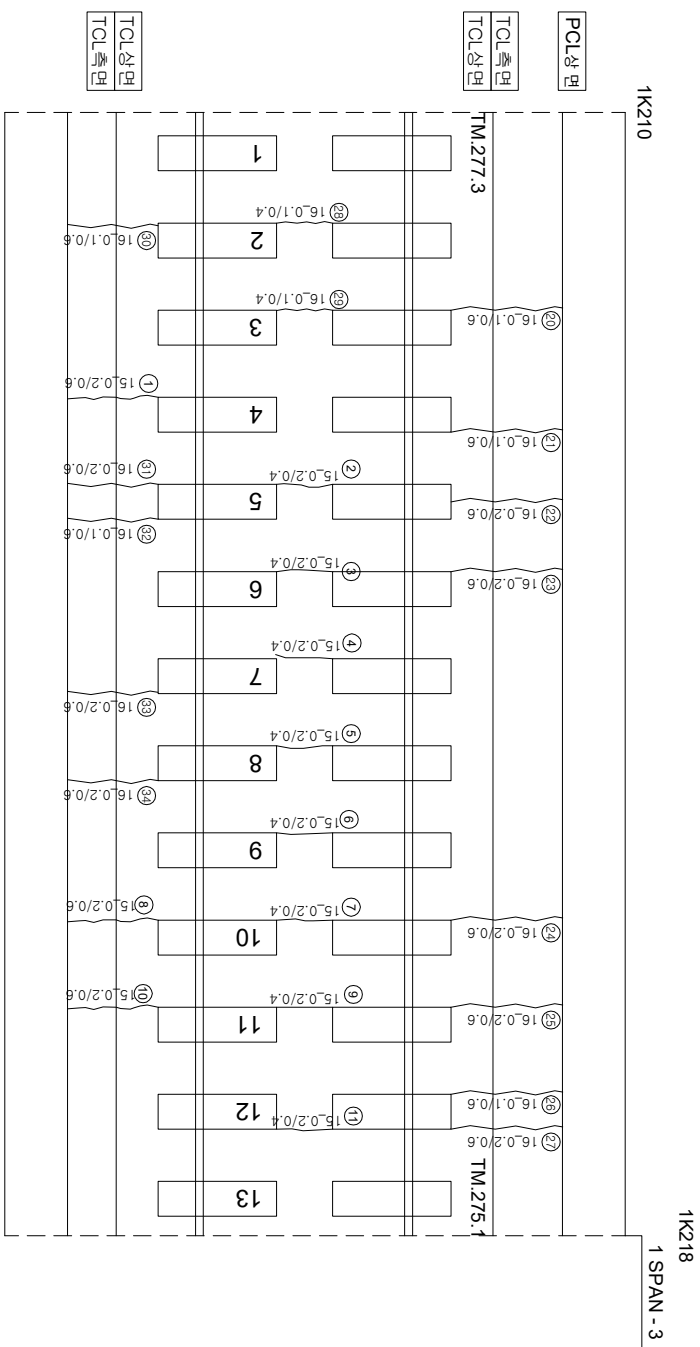
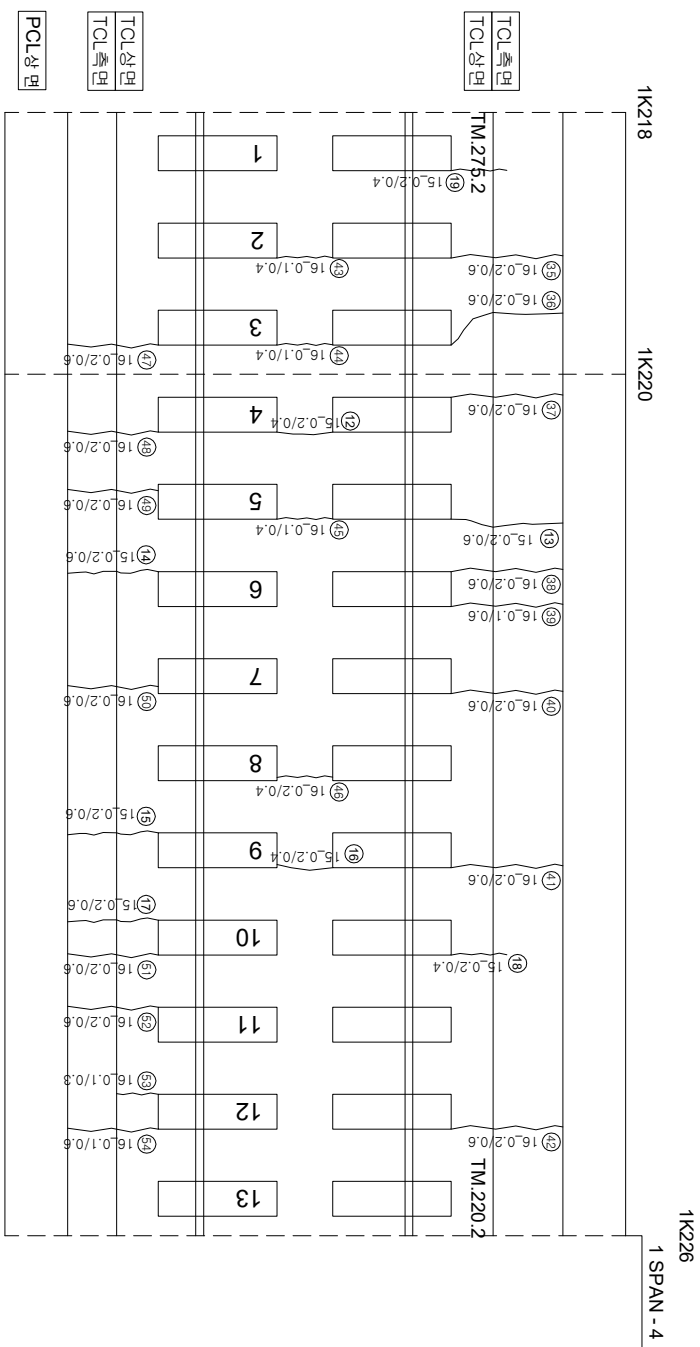
| 연번 | 순상 | 목 | 연장 | 비고 | 연번 | 순상 | 목 | 연장 | 비고 |
|---|---|---|---|---|---|---|---|---|---|
| 1 | 균열 | 0.2 mm | 0.6 m | | 56 | | | | |
| 2 | 균열 | 0.2 mm | 0.4 m | | 57 | | | | |
| 3 | 균열 | 0.2 mm | 0.4 m | | 58 | | | | |
| 4 | 균열 | 0.2 mm | 0.4 m | | 59 | | | | |
| 5 | 균열 | 0.2 mm | 0.4 m | | 60 | | | | |
| 6 | 균열 | 0.2 mm | 0.4 m | | 61 | | | | |
| 7 | 균열 | 0.2 mm | 0.4 m | | 62 | | | | |
| 8 | 균열 | 0.2 mm | 0.6 m | | 63 | | | | |
| 9 | 균열 | 0.2 mm | 0.4 m | | 64 | | | | |
| 10 | 균열 | 0.2 mm | 0.6 m | | 65 | | | | |
| 11 | 균열 | 0.2 mm | 0.4 m | | 66 | | | | |
| 12 | 균열 | 0.2 mm | 0.4 m | | 67 | | | | |
| 13 | 균열 | 0.2 mm | 0.6 m | | 68 | | | | |
| 14 | 균열 | 0.2 mm | 0.6 m | | 69 | | | | |
| 15 | 균열 | 0.2 mm | 0.6 m | | 70 | | | | |
| 16 | 균열 | 0.2 mm | 0.4 m | | 71 | | | | |
| 17 | 균열 | 0.2 mm | 0.6 m | | 72 | | | | |
| 18 | 균열 | 0.2 mm | 0.4 m | | 73 | | | | |
| 19 | 균열 | 0.2 mm | 0.4 m | | 74 | | | | |
| 20 | 균열 | 0.1 mm | 0.6 m | | 75 | | | | |
| 21 | 균열 | 0.1 mm | 0.6 m | | 76 | | | | |
| 22 | 균열 | 0.2 mm | 0.6 m | | 77 | | | | |
| 23 | 균열 | 0.2 mm | 0.6 m | | 78 | | | | |
| 24 | 균열 | 0.2 mm | 0.6 m | | 79 | | | | |
| 25 | 균열 | 0.2 mm | 0.6 m | | 80 | | | | |
| 26 | 균열 | 0.1 mm | 0.6 m | | 81 | | | | |
| 27 | 균열 | 0.2 mm | 0.6 m | | 82 | | | | |
| 28 | 균열 | 0.1 mm | 0.4 m | | 83 | | | | |
| 29 | 균열 | 0.1 mm | 0.4 m | | 84 | | | | |
| 30 | 균열 | 0.1 mm | 0.6 m | | 85 | | | | |
| 31 | 균열 | 0.2 mm | 0.6 m | | 86 | | | | |
| 32 | 균열 | 0.1 mm | 0.6 m | | 87 | | | | |
| 33 | 균열 | 0.2 mm | 0.6 m | | 88 | | | | |
| 34 | 균열 | 0.2 mm | 0.6 m | | 89 | | | | |
| 35 | 균열 | 0.2 mm | 0.6 m | | 90 | | | | |
| 36 | 균열 | 0.2 mm | 0.6 m | | 91 | | | | |
| 37 | 균열 | 0.2 mm | 0.6 m | | 92 | | | | |
| 38 | 균열 | 0.2 mm | 0.6 m | | 93 | | | | |
| 39 | 균열 | 0.1 mm | 0.6 m | | 94 | | | | |
| 40 | 균열 | 0.2 mm | 0.6 m | | 95 | | | | |
| 41 | 균열 | 0.2 mm | 0.6 m | | 96 | | | | |
| 42 | 균열 | 0.2 mm | 0.6 m | | 97 | | | | |
| 43 | 균열 | 0.1 mm | 0.4 m | | 98 | | | | |
| 44 | 균열 | 0.1 mm | 0.4 m | | 99 | | | | |
| 45 | 균열 | 0.1 mm | 0.4 m | | 100 | | | | |
| 46 | 균열 | 0.2 mm | 0.4 m | | 101 | | | | |
| 47 | 균열 | 0.2 mm | 0.6 m | | 102 | | | | |
| 48 | 균열 | 0.2 mm | 0.6 m | | 103 | | | | |
| 49 | 균열 | 0.2 mm | 0.6 m | | 104 | | | | |
| 50 | 균열 | 0.2 mm | 0.6 m | | 105 | | | | |
| 51 | 균열 | 0.2 mm | 0.6 m | | 106 | | | | |
| 52 | 균열 | 0.2 mm | 0.6 m | | 107 | | | | |
| 53 | 균열 | 0.1 mm | 0.6 m | | 108 | | | | |
| 54 | 균열 | 0.1 mm | 0.6 m | | 109 | | | | |
