화남고속선 오송고가(T1)\_토공노반\_62(4.300~4.320km, L=20m)

| 시 | 행 | 사 | 용 | 역 | 영 | 사 | 단 | | |
|---|---|---|---|---|---|---|---|---|---|
| KORAIL<br>KOREA RAILROAD | 한국철도공사 | 2017년도 호남고속선 오송-광주승정간 콘크리트케도 점검용역 | (주) 한국구조물안전연구원<br>(주) 한국도로안전연구원<br>(재) 한국건설품질연구원 | 이 복 영 | 간윤강<br>김경기<br>문석기 | 영원 | 0220 (0.3m이하 : 목책) | 점목도상방탄리 | 차로방탄리 |

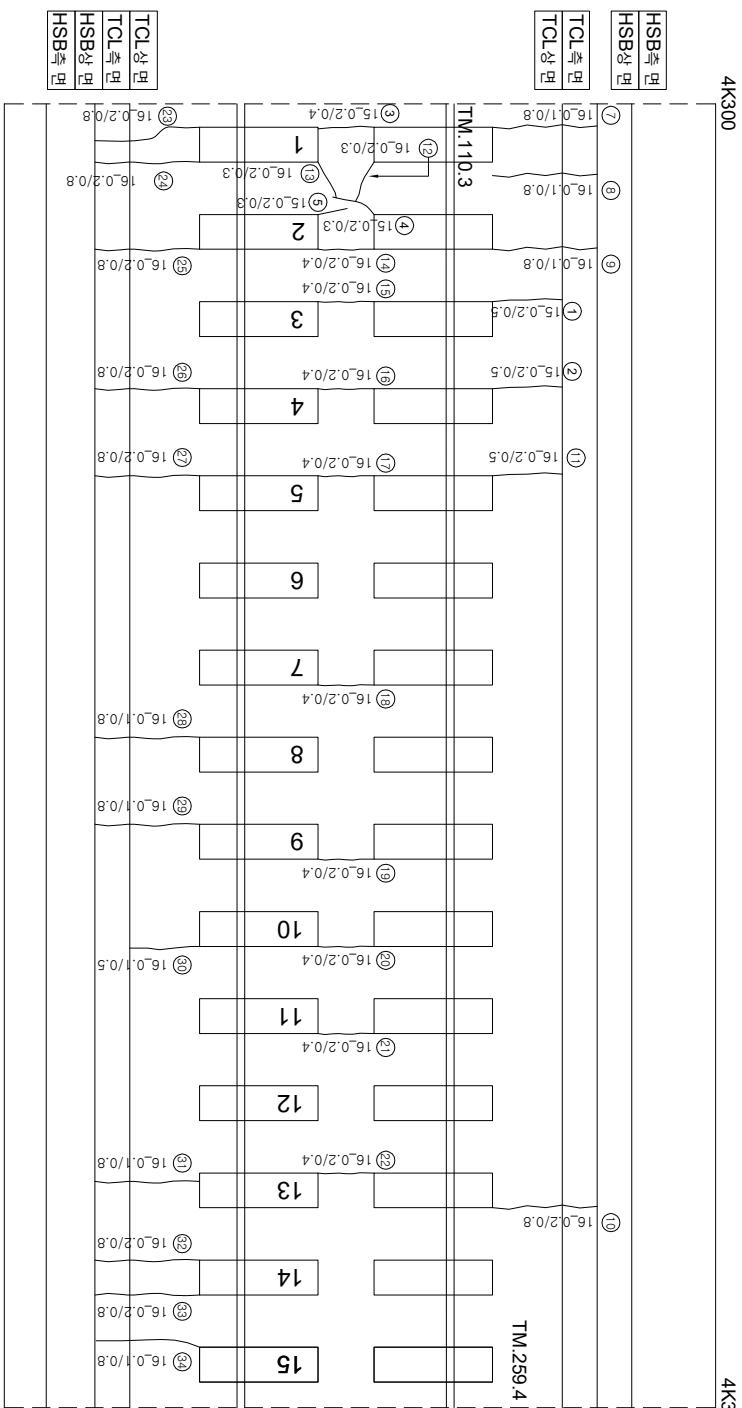
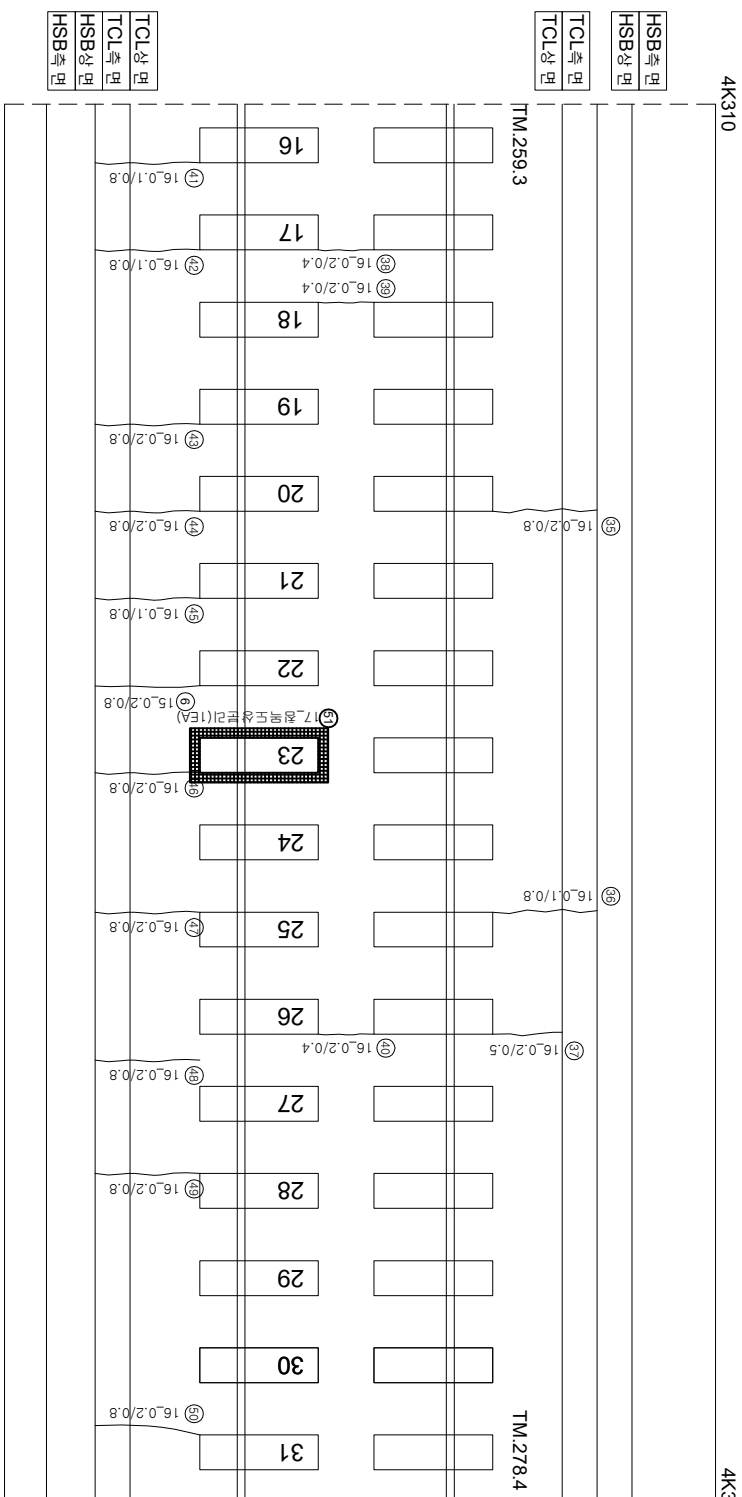
| 연번 | 산선 | 폭 | 연장 | 비고 | 연번 | 산선 | 폭 | 연장 | 비고 |
|---|---|---|---|---|---|---|---|---|---|
| 1 | 균열 | 0.1 mm | 0.5 m | | 56 | | | | |
| 2 | 균열 | 0.2 mm | 0.5 m | | 57 | | | | |
| 3 | 균열 | 0.2 mm | 0.4 m | | 58 | | | | |
| 4 | 균열 | 0.1 mm | 0.3 m | | 59 | | | | |
| 5 | 균열 | 0.2 mm | 0.3 m | | 60 | | | | |
| 6 | 균열 | 0.2 mm | 0.8 m | | 61 | | | | |
| 7 | 균열 | 0.1 mm | 0.8 m | | 62 | | | | |
| 8 | 균열 | 0.1 mm | 0.8 m | | 63 | | | | |
| 9 | 균열 | 0.1 mm | 0.8 m | | 64 | | | | |
| 10 | 균열 | 0.2 mm | 0.8 m | | 65 | | | | |
| 11 | 균열 | 0.2 mm | 0.5 m | | 66 | | | | |
| 12 | 균열 | 0.2 mm | 0.3 m | | 67 | | | | |
| 13 | 균열 | 0.2 mm | 0.3 m | | 68 | | | | |
| 14 | 균열 | 0.2 mm | 0.4 m | | 69 | | | | |
| 15 | 균열 | 0.2 mm | 0.4 m | | 70 | | | | |
| 16 | 균열 | 0.2 mm | 0.4 m | | 71 | | | | |
| 17 | 균열 | 0.2 mm | 0.4 m | | 72 | | | | |
| 18 | 균열 | 0.2 mm | 0.4 m | | 73 | | | | |
| 19 | 균열 | 0.2 mm | 0.4 m | | 74 | | | | |
| 20 | 균열 | 0.2 mm | 0.4 m | | 75 | | | | |
| 21 | 균열 | 0.2 mm | 0.4 m | | 76 | | | | |
| 22 | 균열 | 0.2 mm | 0.4 m | | 77 | | | | |
| 23 | 균열 | 0.2 mm | 0.8 m | | 78 | | | | |
| 24 | 균열 | 0.2 mm | 0.8 m | | 79 | | | | |
| 25 | 균열 | 0.2 mm | 0.8 m | | 80 | | | | |
| 26 | 균열 | 0.2 mm | 0.8 m | | 81 | | | | |
| 27 | 균열 | 0.2 mm | 0.8 m | | 82 | | | | |
| 28 | 균열 | 0.1 mm | 0.8 m | | 83 | | | | |
| 29 | 균열 | 0.1 mm | 0.8 m | | 84 | | | | |
| 30 | 균열 | 0.1 mm | 0.5 m | | 85 | | | | |
| 31 | 균열 | 0.1 mm | 0.8 m | | 86 | | | | |
| 32 | 균열 | 0.2 mm | 0.8 m | | 87 | | | | |
| 33 | 균열 | 0.2 mm | 0.8 m | | 88 | | | | |
| 34 | 균열 | 0.1 mm | 0.8 m | | 89 | | | | |
| 35 | 균열 | 0.2 mm | 0.8 m | | 90 | | | | |
| 36 | 균열 | 0.1 mm | 0.8 m | | 91 | | | | |
| 37 | 균열 | 0.2 mm | 0.5 m | | 92 | | | | |
| 38 | 균열 | 0.2 mm | 0.4 m | | 93 | | | | |
| 39 | 균열 | 0.2 mm | 0.4 m | | 94 | | | | |
| 40 | 균열 | 0.2 mm | 0.4 m | | 95 | | | | |
| 41 | 균열 | 0.1 mm | 0.8 m | | 96 | | | | |
| 42 | 균열 | 0.1 mm | 0.8 m | | 97 | | | | |
| 43 | 균열 | 0.2 mm | 0.8 m | | 98 | | | | |
| 44 | 균열 | 0.2 mm | 0.8 m | | 99 | | | | |
| 45 | 균열 | 0.1 mm | 0.8 m | | 100 | | | | |
| 46 | 균열 | 0.2 mm | 0.8 m | | 101 | | | | |
| 47 | 균열 | 0.2 mm | 0.8 m | | 102 | | | | |
| 48 | 균열 | 0.2 mm | 0.8 m | | 103 | | | | |
| 49 | 균열 | 0.2 mm | 0.8 m | | 104 | | | | |
| 50 | 균열 | 0.2 mm | 0.8 m | | 105 | | | | |
| 51 | 잔해도상 분리 | | 1.0 ea | 산구 | 106 | | | | |
