호남고속선 박산고가 \_55(22.044~22.051km, S10-2)

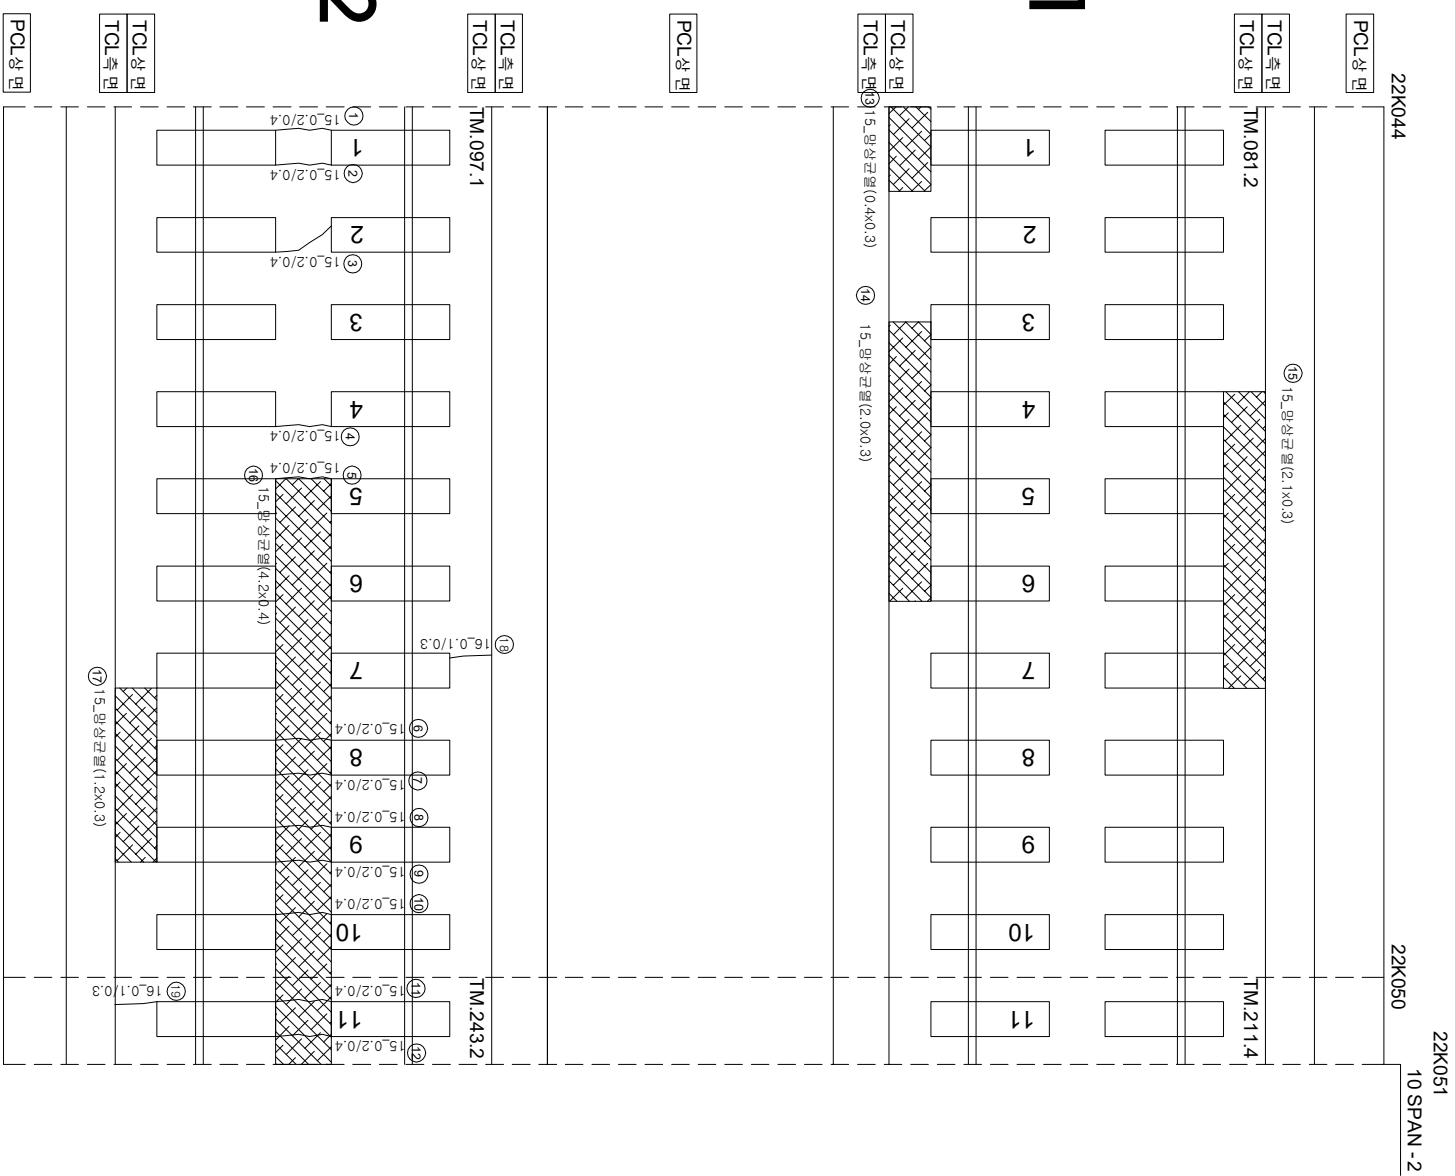
| 연번 | 순차 | 폭 | 연장 | 비고 | 연번 | 순차 | 폭 | 연장 | 비고 |
|---|---|---|---|---|---|---|---|---|---|
| 1 | 균열 | 0.2 mm | 0.4 m | | 56 | | | | |
| 13 | 방수균열 | 0.4 m | 0.3 m | | 68 | | | | |
| 18 | 균열 | 0.1 mm | 0.3 m | | 73 | | | | |
