# 호남고속선 광주고가\_31(43.855~43.863km, S30)

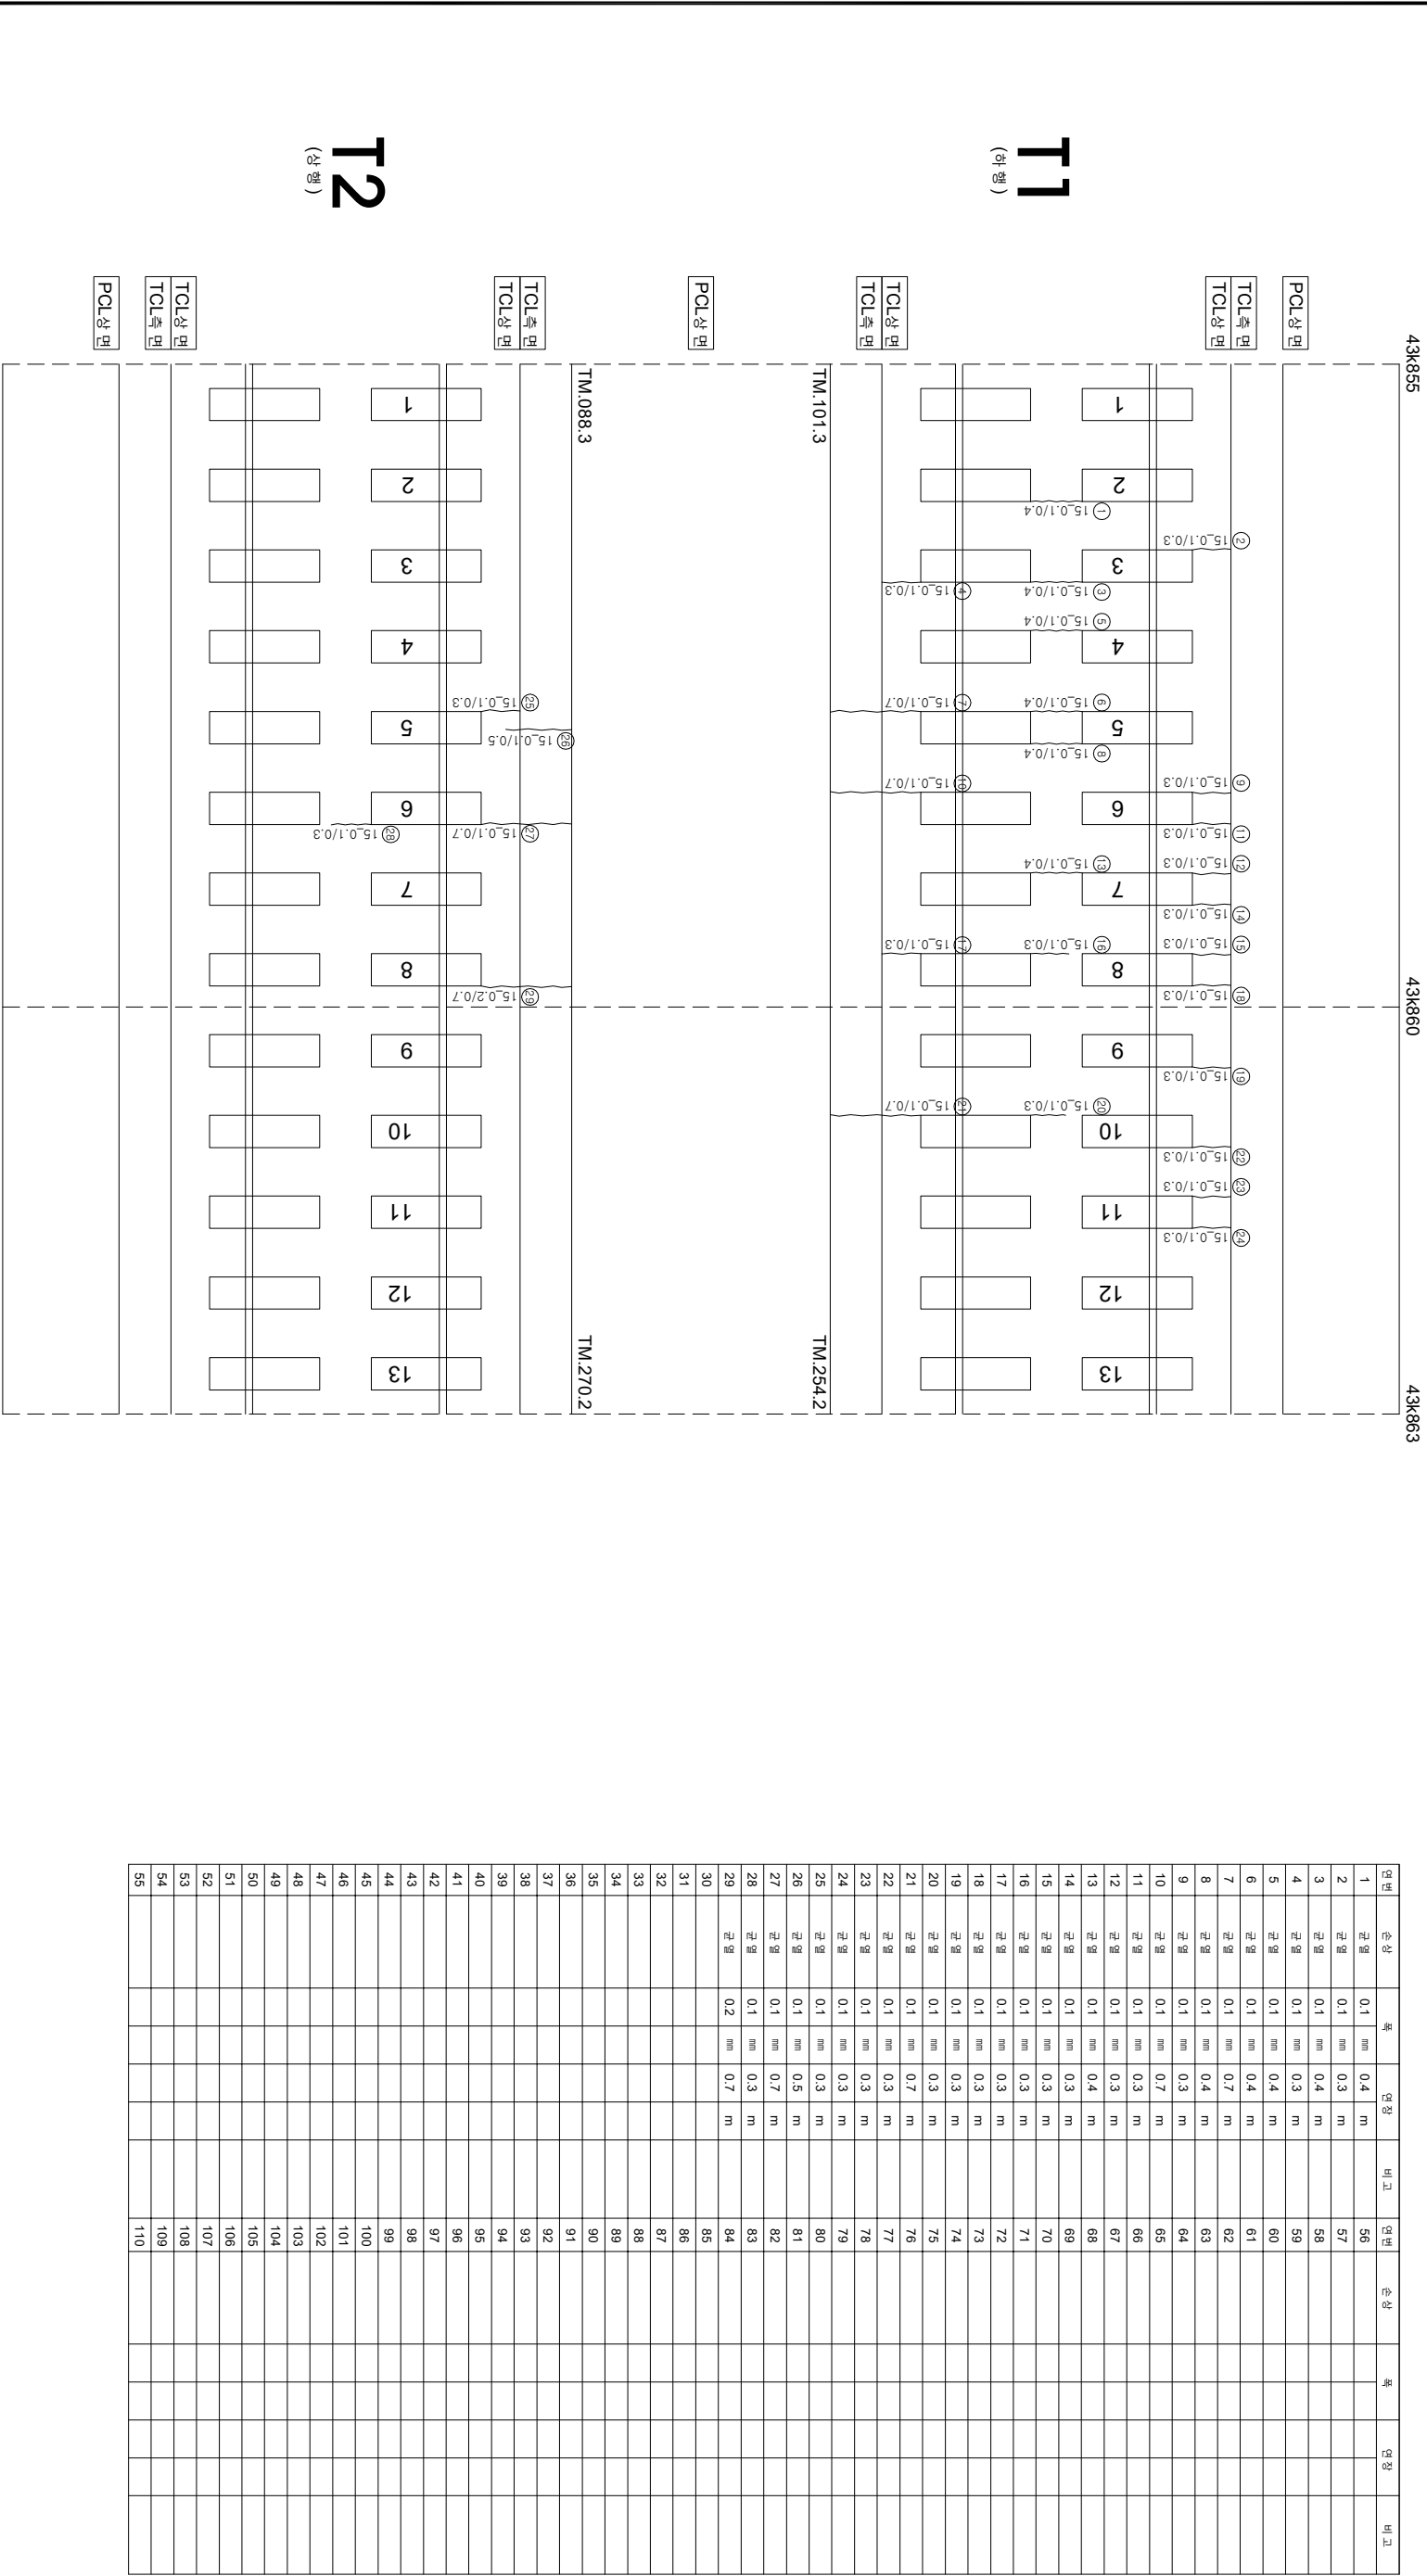
| 연번 | 손상 | 폭 | 연장 | 비고 | 연번 | 손상 | 폭 | 연장 | 비고 |
| 1 | 균열 | 0.1 mm | 0.4 m | | 56 | | | | |
| 2 | 균열 | 0.1 mm | 0.3 m | | 57 | | | | |
| 3 | 균열 | 0.1 mm | 0.4 m | | 58 | | | | |
| 4 | 균열 | 0.1 mm | 0.3 m | | 59 | | | | |
| 5 | 균열 | 0.1 mm | 0.4 m | | 60 | | | | |
| 6 | 균열 | 0.1 mm | 0.4 m | | 61 | | | | |
| 7 | 균열 | 0.1 mm | 0.7 m | | 62 | | | | |
| 8 | 균열 | 0.1 mm | 0.4 m | | 63 | | | | |
| 9 | 균열 | 0.1 mm | 0.3 m | | 64 | | | | |
| 10 | 균열 | 0.1 mm | 0.7 m | | 65 | | | | |
| 11 | 균열 | 0.1 mm | 0.3 m | | 66 | | | | |
| 12 | 균열 | 0.1 mm | 0.3 m | | 67 | | | | |
| 13 | 균열 | 0.1 mm | 0.4 m | | 68 | | | | |
| 14 | 균열 | 0.1 mm | 0.3 m | | 69 | | | | |
| 15 | 균열 | 0.1 mm | 0.3 m | | 70 | | | | |
| 16 | 균열 | 0.1 mm | 0.3 m | | 71 | | | | |
| 17 | 균열 | 0.1 mm | 0.3 m | | 72 | | | | |
| 18 | 균열 | 0.1 mm | 0.3 m | | 73 | | | | |
| 19 | 균열 | 0.1 mm | 0.3 m | | 74 | | | | |
| 20 | 균열 | 0.1 mm | 0.3 m | | 75 | | | | |
| 21 | 균열 | 0.1 mm | 0.7 m | | 76 | | | | |
| 22 | 균열 | 0.1 mm | 0.3 m | | 77 | | | | |
| 23 | 균열 | 0.1 mm | 0.3 m | | 78 | | | | |
| 24 | 균열 | 0.1 mm | 0.3 m | | 79 | | | | |
| 25 | 균열 | 0.1 mm | 0.3 m | | 80 | | | | |
| 26 | 균열 | 0.1 mm | 0.5 m | | 81 | | | | |
| 27 | 균열 | 0.1 mm | 0.7 m | | 82 | | | | |
| 28 | 균열 | 0.1 mm | 0.3 m | | 83 | | | | |
| 29 | 균열 | 0.2 mm | 0.7 m | | 84 | | | | |
