호남고속선 호암교\_113(47.103~47.110km, S23-2)

23SPAN - 2

| | 시행사 | 한국철도공사 | 2017년도 호남고속선 오송-광주승정간 편크리트케도 점검용역 | 용역명 | 용역사 | 이 박 영 | | 용역 | | 0220 (0.3mm이하 : 흑색) | | 한목도상문리 | | 재료문리 | | | | | | | | | | | | | | | |

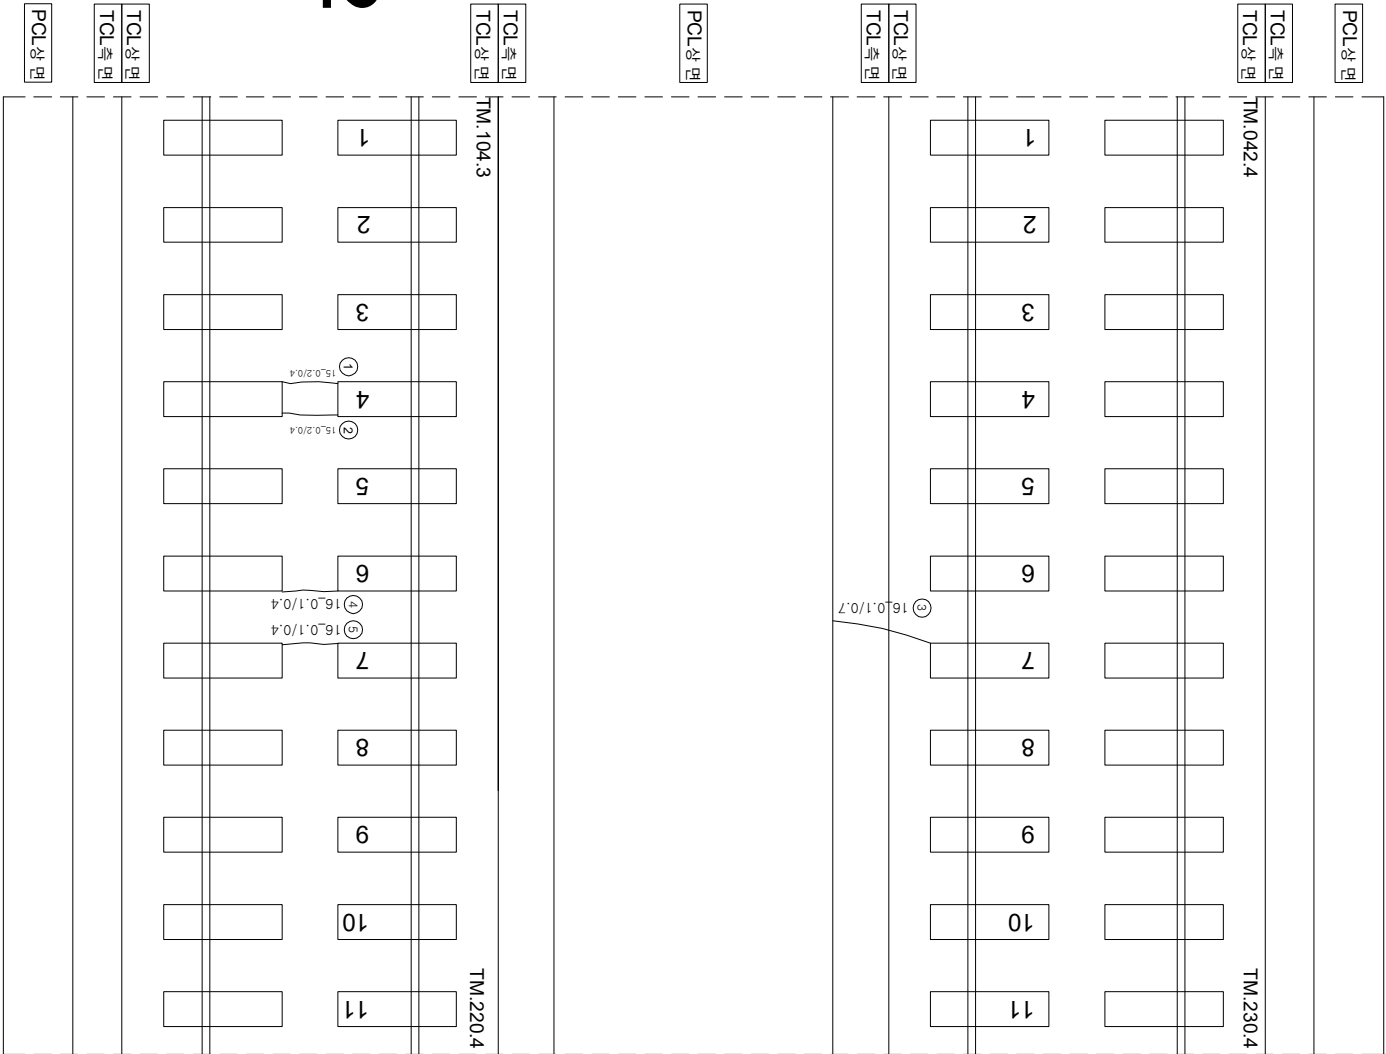
| 연번 | 순상 | 폭 | 연장 | 비고 | 연번 | 순상 | 폭 | 연장 | 비고 |
|---|---|---|---|---|---|---|---|---|---|
| 1 | 균열 0.2 | mm 0.4 | m | | 56 | | | | |
| 2 | 균열 0.2 | mm 0.4 | m | | 57 | | | | |
| 3 | 균열 0.1 | mm 0.7 | m | | 58 | | | | |
| 4 | 균열 0.1 | mm 0.4 | m | | 59 | | | | |
| 5 | 균열 0.1 | mm 0.4 | m | | 60 | | | | |
