# 호남고속선 장구교\_6(48.530~48.537km, S1-5)

P1  
48K537  
1 SPAN - 5

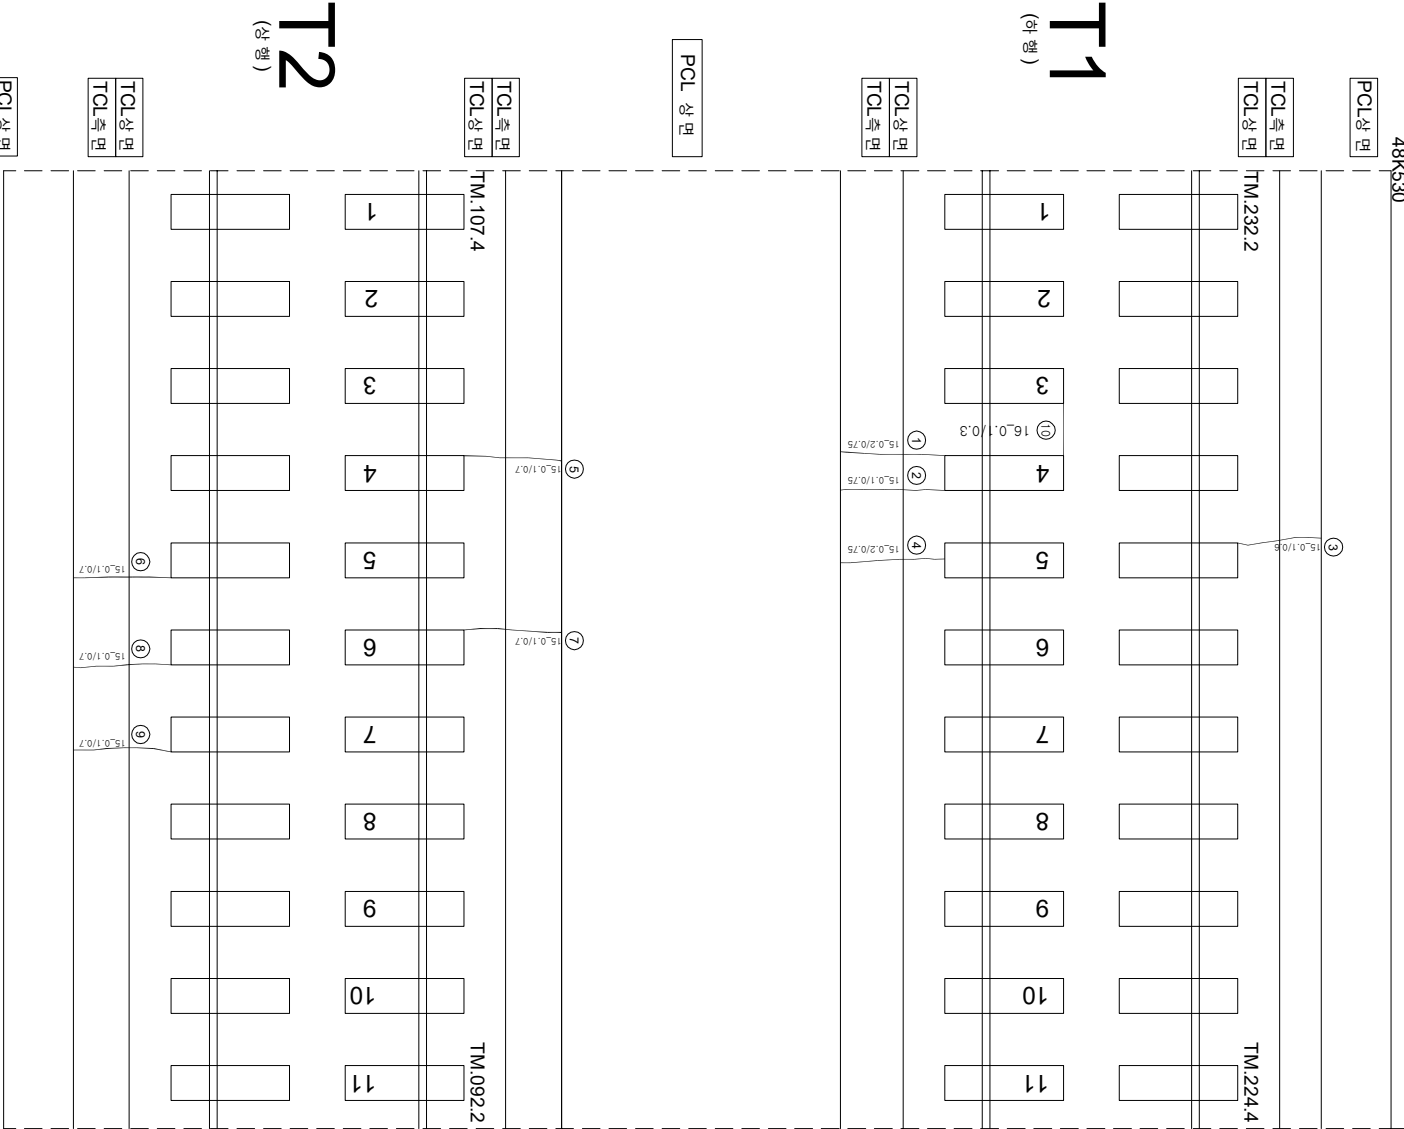
| 면번 | 손상 | 폭 | 면장 | 비고 | 면번 | 손상 | 폭 | 면장 | 비고 |
|---|---|---|---|---|---|---|---|---|---|
| 1 | 균열 | 0.2 mm | 0.75 m | | 55 | | | | |
| 2 | 균열 | 0.1 mm | 0.75 m | | 56 | | | | |
| 3 | 균열 | 0.1 mm | 0.6 m | | 57 | | | | |
| 4 | 균열 | 0.2 mm | 0.75 m | | 58 | | | | |
| 5 | 균열 | 0.1 mm | 0.7 m | | 59 | | | | |
| 6 | 균열 | 0.1 mm | 0.7 m | | 60 | | | | |
| 7 | 균열 | 0.1 mm | 0.7 m | | 61 | | | | |
| 8 | 균열 | 0.1 mm | 0.7 m | | 62 | | | | |
| 9 | 균열 | 0.1 mm | 0.7 m | | 63 | | | | |
| 10 | 균열 | 0.1 mm | 0.3 m | | 64 | | | | |
