호남고속선장구표-123(49.349~49.356km, S25-2)

| 시행사 | 영역 | 영역 | 영역 | 사 | 이부영 | | 구분 | | | |
|---|---|---|---|---|---|---|---|---|---|---|
| KORAIL<br>KOREA RAILROAD<br>한국철도공사 | 2017년도 호남고속선 오송-광주승경간 콘크리트캐드 점검공역 | (주) 한국구조물안전연구원<br>(주) 한국국토안전연구원<br>(재) 한국건설품질연구원 | 이부영 | 김윤강<br>김경기<br>문석기 | 영원 | | 0220 (0.3m이하 : 철책) | | 차료분리 | |

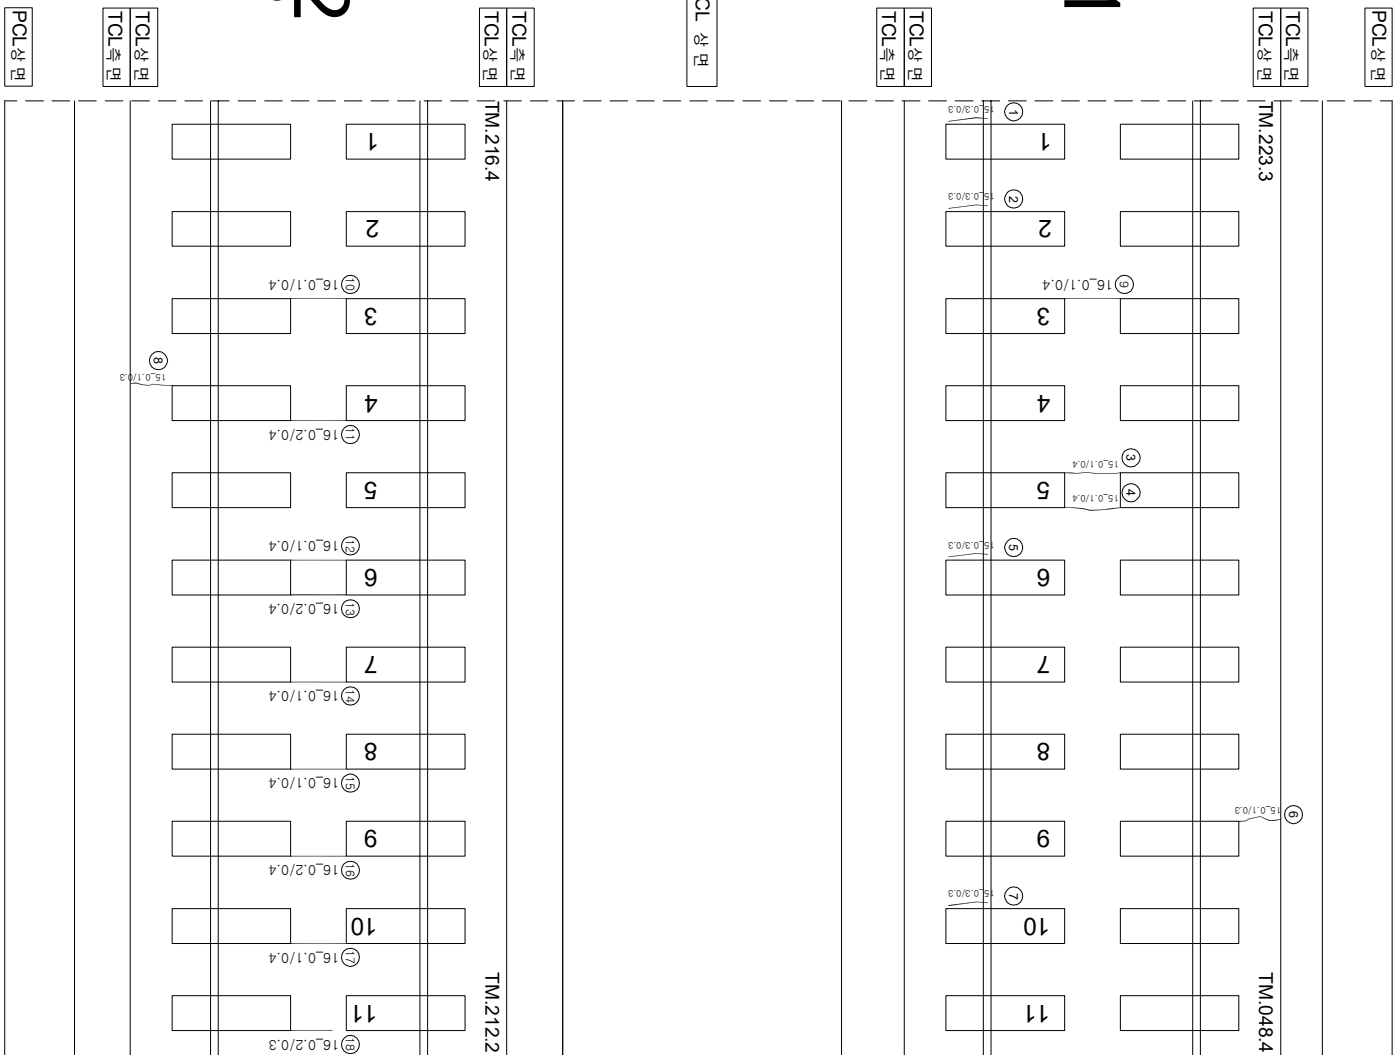
| 연번 | 손상 | 폭 | 연장 | 비고 | 연번 | 손상 | 폭 | 연장 | 비고 |
|---|---|---|---|---|---|---|---|---|---|
| 1 | 강제부 균열 | 0.3 mm | 0.3 m | | 55 | | | | |
| 2 | 강제부 균열 | 0.3 mm | 0.3 m | | 56 | | | | |
| 3 | 균열 | 0.1 mm | 0.4 m | | 57 | | | | |
| 4 | 균열 | 0.1 mm | 0.4 m | | 58 | | | | |
| 5 | 강제부 균열 | 0.3 mm | 0.3 m | | 59 | | | | |
| 6 | 균열 | 0.1 mm | 0.3 m | | 60 | | | | |
| 7 | 강제부 균열 | 0.3 mm | 0.3 m | | 61 | | | | |
| 8 | 균열 | 0.1 mm | 0.3 m | | 62 | | | | |
| 9 | 균열 | 0.1 mm | 0.4 m | | 63 | | | | |
| 10 | 균열 | 0.1 mm | 0.4 m | | 64 | | | | |
| 11 | 균열 | 0.2 mm | 0.4 m | | 65 | | | | |
| 12 | 균열 | 0.1 mm | 0.4 m | | 66 | | | | |
| 13 | 균열 | 0.2 mm | 0.4 m | | 67 | | | | |
| 14 | 균열 | 0.1 mm | 0.4 m | | 68 | | | | |
| 15 | 균열 | 0.1 mm | 0.4 m | | 69 | | | | |
| 16 | 균열 | 0.2 mm | 0.4 m | | 70 | | | | |
| 17 | 균열 | 0.1 mm | 0.4 m | | 71 | | | | |
| 18 | 균열 | 0.2 mm | 0.3 m | | 72 | | | | |
