호남고속선 장구교\_172(49.692~49.699km, S35-1)

35 SPAN - 1

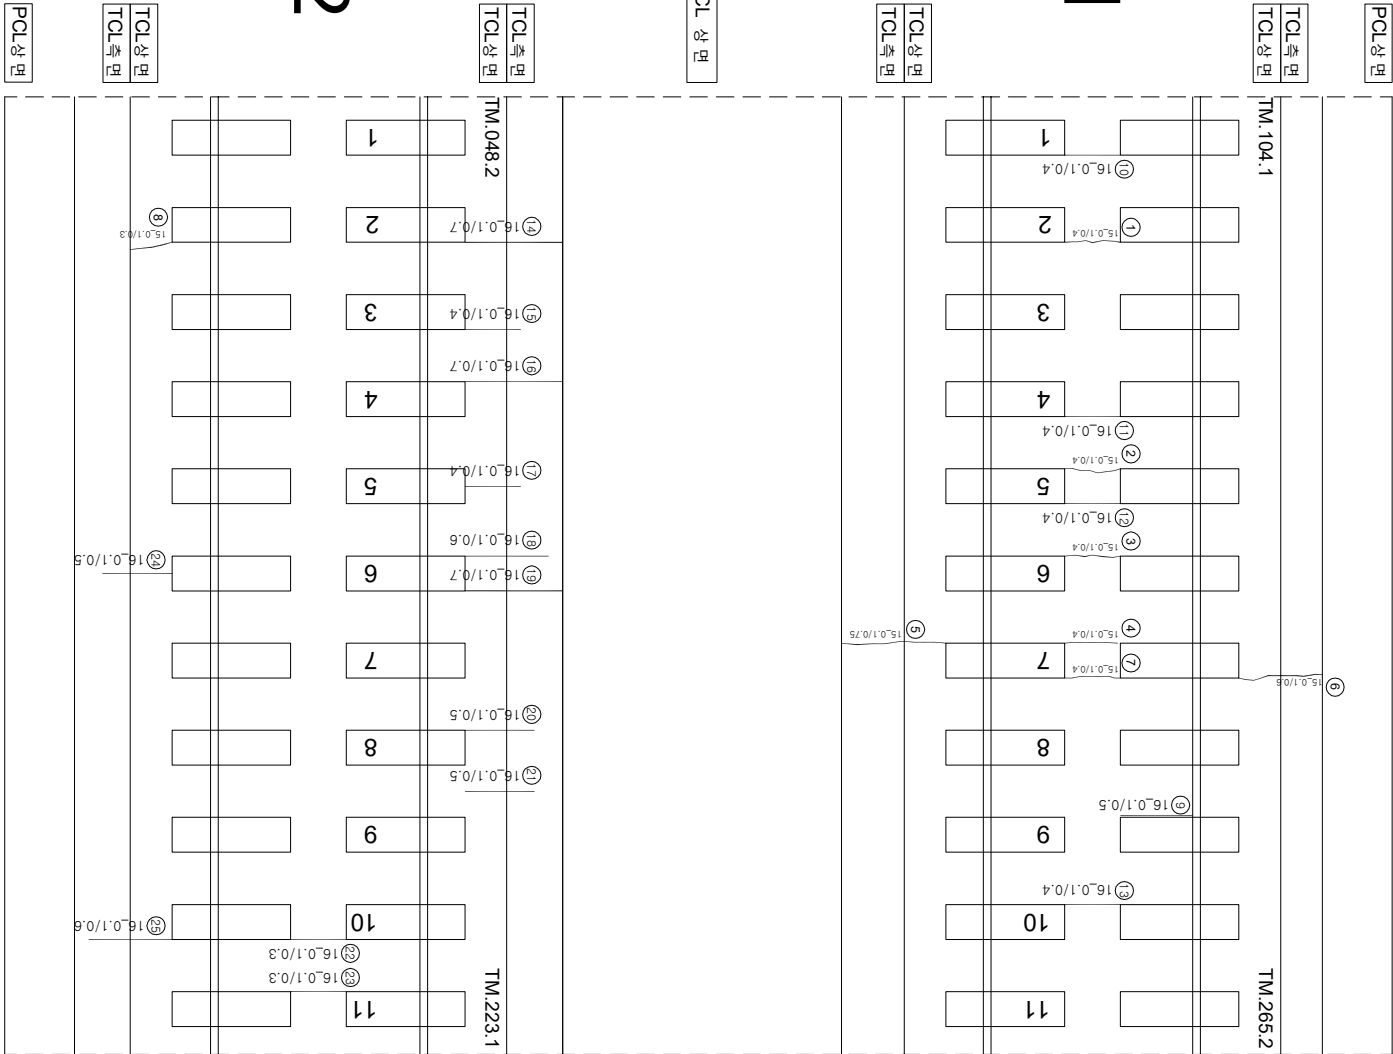
| 연번 | 손상 | 폭 | 연장 | 비고 | 연번 | 손상 | 폭 | 연장 | 비고 |
|---|---|---|---|---|---|---|---|---|---|
| 1 | 균열 | 0.1 mm | 0.4 m | m | 55 | | | | |
| 2 | 균열 | 0.1 mm | 0.4 m | | 56 | | | | |
| 3 | 균열 | 0.1 mm | 0.4 m | | 57 | | | | |
| 4 | 균열 | 0.1 mm | 0.4 m | | 58 | | | | |
| 5 | 균열 | 0.1 mm | 0.75 m | m | 59 | | | | |
| 6 | 균열 | 0.1 mm | 0.6 m | | 60 | | | | |
| 7 | 균열 | 0.1 mm | 0.4 m | | 61 | | | | |
| 8 | 균열 | 0.1 mm | 0.3 m | | 62 | | | | |
| 9 | 경계부 균열 | 0.1 mm | 0.5 m | | 63 | | | | |
| 10 | 균열 | 0.1 mm | 0.4 m | | 64 | | | | |
| 11 | 균열 | 0.1 mm | 0.4 m | | 65 | | | | |
| 12 | 균열 | 0.1 mm | 0.4 m | | 66 | | | | |
| 13 | 균열 | 0.1 mm | 0.4 m | | 67 | | | | |
| 14 | 균열 | 0.1 mm | 0.7 m | | 68 | | | | |
| 15 | 균열 | 0.1 mm | 0.4 m | | 69 | | | | |
| 16 | 균열 | 0.1 mm | 0.7 m | | 70 | | | | |
| 17 | 균열 | 0.1 mm | 0.4 m | | 71 | | | | |
| 18 | 균열 | 0.1 mm | 0.6 m | | 72 | | | | |
| 19 | 균열 | 0.1 mm | 0.7 m | | 73 | | | | |
| 20 | 균열 | 0.1 mm | 0.5 m | | 74 | | | | |
| 21 | 균열 | 0.1 mm | 0.5 m | | 75 | | | | |
| 22 | 균열 | 0.1 mm | 0.3 m | | 76 | | | | |
| 23 | 균열 | 0.1 mm | 0.3 m | | 77 | | | | |
| 24 | 균열 | 0.1 mm | 0.5 m | | 78 | | | | |
| 25 | 균열 | 0.1 mm | 0.6 m | | 79 | | | | |
