호남고속선 정지고가 503(60.415~60.422km, S97-1)

60K422  
97 SPAN - 1

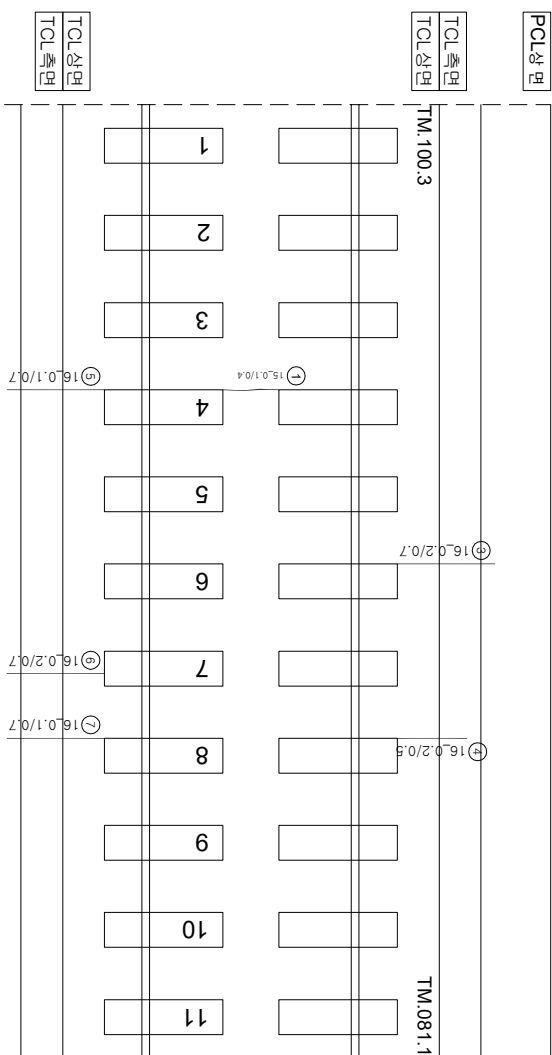
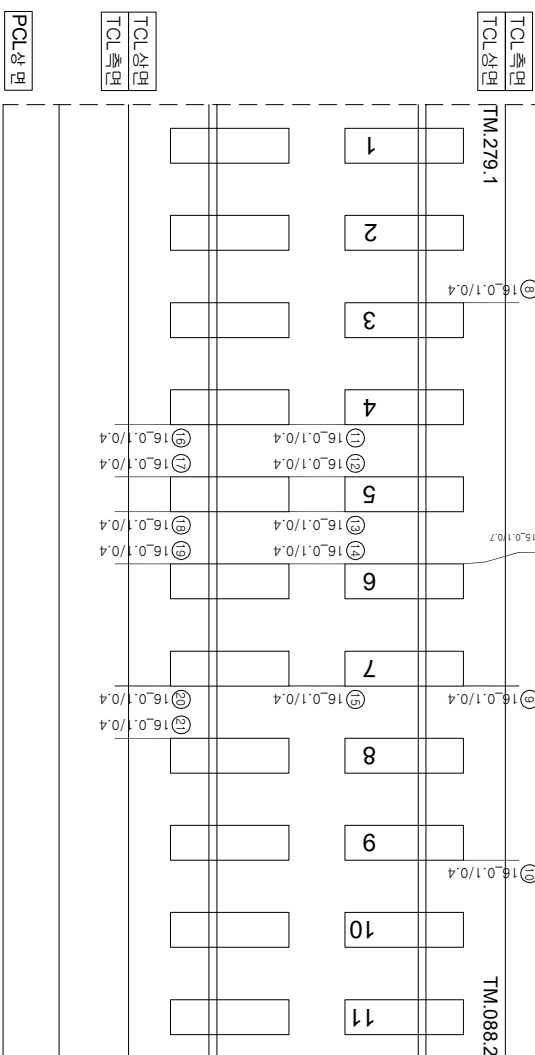
PCL상면

| 순번 | 손상 | 폭 | 연장 | 비고 | 연번 | 손상 | 폭 | 연장 | 비고 |
| 1 | 균열 | 0.1 mm | 0.4 m | | 55 | | | | |
| 2 | 균열 | 0.1 mm | 0.7 m | | 56 | | | | |
| 3 | 균열 | 0.2 mm | 0.7 m | | 57 | | | | |
| 4 | 균열 | 0.2 mm | 0.5 m | | 58 | | | | |
| 5 | 균열 | 0.1 mm | 0.7 m | | 59 | | | | |
| 6 | 균열 | 0.2 mm | 0.7 m | | 60 | | | | |
| 7 | 균열 | 0.1 mm | 0.7 m | | 61 | | | | |
| 8 | 균열 | 0.1 mm | 0.4 m | | 62 | | | | |
| 9 | 균열 | 0.1 mm | 0.4 m | | 63 | | | | |
| 10 | 균열 | 0.1 mm | 0.4 m | | 64 | | | | |
| 11 | 균열 | 0.1 mm | 0.4 m | | 65 | | | | |
| 12 | 균열 | 0.1 mm | 0.4 m | | 66 | | | | |
| 13 | 균열 | 0.1 mm | 0.4 m | | 67 | | | | |
| 14 | 균열 | 0.1 mm | 0.4 m | | 68 | | | | |
| 15 | 균열 | 0.1 mm | 0.4 m | | 69 | | | | |
| 16 | 균열 | 0.1 mm | 0.4 m | | 70 | | | | |
| 17 | 균열 | 0.1 mm | 0.4 m | | 71 | | | | |
| 18 | 균열 | 0.1 mm | 0.4 m | | 72 | | | | |
| 19 | 균열 | 0.1 mm | 0.4 m | | 73 | | | | |
| 20 | 균열 | 0.1 mm | 0.4 m | | 74 | | | | |
| 21 | 균열 | 0.1 mm | 0.4 m | | 75 | | | | |
