한남고속선 죽산교\_230(74.662~74.668km, S46-4)

| 시 | 행 사 | 영역 | 영역 | 영역 | 사 | 과목 | | 단 | | | | | | | |
|---|---|---|---|---|---|---|---|---|---|---|---|---|---|---|---|
| KORAIL<br>KOREA RAILROAD | 한국철도공사 | 2017년도 호남고속선 오송-광주승정간 콘크리트케도 점검공역 | (주) 한국구조물안전연구원<br>(주) 한국국토안전연구원<br>(재) 한국건설품질연구원 | 이 부영 | 김 원 강<br>김 경 기<br>문 윤 석 | 영원 | | 0220 | (0.3mm이하 : 흑색) | | 참목도상분리 | | 재료분리 | | |

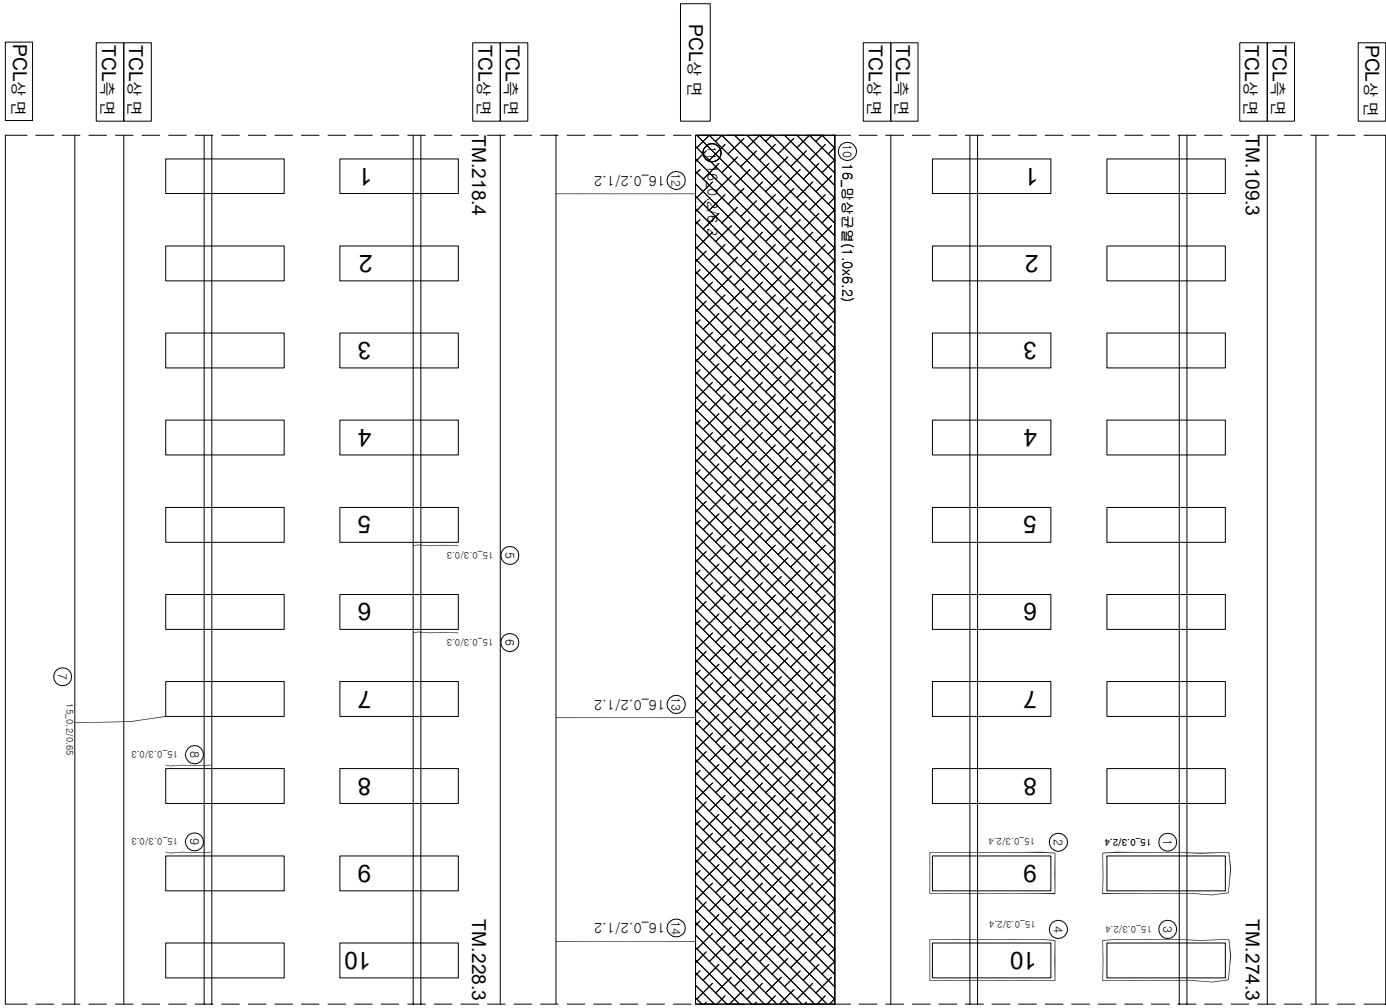
| 연번 | 산선 | 폭 | 연장 | 비고 | 연번 | 산선 | 폭 | 연장 | 비고 |
|---|---|---|---|---|---|---|---|---|---|
| 1 | 강계부 군열 | 0.3 | mm | 2.4 m | 55 | | | | |
| 2 | 강계부 군열 | 0.3 | mm | 2.4 m | 56 | | | | |
| 3 | 강계부 군열 | 0.3 | mm | 2.4 m | 57 | | | | |
| 4 | 강계부 군열 | 0.3 | mm | 2.4 m | 58 | | | | |
| 5 | 강계부 군열 | 0.3 | mm | 0.3 m | 59 | | | | |
| 6 | 강계부 군열 | 0.3 | mm | 0.3 m | 60 | | | | |
| 7 | 군열 | 0.2 | mm | 0.65 m | 61 | | | | |
| 8 | 강계부 군열 | 0.3 | mm | 0.3 m | 62 | | | | |
| 9 | 강계부 군열 | 0.3 | mm | 0.3 m | 63 | | | | |
| 10 | 망상군열 | 1.0 | mm | 6.2 m | 6.23 <sup>m</sup> | 64 | | | |
| 11 | 군열 | 0.2 | mm | 1.2 m | 65 | | | | |
| 12 | 군열 | 0.2 | mm | 1.2 m | 66 | | | | |
| 13 | 군열 | 0.2 | mm | 1.2 m | 67 | | | | |
