한남고속선 공리표\_25 (75.867~75.874km, S5-4)

| 시 | 행 사 | 영역 | 영역명 | 영역사 | 관리인 | | 구간 | | | |
|---|---|---|---|---|---|---|---|---|---|---|
| KORAIL<br>KOREA RAILROAD | 한국철도공사 | 2017년도 호남고속선 오송-광주승정간 콘크리트케도 점검영역 | (주) 한국구조물안전연구원<br>(주) 한국도로안전연구원<br>(재) 한국건설품질연구원 | 이 복 영 | 김 원 강<br>김 경 기<br>문 은 석 | 구간 | 0.220 (0.3mm이하 : 흑색) | 점목도상판리 | 재료분리 | |

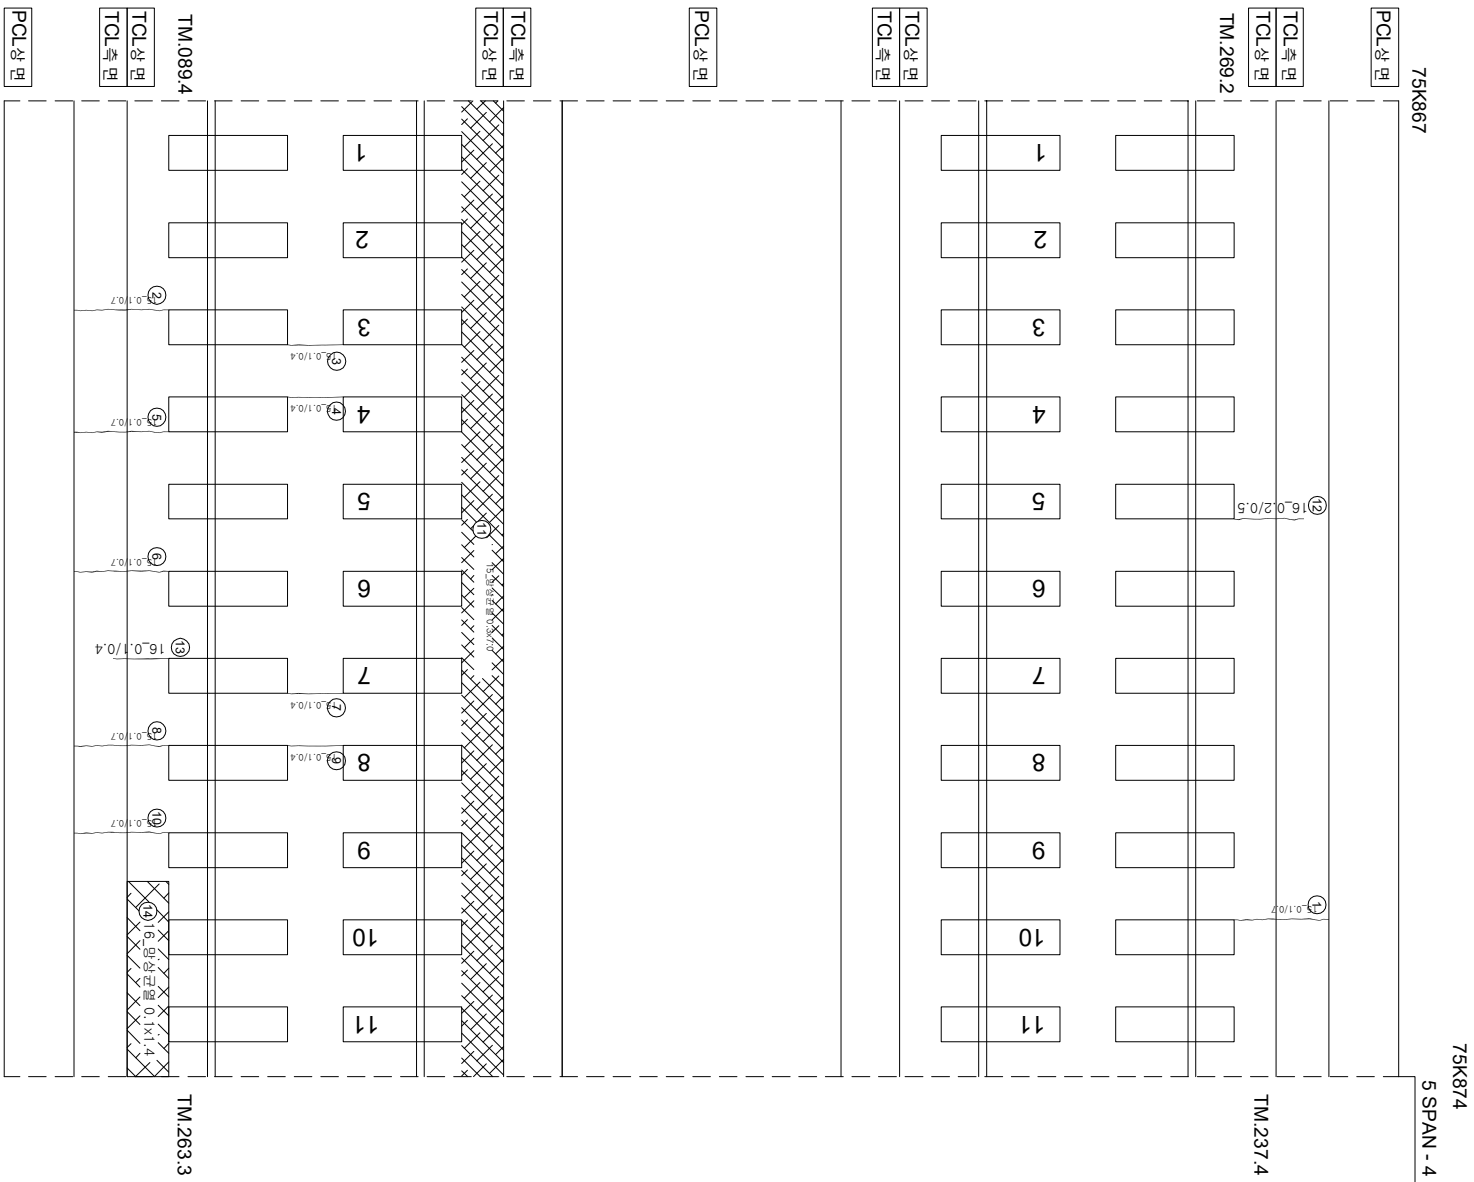
| 구분 | 순상 | 폭 | 연장 | 비고 | 구분 | 순상 | 폭 | 연장 |
|---|---|---|---|---|---|---|---|---|
| 1 | 균열 | 0.1 mm | 0.7 m | | 55 | | | |
| 2 | 균열 | 0.1 mm | 0.7 m | | 56 | | | |
| 3 | 균열 | 0.1 mm | 0.4 m | | 57 | | | |
| 4 | 균열 | 0.1 mm | 0.4 m | | 58 | | | |
| 5 | 균열 | 0.1 mm | 0.7 m | | 59 | | | |
| 6 | 균열 | 0.1 mm | 0.7 m | | 60 | | | |
| 7 | 균열 | 0.1 mm | 0.4 m | | 61 | | | |
| 8 | 균열 | 0.1 mm | 0.7 m | | 62 | | | |
| 9 | 균열 | 0.1 mm | 0.4 m | | 63 | | | |
| 10 | 균열 | 0.1 mm | 0.7 m | | 64 | | | |
| 11 | 망상균열 | 0.3 mm | 7.0 m | | 65 | | | |
| 12 | 균열 | 0.2 mm | 0.5 m | | 66 | | | |
| 13 | 균열 | 0.1 mm | 0.4 m | | 67 | | | |
| 14 | 망상균열 | 0.1 m | 1.4 m | | 68 | | | |
