## **6. 현황조사 및 외관조사 사진첩**

## 01. 남전천교

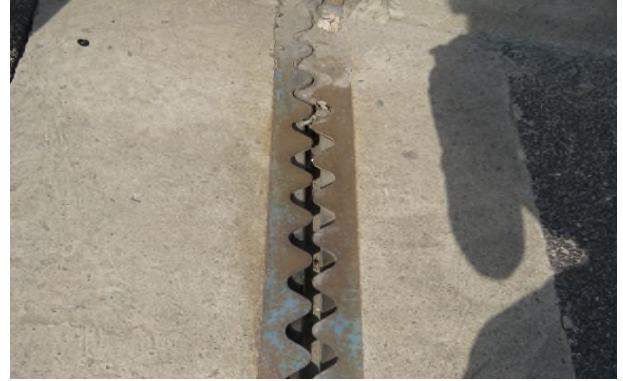
③ 신축이음 녹발생 (1EA)

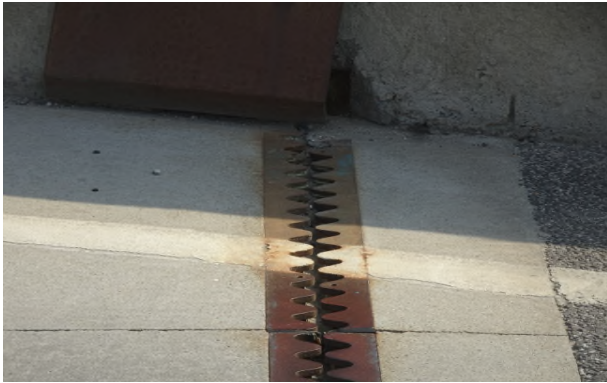
④ 부식 0.2m x 0.5m

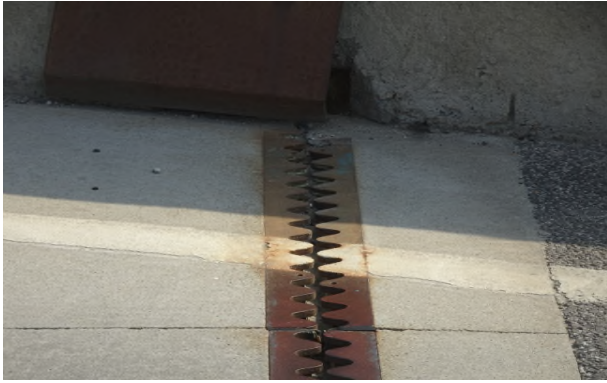
③ 부식 0.1m x 0.5m

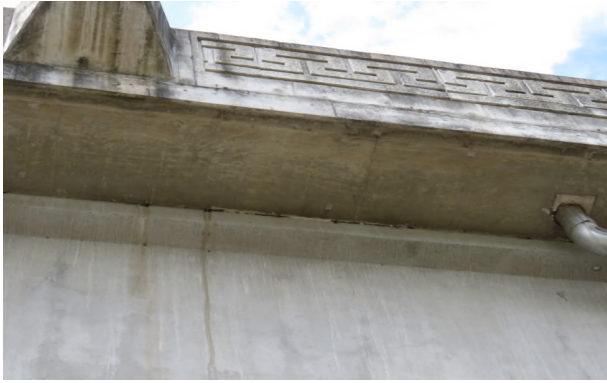
① 마감불량 0.1m x 0.2m (보수완료)

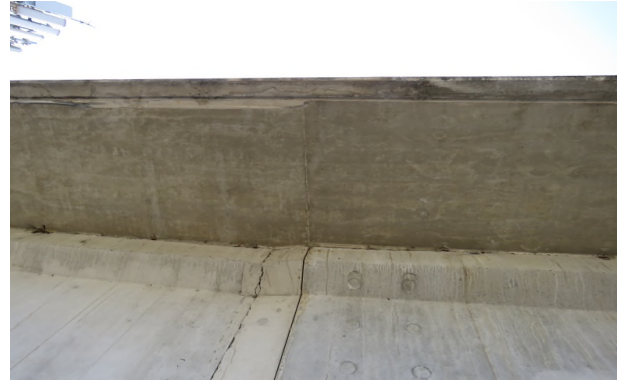
② 와이어 미제거 (1EA) (보수완료)

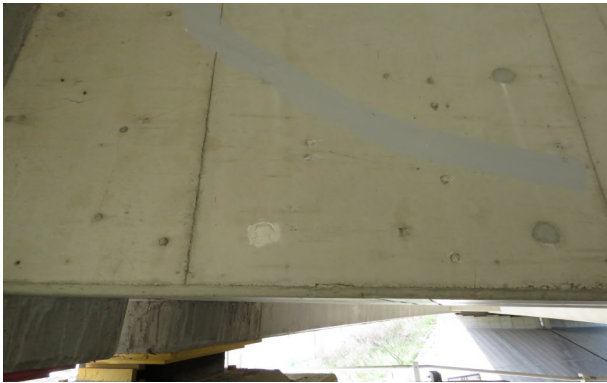
③ 가로보 홀메움 미처리 (1EA) (보수완료)

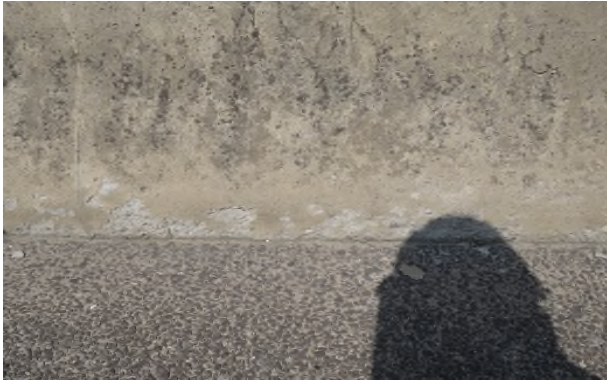
㉕ 박리 0.1m x 49.15m

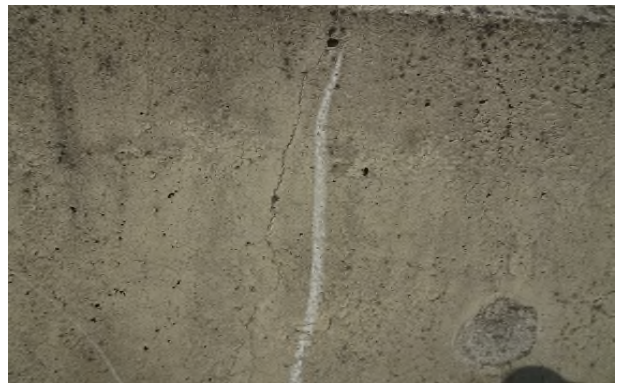
㉘ 균열 (0.3mm미만) cw=0.1mm / 1.0m

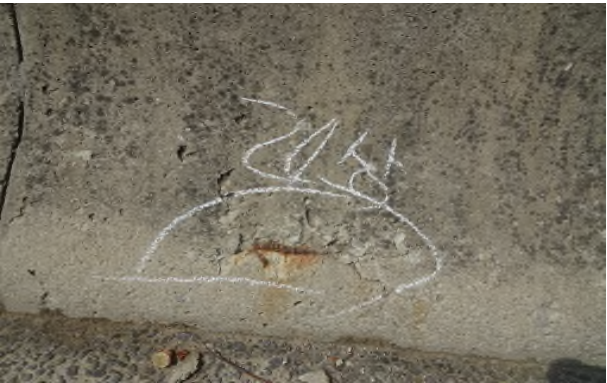
㉙ 철근노출 0.1m x 0.2m

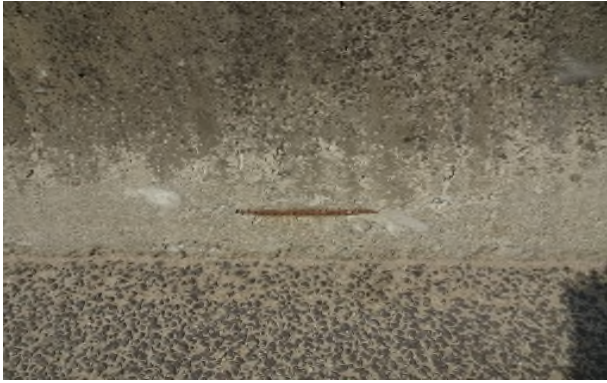
㉓ 철근노출 0.1m x 0.3m (3EA)

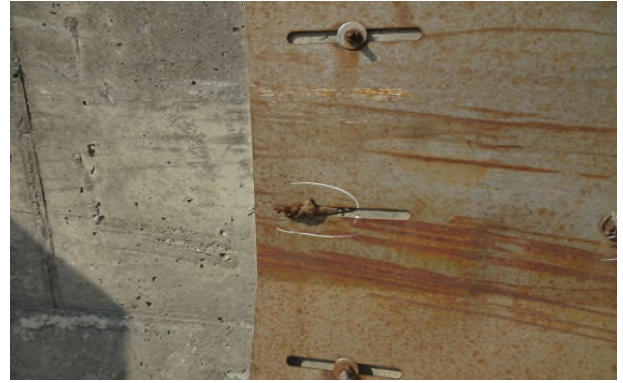
㉔ 차수판 볼트불량 (2EA)

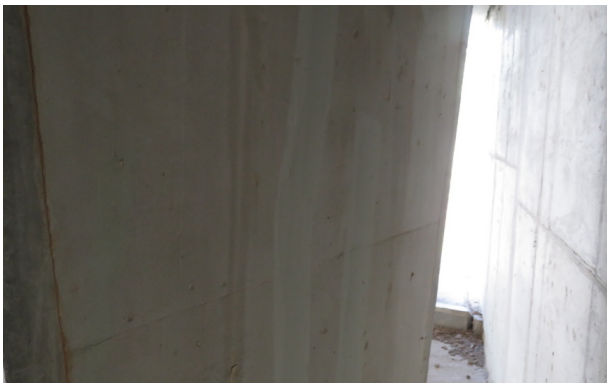
⑤ 백태 0.1m x 0.1m (보수완료)

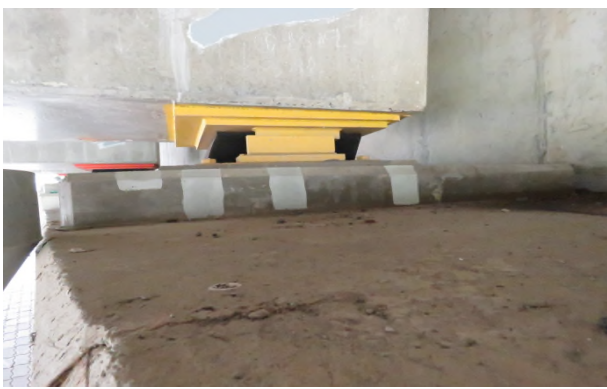
⑫ 철근노출 (1EA) (보수완료)

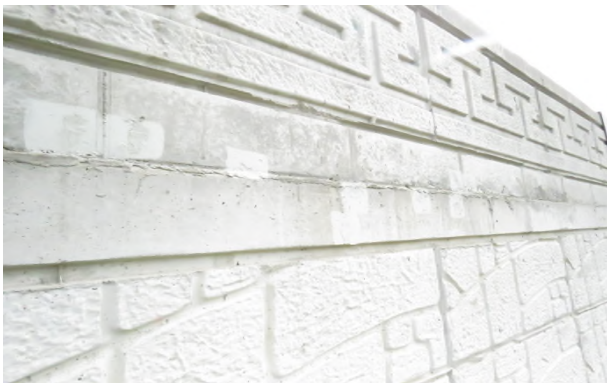
⑯ 잡철물 미제거 (36EA) (보수완료)

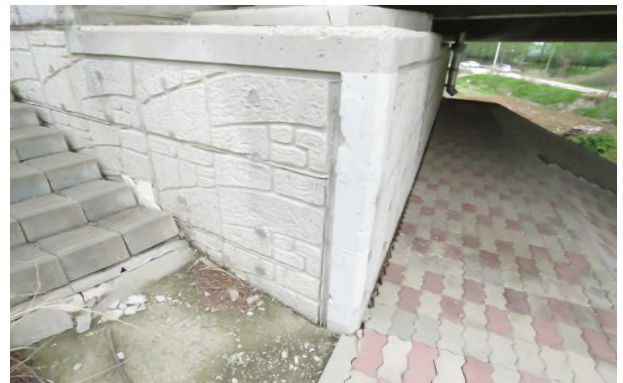
⑰ 보수부 박리 0.1m x 0.1m (4EA) (보수완료)

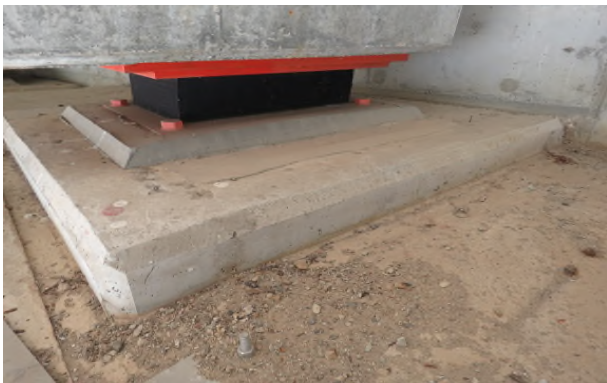
⑦ 철근노출 (1EA) (보수완료)

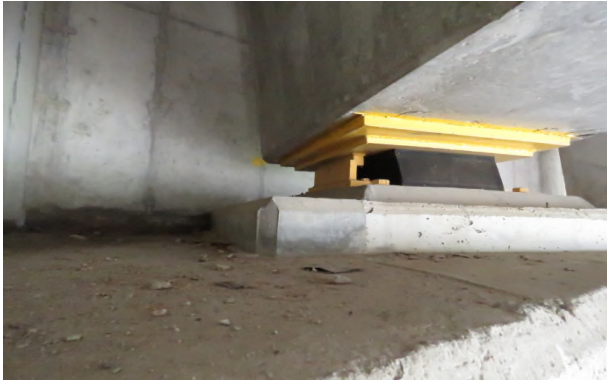
① 철근노출 (1EA) (보수완료)

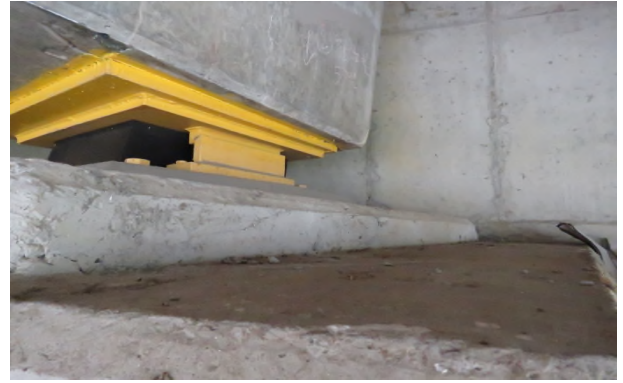
② 철근노출 (5EA) (보수완료)

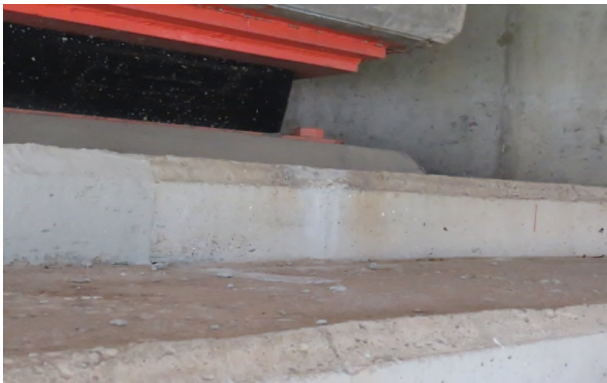
⑤ 철근노출 (2EA) (보수완료)

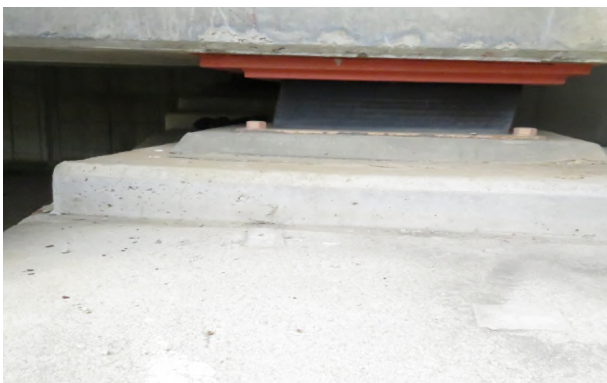
⑦ 철근노출 (4EA) (보수완료)

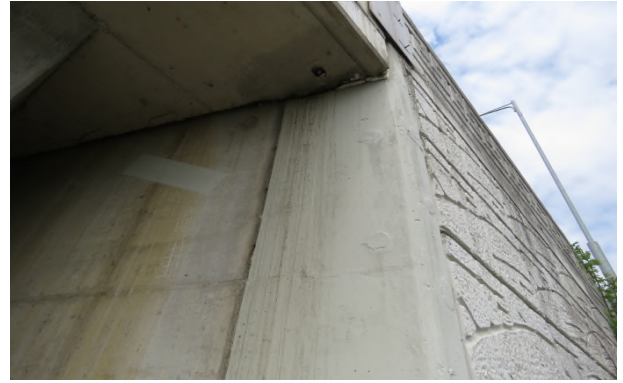
⑩ 누수흔적 0.3m x 2.5m (보수완료)

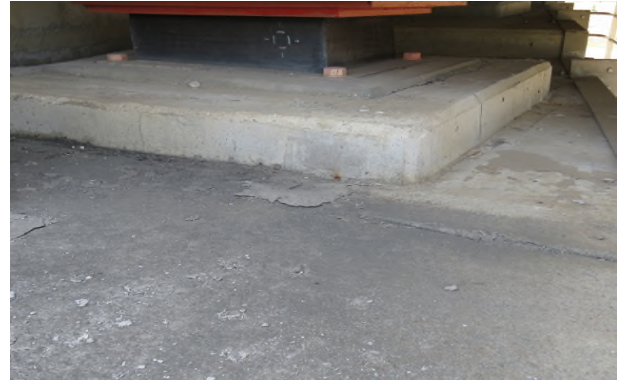
③ 철근노출 (3EA) (보수완료)

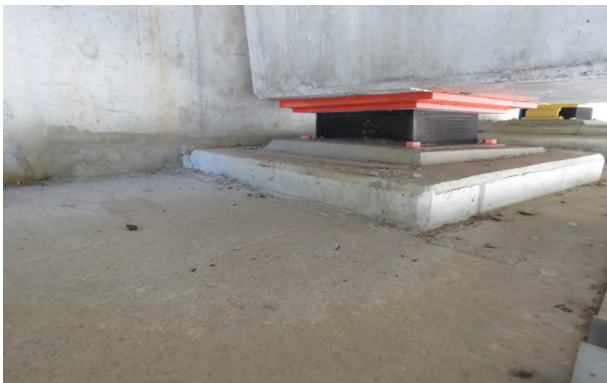
④ 철근노출 (3EA) (보수완료)

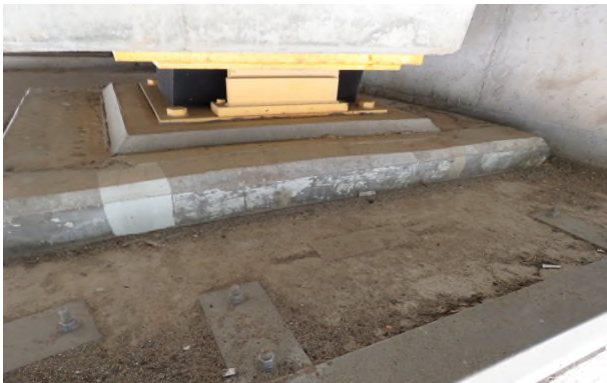
⑦ 잡철물 미제거 (1EA) (보수완료)

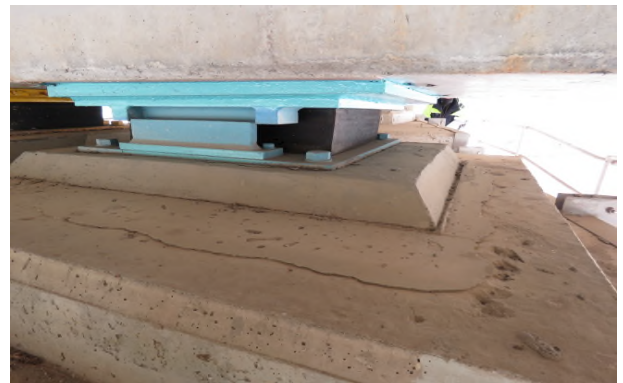
⑧ 무수축물탈 박리  $0.1\text{m} \times 0.2\text{m}$

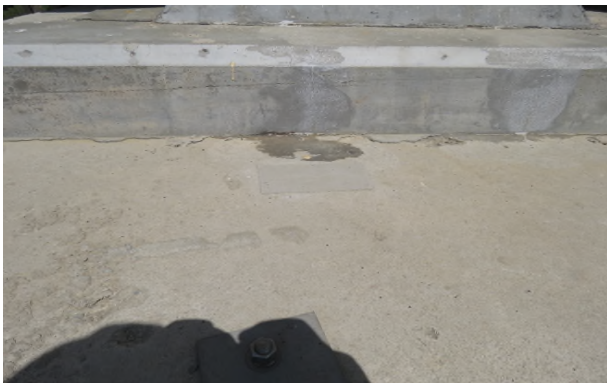
⑪ 철근노출 (1EA) (보수완료)

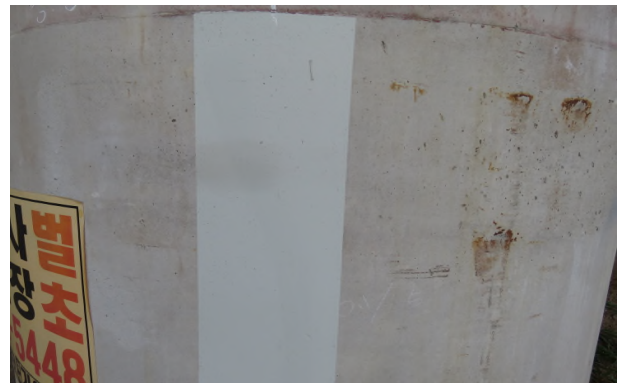
⑫ 균열( $0.3\text{mm}$ 미만)  $cw=0.1\text{mm}$  /  $1.4\text{m}$  (보수완료)

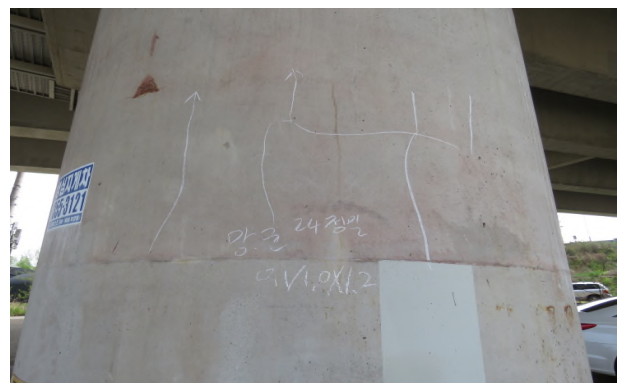
⑭ 망상균열 ( $0.3\text{mm}$ 미만)  $cw=0.1\text{mm}$  /  $1.0\text{m} \times 1.2\text{m}$

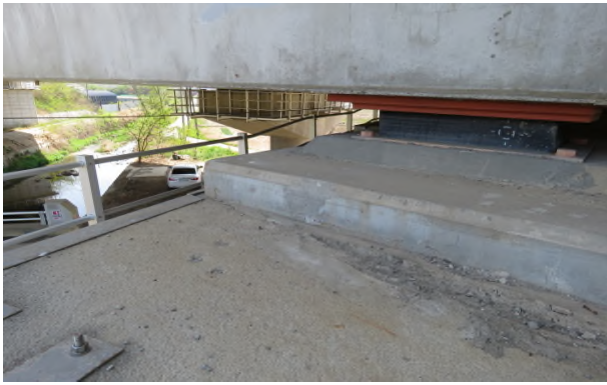
⑤ 잡철물 미제거 (2EA) (보수완료)

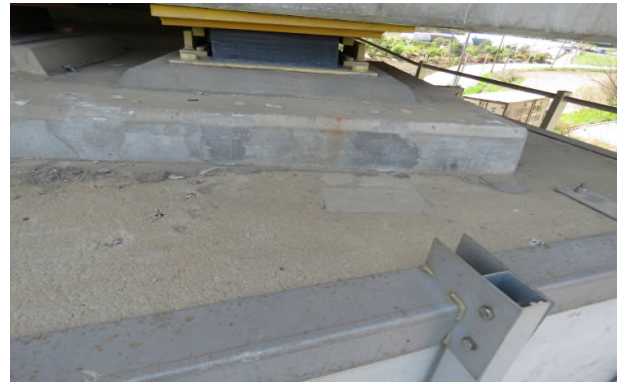
⑦ 잡철물 미제거 (2EA) (보수완료)

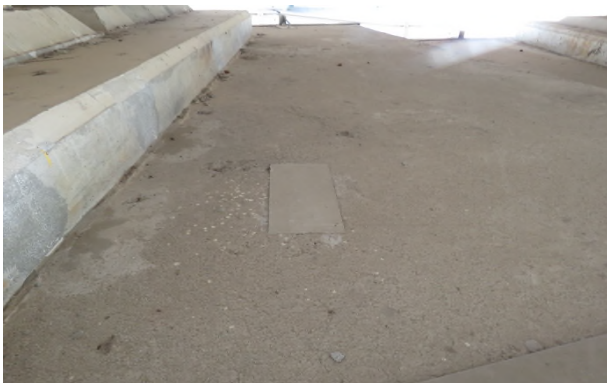
⑩ 철근노출 (2EA) (보수완료)

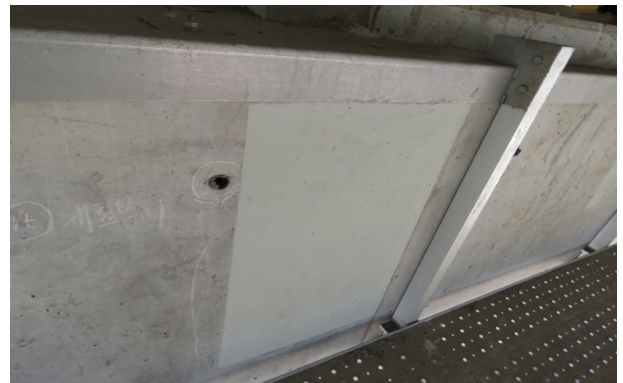
⑮ 재료분리 0.7m x 1.0m (보수완료)

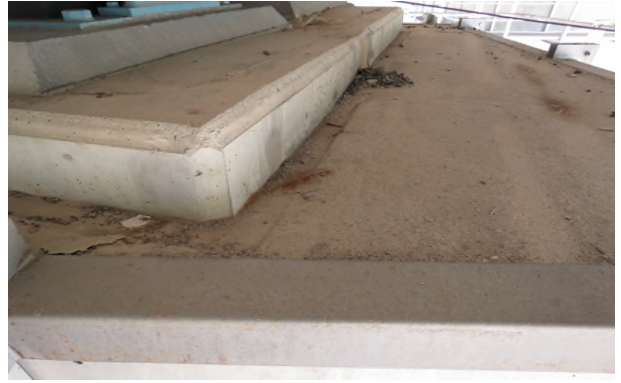
⑲ 잡철물 미제거(녹발생) (1EA) (보수완료)

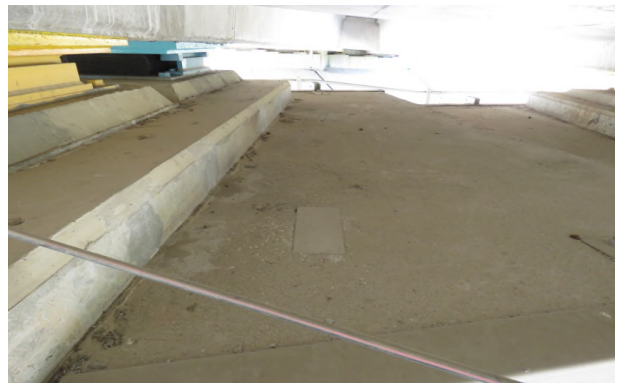
㉑ 잡철물 미제거(녹발생) (2EA) (보수완료)

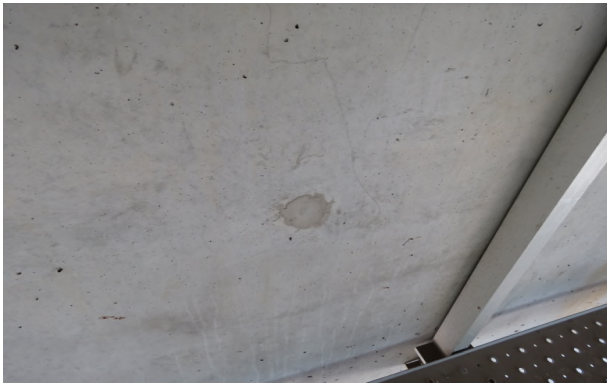
㉒ 홀메움 미처리 (9EA) (보수완료)

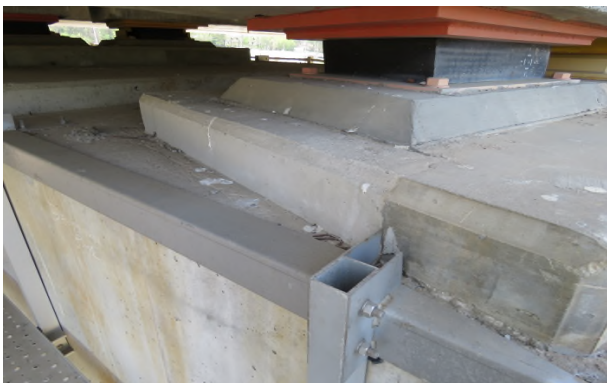
㉔ 재료분리 1.0 x 0.3m (보수완료)

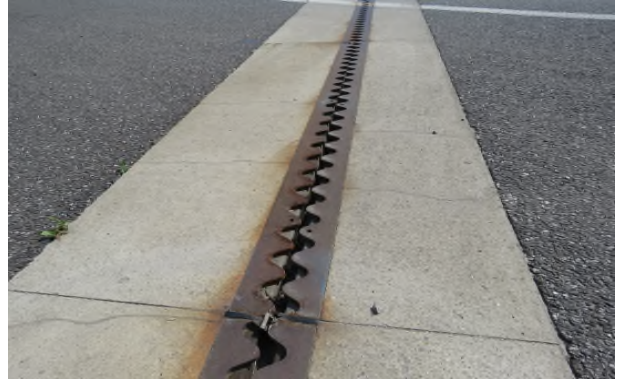
⑦ 신축이음 부식 4.4m

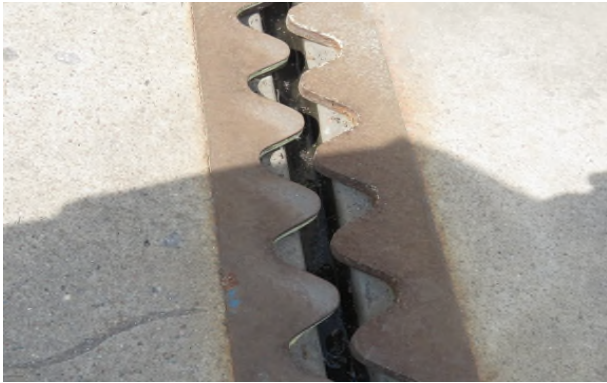
⑧ 신축이음 체수 0.5m

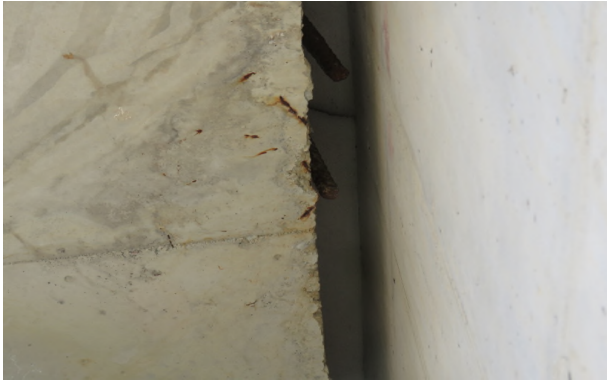
① 철근노출 (1EA)

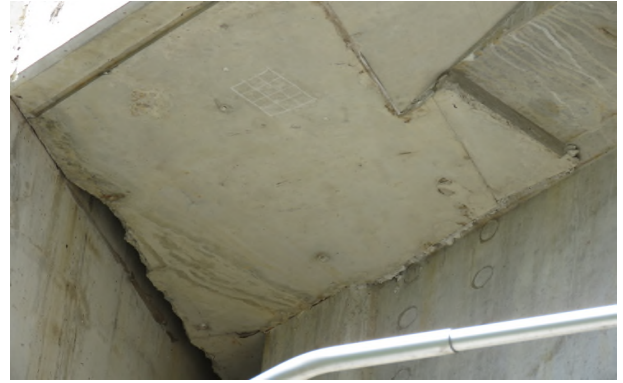
③ 재료분리 0.1m x 0.5m (보수완료)

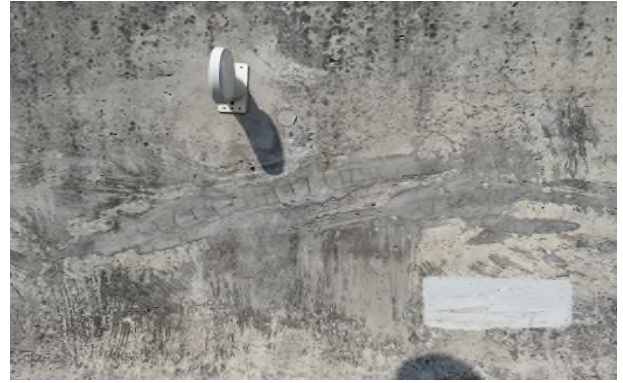
② 굽힘 0.5m x 5.0m (보수완료)

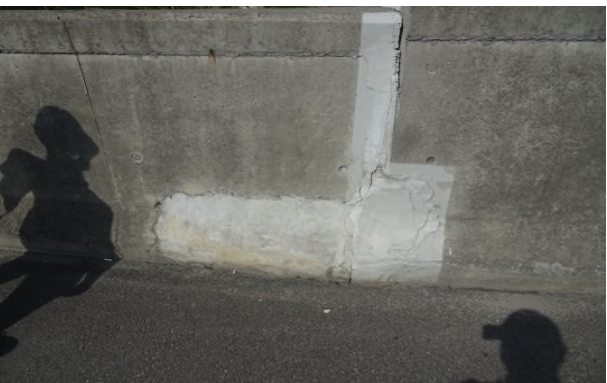
㉓ 이격단차 (1EA) (보수완료)

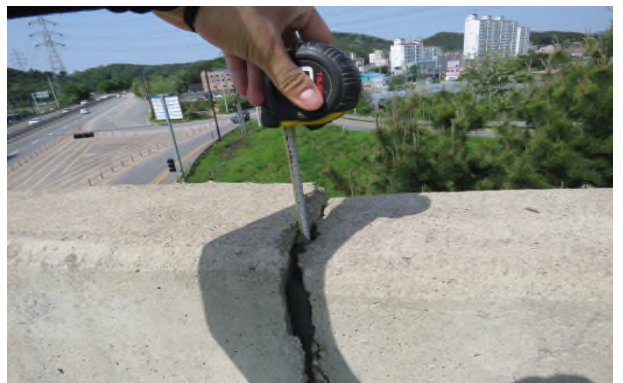
㉔ 이격단차 (1EA) ( $T=3.0cm$ )

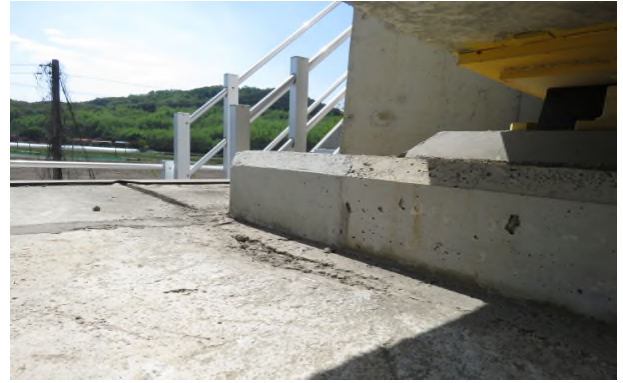
⑪ 철근노출 (4EA) (보수완료)

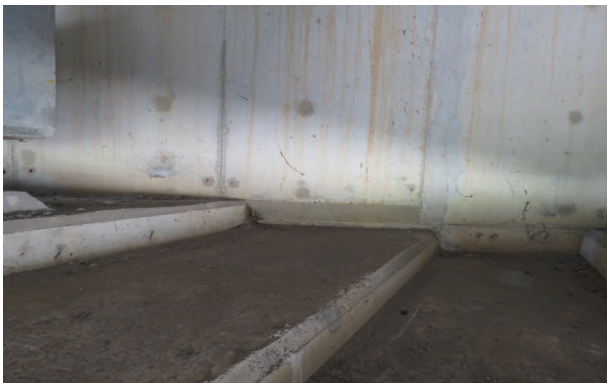
⑫ 철근노출 (4EA) (보수완료)

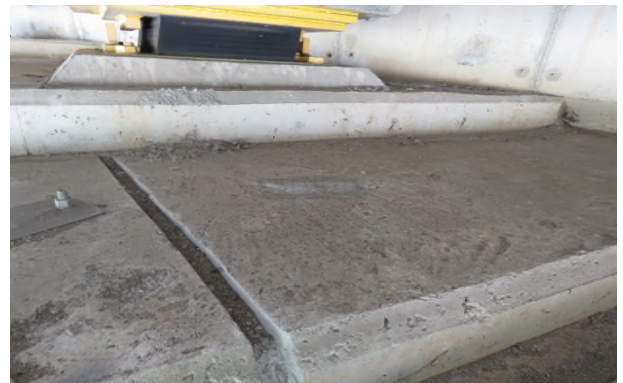
⑬ 철근노출 (4EA) (보수완료)

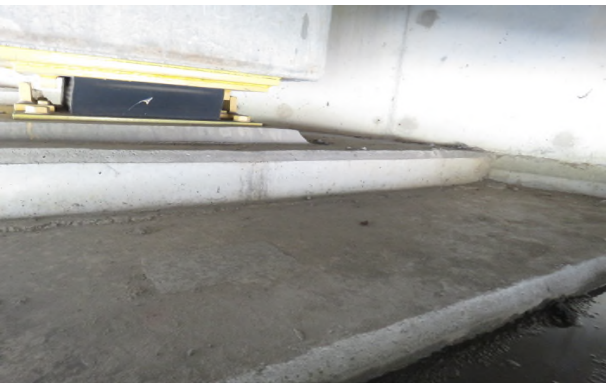
⑭ 철근노출 (4EA) (보수완료)

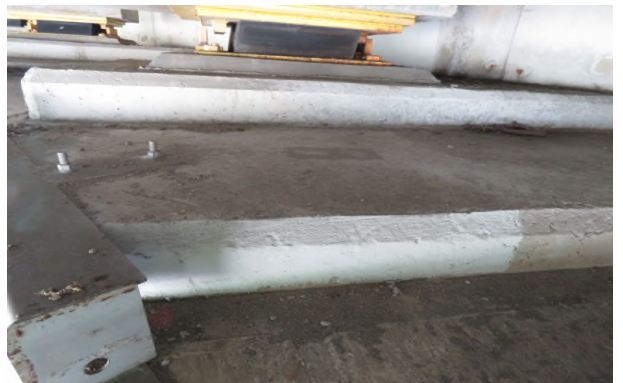
⑮ 재료분리 0.1m x 0.5m (보수완료)

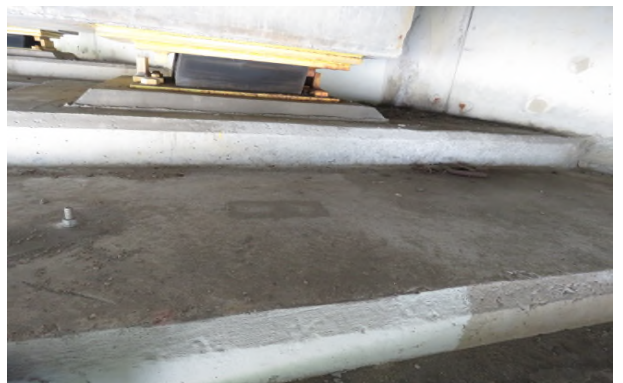
⑰ 철근노출 (4EA) (보수완료)

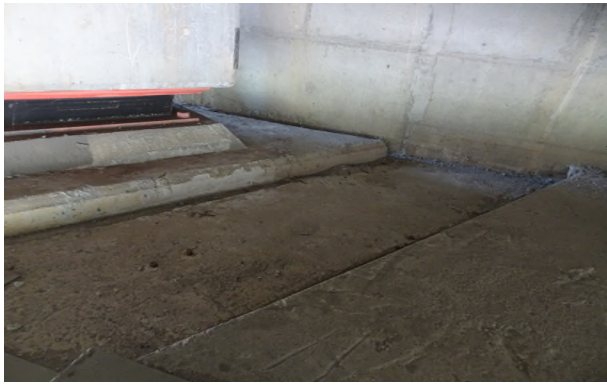
⑧ 폐콘크리트 적치 0.6m x 0.5m (2EA) (보수완료)

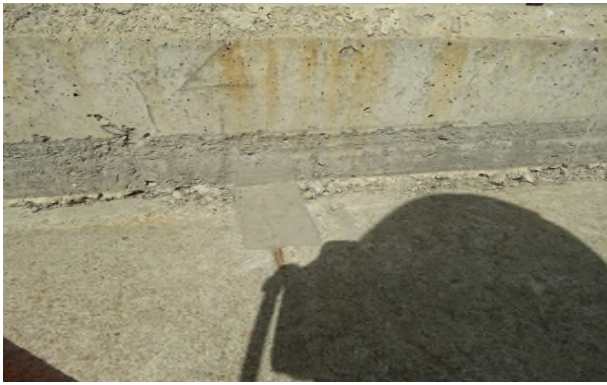
⑰ 철근노출 (11EA) (보수완료)

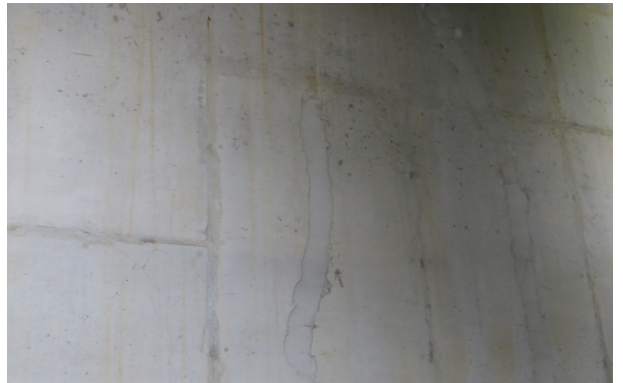
㉒ 누수흔적 1.0m x 3.5m (보수완료)

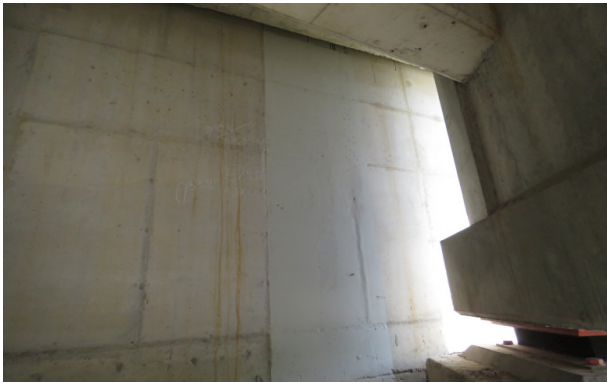
㉖ 오염 0.3m x 2.0m (보수완료)

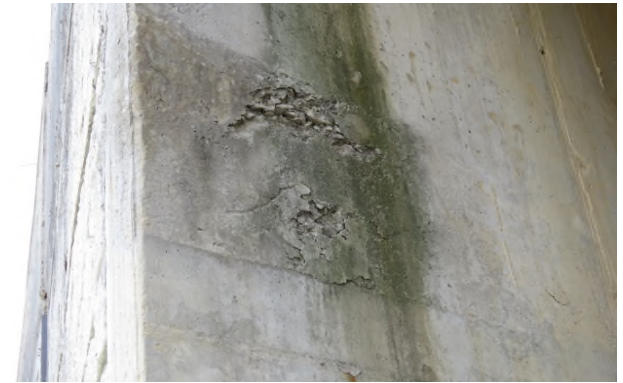
㉗ 재료분리 0.2m x 0.2m

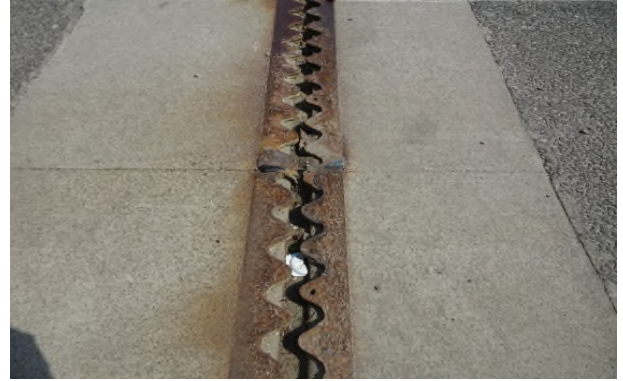
③ 신축이음 부식 0.2m x 1.2m

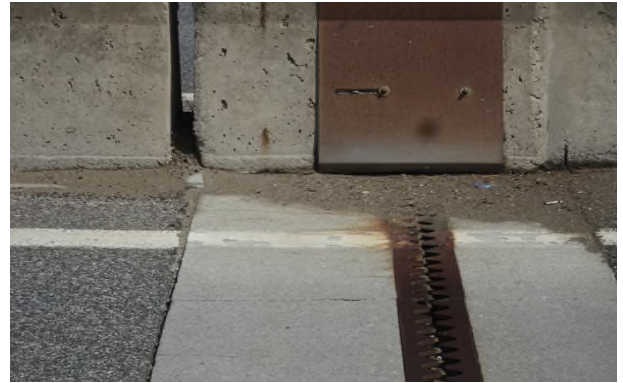
⑤ 부식 및 토사퇴적 0.1m x 0.5m

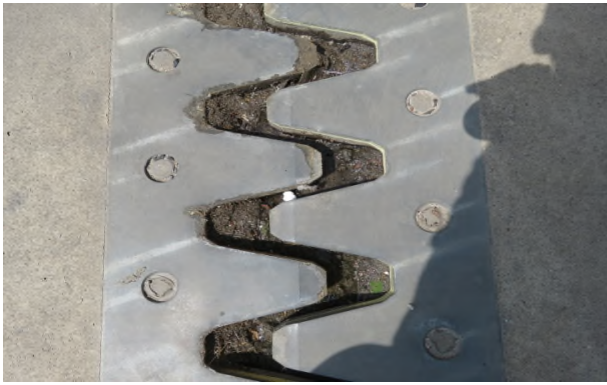
① 신축이음 체수 2.0m

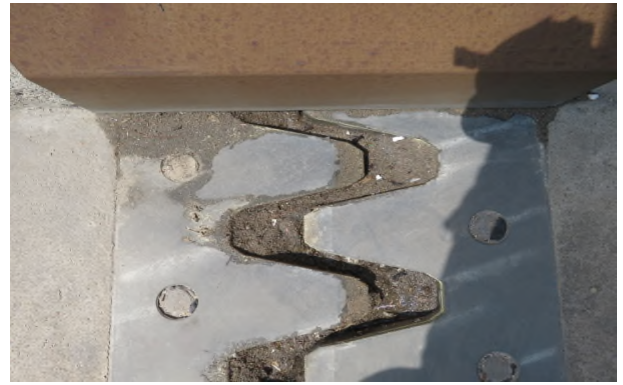
③ 신축이음 토사퇴적 4.0m

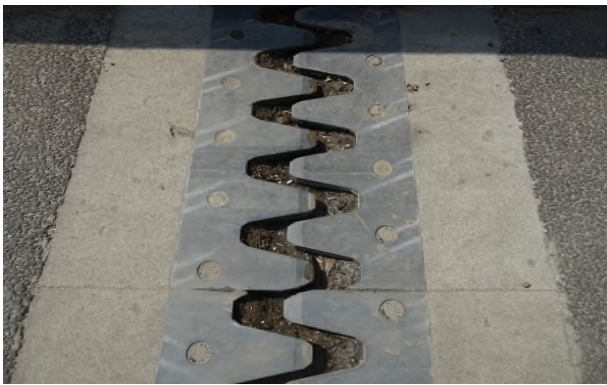
④ 신축이음 토사퇴적 2.0m

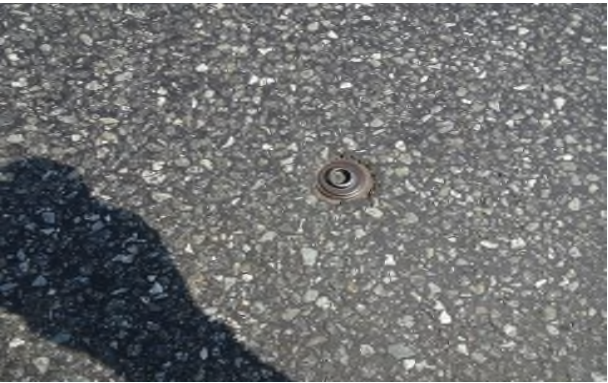
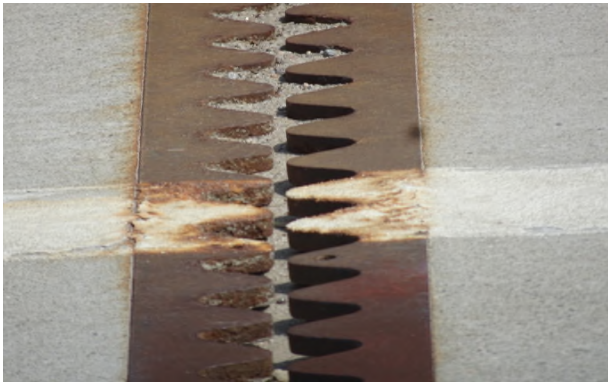
| ① 잡철물 미제거 (1EA) | ② 부식 및 토사퇴적 0.2m x 0.8m |

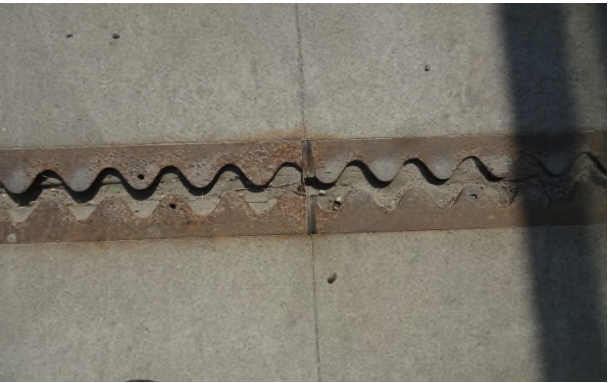
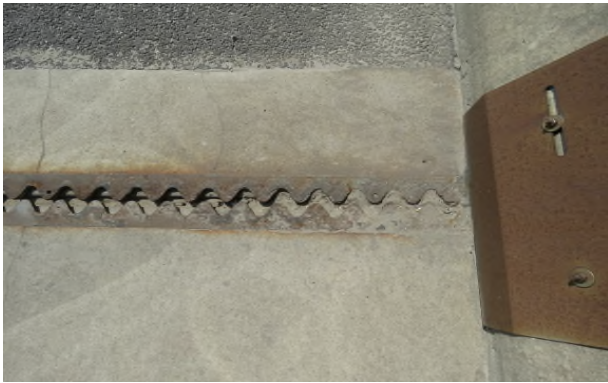
| ③ 부식 및 토사퇴적 0.2m x 1.0m | ④ 유간 부식 및 토사퇴적 0.2m x 0.5m (2EA) |

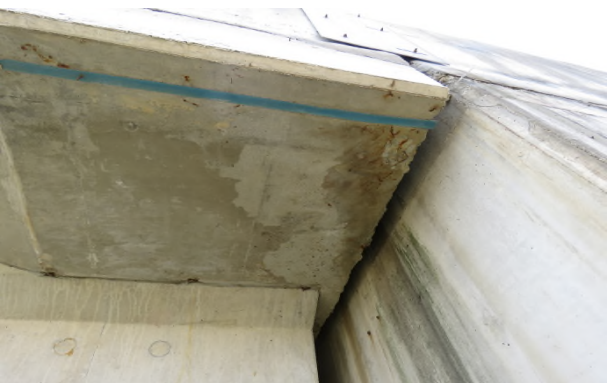
| ① 열화 0.3m x 0.2m | |

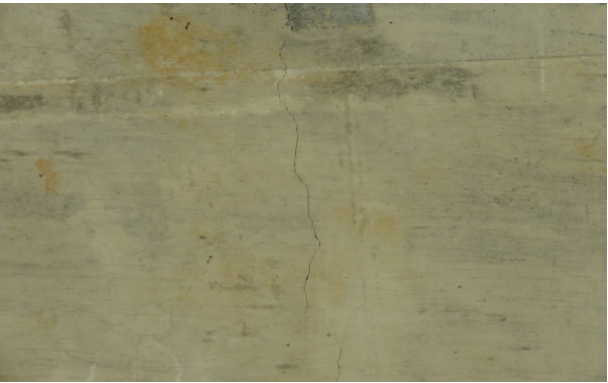
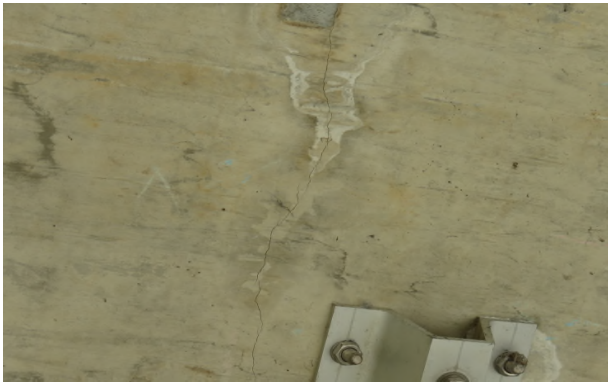
| ② 균열 (0.3mm미만) cw=0.2mm / 0.4m | ③ 균열 (0.3mm미만) cw=0.2mm / 0.4m |

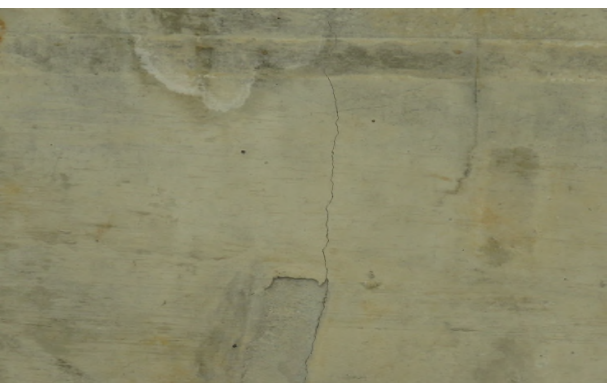
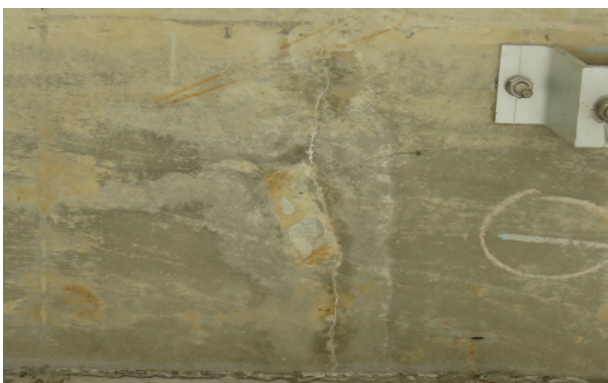
| ① 균열 (0.3mm미만) cw=0.2mm / 0.4m | ② 균열 (0.3mm미만) cw=0.2mm / 0.3m |

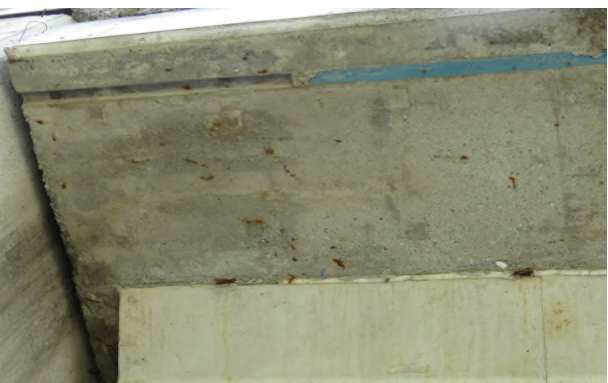
| ③ 열화 0.2m x 0.4m | |

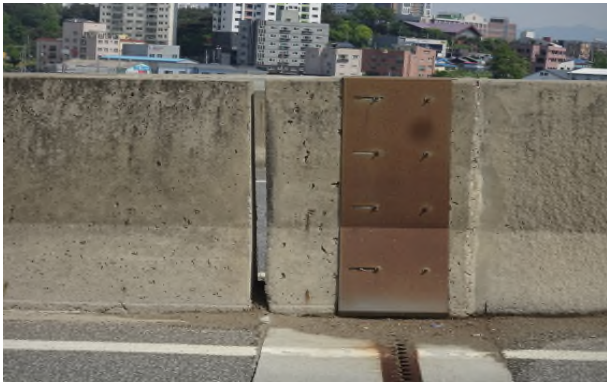
⑨ 이격 (1EA)

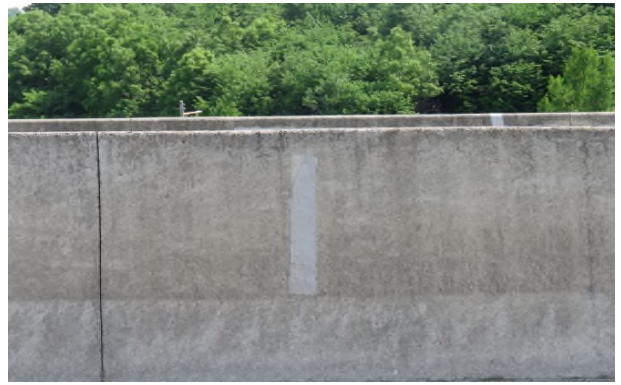
⑩ 녹발생 (1EA) (보수완료)

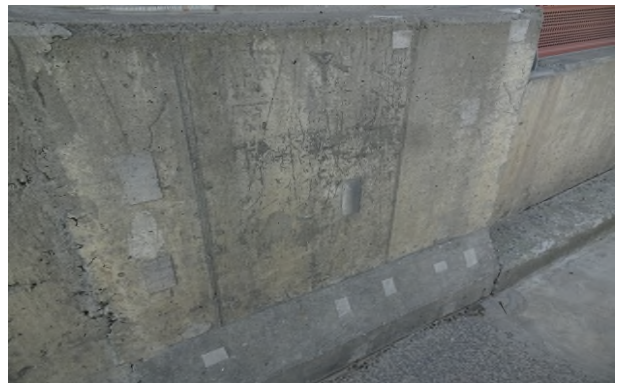
⑫ 잡철물 미제거 (15EA) (보수완료)

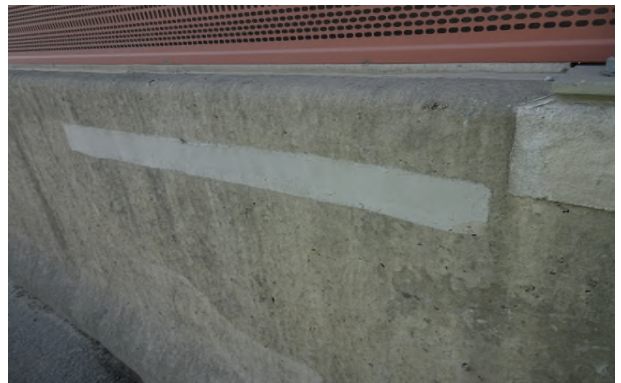
⑭ 파손 0.1m x 0.2m (2EA) (보수완료)

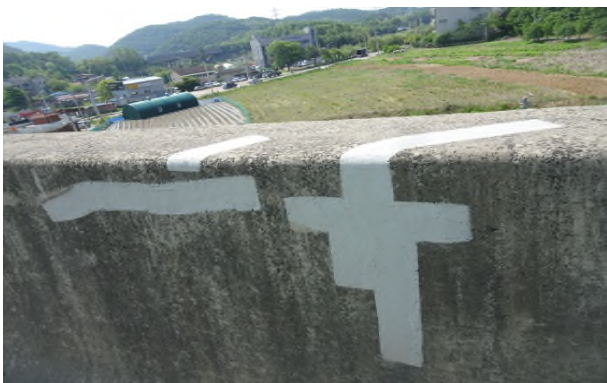
⑦ 보수부 백태 0.1m x 0.6m (보수완료)

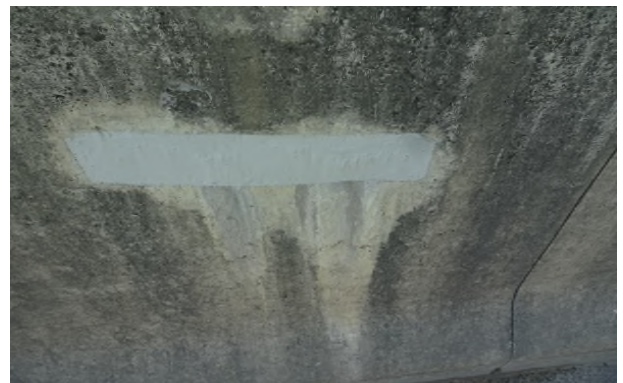
⑯ 균열부 백태 (0.3mm미만)  $cw=0.2mm$  / 0.5m  
(보수완료)

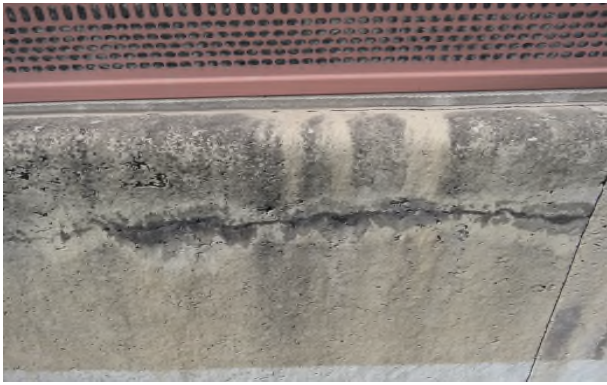
⑱ 균열부 백태 (0.3mm미만) cw=0.1mm /0.7m (2EA)

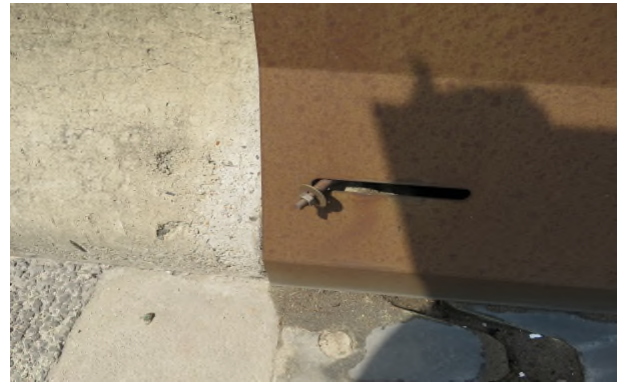
㉕ 차수판 볼트탈락 (1EA)

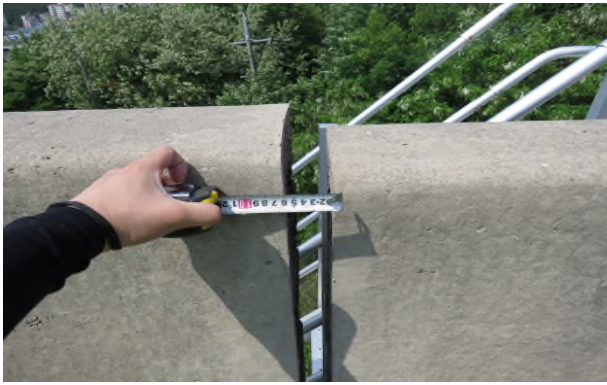
⑰ 접속부 방호벽 이격단차 (1EA) (5.1cm)

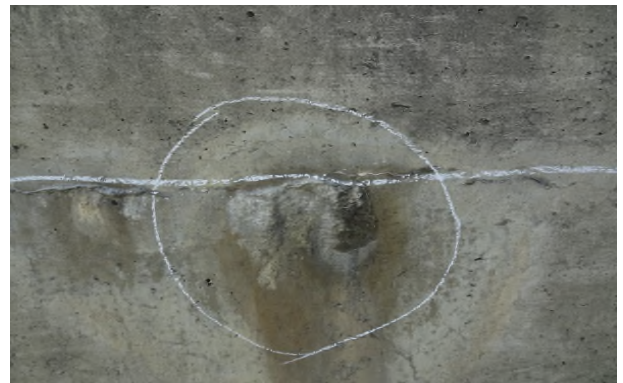
⑳ 백태 0.2m x 0.2m

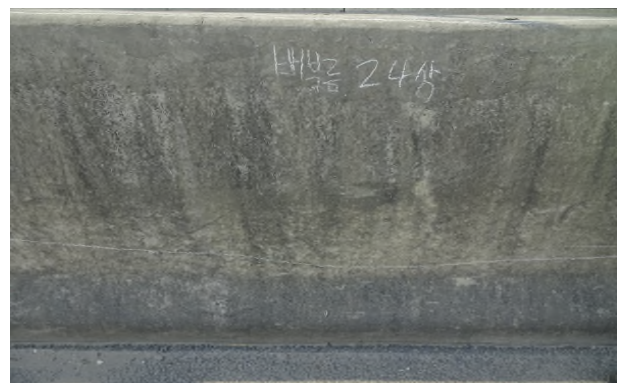
㉔ 배부름 4.0m x 1.0m

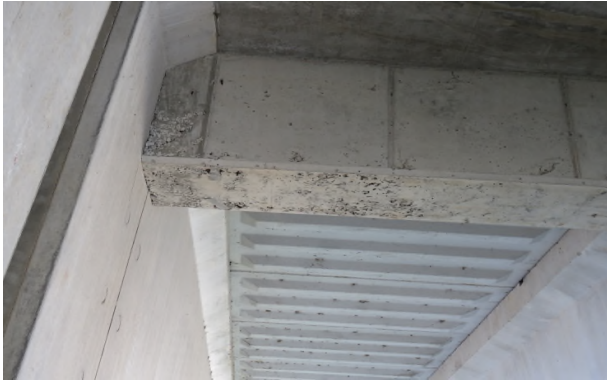
② 가로보 재료분리 0.2m x 0.6m

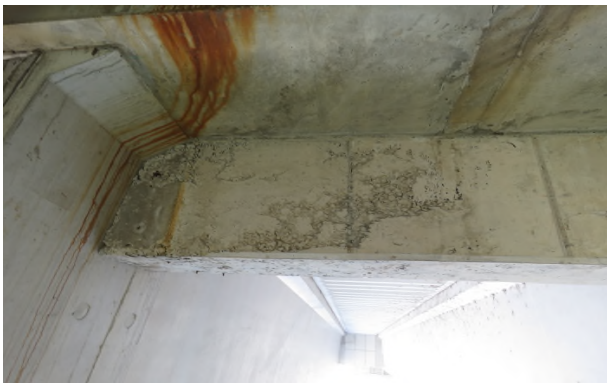
㉖ 가로보 재료분리 0.3m x 1.0m

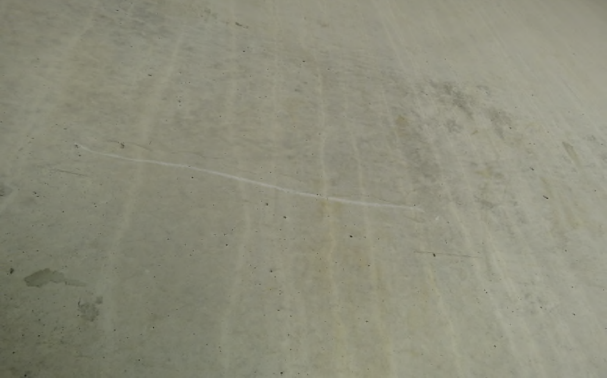
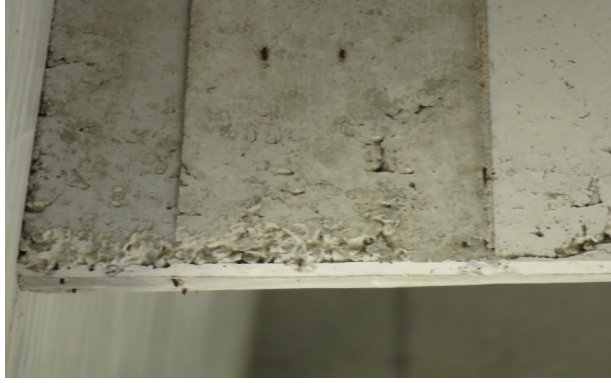
| ⑬ 균열 (0.3mm미만) cw=0.2mm / 1.0m | ⑮ 가로보 재료분리 0.2m x 0.5m |

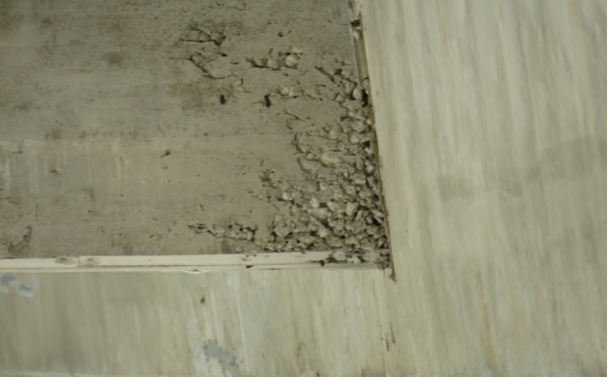
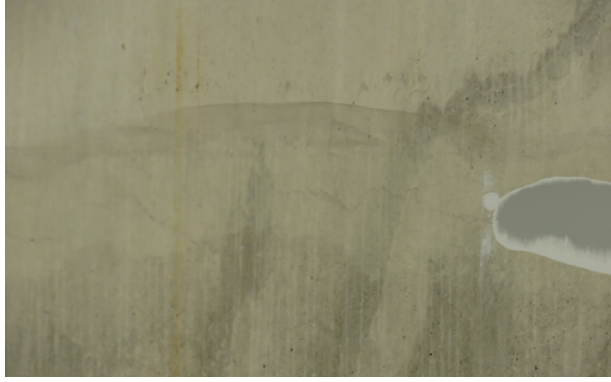
| ⑧ 가로보 재료분리 0.6m x 0.5m | ⑨ 망상균열 (0.3mm미만) cw=0.2mm / 1.0m x 1.0m |

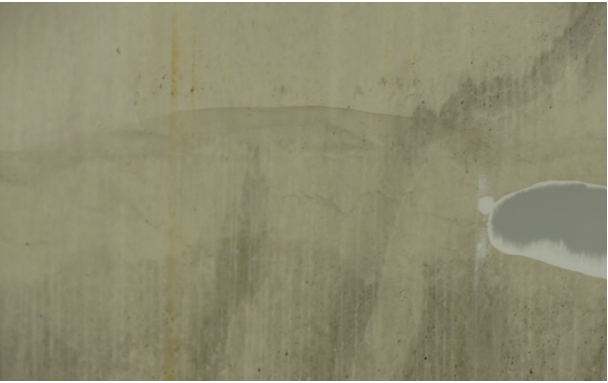
| ⑧ 가로보 철근노출 (1EA) (보수완료) | |

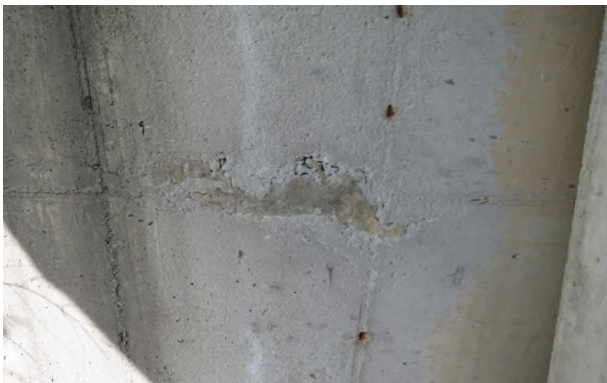
④ 재료분리 0.1m x 0.2m

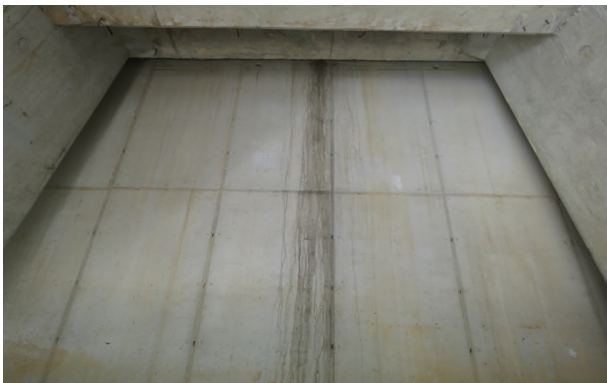
⑦ 누수흔적 (2EA)

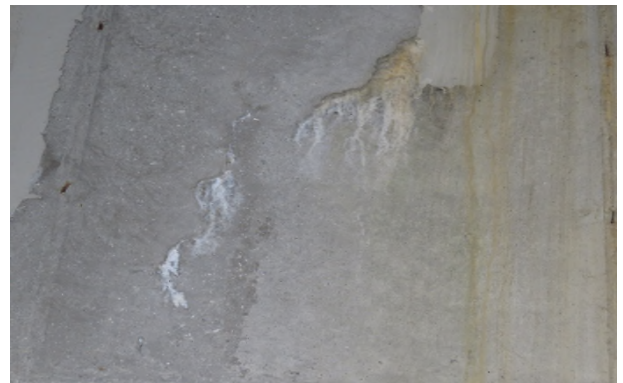
⑧ 백태 0.1m x 0.6m

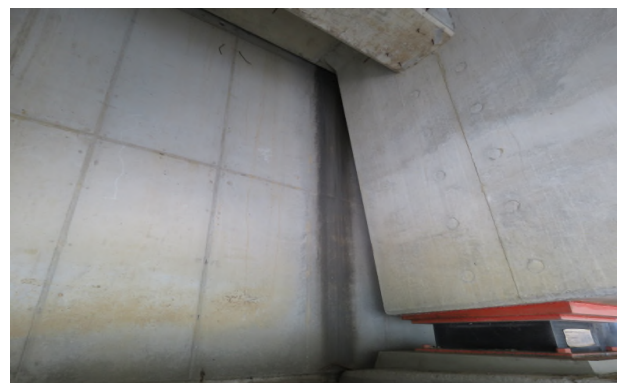
⑩ 누수흔적 (1EA)

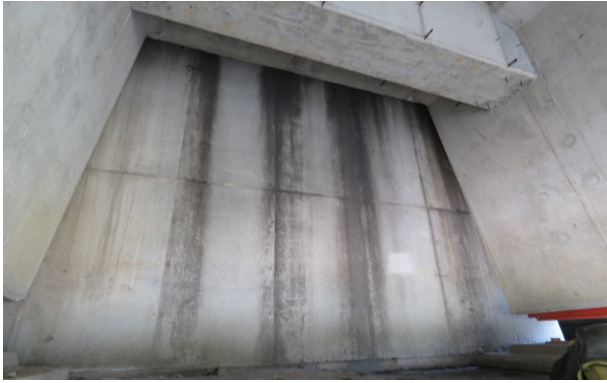
⑪ 누수흔적 (4EA)

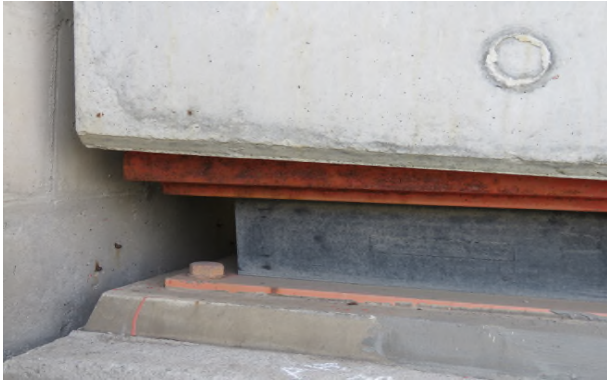
⑥ 플레이트 부식 0.1m x 0.6m

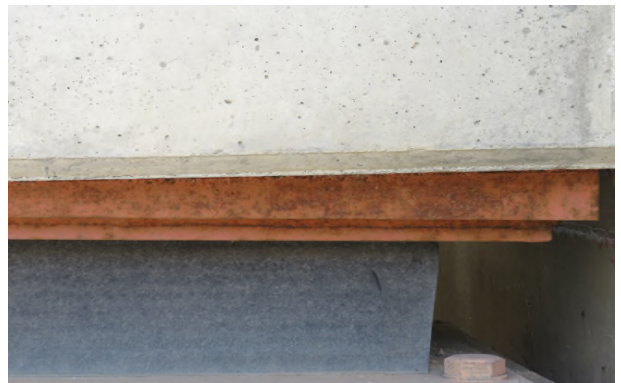
⑨ 플레이트 부식 0.1m x 0.6m

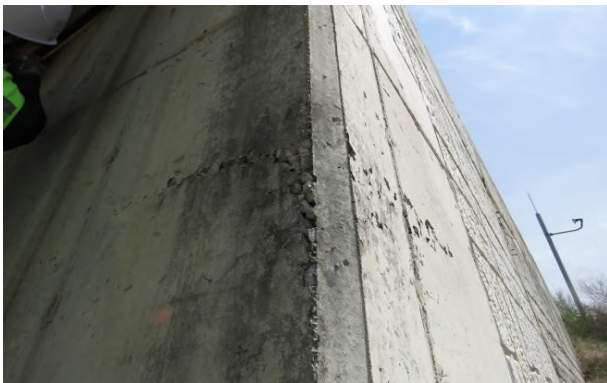
⑩ 재료분리 0.1m x 0.5m

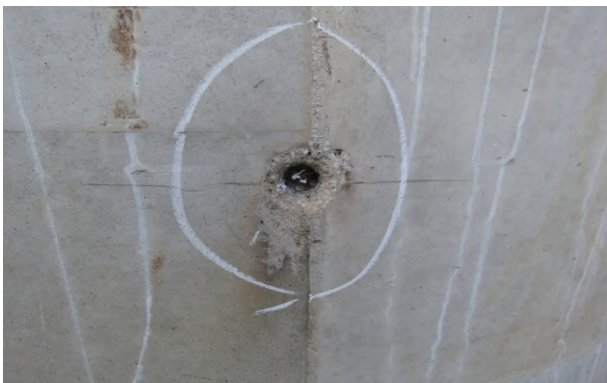
⑲ 마감불량 0.1m x 0.1m
