## **6. 현황조사 및 외관조사 사진첩**

## 01. 남전천교

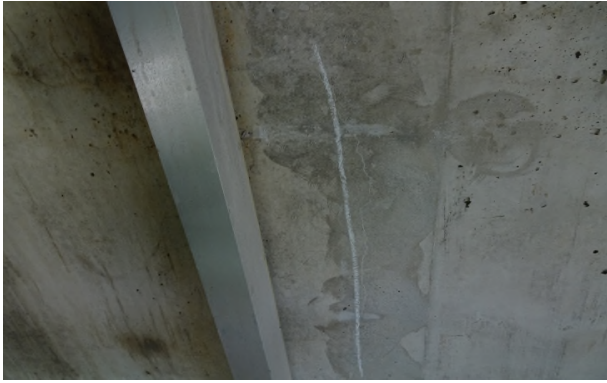
⑩ 균열  $cw=0.3mm$  / 1.5m (2EA) (보수완료)

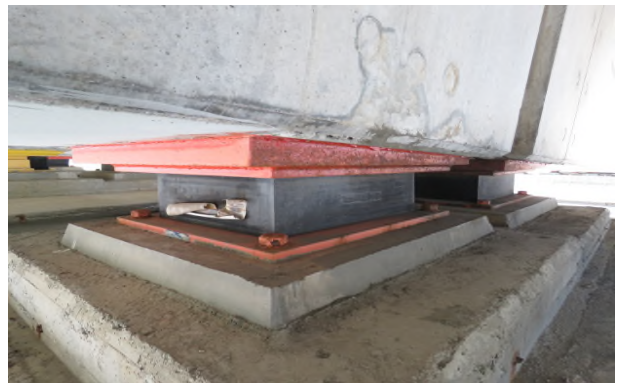
⑯ 플레이트 부식 0.1m x 0.8m (2EA)

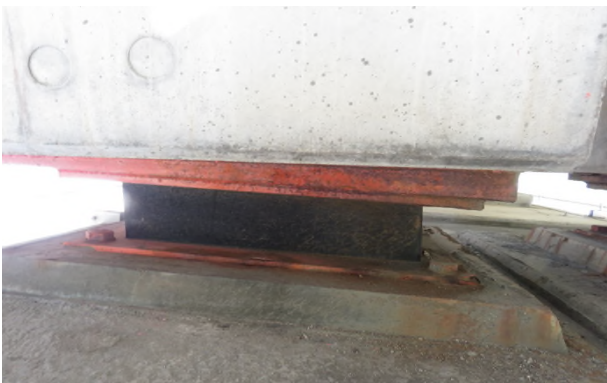
⑰ 플레이트 부식 0.3m x 0.3m (2EA)

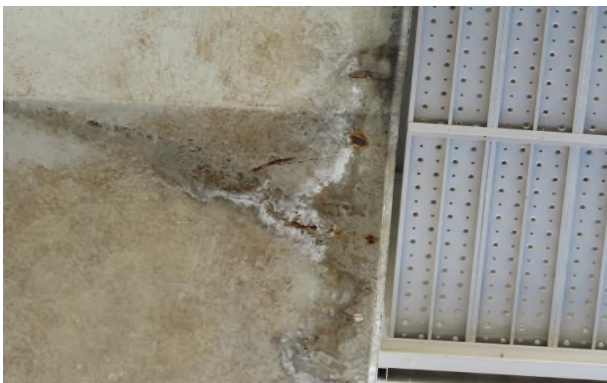
⑲ 백태 0.2m x 1.0m

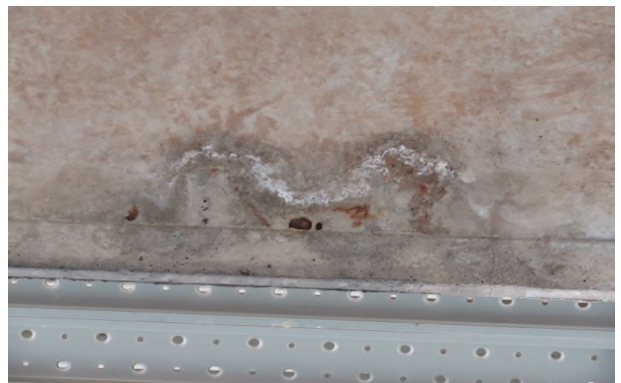
⑳ 백태 0.1m x 0.2m

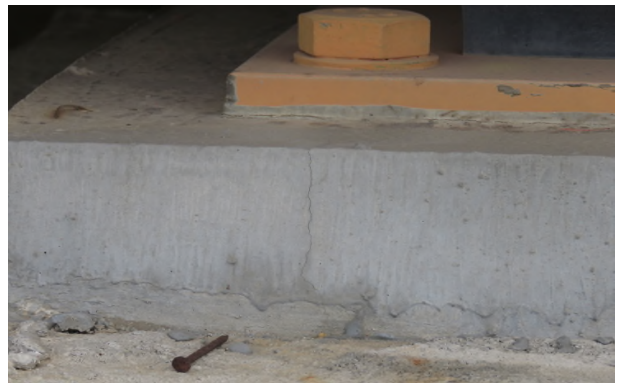
⑬ 무수축물탈균열 (0.3mm미만) cw=0.1mm / 0.1m (3EA)

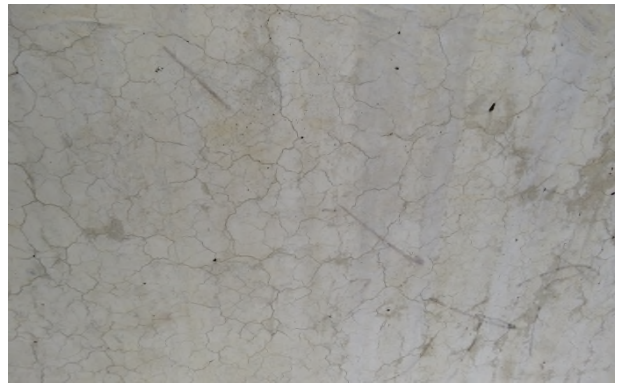
⑮ 망상균열 (0.3mm미만) cw=0.1mm / 1.0m x 0.8m (2EA)

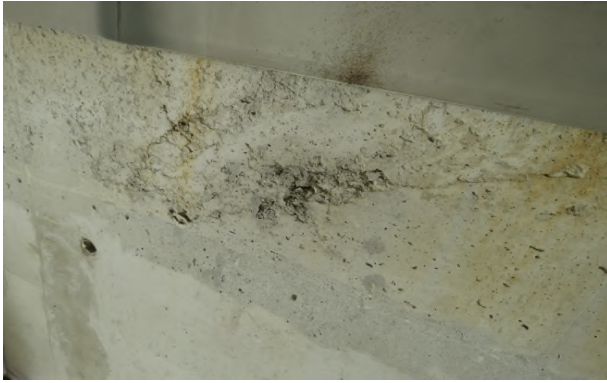
㉞ 재료분리 0.1m x 0.3m

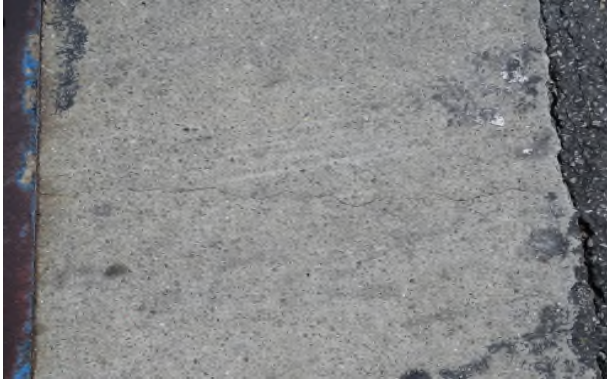
① 후타재균열 0.1mm / 0.2m (2EA)

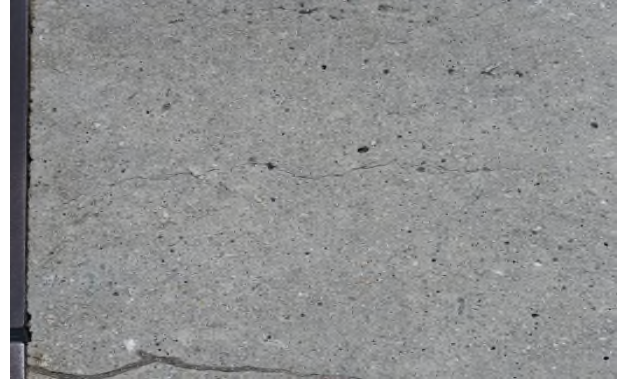
② 후타재균열 0.1mm / 0.6m

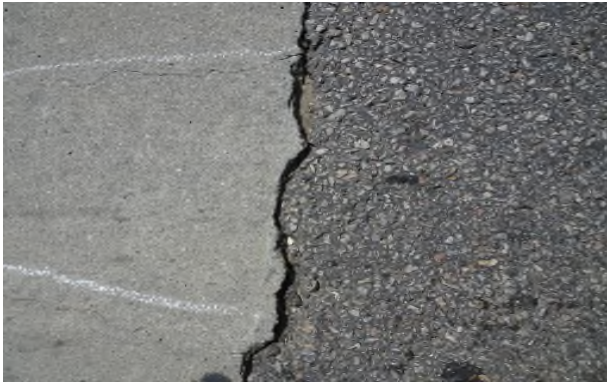
④ 후타재균열 0.1mm / 0.7m

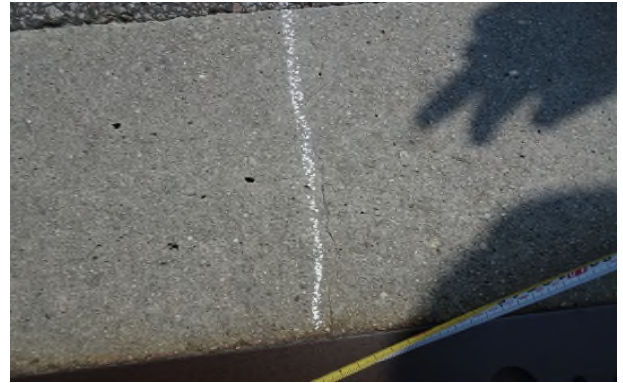
⑤ 후타재균열 0.2m / 0.3m (5EA)

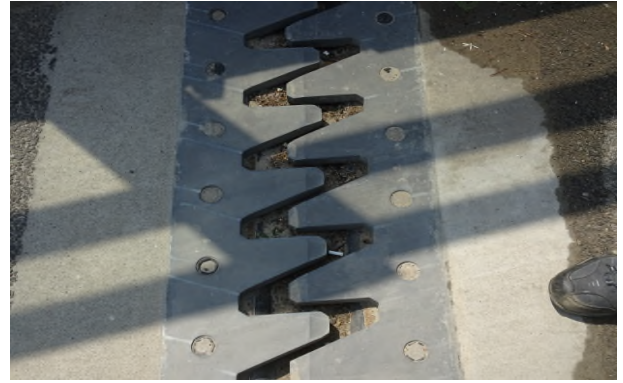
③ 신축이음 토사퇴적 L=2.0m

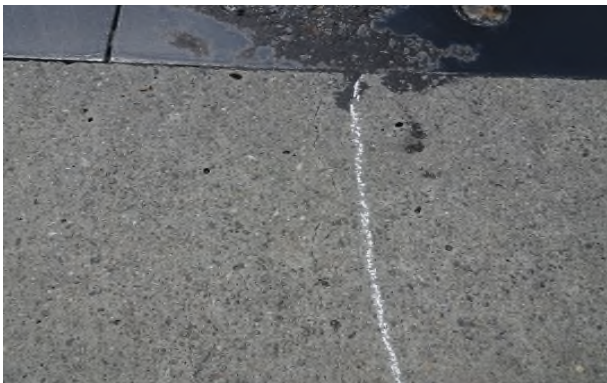
④ 후타재균열 0.1mm / 0.2m (2EA)

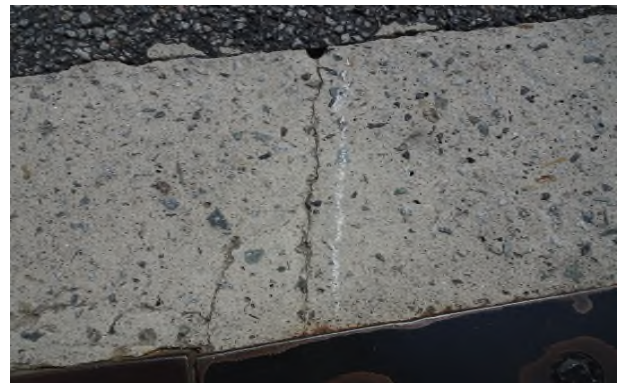
⑤ 후타재균열 0.1mm / 0.2m

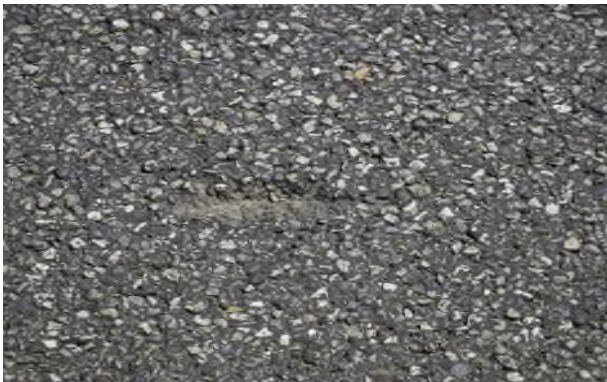
② 포장파손 0.1m x 0.1m

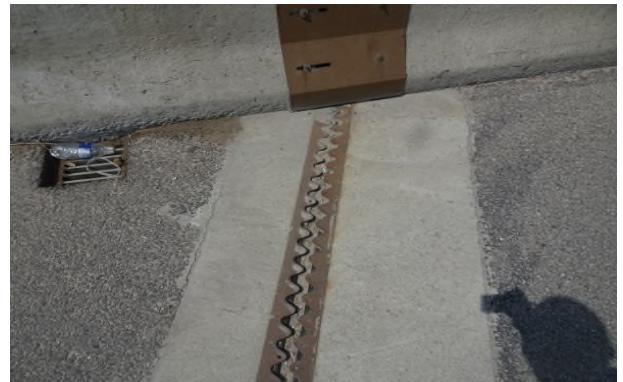
③ 부식 및 토사퇴적 0.1m x 0.1m

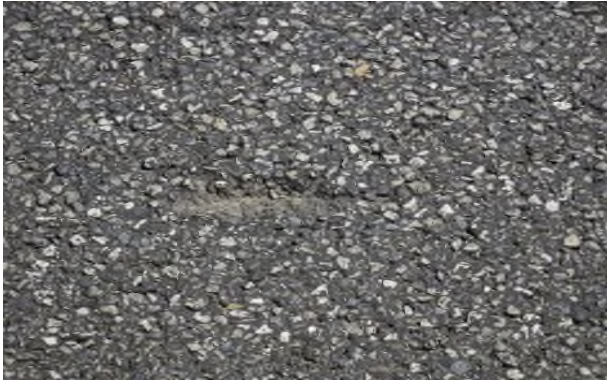
④ 포장파손 0.1m x 0.2m

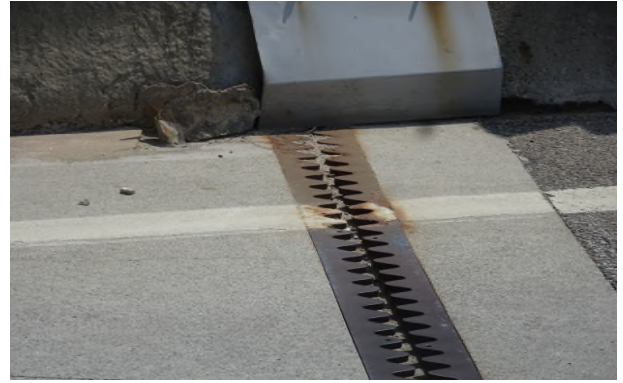
⑤ 신축이음부식 0.1m x 0.5m

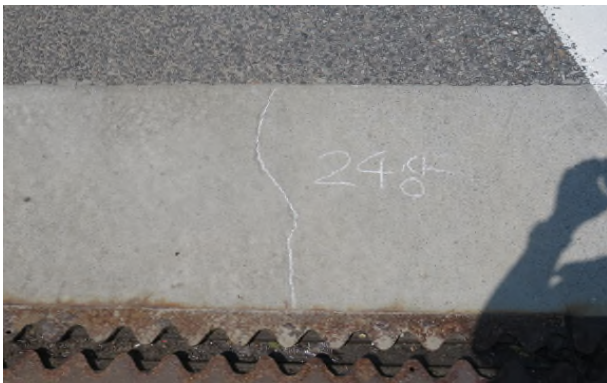
⑥ 후타재균열 0.1mm / 0.3m

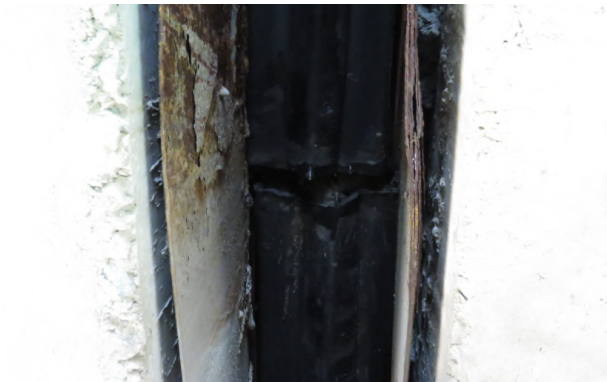
① 물받이 길이부족 (2EA)

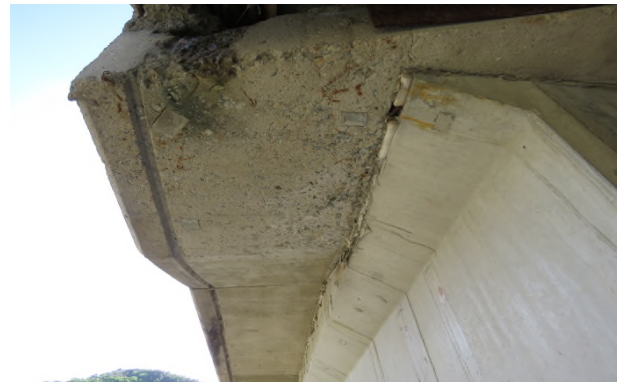
② 콘크리트열화 0.5m x 0.6m

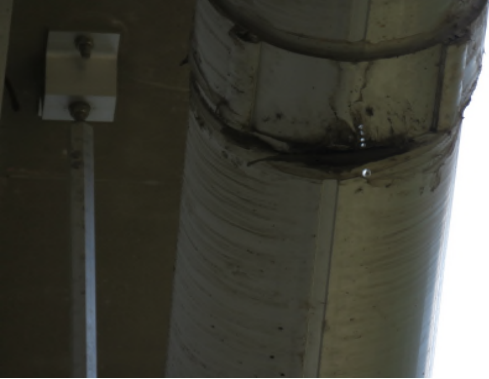
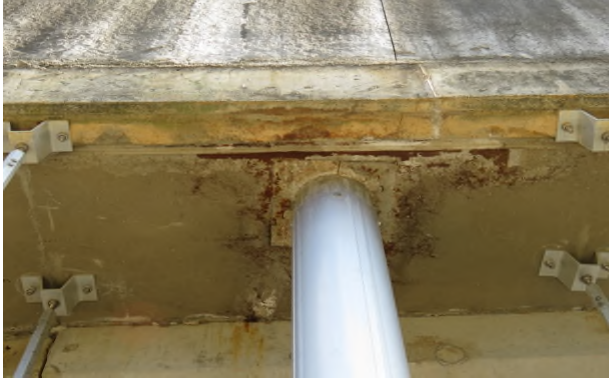
| ① 배수관누수 (1EA) | ② 부식 0.5m x 0.4m |

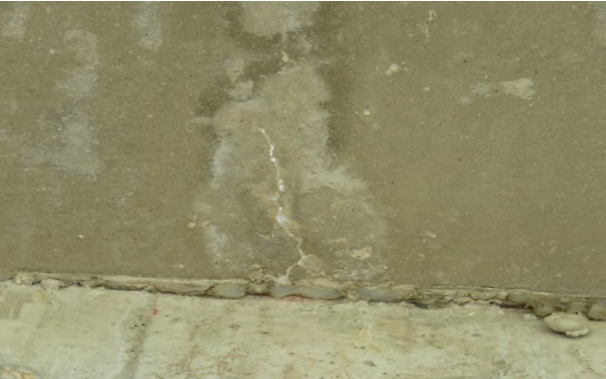
| ③ 백태 0.1m x 0.2m | |

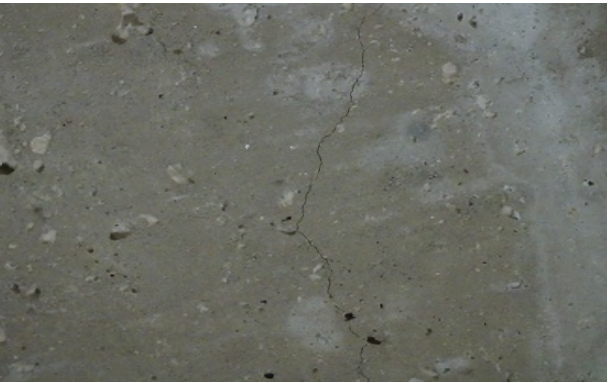
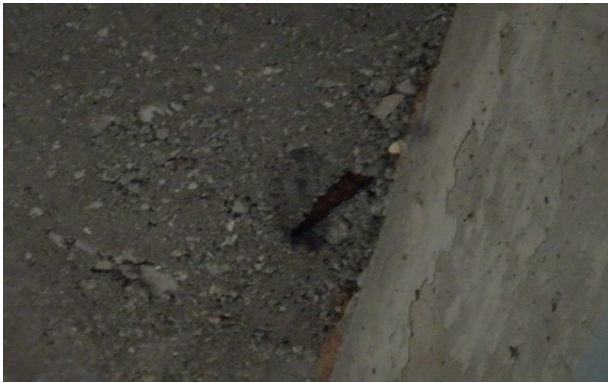
| ① 균열 0.2mm / 0.6m | ② 철근노출 (1EA) |

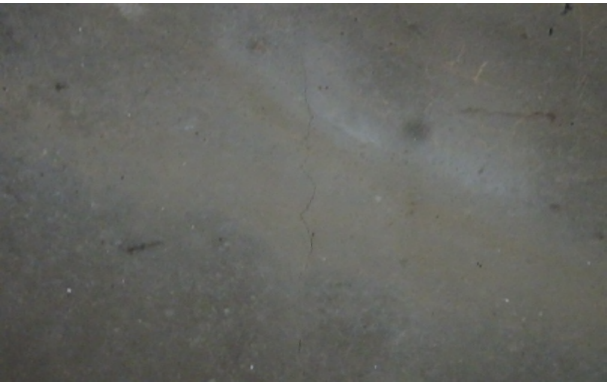
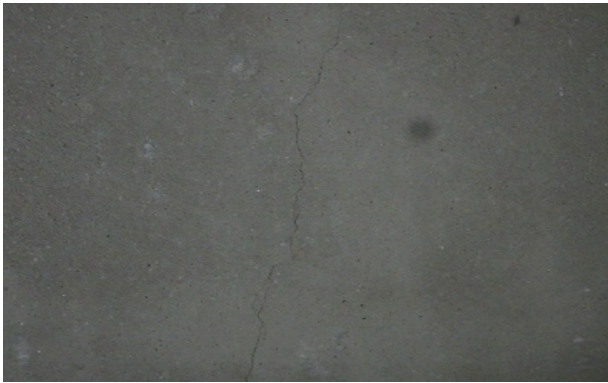
| ③ 균열 0.1mm / 0.3m (5EA) | ④ 균열 0.1mm / 0.4m |

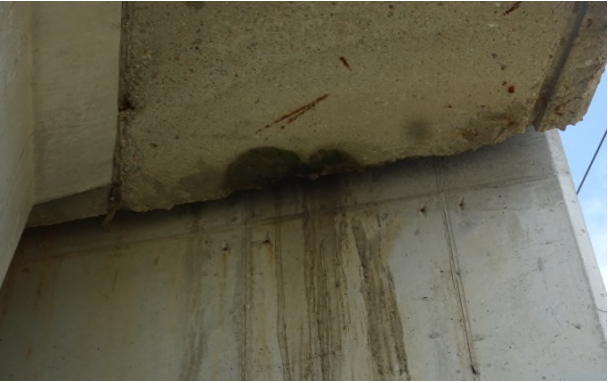
| ⑤ 콘크리트 열화 0.6m x 1.0m | |

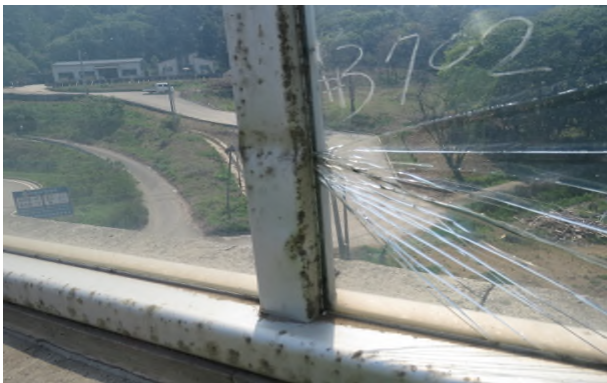
⑰ 방음벽 프레임 손상 (1EA)

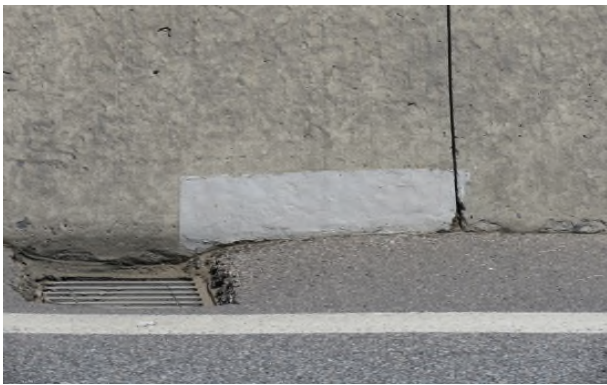
④ 백태 0.1m x 0.1m (보수완료)

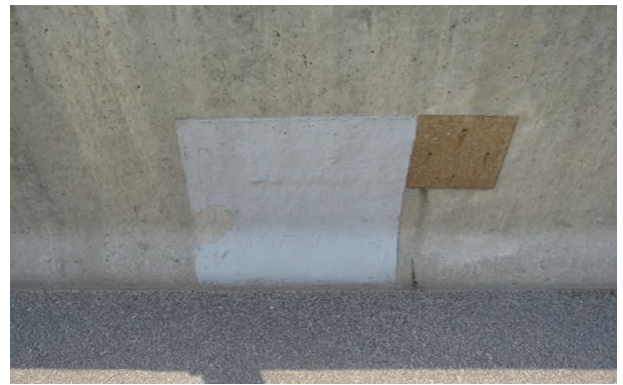
⑫ 표면불량 0.6m x 0.3m (보수완료)

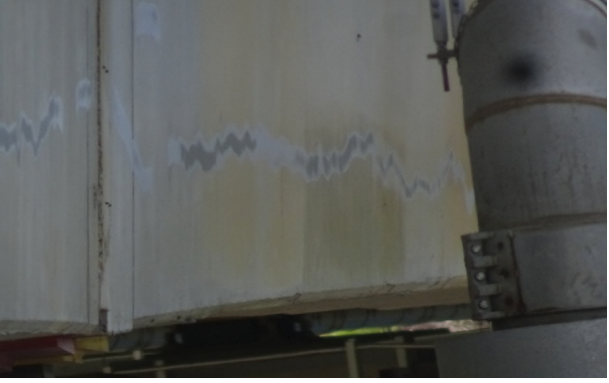
| ① 균열 0.2mm / 2.7m (보수완료) | ② 균열 0.2mm / 3.2m (보수완료) |

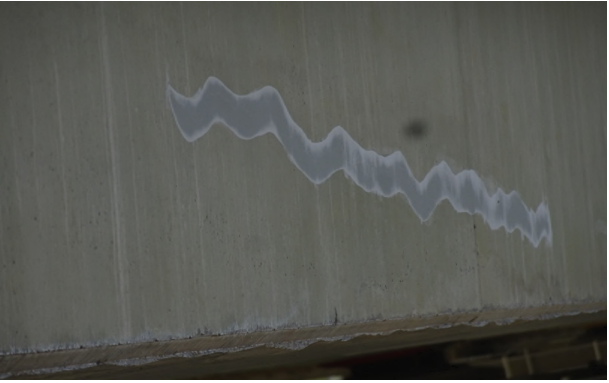
| ④ 균열 0.2mm / 13.3m (보수완료) | |

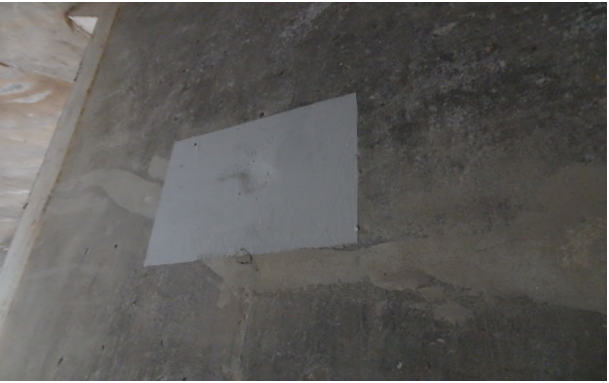
| ㉑ 백태 0.1m x 0.1m (보수완료) | ㉒ 균열 0.2mm / 1.0m (보수완료) |

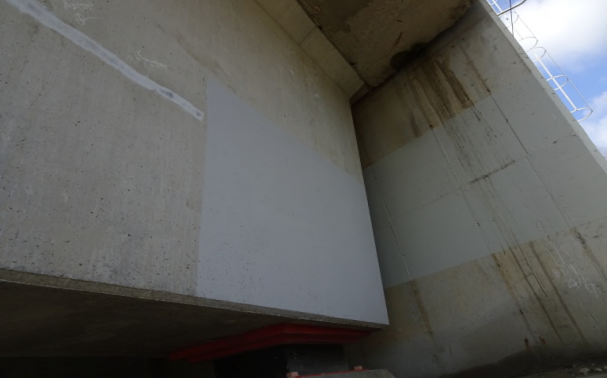
| <p>㉪ 균열 0.1mm / 1.1m (보수완료)</p> | |

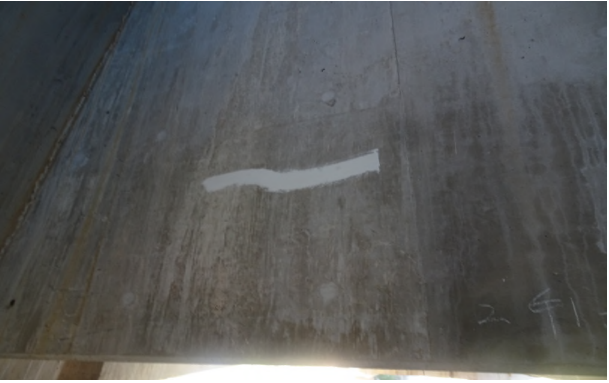
| <p>① 균열 0.1mm / 0.3m (보수완료)</p> | <p>② 균열 0.2mm / 0.5m (보수완료)</p> |

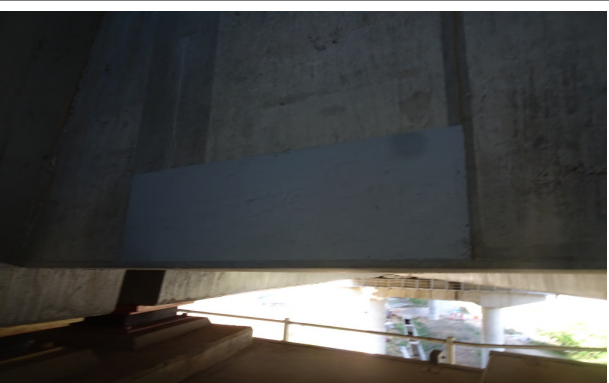
| <p>③ 재료분리 0.2m x 0.5m (보수완료)</p> | <p>④ 균열 0.2mm / 0.5m (보수완료)</p> |

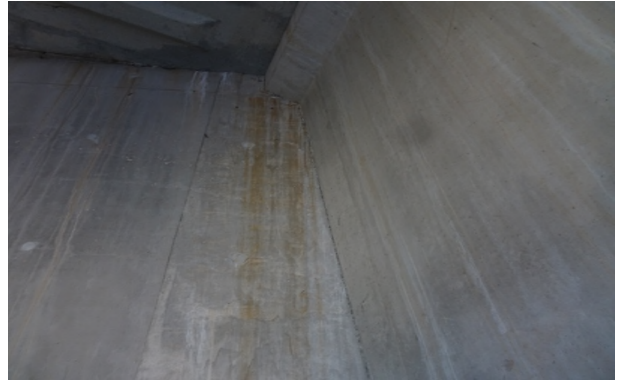
⑥ 누수흔적 0.5m x 0.5m

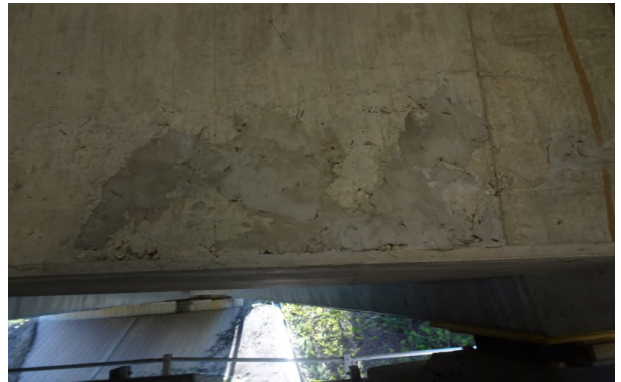
② 망상균열 0.1mm / 0.3m x 0.6m

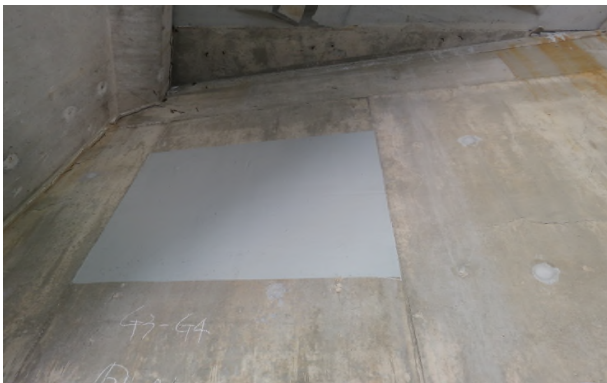
⑥ 망상균열 0.2mm / 0.5m x 0.5m (보수완료)

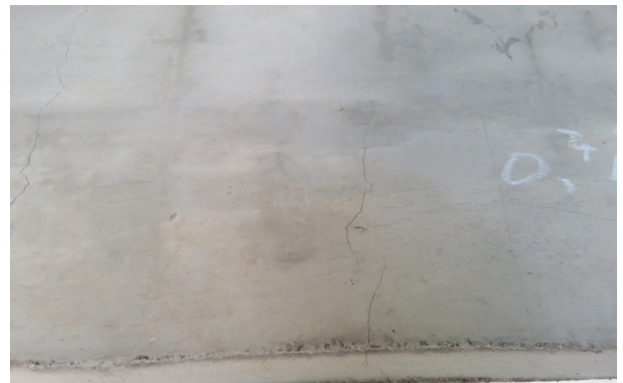
⑳ 균열 0.3mm / 0.5m (8EA)

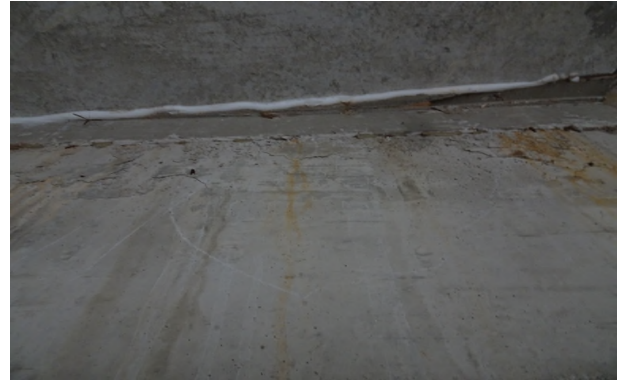
④ 재료분리 0.3m x 2.5m

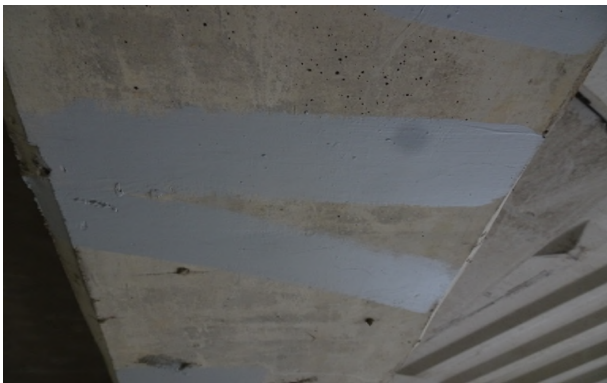
⑤ 균열 0.3mm / 0.6m (8EA)

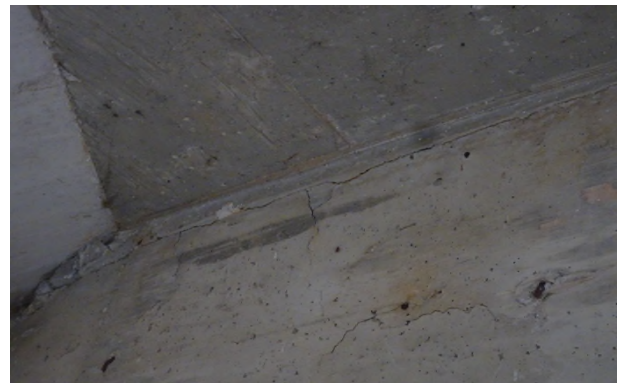
⑥ 균열 0.2mm / 1.0m

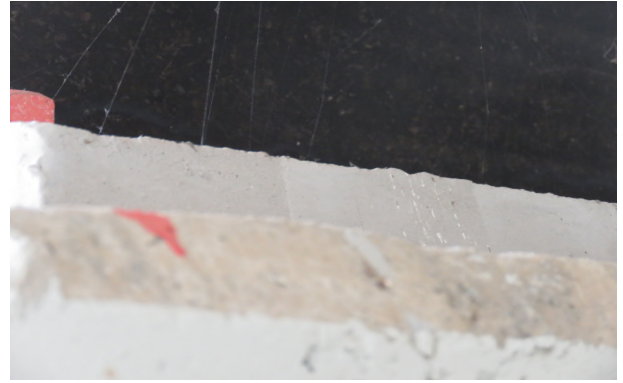
⑥ 무수축물탈균열 0.1mm / 0.1m (8EA) (보수완료)

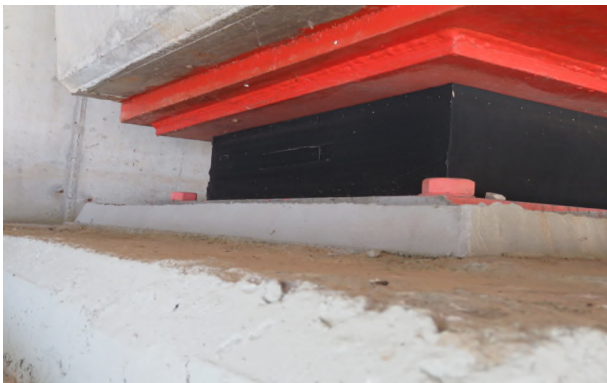
⑨ 무수축물탈균열 0.1mm / 0.1m (4EA) (보수완료)

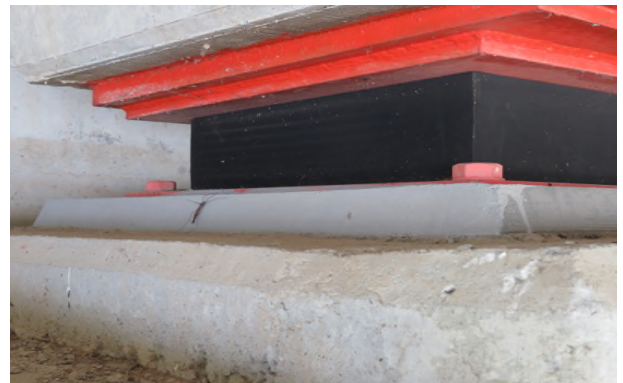
⑩ 무수축물탈균열 0.2mm / 0.1m (4EA) (보수완료)

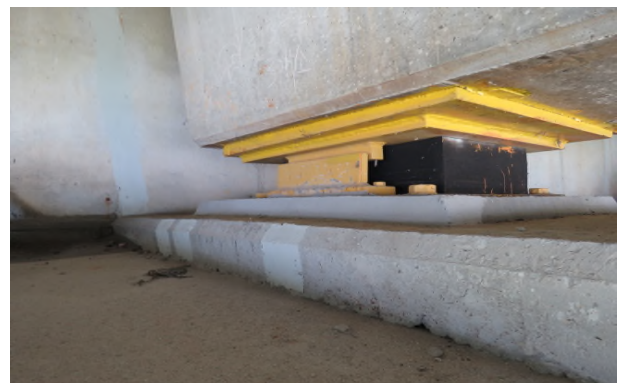
⑫ 무수축물탈균열 0.1mm / 0.1m (3EA) (보수완료)

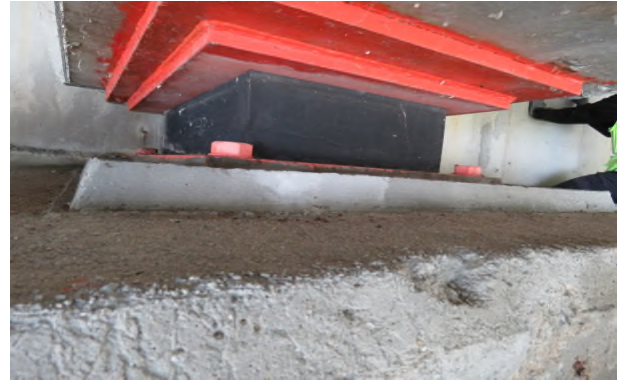
⑭ 무수축물탈균열 0.1mm / 0.1m (2EA) (보수완료)

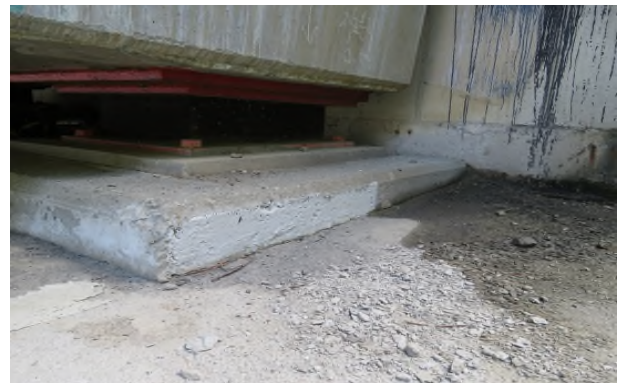
⑯ 무수축물탈균열 0.1mm / 0.1m (4EA) (보수완료)

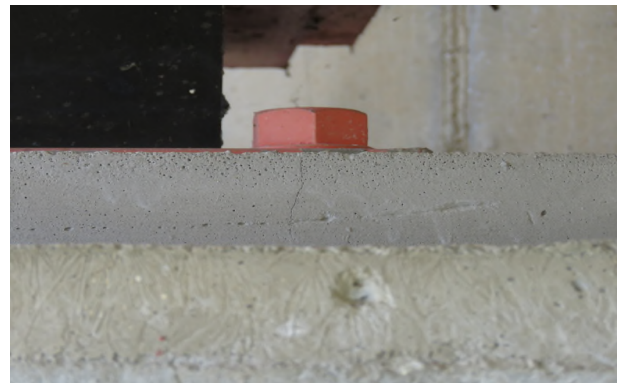
⑳ 무수축물탈균열 0.1mm / 0.1m

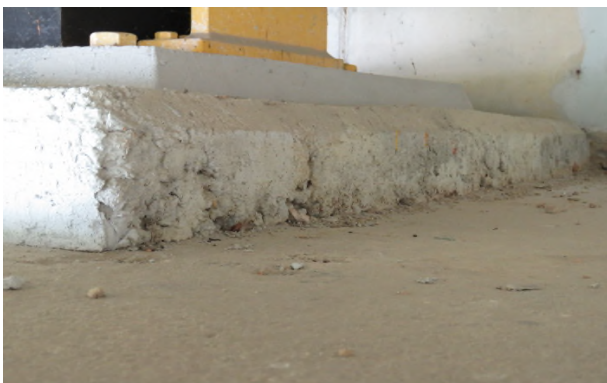
㉕ 받침콘크리트 재료분리 0.1m x 1.0m

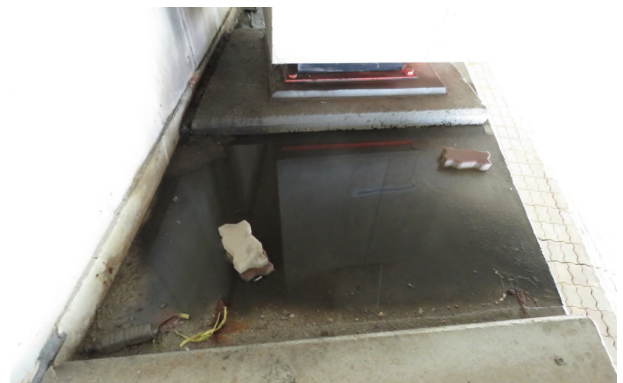
㉖ 체수 0.5m x 1.0m

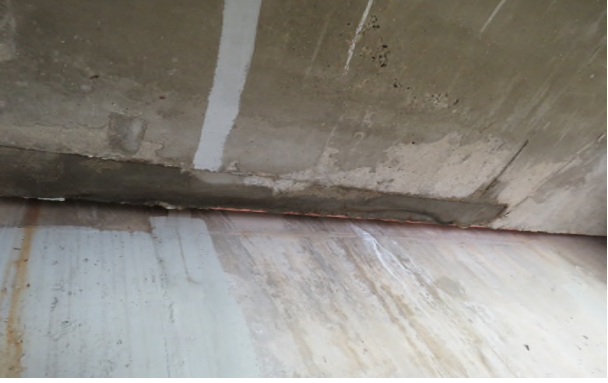
| ②⑦ 누수흔적 0.5m x 1.5m | ②⑧ 균열 0.2mm / 1.0m |

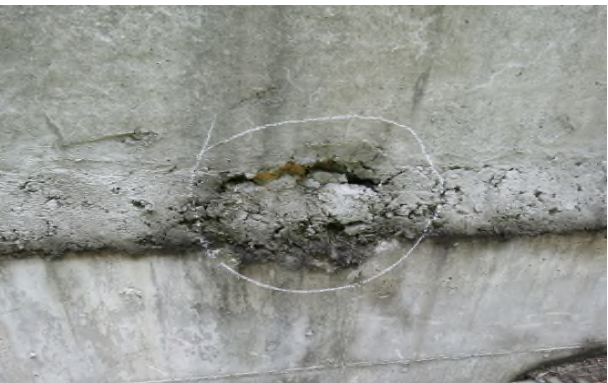
| ②⑨ 파손 0.2m x 0.2m | |

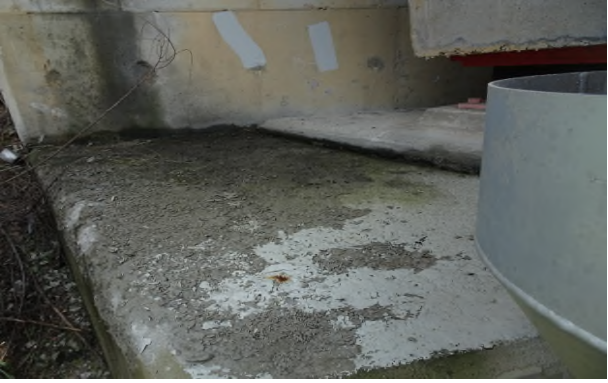
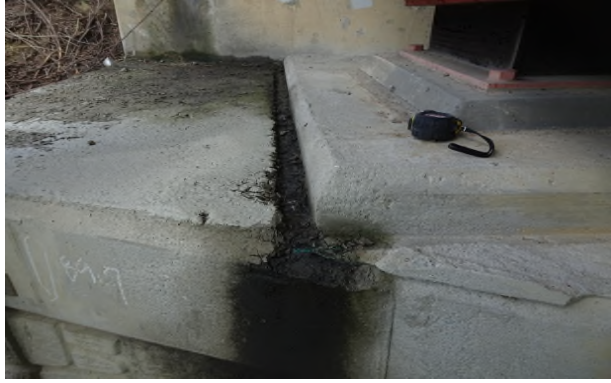
| ① 콘크리트 열화 0.4m x 0.3m | ② 체수 1.0m x 0.7m |

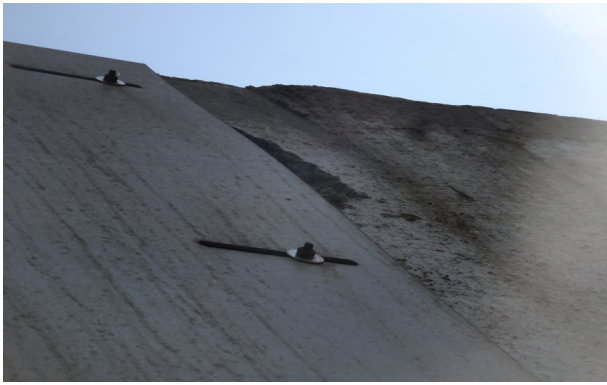
③ 잡철물미제거(녹발생) (20EA)

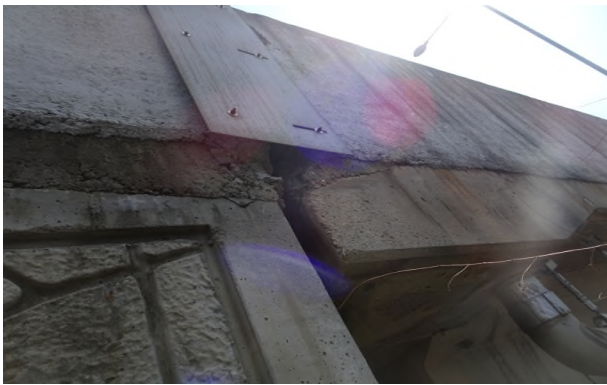
⑤ 마감불량 0.1m x 0.2m

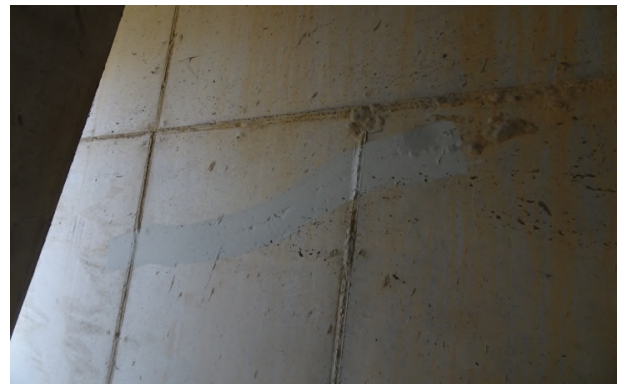
⑥ 재료분리 0.1m x 1.0m (보수완료)

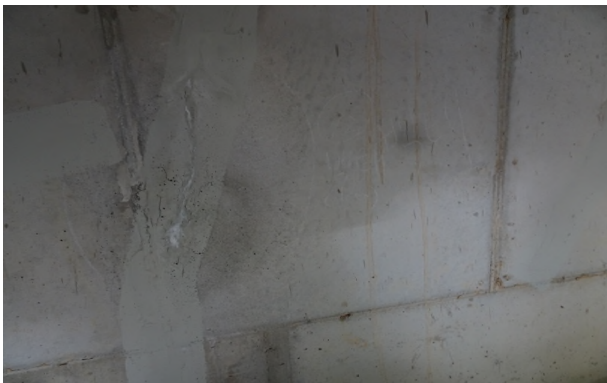
⑫ 백태 0.1m x 0.3m

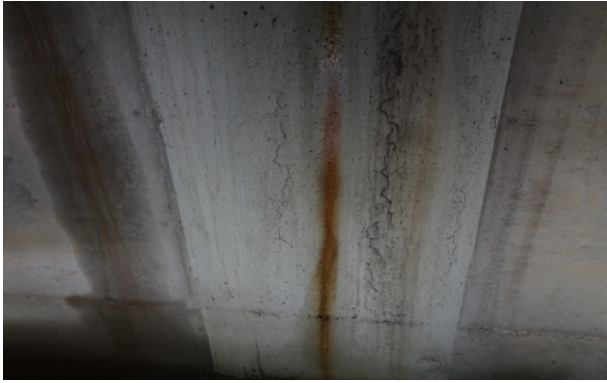
⑭ 누수(녹발생) 0.5m x 6.0m

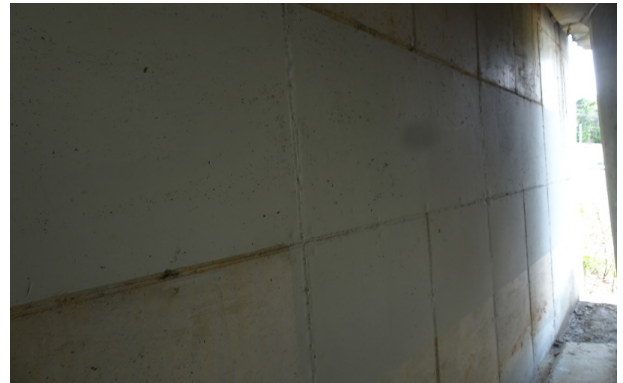
⑲ 재료분리 5.0m x 1.0m (보수완료)

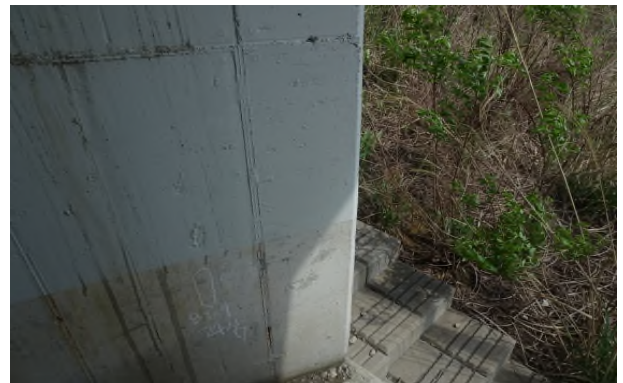
㉑ 잡철물미제거(녹발생) (45EA) (보수완료)

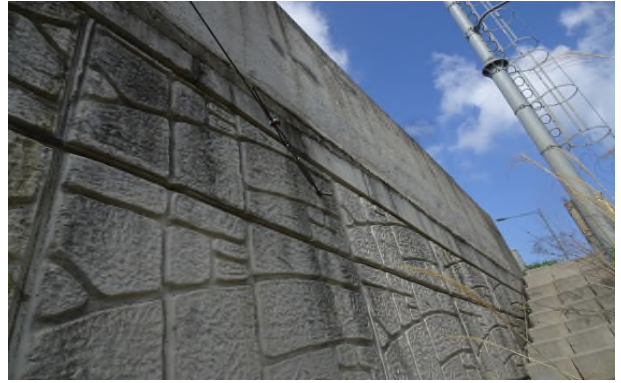
㉓ 잡철물미제거(녹발생) (39EA)

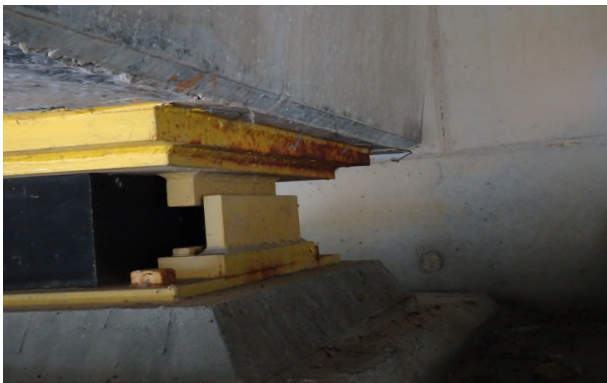
㉔ 플레이트 부식 0.1m x 0.8m

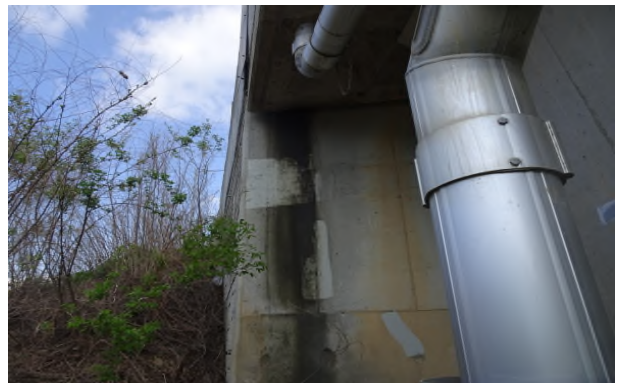
㉕ 누수흔적 0.5m x 2.0m

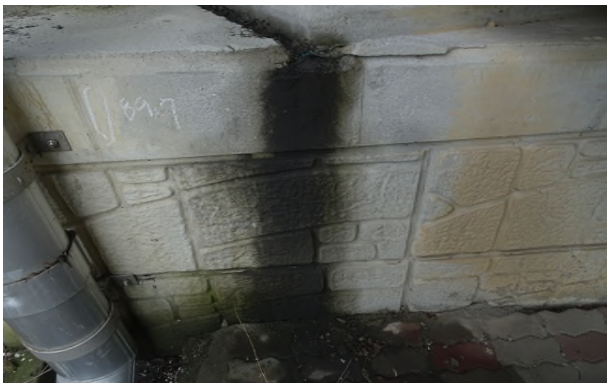
㉖ 누수흔적 0.5m x 1.0m

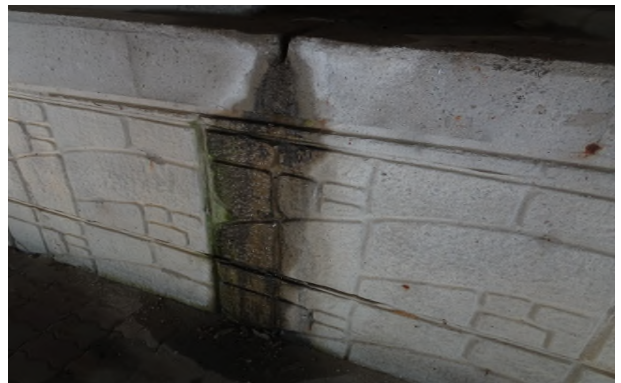
㉗ 누수흔적 0.5m x 1.0m

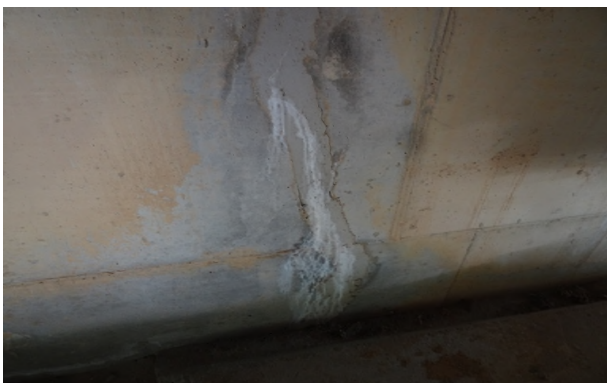
㉘ 백태 0.1m x 0.3m

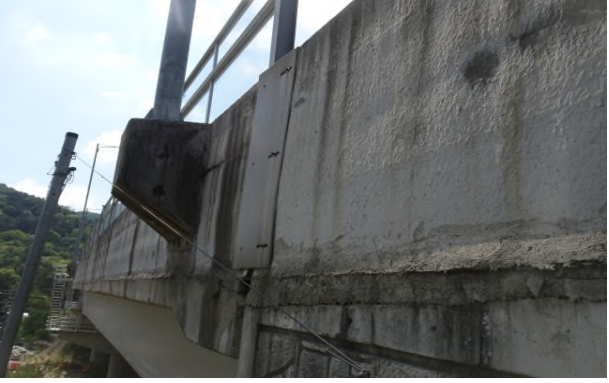
| ③⑩ 백태 (3EA) | ③⑪ 철근노출 (1EA) |

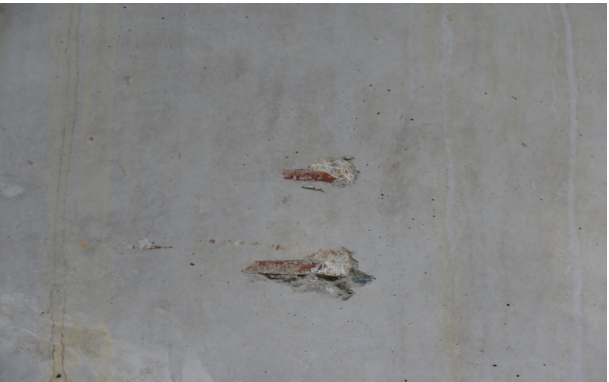
| ⑬ 균열 0.1m x 0.1m (2EA) | ⑭ 재료분리 0.3m x 0.3m |

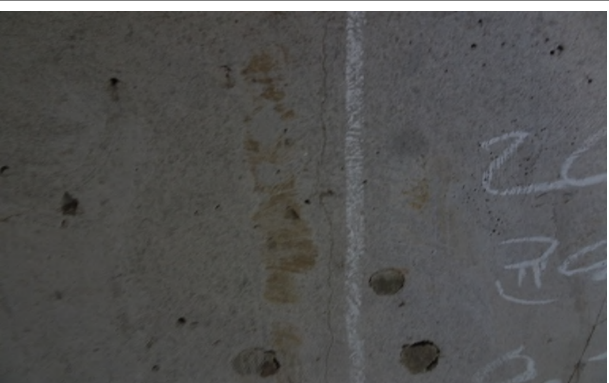
| ⑮ 균열 0.1mm / 1.0m | ⑯ 균열 0.1mm / 0.7m |

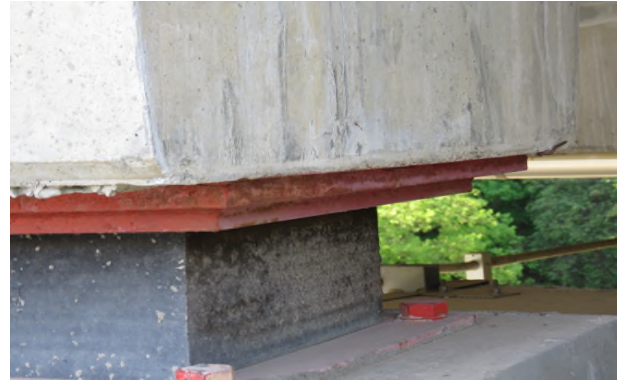
⑲ 플레이트 부식 0.1m x 0.8m

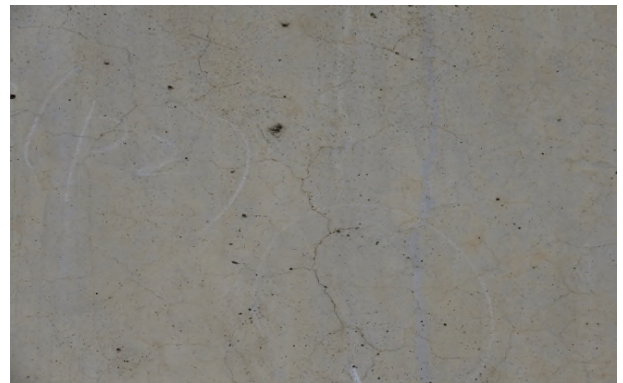
㉑ 망상균열 0.1mm / 1.0m x 1.0m

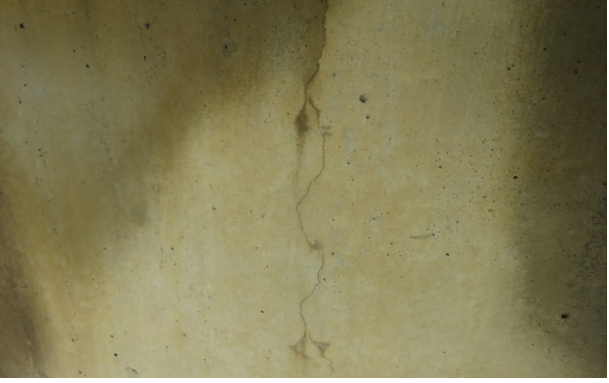
| ㉔ 균열 0.2mm / 1.5m | ㉕ 균열 0.1mm / 0.8m |

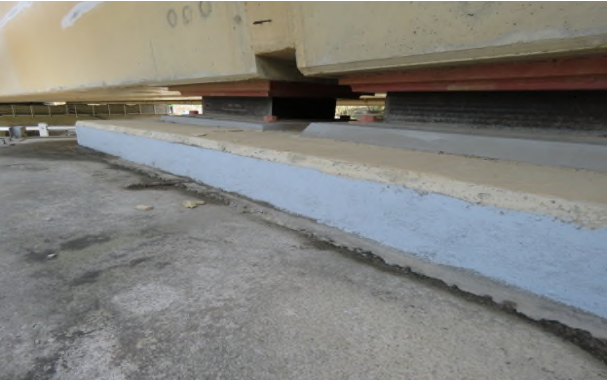
| ③ 받침콘크리트재료분리 0.15m x 0.4m (보수완료) | ④ 받침콘크리트재료분리 0.15m x 2.5m (보수완료) |

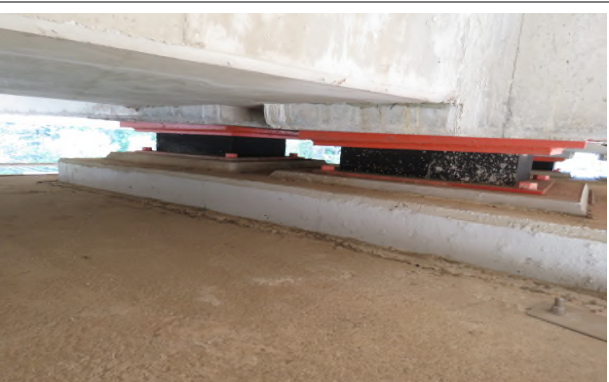
| ⑤ 받침콘크리트재료분리 0.15m x 2.3m (보수완료) | ⑥ 무수축물탈표면불량 0.1m x 0.1m (보수완료) |

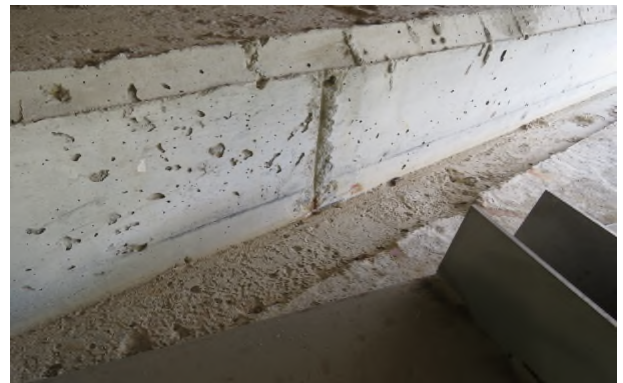
⑪ 철근노출 (1EA) (보수완료)

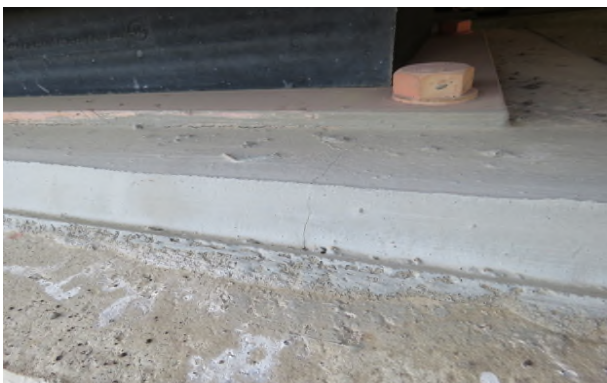
⑭ 무수축물탈균열 0.1mm / 0.1m (3EA)

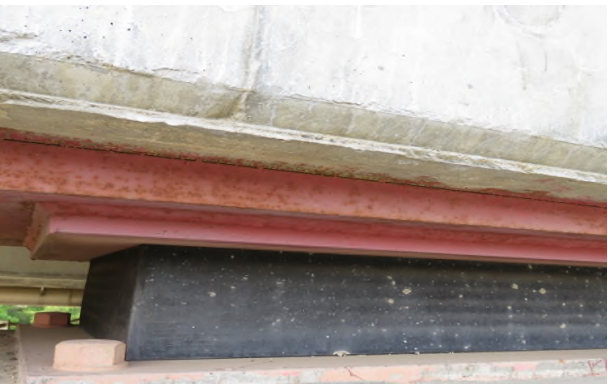
| <p>⑯ 플레이트부식 0.1m x 0.8m (2EA)</p> | <p>⑰ 망상균열 0.1mm / 2.0m x 0.5m</p> |

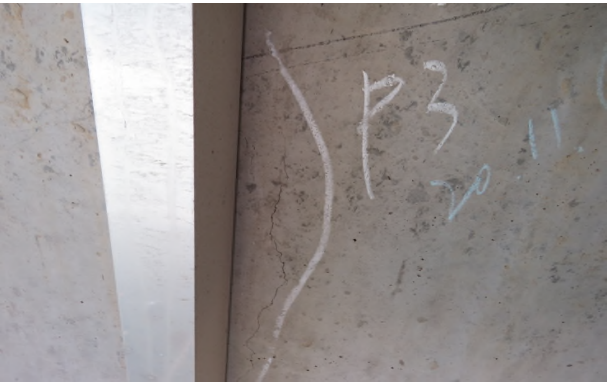
| <p>⑱ 균열 0.3mm / 0.6m (2EA)</p> | <p>⑲ 균열 0.2mm / 0.4m</p> |

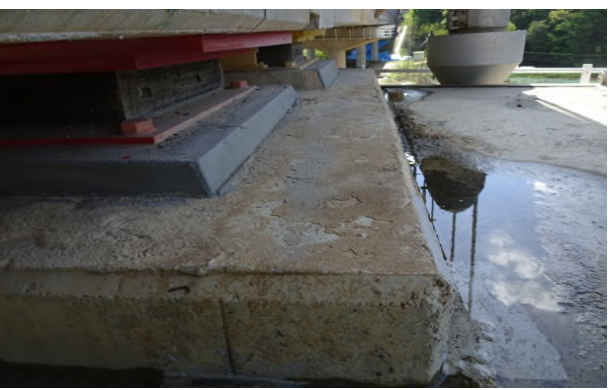
| <p>⑳ 받침콘크리트재료분리 0.1m x 0.1m</p> | <p>㉑ 철근노출 (2EA)</p> |

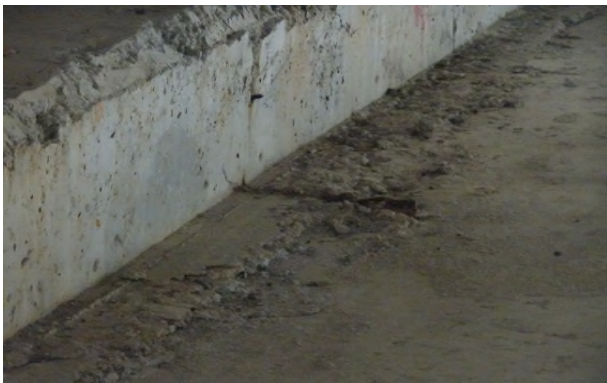
⑭ 철근노출 (1EA)

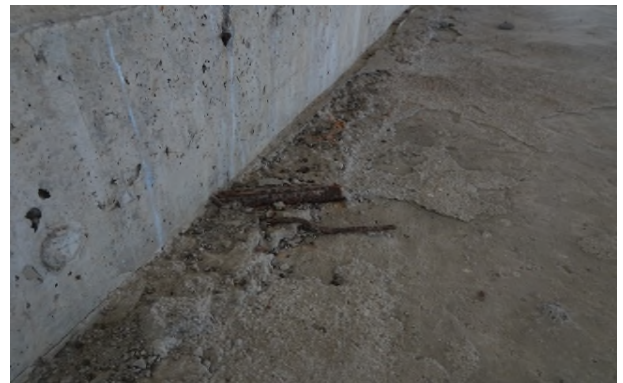
⑮ 철근노출 (1EA)

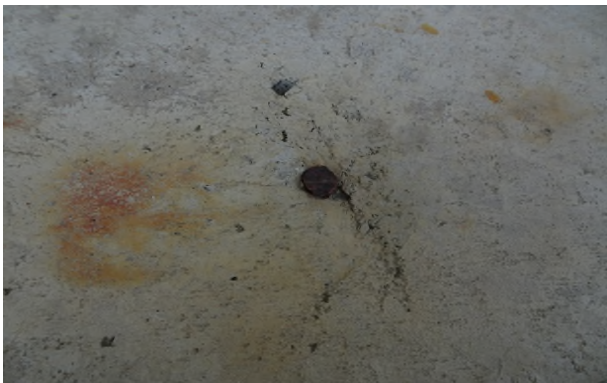
⑯ 철근노출 (2EA)

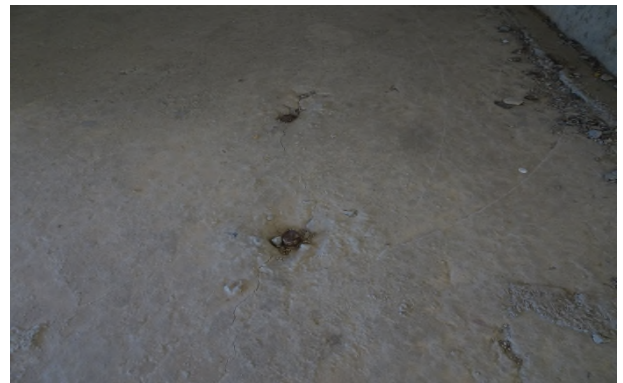
⑰ 철근노출 (2EA)

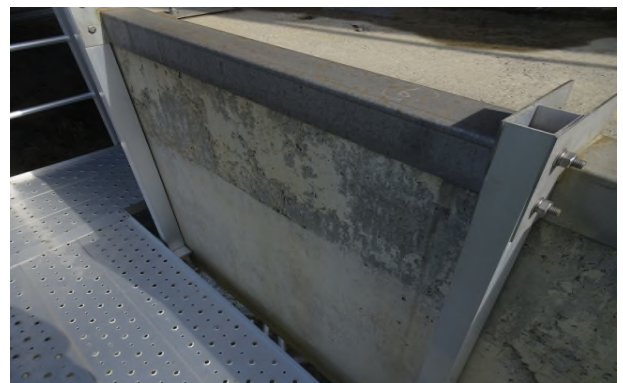
⑲ 표면불량 0.3m x 2.0m

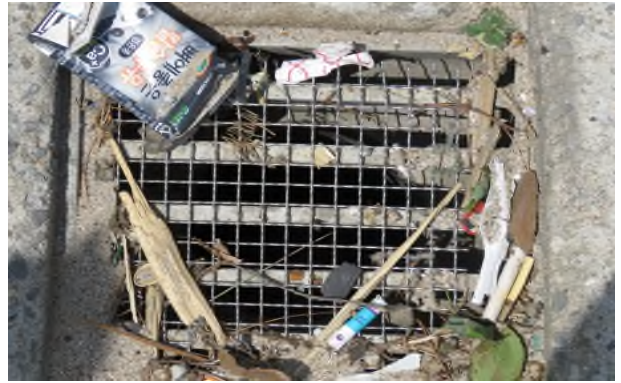
④ 배수구 이물질퇴적 (2EA)

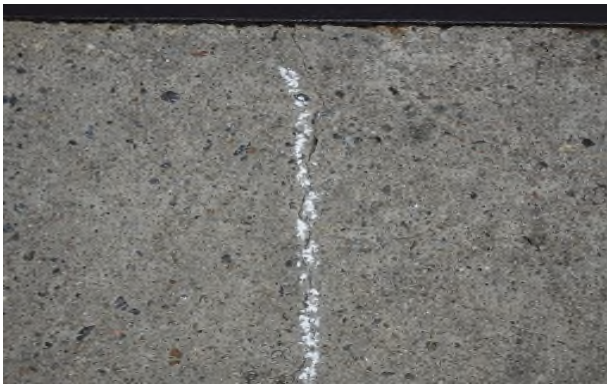
⑦ 후타재균열 0.1mm / 0.4m (3EA)

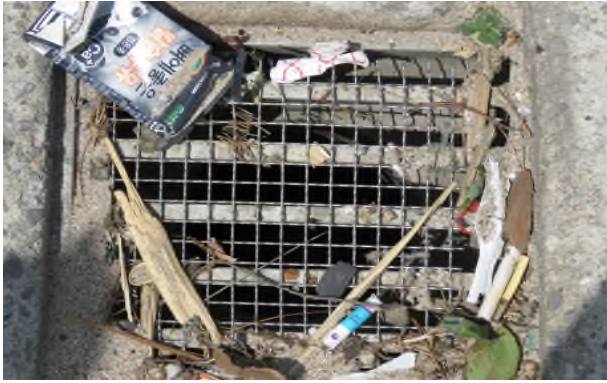
⑪ 배수구막힘 (1EA)

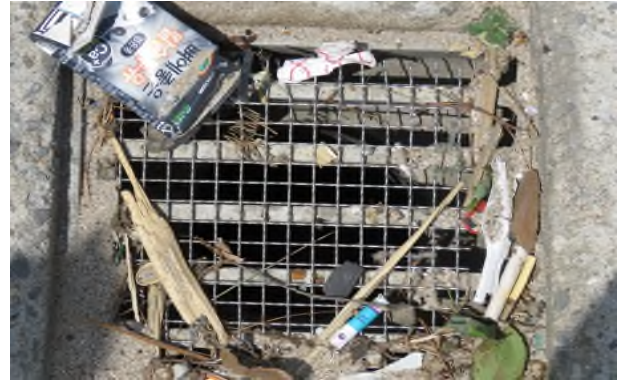
⑫ 배수구막힘 (1EA)

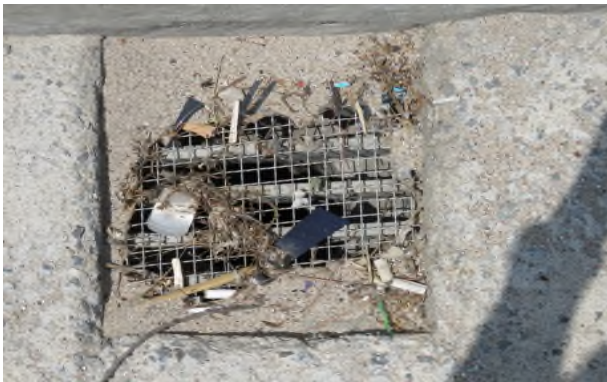
① 배수구 이물질퇴적 (1EA)

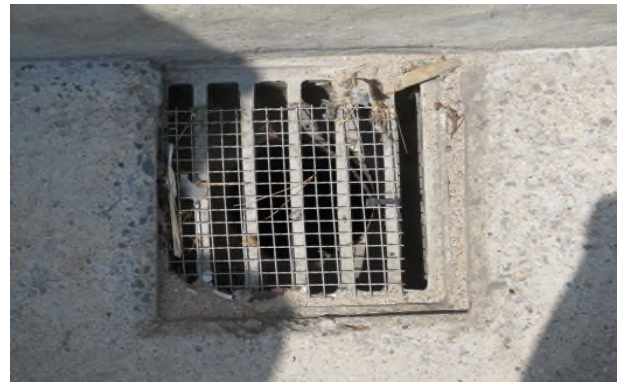
② 배수구 이물질퇴적 (1EA) (보수완료)
