## **6. 현황조사 및 외관조사 사진첩**

## 01. 남전천교

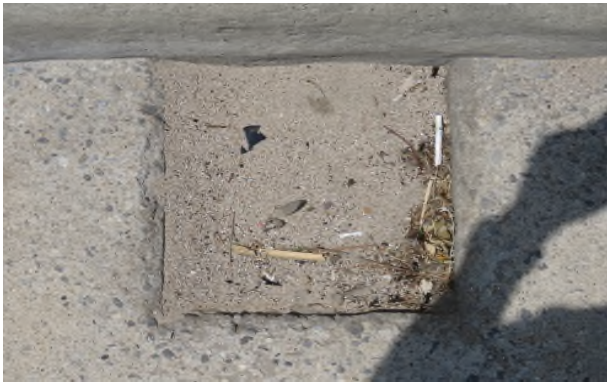
③ 배수구 이물질퇴적 (1EA)

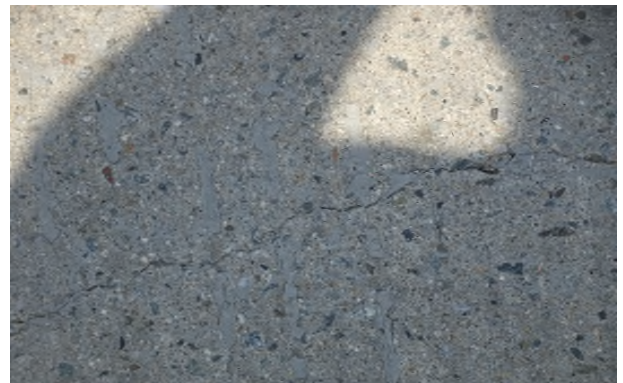
⑥ 균열 0.2mm / 69.0m

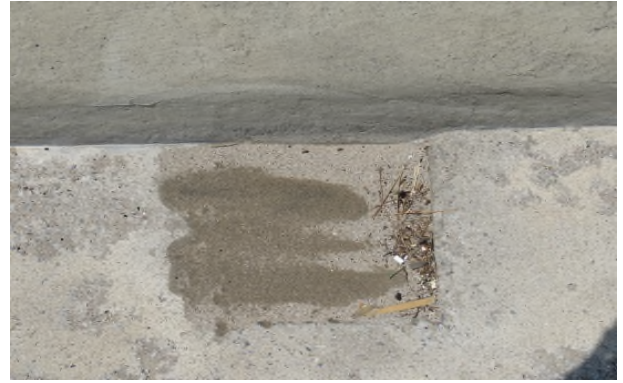
② 배수구 이물질퇴적 (1EA)

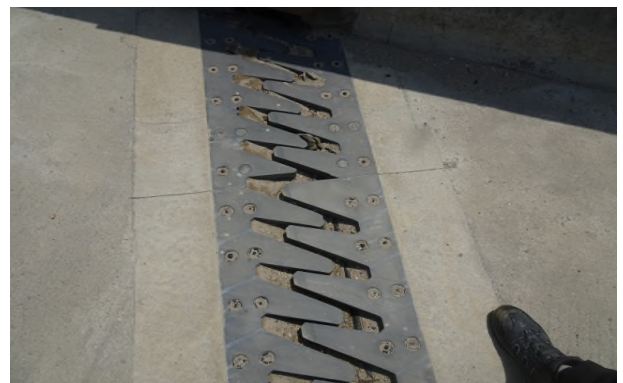
⑩ 신축이음 토사퇴적 0.2m x 1.0m

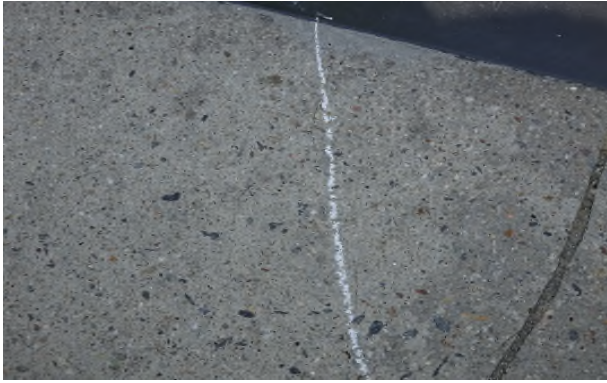
① 후타재균열 0.2mm / 0.3m (4EA)

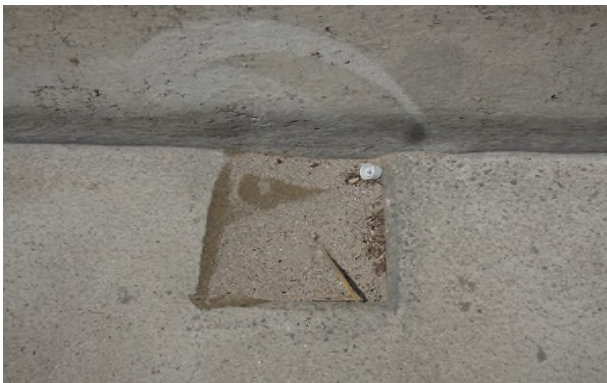
⑥ 배수구 이물질퇴적 (1EA)

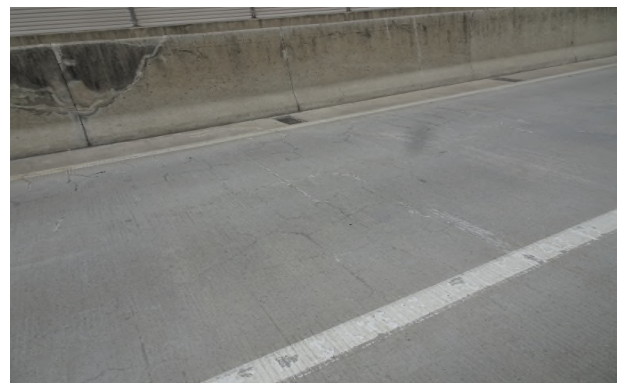
⑬ 망상균열 0.2mm / 4.0m x 2.0m (보수완료)

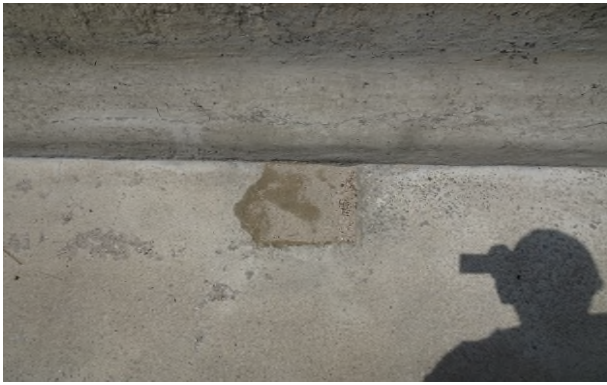
② 배수구 이물질퇴적 (3EA)

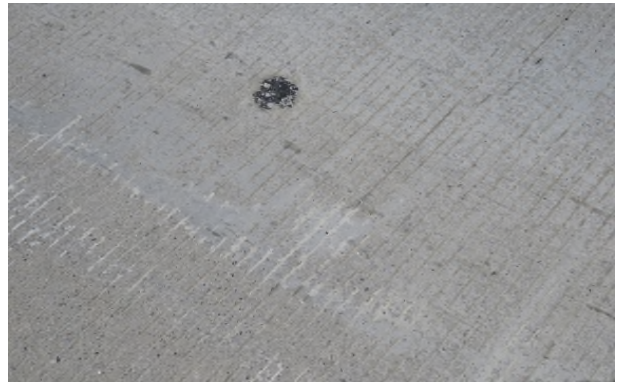
③ 요철 (1EA)

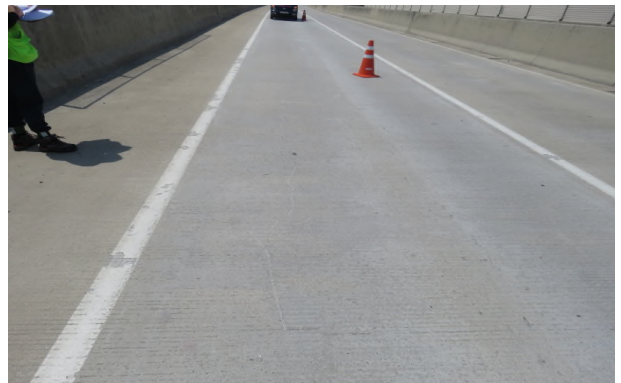
⑤ 망상균열 0.1mm / 4.0m x 2.0m

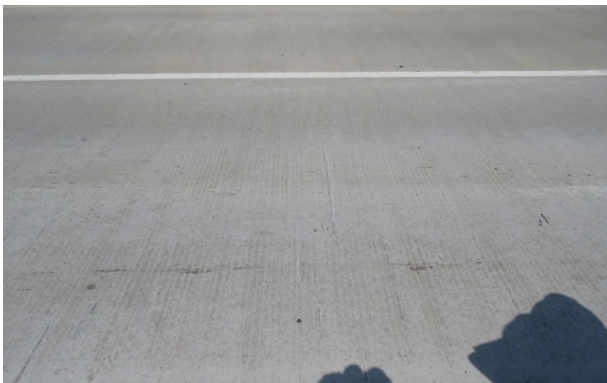
⑥ 균열 0.1mm / 1.2m (3EA)

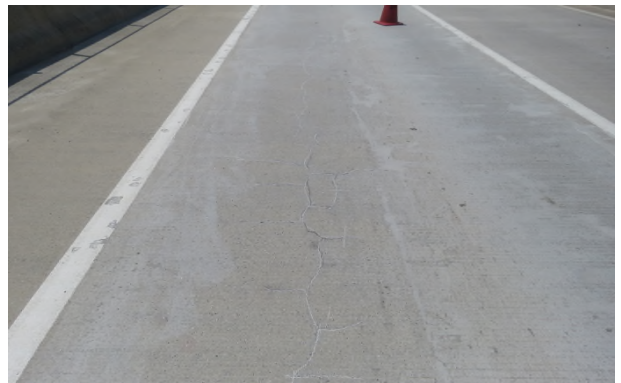
⑦ 망상균열 0.1mm / 5.0m x 2.0m

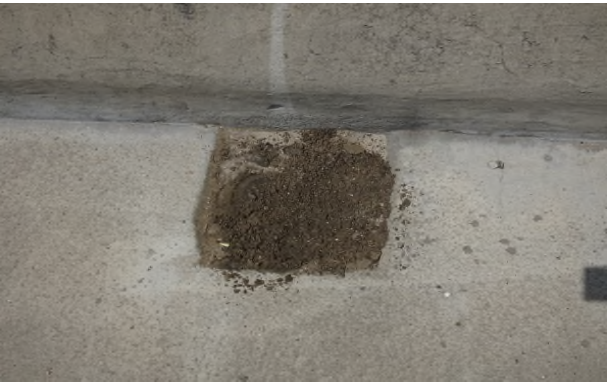
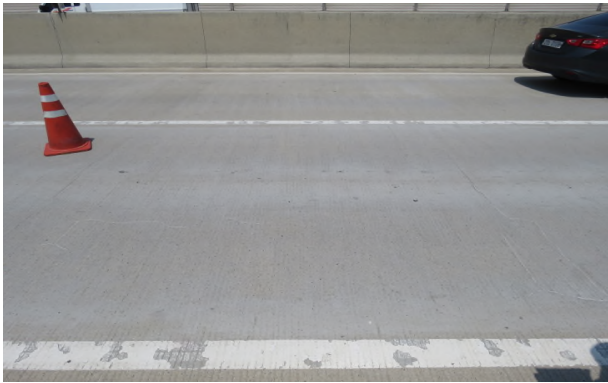
| ① 배수구 막힘 (1EA) | ② 망상균열 0.1mm / 8.0m x 30.0m |

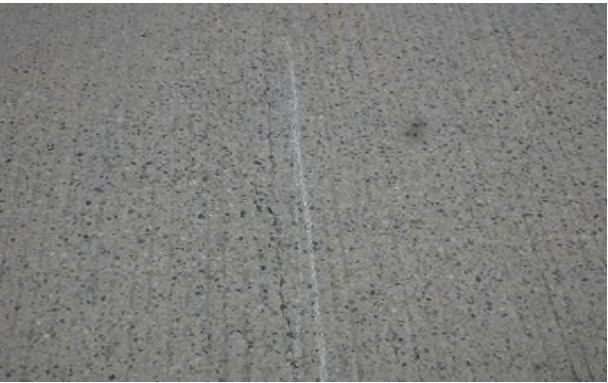
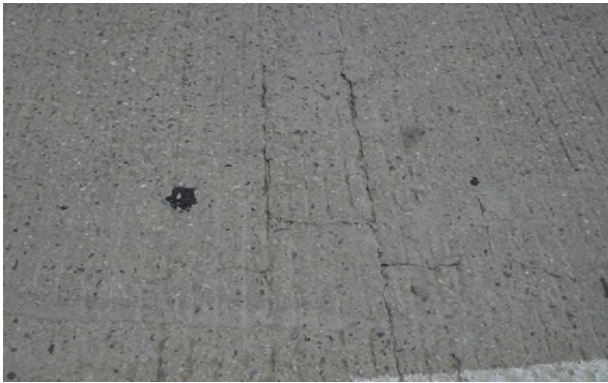
| ③ 균열 0.2mm / 1.0m | ④ 균열 0.2mm / 1.0m |

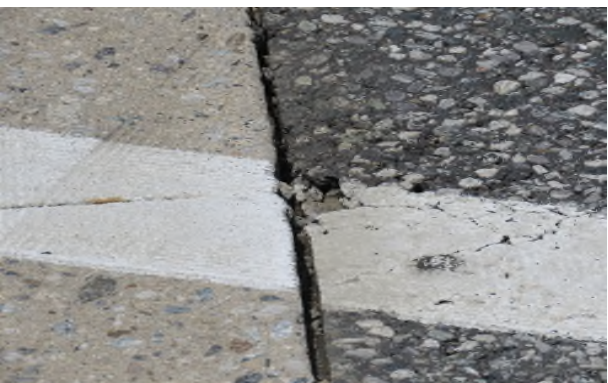
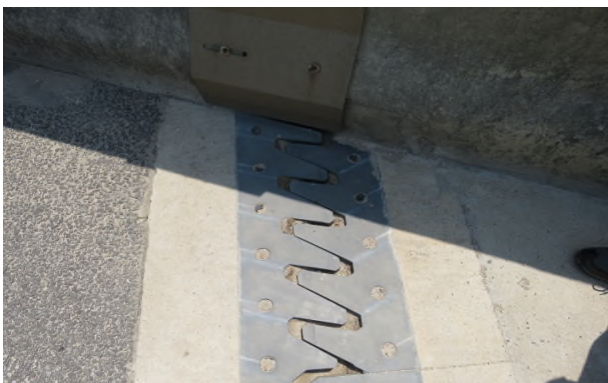
| ③ 파손 0.1m x 0.1m | ④ 신축이음 토사퇴적 L=3.0m |

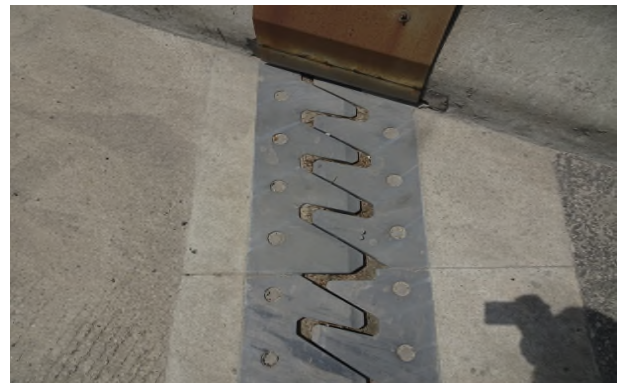
⑪ 신축이음 토사퇴적 0.1m x 0.5m

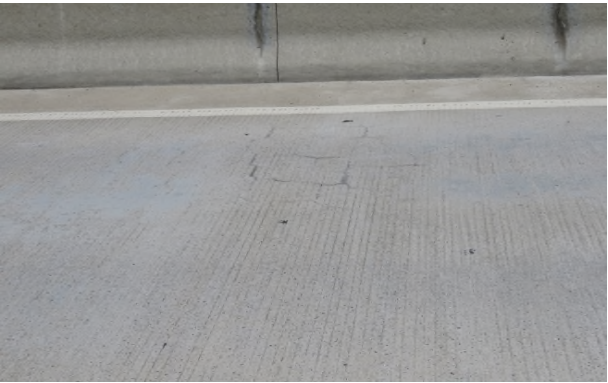
| <p>⑭ 망상균열 0.1mm / 5.5m x 14.0m</p> | |

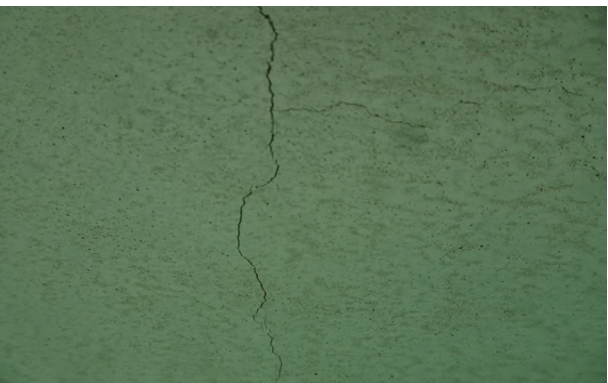
| <p>③ 균열 0.2mm / 0.3m (4EA)</p> | <p>④ 균열 0.2mm / 0.6m</p> |

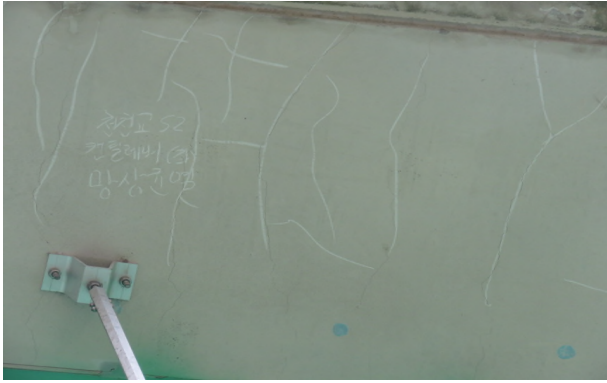
① 망상균열 0.1mm / 0.5m x 1.0m

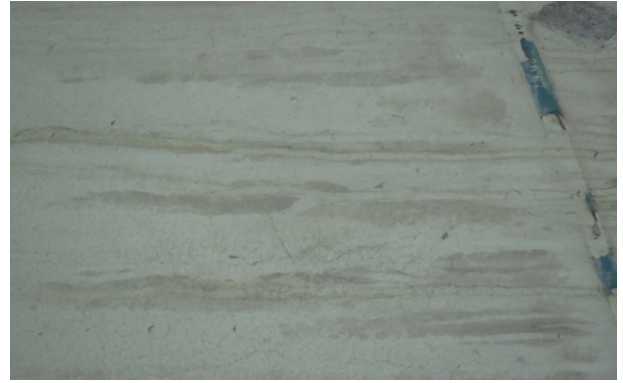
② 망상균열 0.1mm / 0.5m x 1.0m

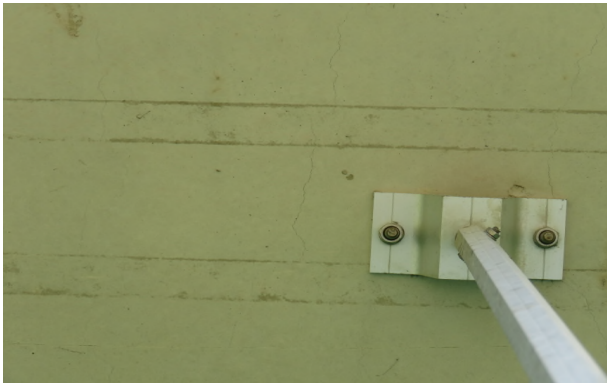
⑤ 균열 0.2mm / 0.8m (2EA)

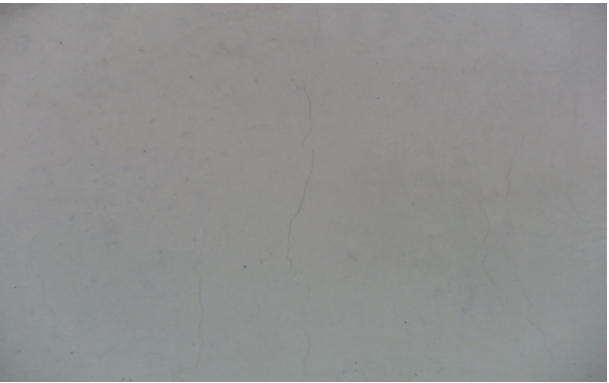
| ③ 균열 0.2mm / 0.5m (12EA) | ④ 균열 0.2mm / 0.6m (11EA) |

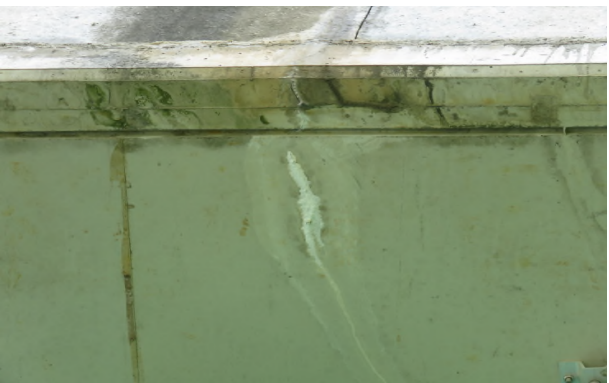
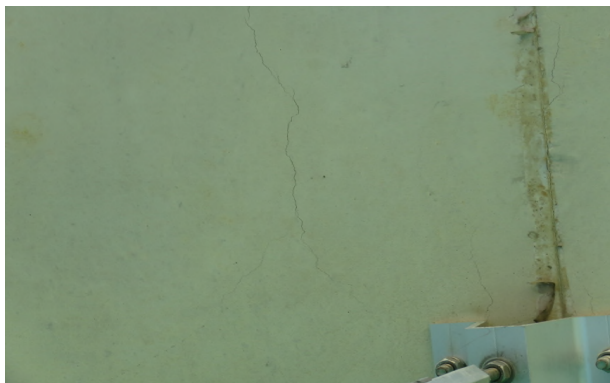
| ② 백태 0.1m x 0.1m (3EA) | ③ 균열 0.1mm / 0.6m (7EA) |

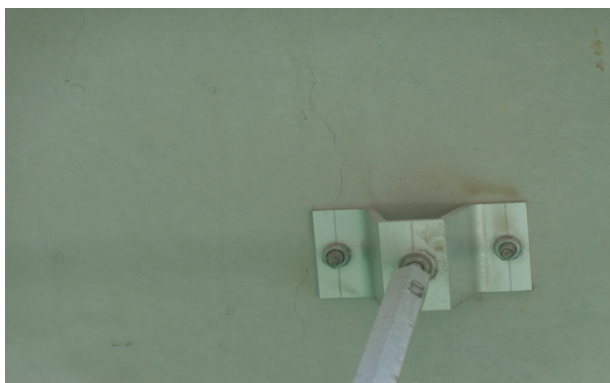
| ① 균열 0.1mm / 0.6m (8EA) | ② 균열 0.1mm / 0.6m (3EA) |

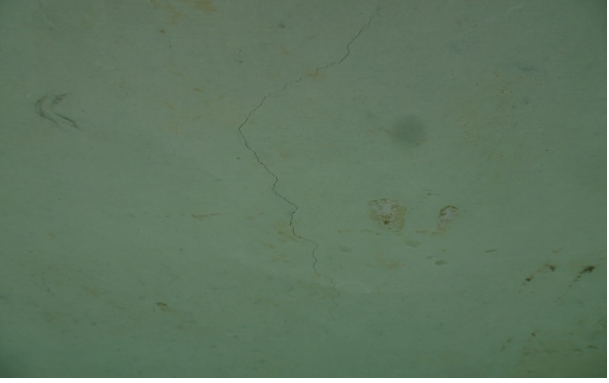
| ③ 균열 0.2mm / 0.5m (4EA) | |

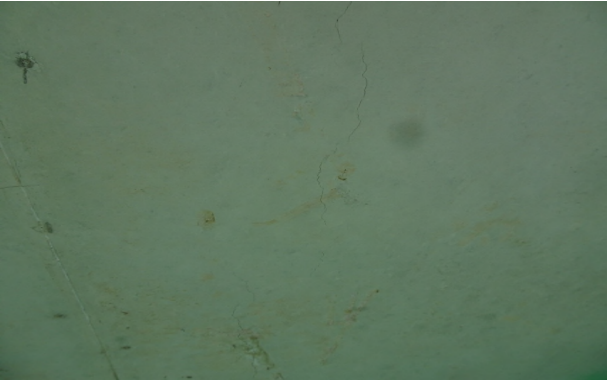
| ① 균열 0.2mm / 0.5m (4EA) | |

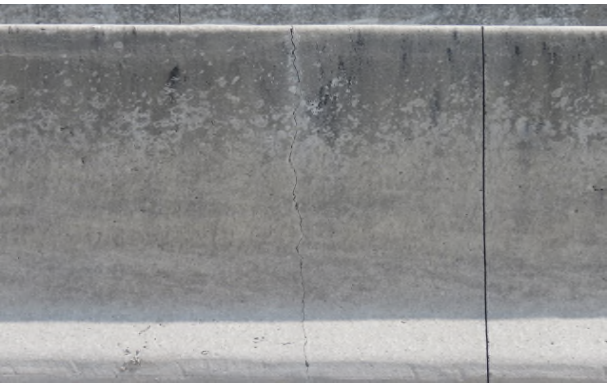
| ㉕ 균열 0.2mm / 1.0m (3EA) | ㉖ 차수판 볼트탈락 (3EA) |

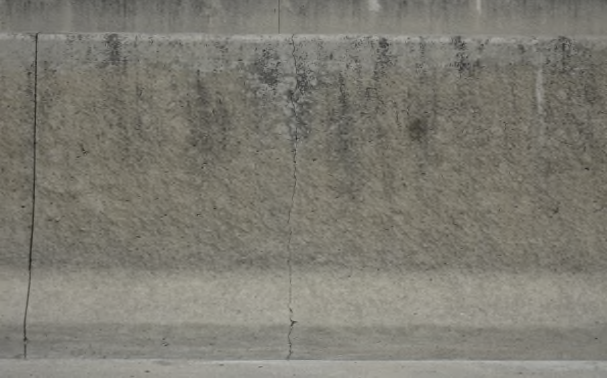
| <p>㉔ 균열 0.3mm / 1.2m (7EA)</p> | |

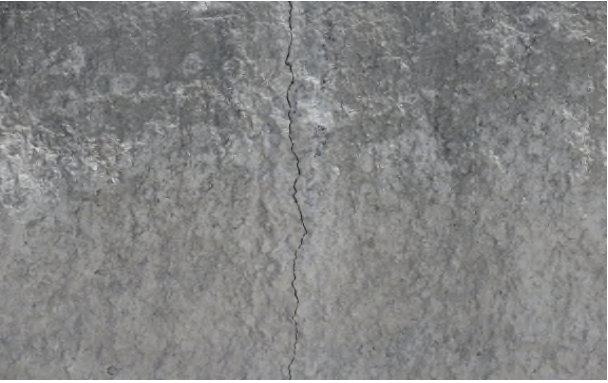
| <p>㉕ 균열 0.2mm / 1.5m</p> | <p>㉖ 균열 0.3mm / 1.5m</p> |

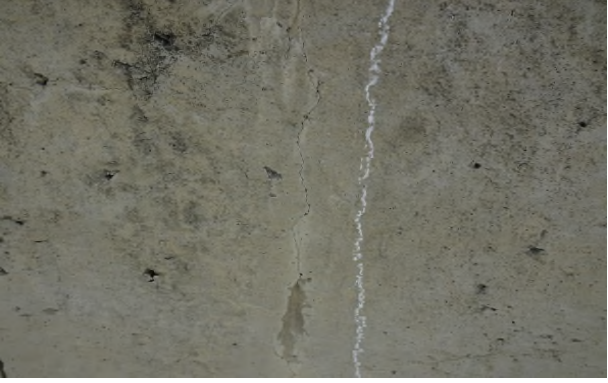
| ㉟ 균열 0.3mm / 1.5m | |

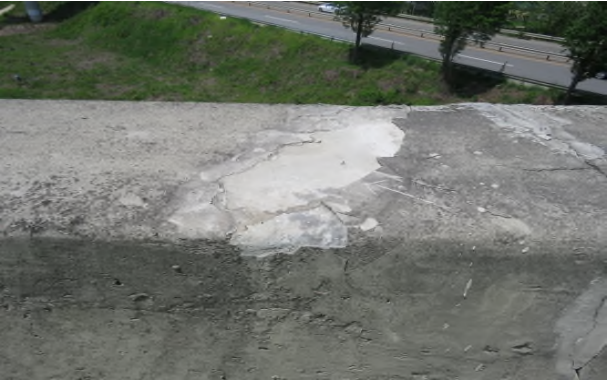
| ① 파손 0.1m x 0.3m (3EA) | ② 파손 0.1m x 0.1m |

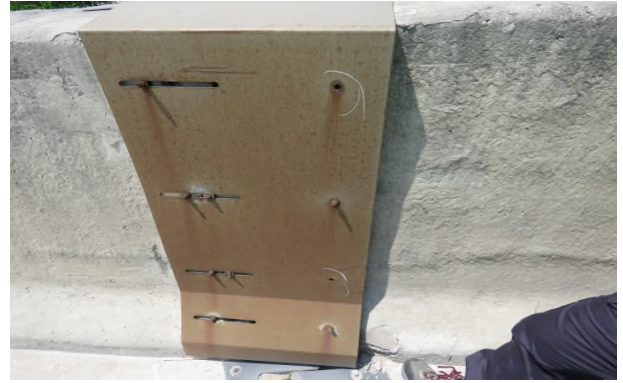
⑮ 차수판 볼트탈락 (2EA)

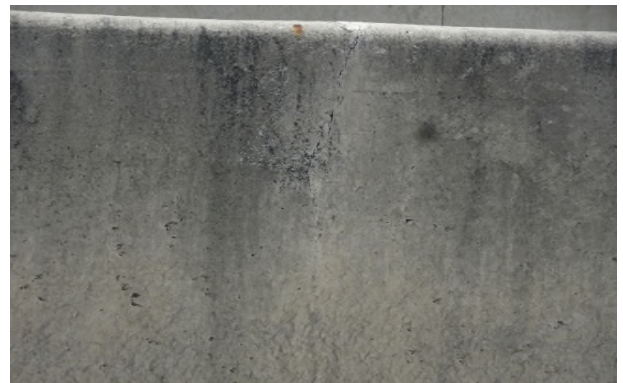
㉒ 균열 0.2mm / 1.2m

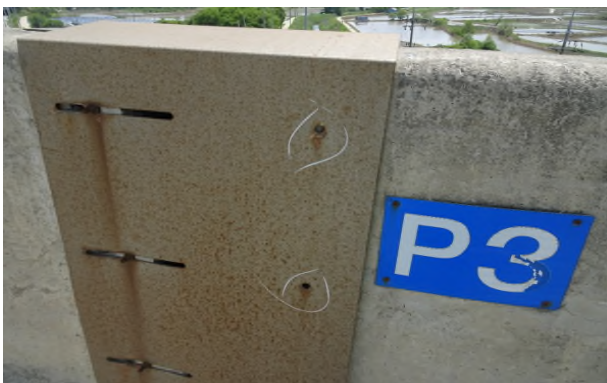
㉓ 차수판 볼트불량 (4EA)

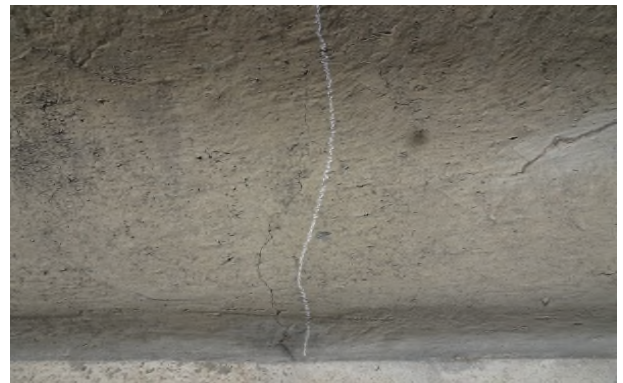
㉗ 균열 0.1mm / 0.5m

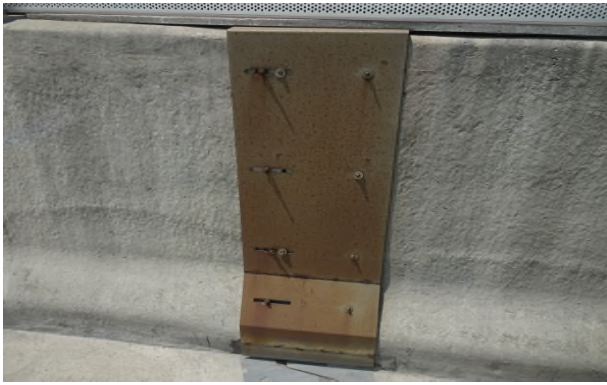
① 차수판 볼트 체결불량 (보수완료)

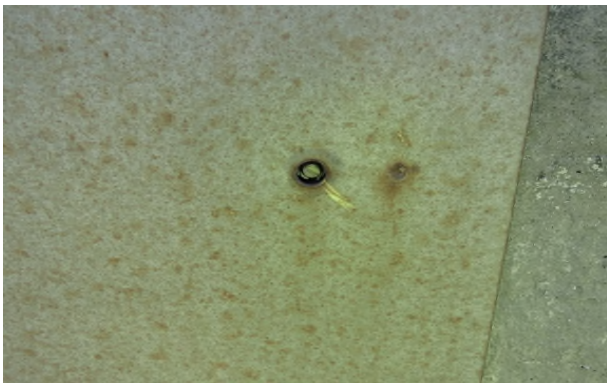
⑩ 차수판 볼트 체결불량 (3EA)

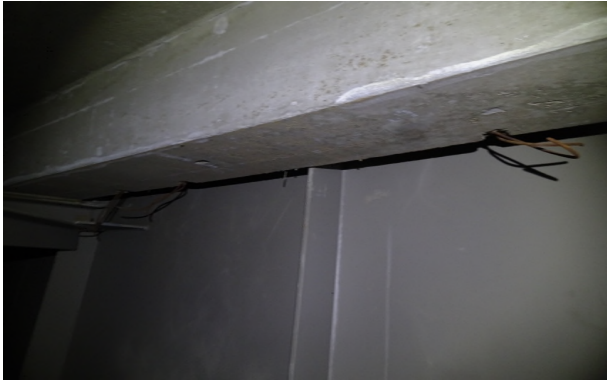
① 잡철물 미제거 (6EA)

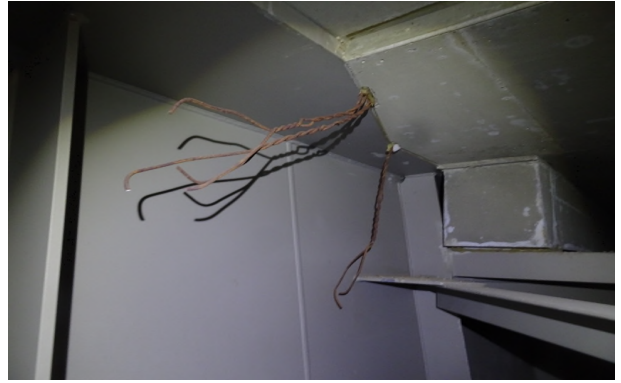
② 잡철물 미제거 (4EA)

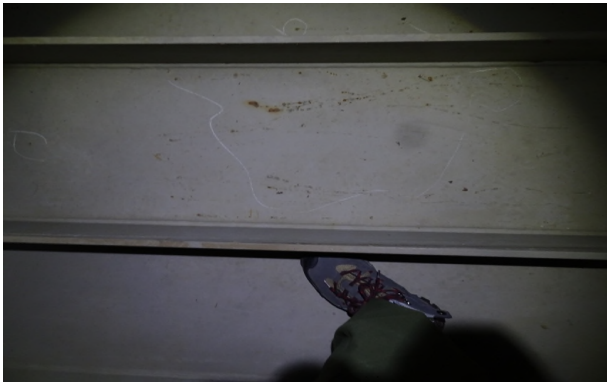
① 녹발생 0.3m x 0.6m

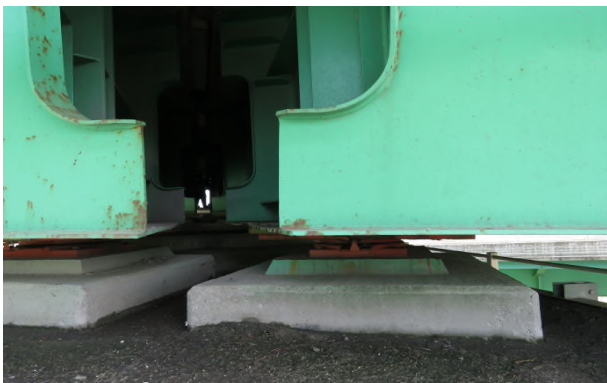
① 녹발생 0.1m x 0.3m

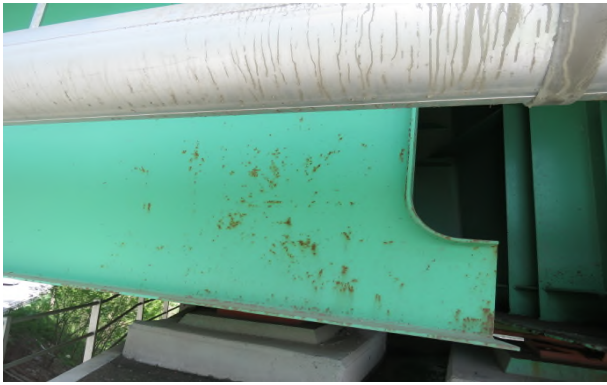
① 부식 0.5m x 1.0m

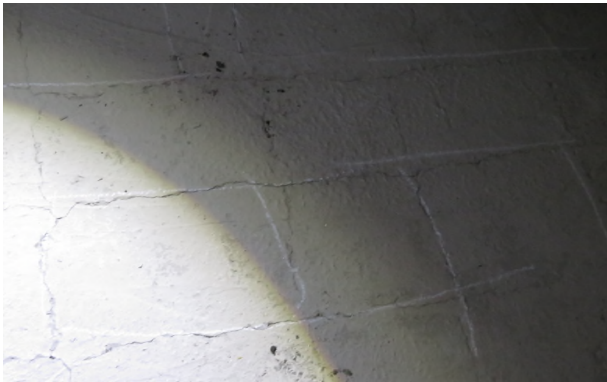
① 망상균열 0.2mm / 1.5m x 2.0m

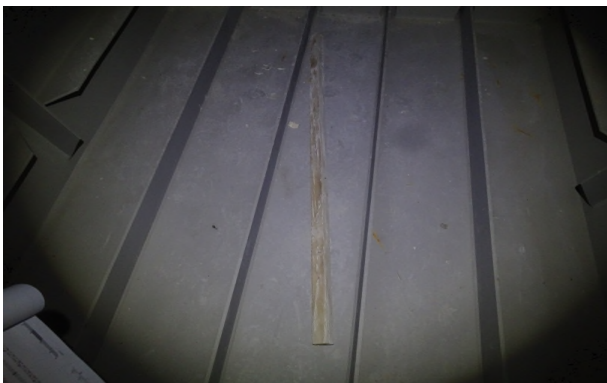
① 폐기물적치 (1EA)

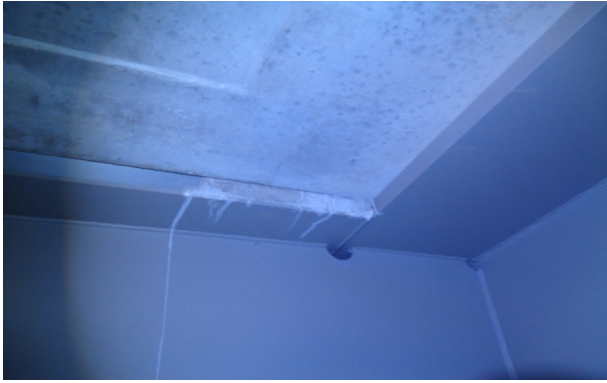
㉠ 박락 0.1m x 0.4m

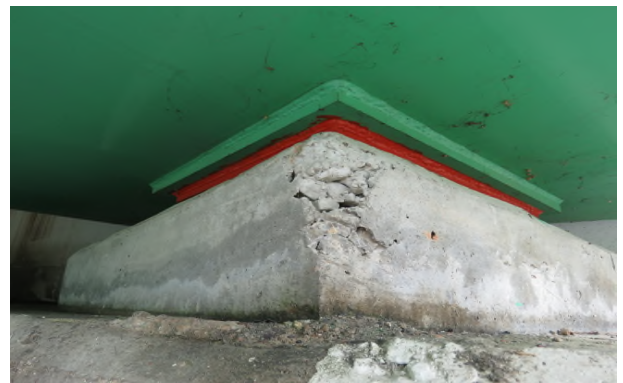
㉣ 받침콘크리트 재료분리 0.1m x 0.2m

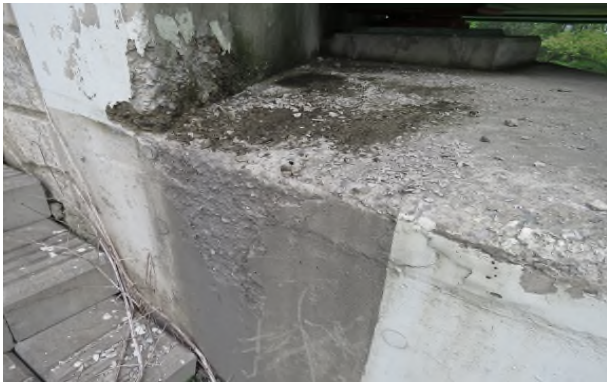
㉔ 열화 0.5m x 1.0m

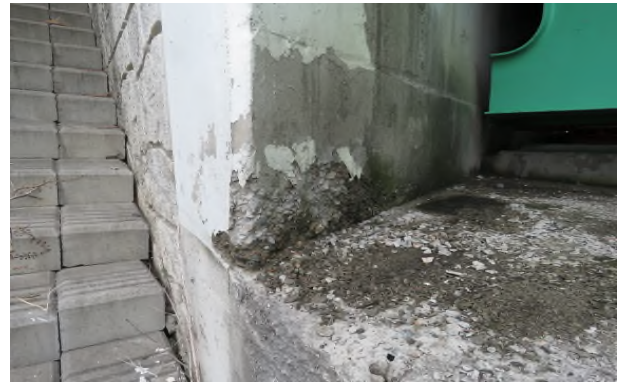
㉕ 재료분리 0.3m x 0.5m

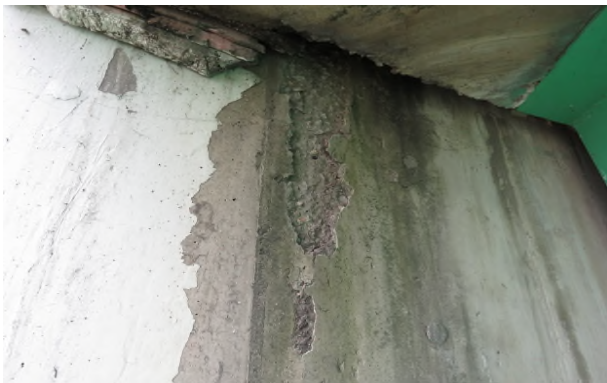
㉖ 열화 0.2m x 1.0m

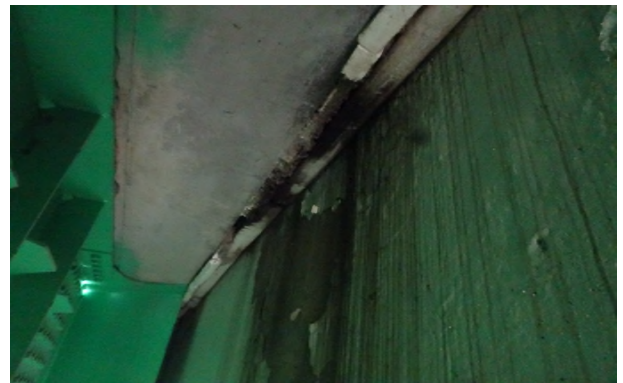
㉗ 누수흔적 0.2m x 1.0 (2EA)

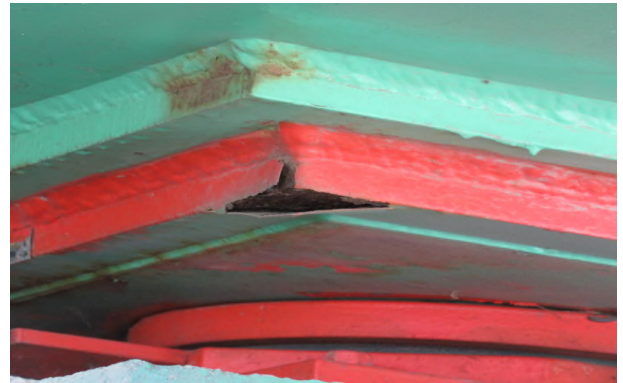
㉙ 플레이트부식 0.1m x 0.1m

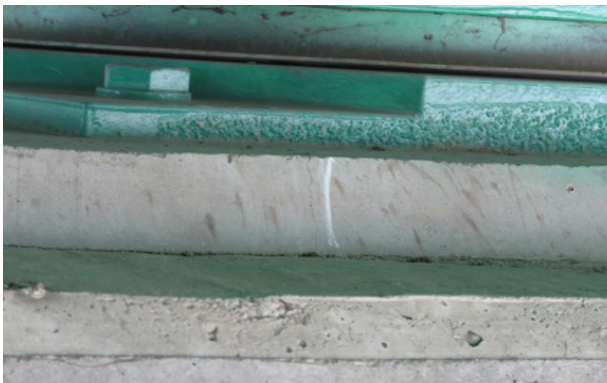
⑮ 무수축물탈균열 0.1mm / 0.1m (3EA)

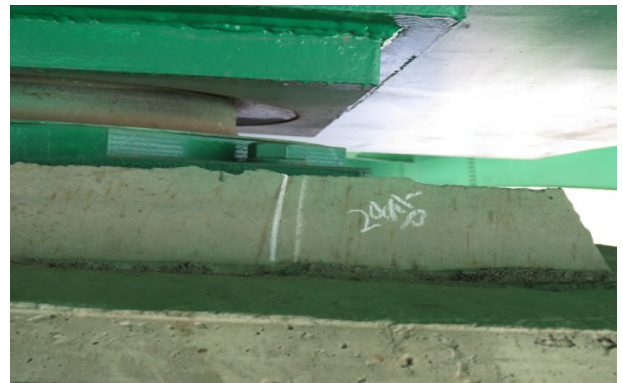
⑯ 무수축물탈균열 0.1mm / 0.1m (2EA)

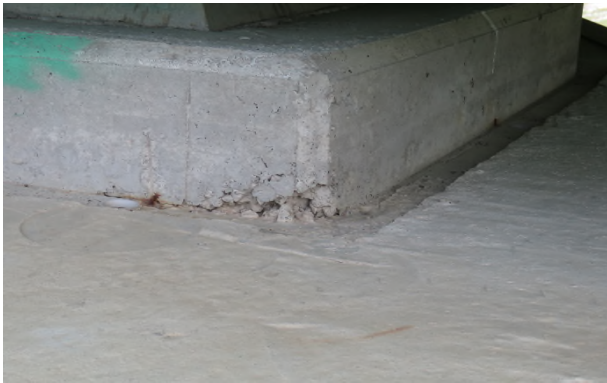
⑰ 받침콘크리트재료분리 0.1m x 0.1m (보수완료)

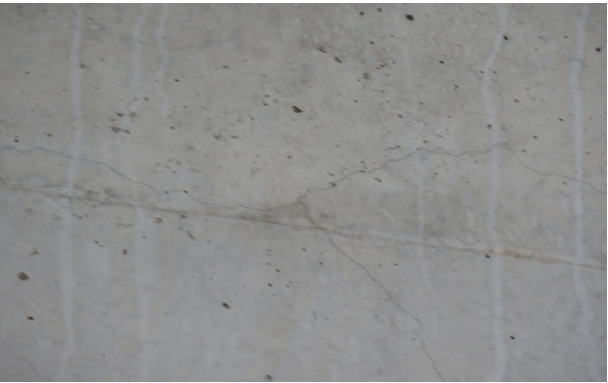
| ㉑ 균열 0.2mm / 3.0m | ㉒ 망상균열 0.1mm / 1.0m x 1.0m |

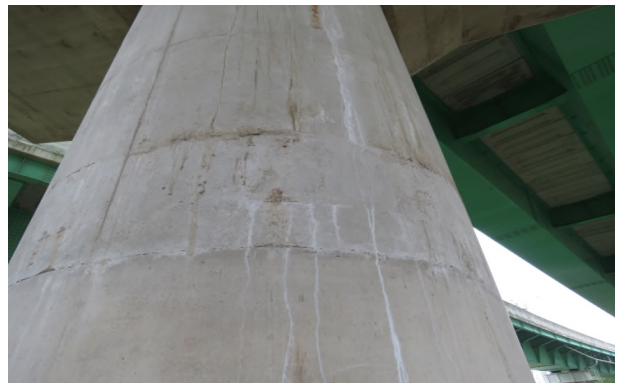
㉖ 백태 0.1m x 5.0m

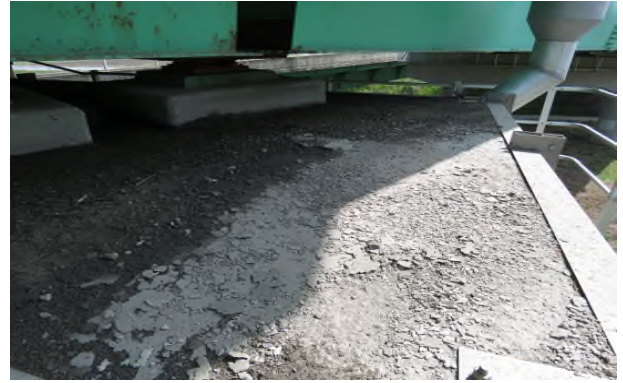
⑧ 열화 4.0m x 2.0m

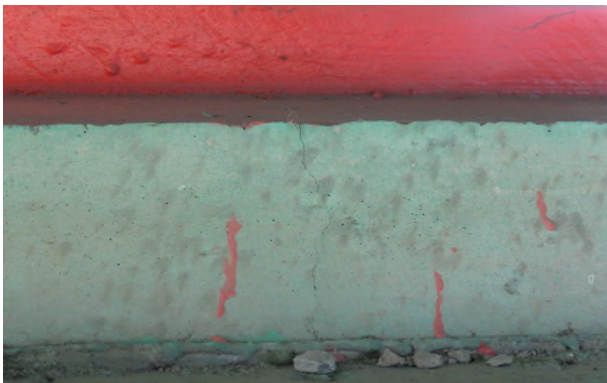
⑨ 무수축물탈균열 0.1mm / 0.1m

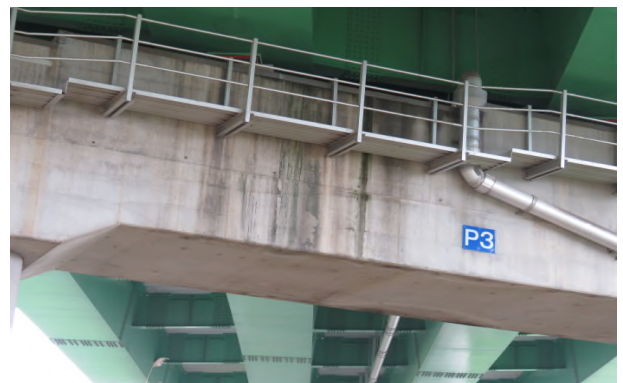
⑭ 누수흔적 1.5m x 2.5m

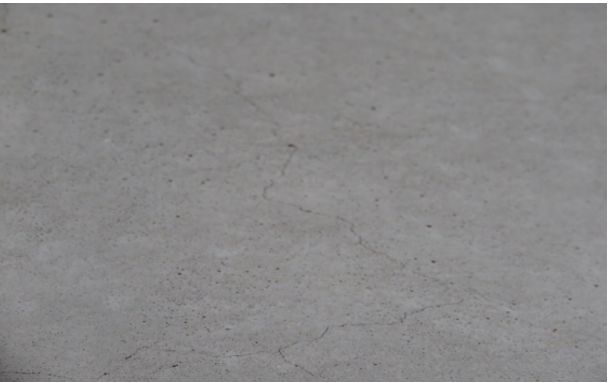
| ⑮ 균열 0.1mm / 0.5m (3EA) | ⑯ 균열 0.2mm / 1.0m (3EA) |

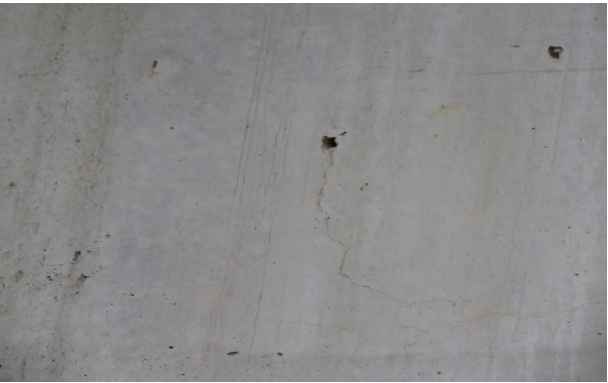
| ⑰ 균열 0.2mm / 1.5m | ⑱ 균열 0.1mm / 4.0m |

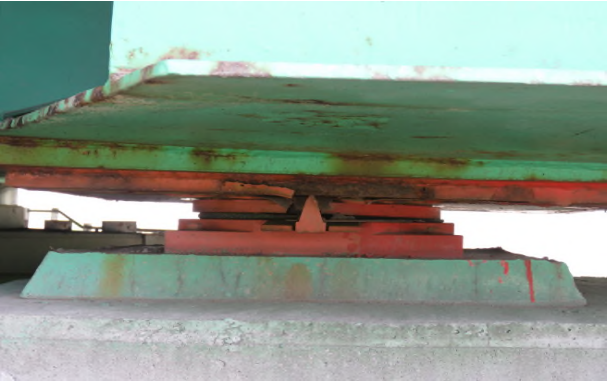
| ⑲ 플레이트부식 0.1m x 0.3m (2EA) | |

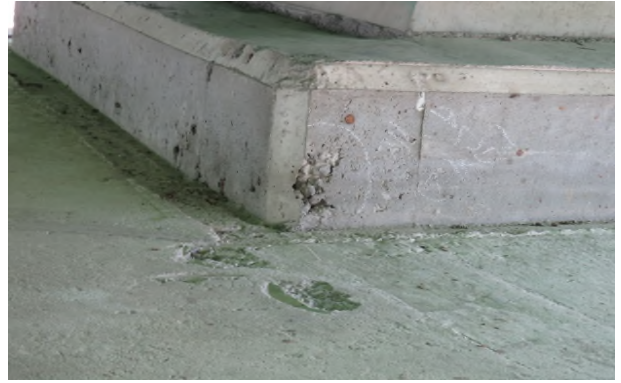
③ 받침콘크리트 재료분리 0.1m x 0.1m

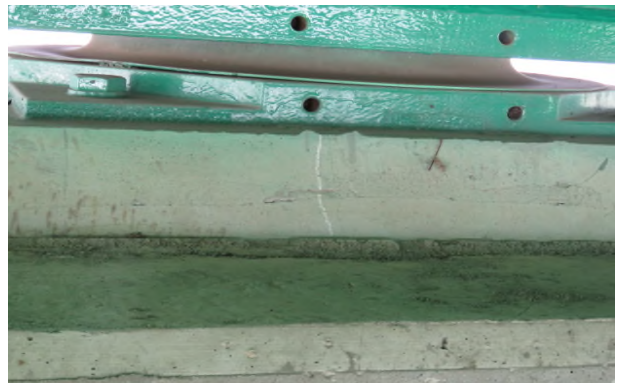
⑤ 무수축물탈균열 0.1mm / 0.2m (2EA)

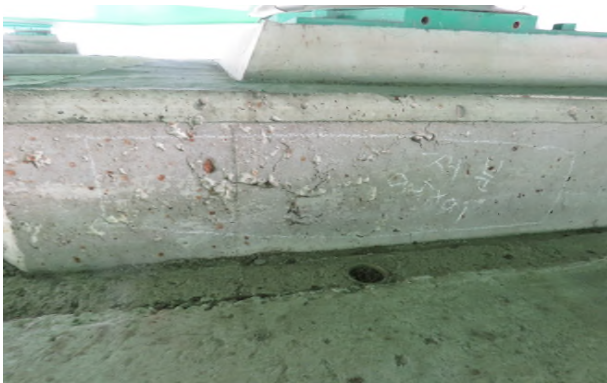
⑥ 받침콘크리트 재료분리 0.1m 4.0m

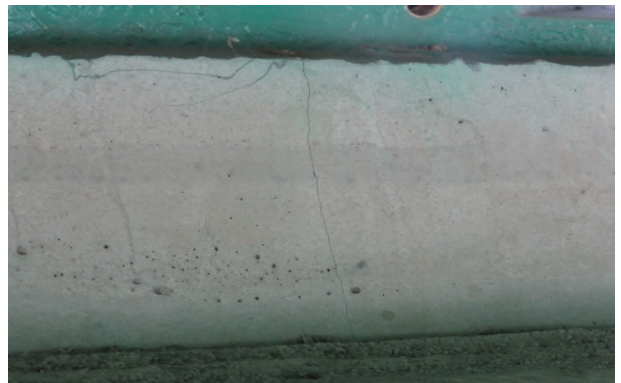
⑦ 무수축물탈균열 0.1mm / 0.2m

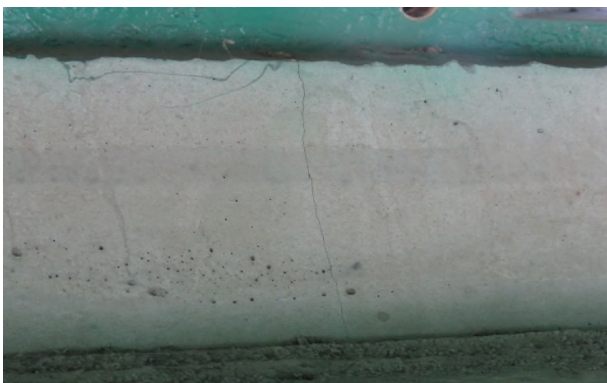
⑧ 무수축물탈균열 0.1mm / 0.1m

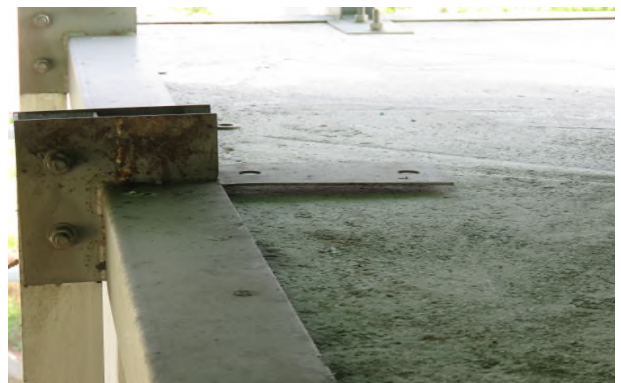
⑨ 점검로 고정볼트 없음 (2EA)

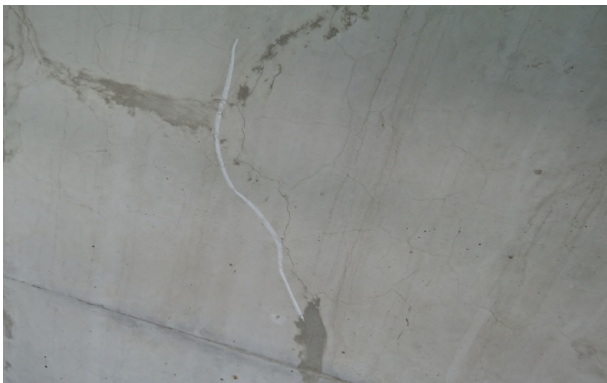
⑫ 망상균열 0.1mm / 3.0m x 0.5m

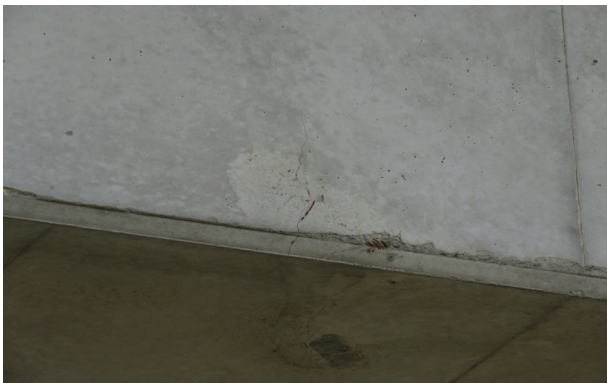
⑯ 균열 0.2mm / 1.5m (2EA)

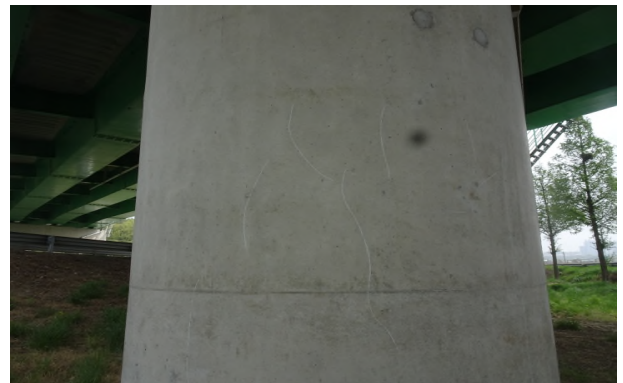
⑰ 망상균열 0.1mm / 2.0m x 3.5m (3EA)

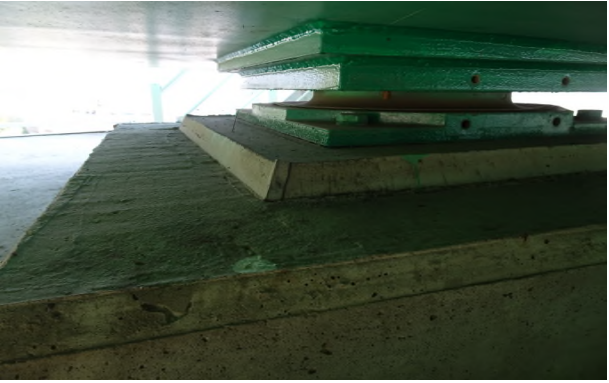
| <p>⑭ 받침콘크리트 재료분리 0.1m x 0.1m (2EA)</p> | <p>⑮ 균열 0.2mm / 1.0m</p> |

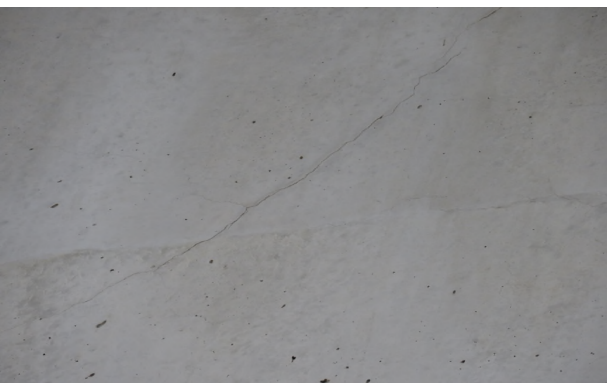
| <p>⑯ 균열 0.2mm / 1.0m</p> | <p>⑰ 균열 0.2mm / 4.0m</p> |

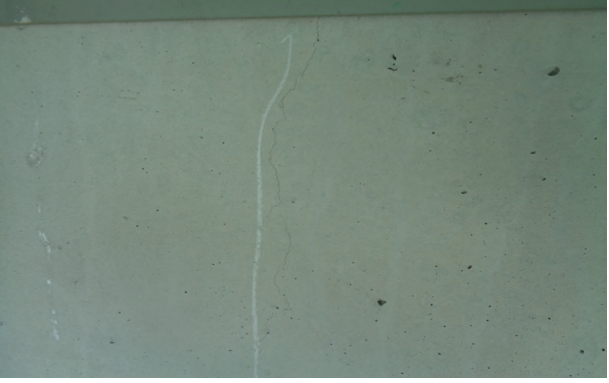
| ⑮ 균열 0.2mm / 0.5m (5EA) | ⑰ 균열 0.2mm / 2.0m |

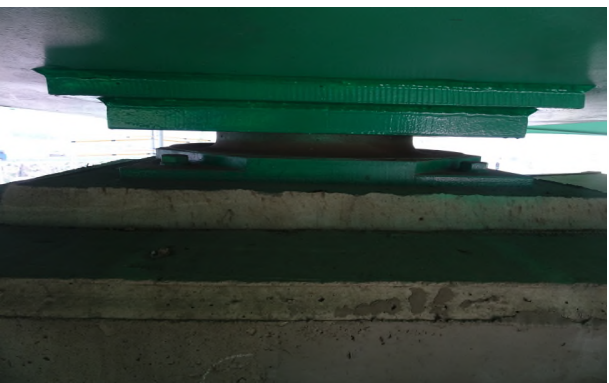
| ⑥ 무수축물탈파손 0.1m x 0.1m | ⑧ 무수축물탈균열 0.1mm / 0.1m |

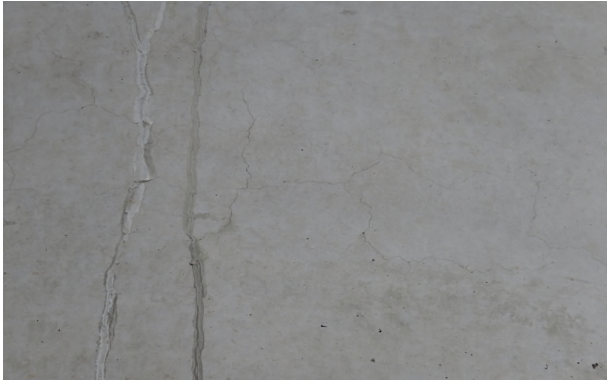
⑲ 망상균열 0.2mm / 1.5m x 1.0m

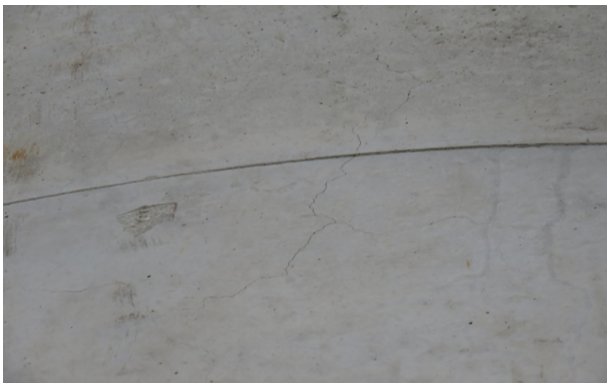
㉓ 망상균열 0.1mm / 1.0m x 1.0m

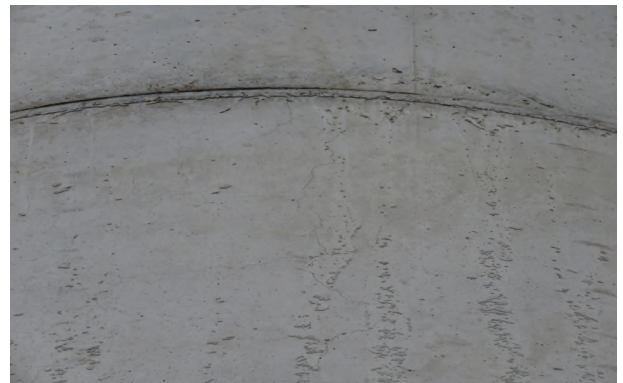
㉔ 균열 0.2mm / 2.0m (2EA)

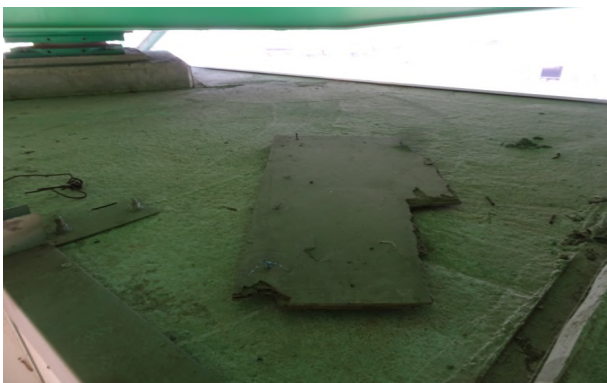
㉕ 폐기물적치 (1EA)

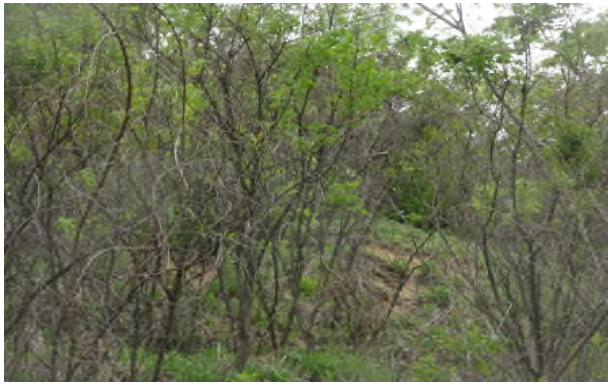
⑩ 식생불량 1EA

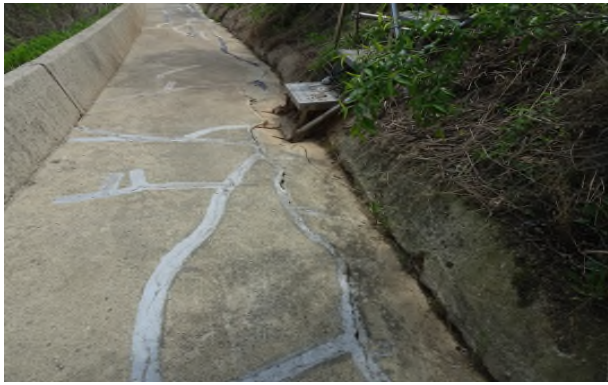
⑪ 침하균열  $cw=4.0\text{mm}$  /  $4.0\text{m}$

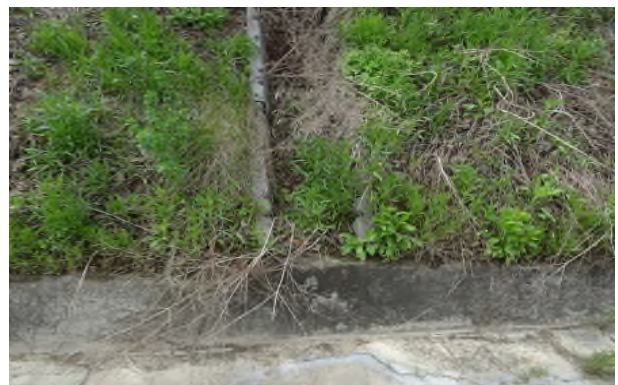
⑨ 낙엽퇴적 1.0m x 2.0m

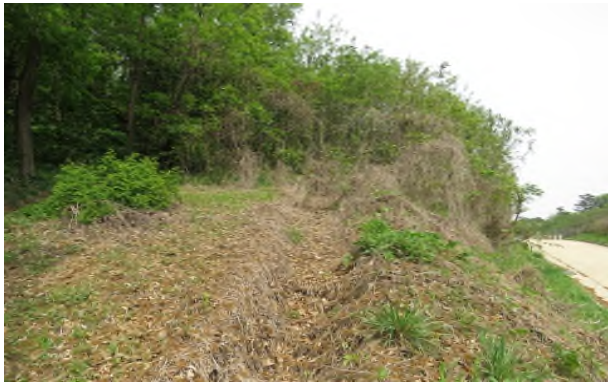
절토사면STA.4+140~4+455(좌)

⑫ 낙엽퇴적 2.0m x 5.0m

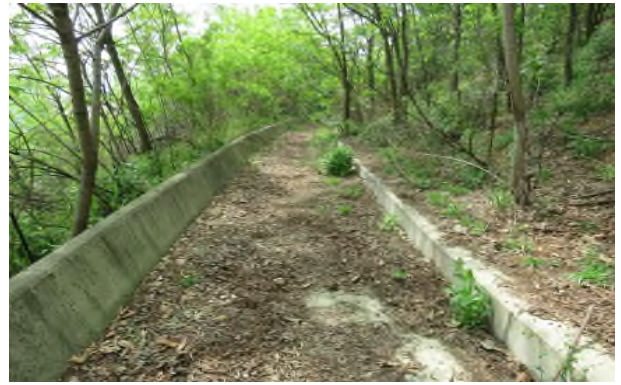
⑬ 낙엽퇴적 2.0m x 6.0m

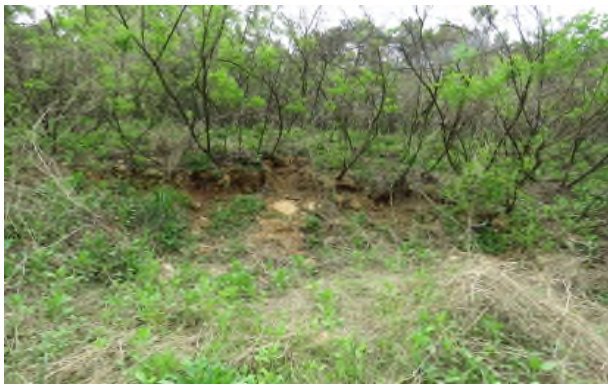
절토사면STA.4+931~5+160(우)

⑤ 표층유실 3.0m x 1.0m

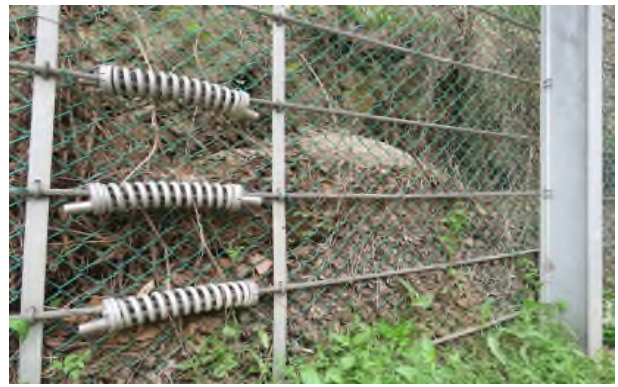
⑥ 토사퇴적 3.0m x 1.0m
