# 화성1송수관로 [2구간]

## 1. 관로 매설환경조사

## 2. 밸브.밸브실 조사

### 3. 관로 부식환경조사

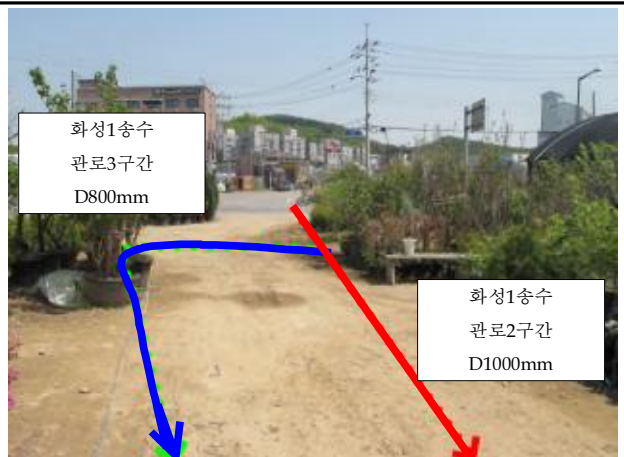
남강계통, 03(02)구간, Sta. No. 1+0.00(역방향)  
관로노선 현황
