## 9. 서문9교(서울방향)

## 손상현황 사진

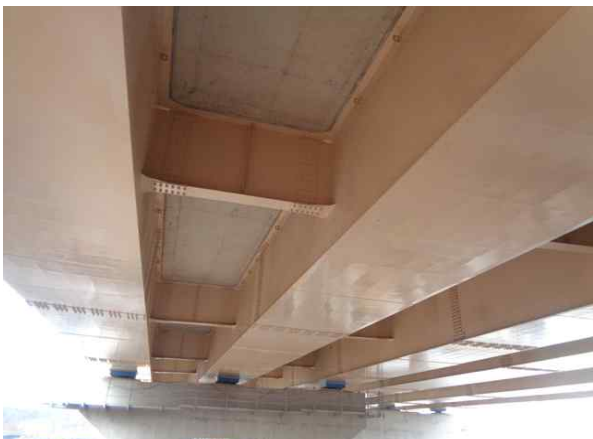
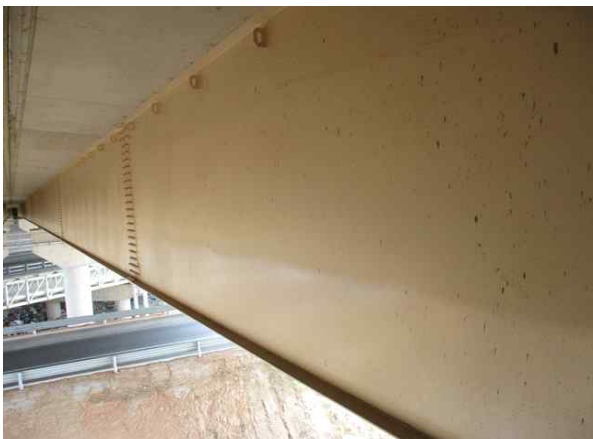
| 거더외부 상태양호 | 거더외부 상태양호 |

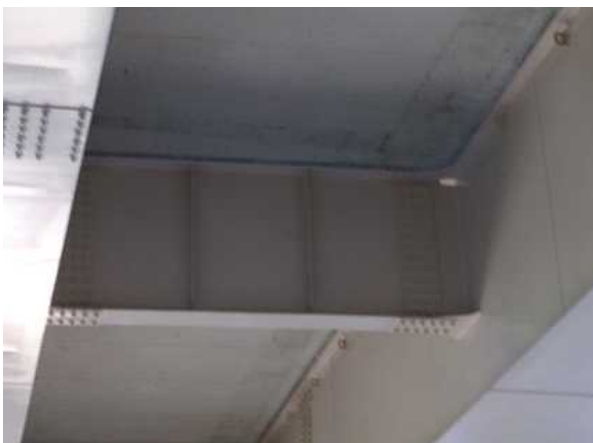
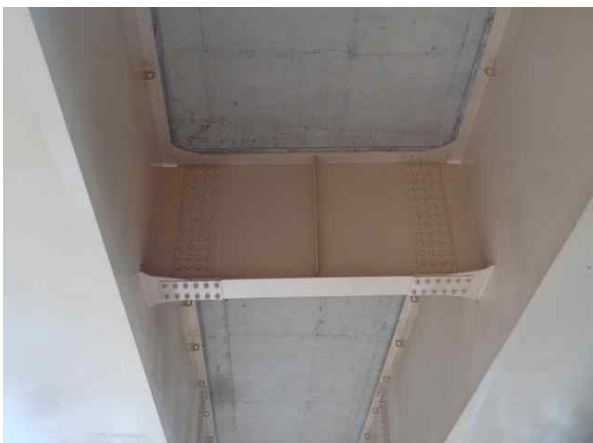
| 가로보 상태양호 | 가로보 상태양호 |

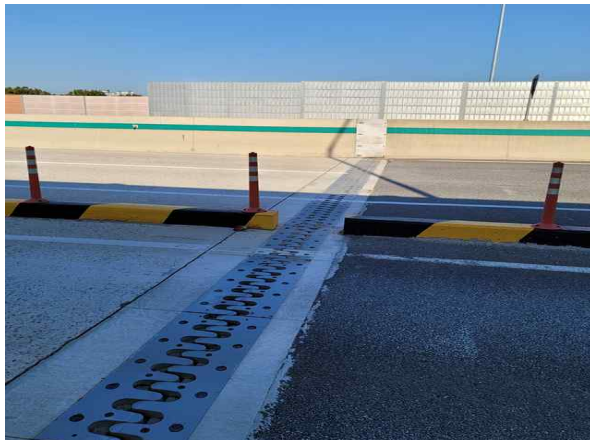
S7 접속부 이격(12.0m)

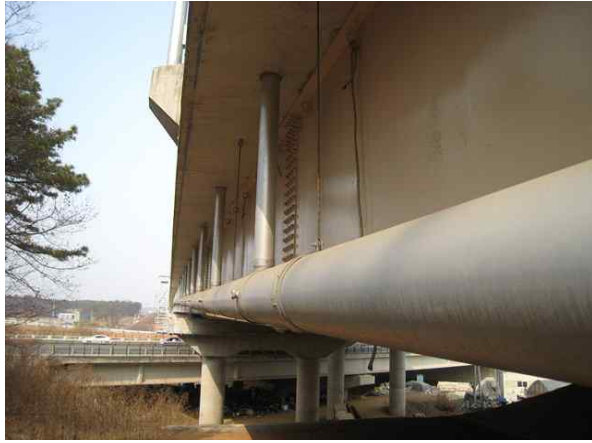
배수구 상태 양호 - 22년 상반기

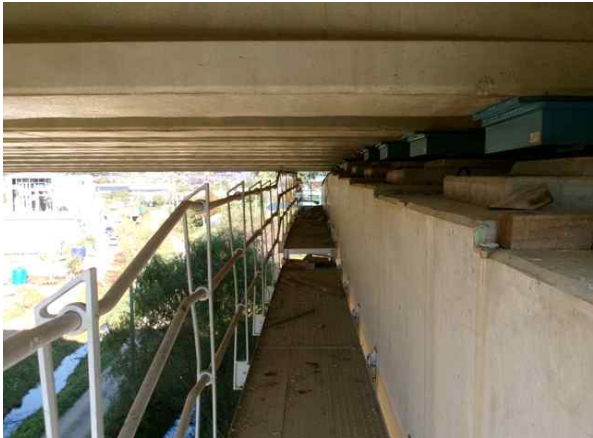
| P4 점검로 폐자재 적치 (15.0m×1.0m) | - |
