# 외 관 조 사 망 도

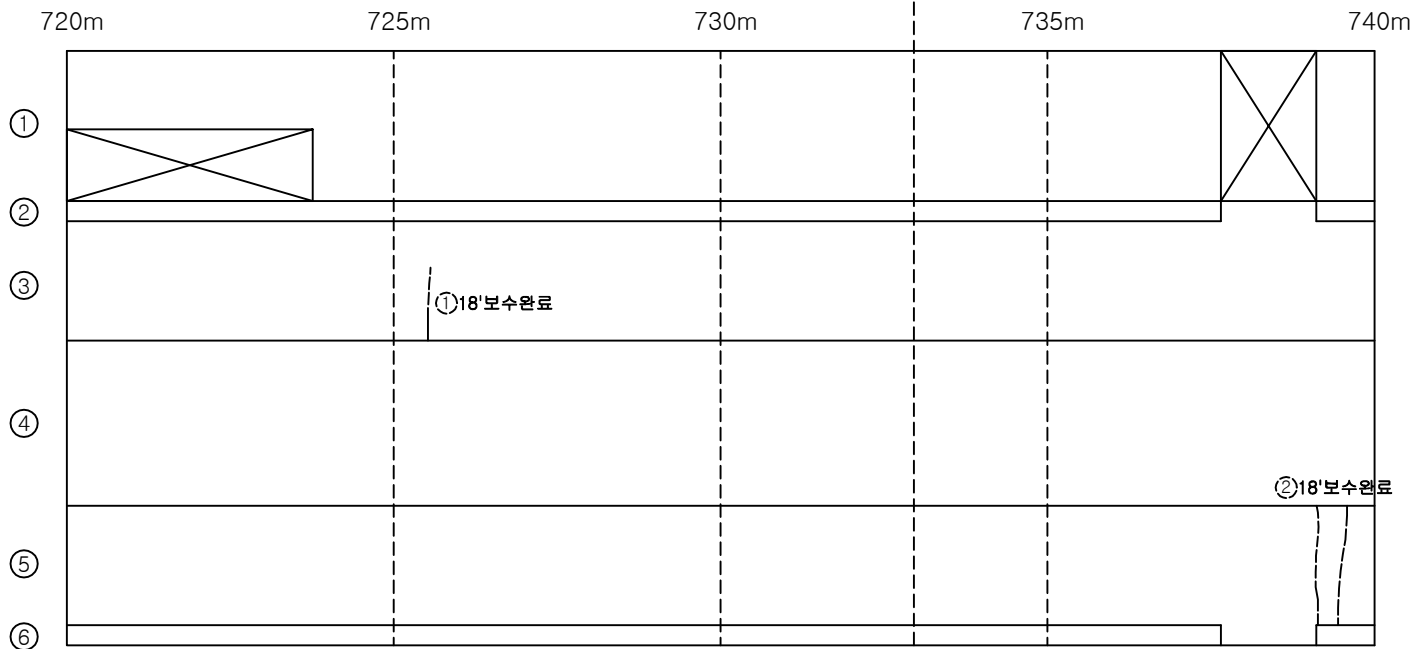
EX. J #26

\*폼타이를 파손 A=0.05mx0.05m(전구간)

②18'보수완료
