## 1. 도곡2교

## 손상현황 사진

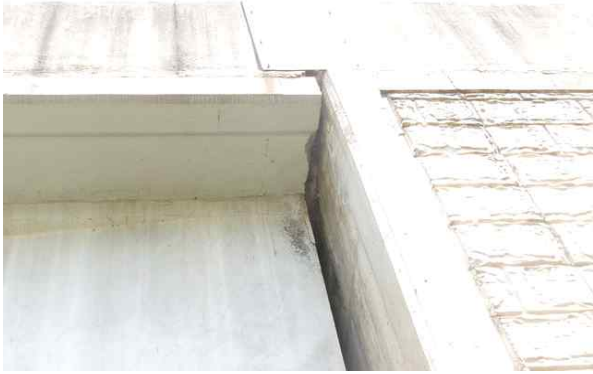
| S1 파손(0.4×0.1) | S2 망상균열(0.4×2.0) |

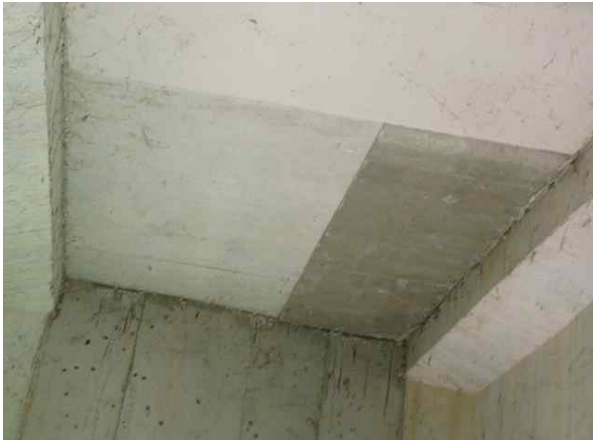
| S2 망상균열(0.4×2.0) | S2 망상균열(1.5×2.5) |

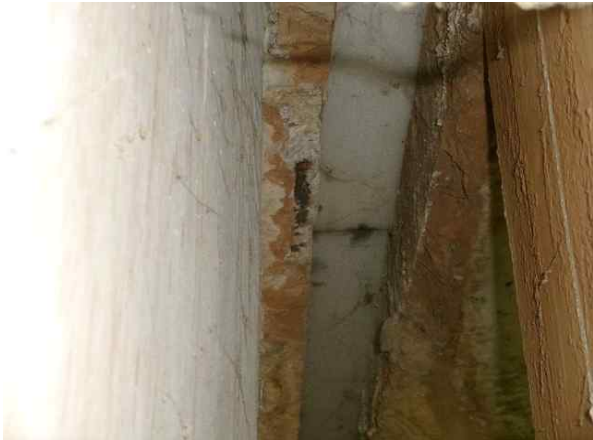
| S3 파손 및 철근노출(0.3×1.0) | S3 파손(0.4×1.0) |

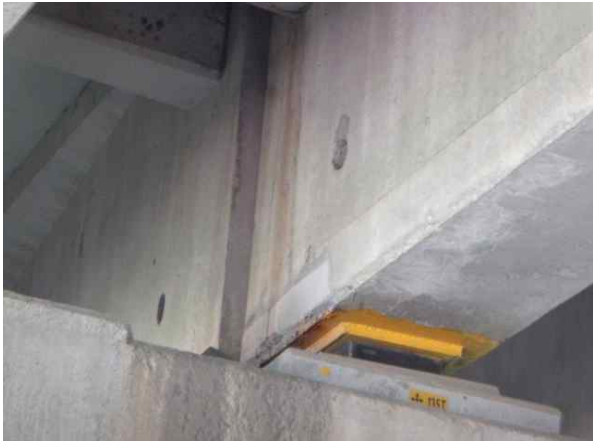
| S2-G7 보수부 박락(0.1×0.2) | S2-G8 보수부 박락(0.2×0.2) |

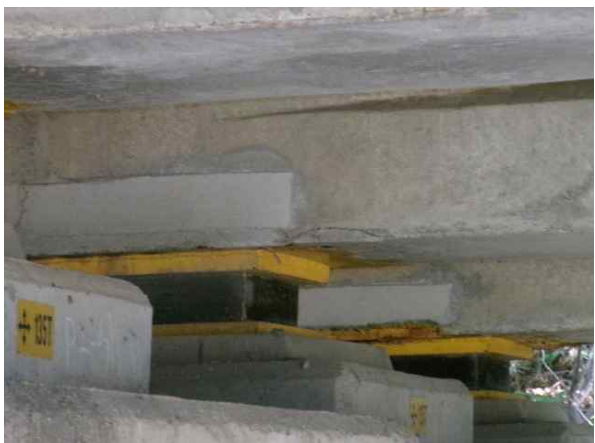
| <p>S2-G8 보수부 박락(0.2×0.2)</p> | <p>S3-G1 인양홀 파손(0.1×0.1)</p> |

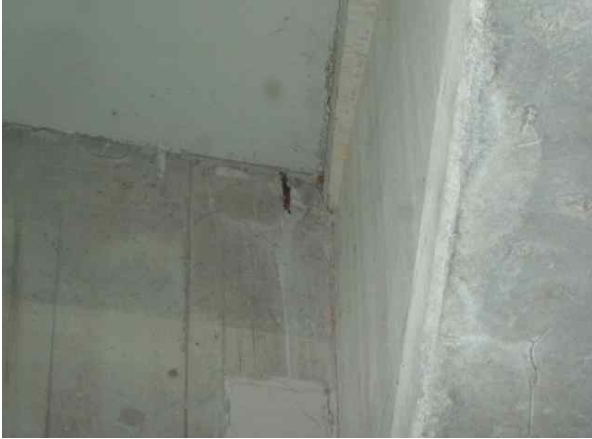
| S2 박락 및 철근노출(0.2×0.3) | S3 균열(0.2mm/0.2m) |

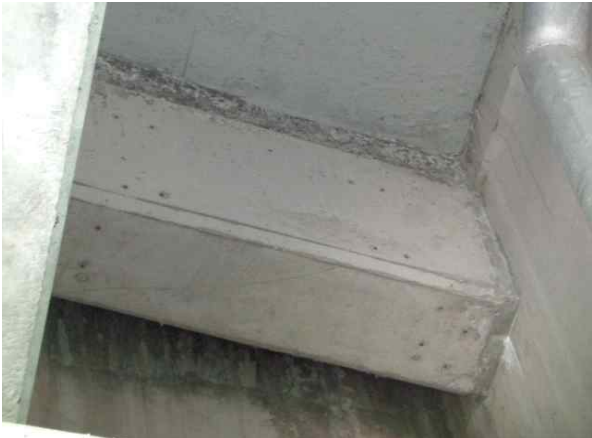
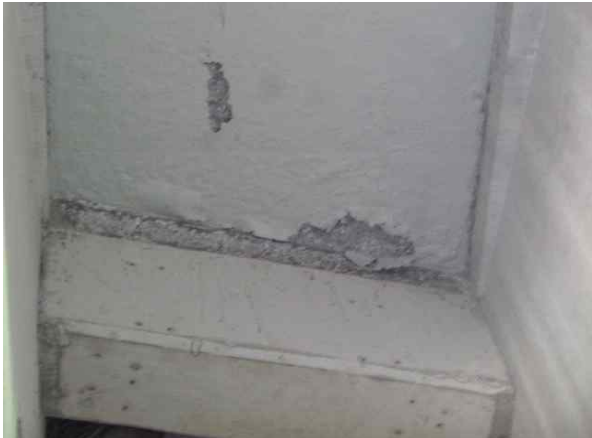
| S7 백태(1.5×0.1) | S7 백태(1.5×0.1) |

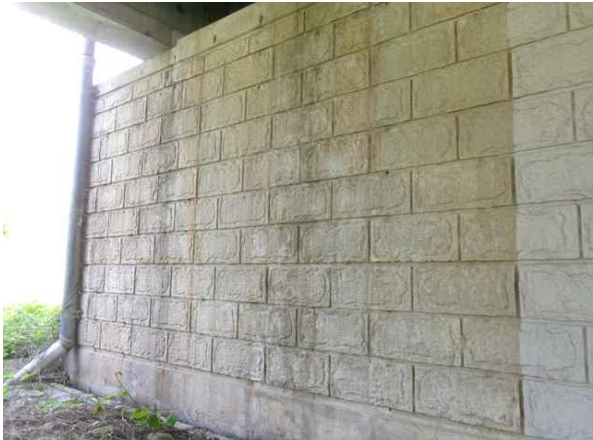
| A1 누수흔적 (0.5×2.2) | A1 백태 (0.3×2.5) |

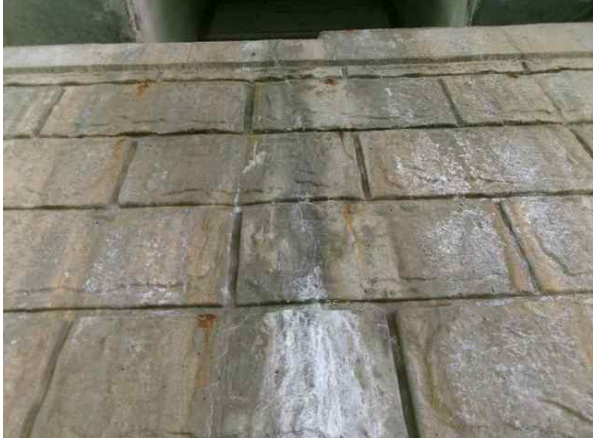
| A1 재균열 (0.3mm/3.5m) | A1 재균열 (0.3mm/0.5m) |

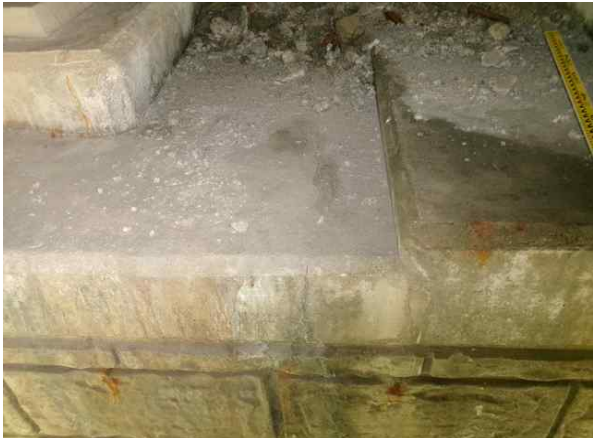
| A1 균열 (0.5mm/0.8m) | A1 누수흔적 (0.5×2.0) |

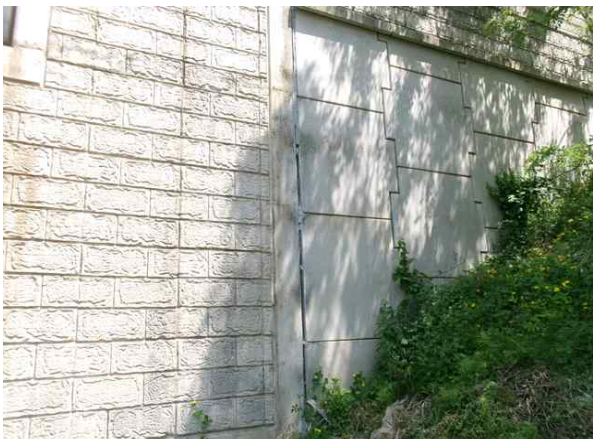
| A1 실런트 탈락 (4.0) | A1 실런트 탈락 (2.0) |

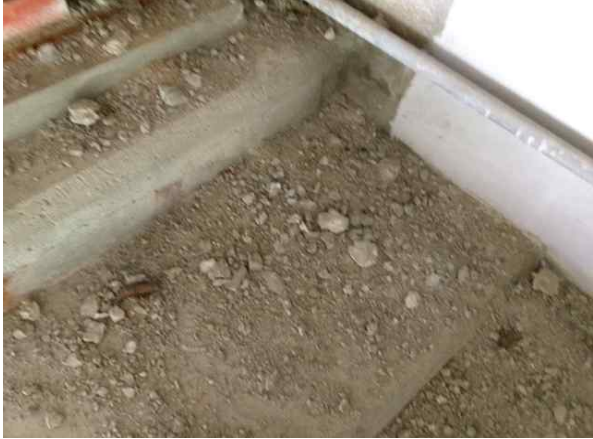
| A1 폐콘크리트 퇴적(1.5×1.0) | A2 균열(0.1㎜/3.0m) |

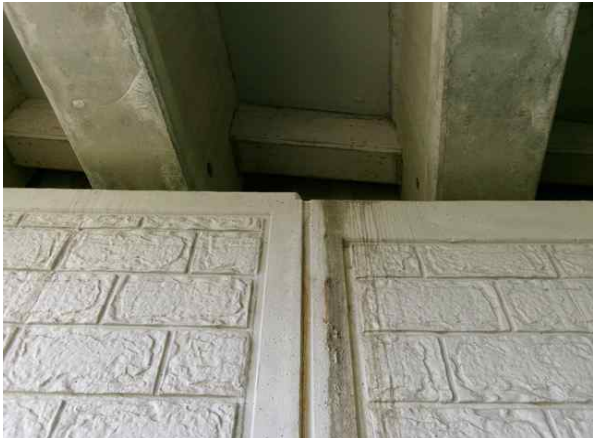
| A2 균열(0.3㎜/0.5m) | A2 녹오염(0.1×3.0) |

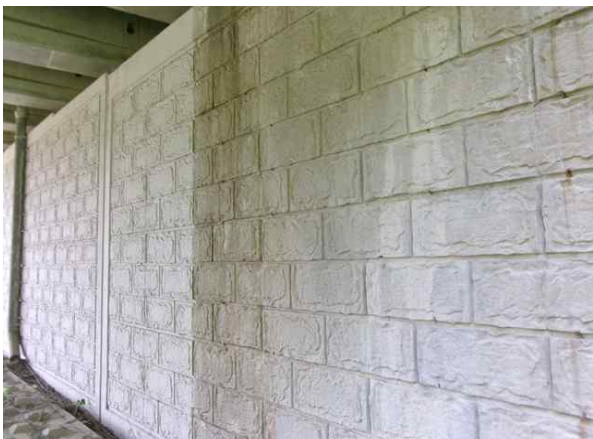
| A2 누수흔적(0.5×3.5) | A1 망상균열(0.1×4.0) |

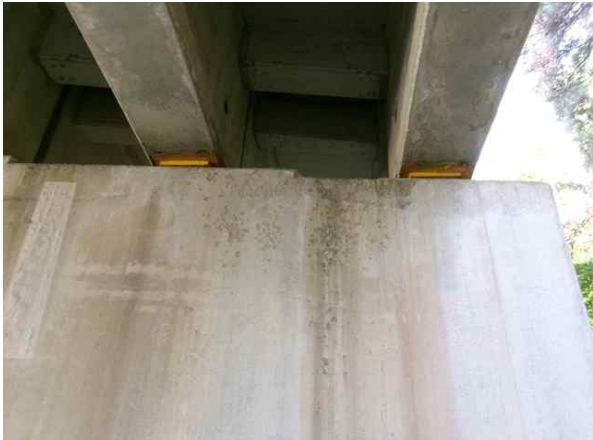
| P2 박리(1.5×2.5) | P2 철근노출(0.2×0.5) |

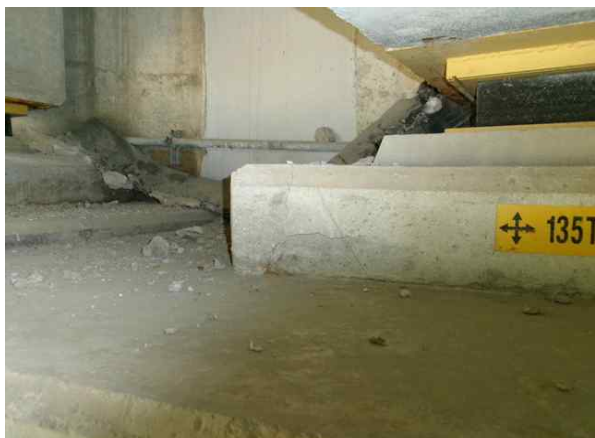
| A1-SH3 받침콘크리트 균열(0.3mm/0.4m) | A1-SH3 받침콘크리트 균열(0.3mm/0.5m) |

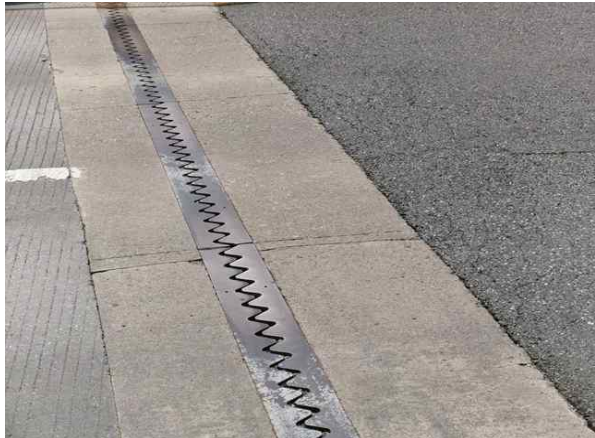
| A2 유간 토사퇴적(1.9) | A2 차수판 볼트탈락 |

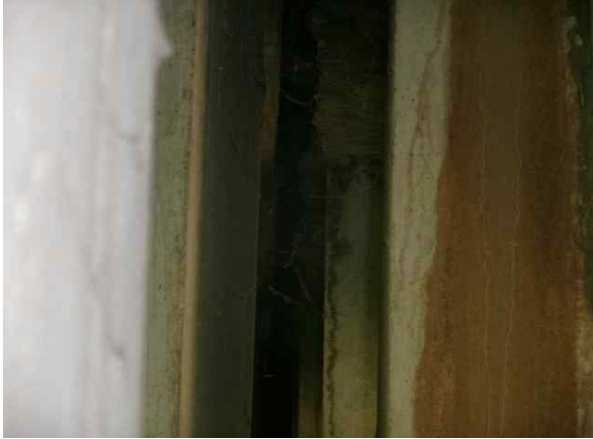
| P2 신축이음 하부누수(0.4×0.2) | P2 유간 토사퇴적(1.9) |

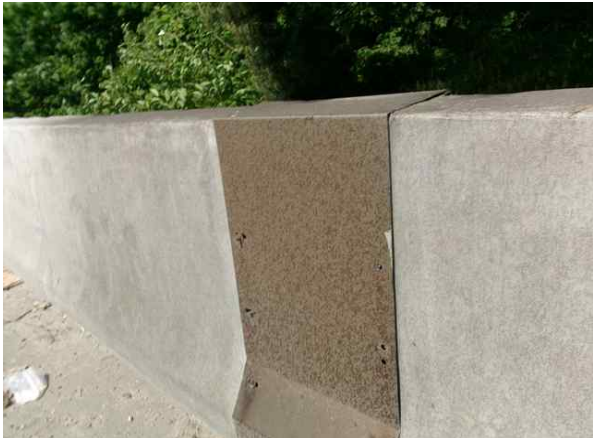
| P2 차수판 볼트탈락 | P2 후타재 균열(0.1mm/0.3m) |

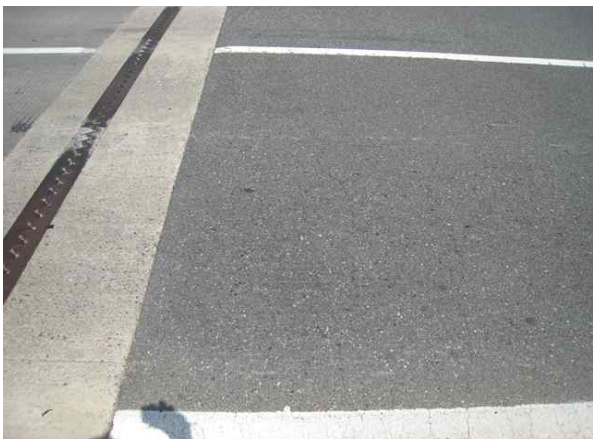
| S1 접속부 아스콘 균열(3.0) | S1 접속부 아스콘 패임 |

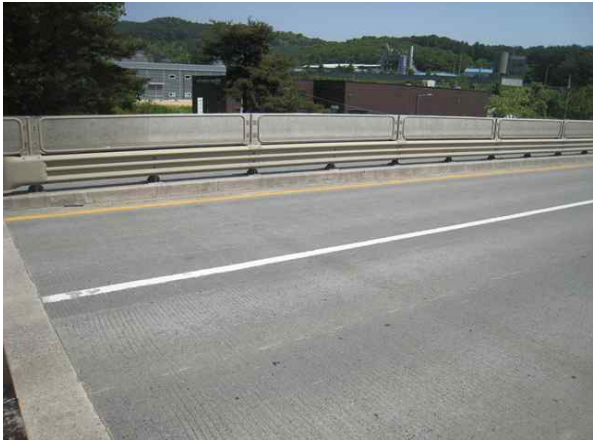
| S2 포장 망상균열 | S3 포장 마모 |

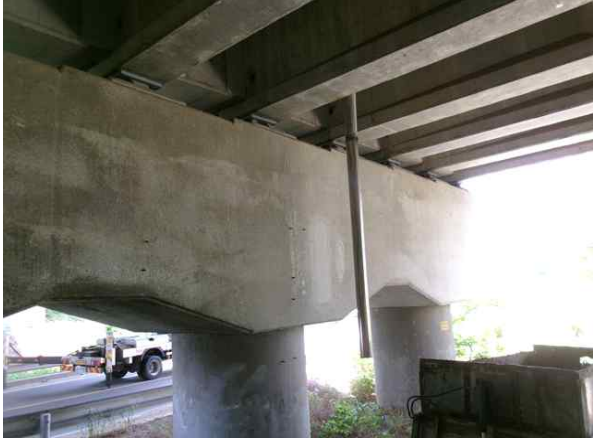
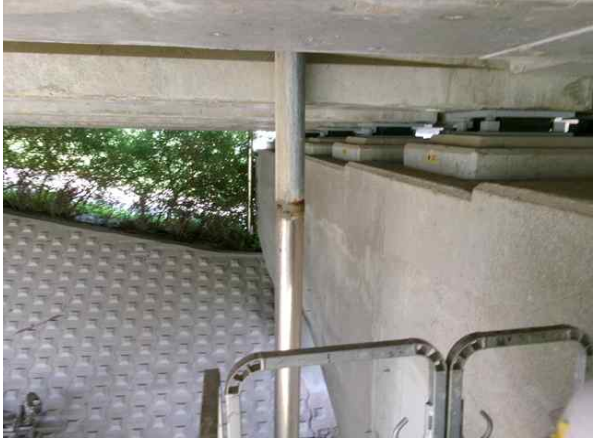
| P1 배수관 고정볼량(손상 경미) | P1 배수관 고정볼량(손상 경미) |

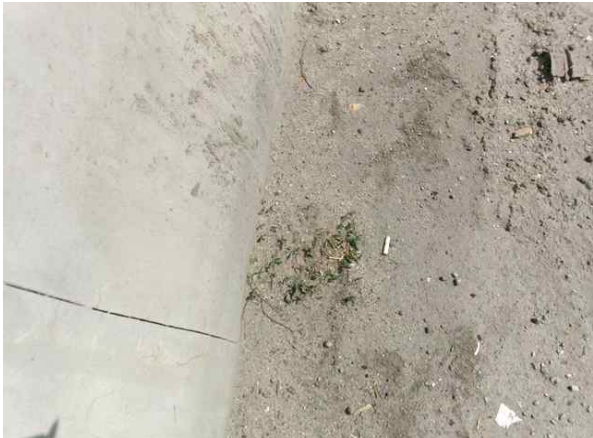
| S1 그레이팅 망실, 막힘 | S2 그레이팅 망실, 막힘 |

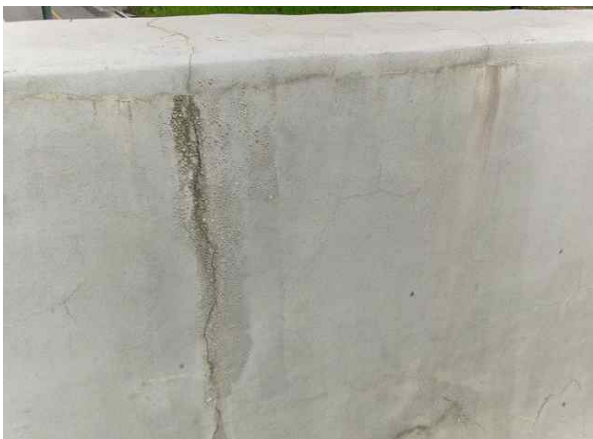
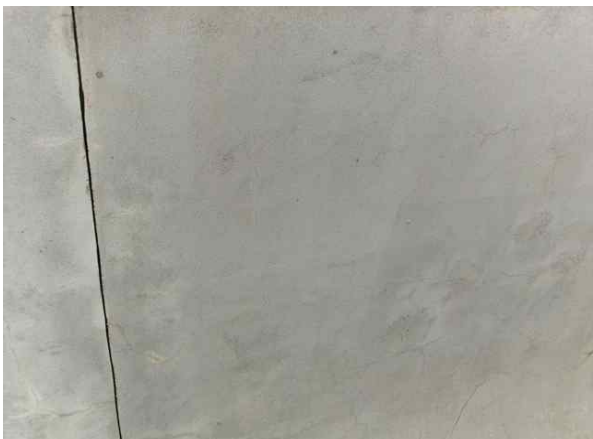
| S1 보수부 망상균열(0.3×2.0) | S1 보수부 망상균열(0.3×2.0) |

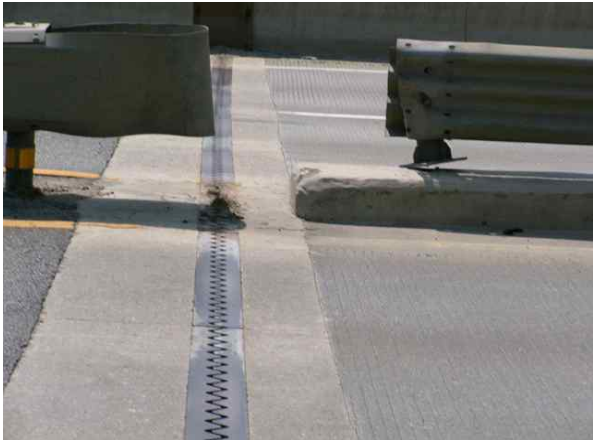
| S1 중분대 파손(0.2×0.2) | S1 차광막탈락(2.0) |

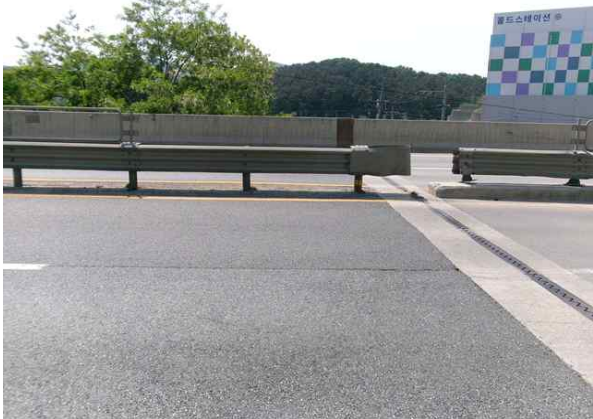
| S1 차광막탈락(4.0) | S2 들뜸(0.3×1.0) |

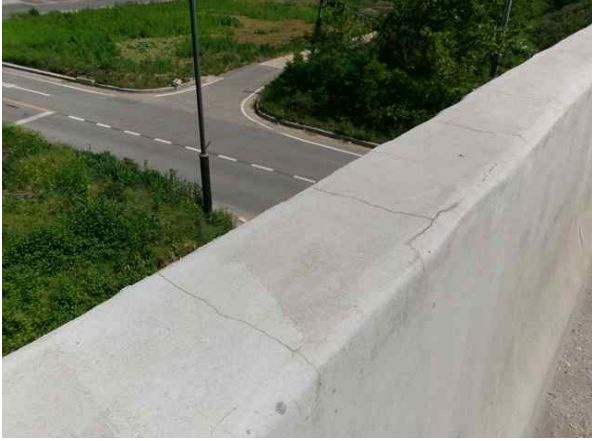
| S2 재균열(0.1mm/0.3m) | S2 재균열(0.2mm/1.5m) |

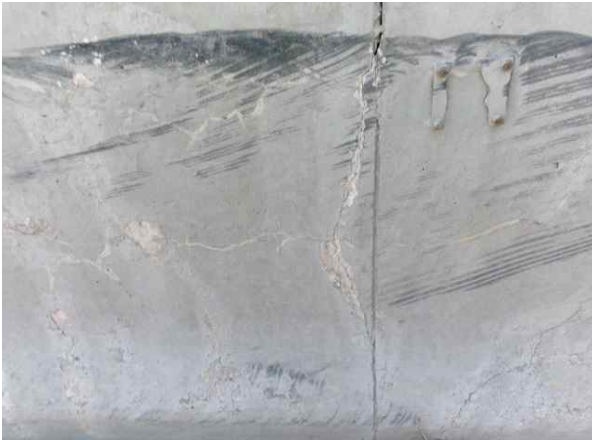
| S4 균열(0.3mm/1.2m) | S4 보수부 박리(0.1×0.1) |

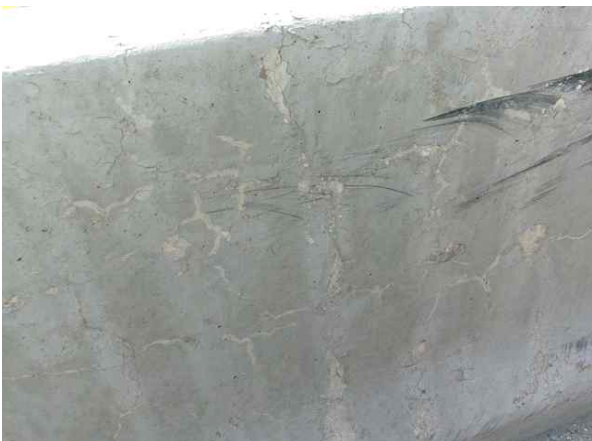
| S4 균열(0.2mm/0.8m) | S4 접속부 용벽 균열(0.3mm/1.0m) |

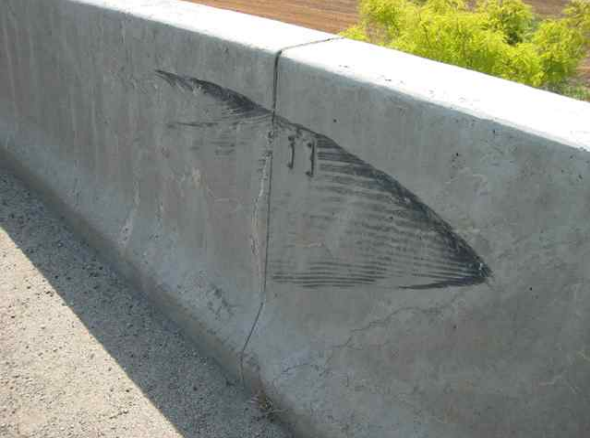
| S4 접속부 보수부 박리(0.1×0.3) | S4 접속부 용벽 균열(0.2mm/0.5m) |
