## 2. 양성교(상)

## 손상현황 사진

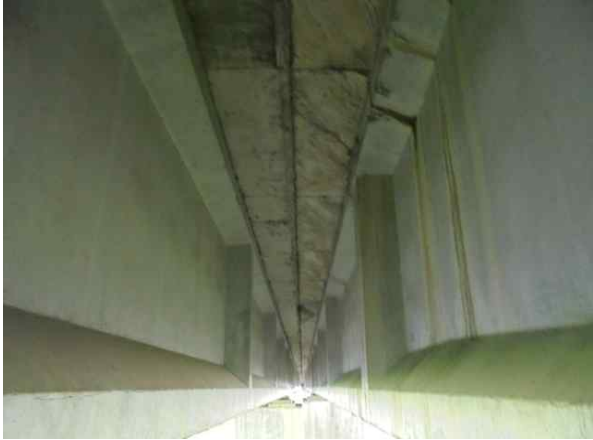
| S1 물끊기홈 미시공 | S2 균열(0.1mm/1.6m) |

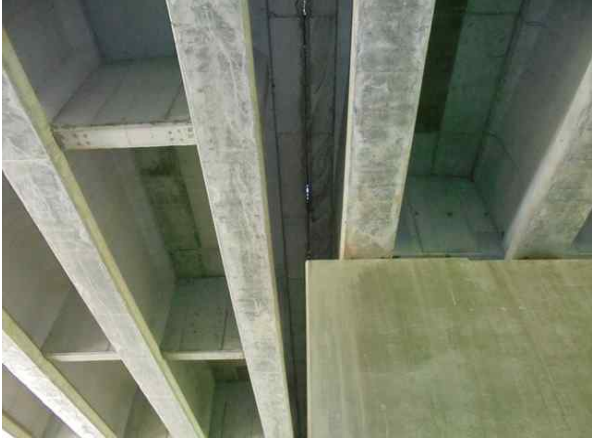
| S1 물끊기흠 미시공 | S3 재균열(0.1mm/1.6m) |

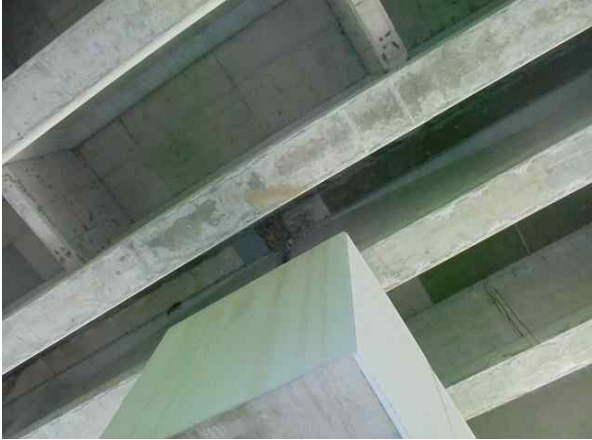
| S3 백태 (0.5×0.5) | S3 물끊기흠 미시공 |

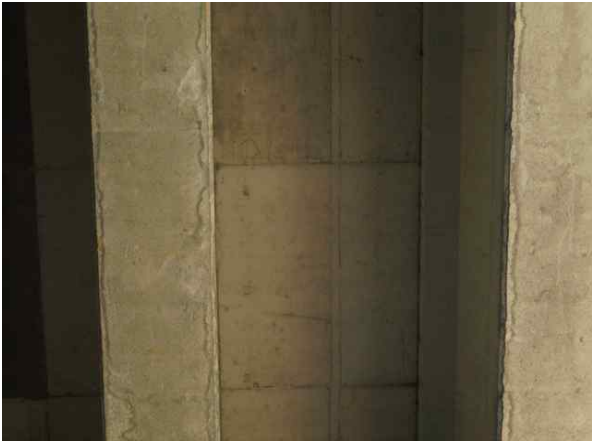
| S4 재균열(0.1mm/1.0m) | S4 균열 보수 |

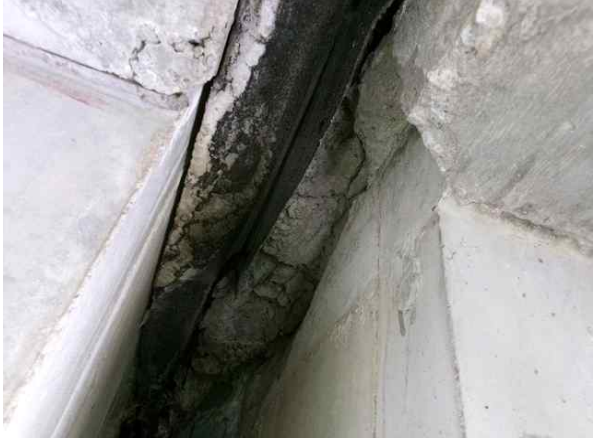
| S4 박락 보수 | S4 파손 (0.5×0.3) |

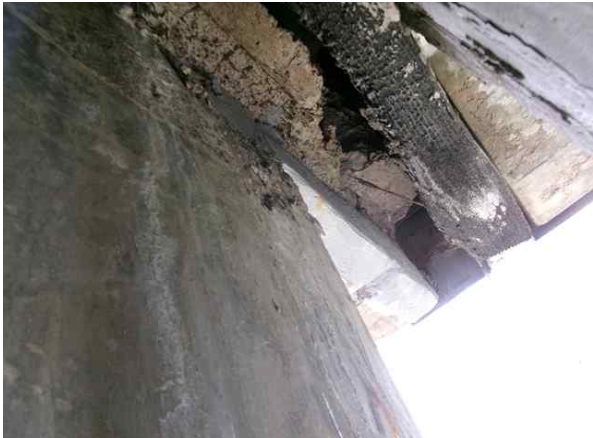
| S4 파손 및 철근노출 (0.5×0.3) | S5 재균열 (0.1mm/1.0m) |

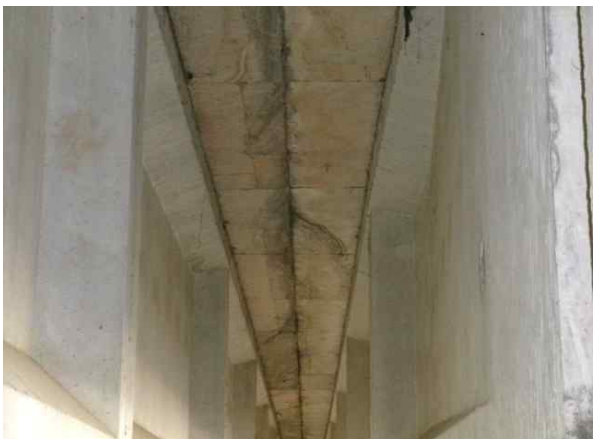
| S5 균열 보수 | S5 물끊기흙 미시공 |

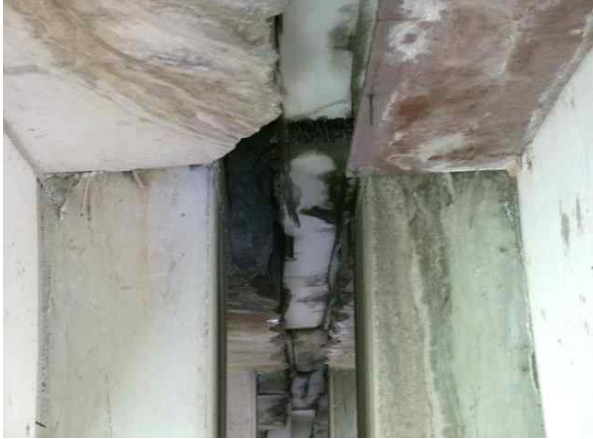
| S6 박락 (0.1×1.0) | S6 파손 및 철근노출 (0.5×0.5) |

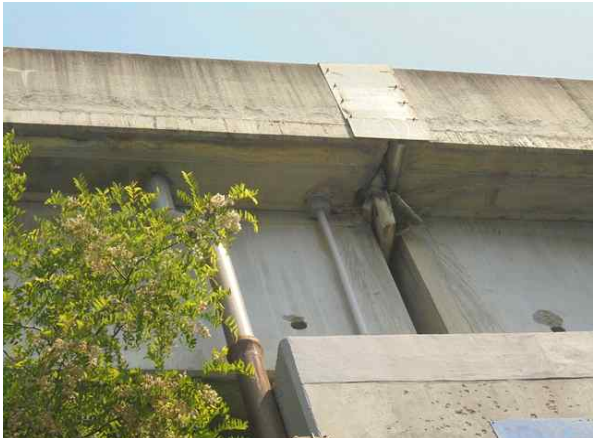
| S6 파손 (0.2×0.4) | S7 균열(0.2mm/1.6m) |

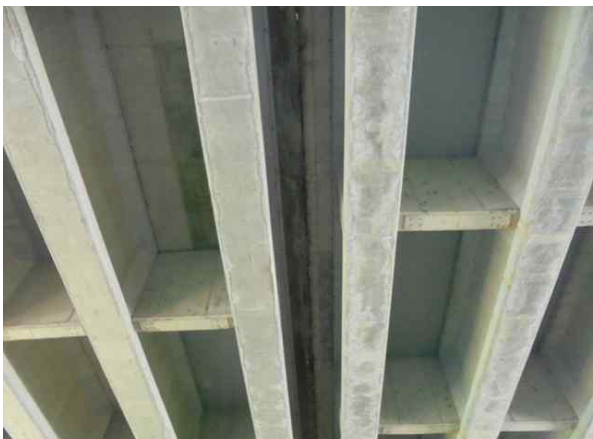
| S7 물끓기흙 미시공 | S8 균열(0.1mm/1.6m) |

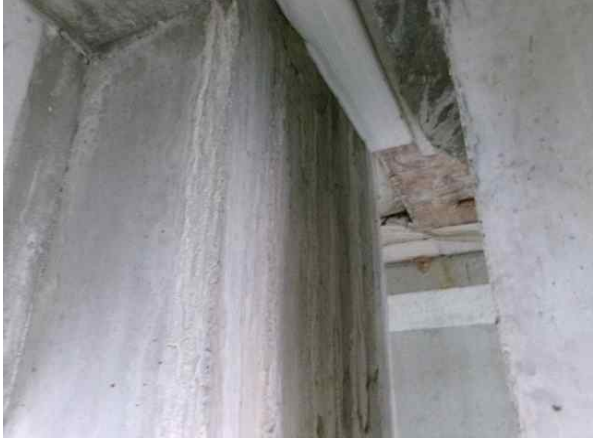
| S3-G1 백태(0.5×0.5) | S3-G1~6 들뜸(1.0×0.4) |

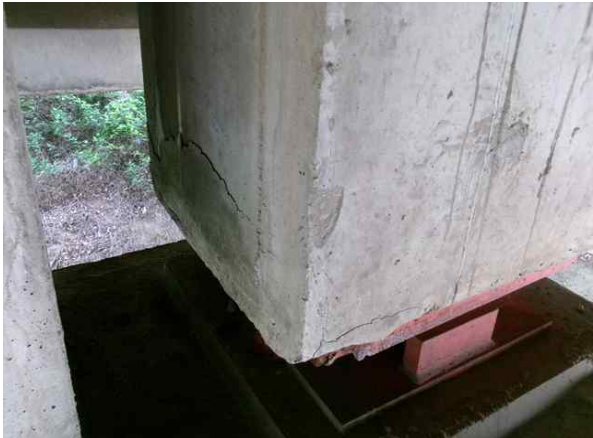
| S4-G5 박락 및 파손 보수 | S4-G1~6 들뜸(1.0×0.4) |

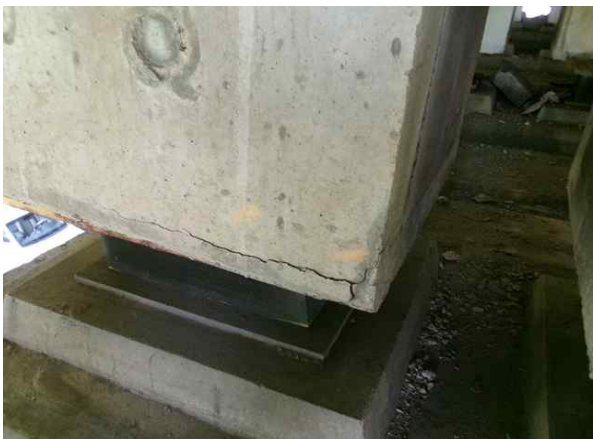
| S6-G2 파손 보수 | S6-G1~6 들뜸(1.0×0.3) |

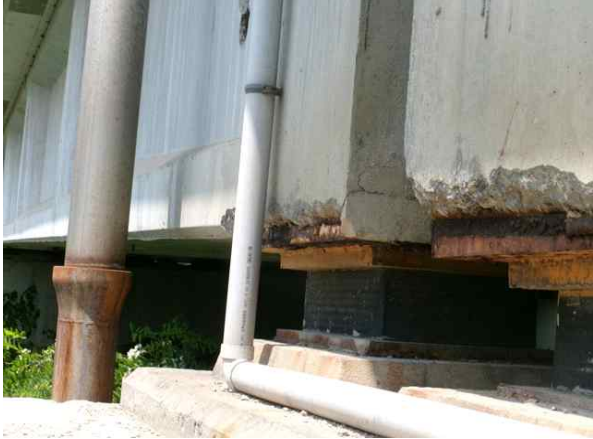
| S6-G6 파손(0.2×0.4) | S7-G1 파손 보수 |

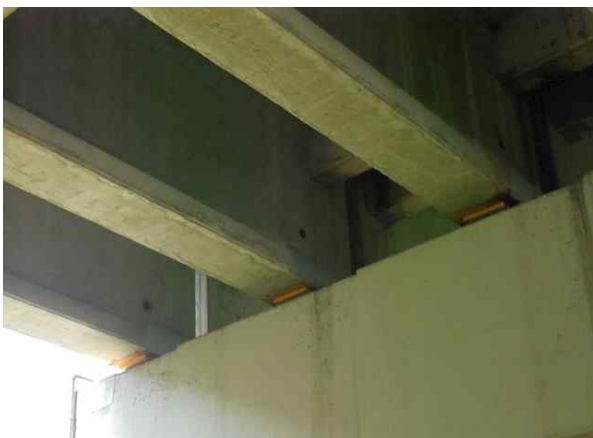
| S7-G1~6 들뜸(1.0×0.3) | S7-G5 파손(0.4×0.2) |

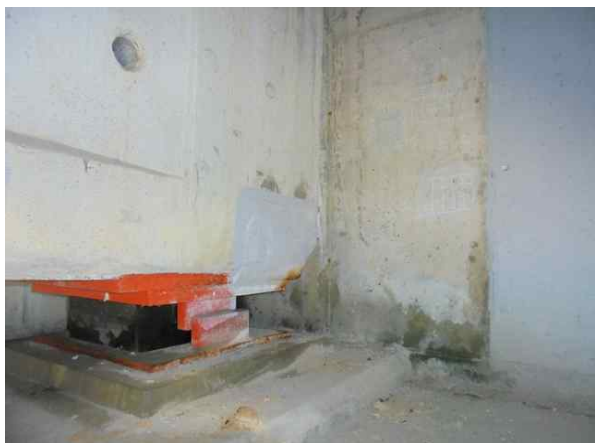
| <p>S8-G1 들뜸 보수</p> | <p>S8-G1 파손(0.1×1.5)</p> |

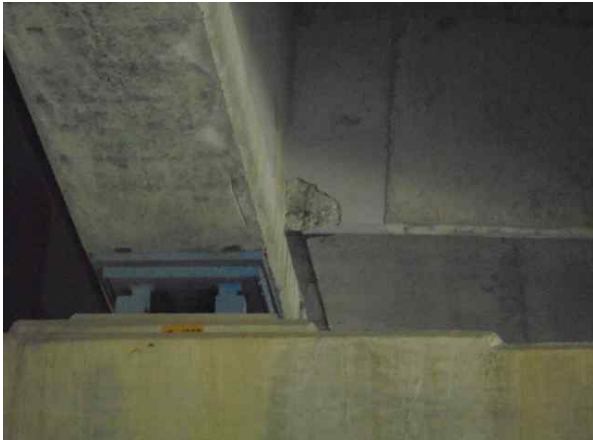
| S2 보수부 박리(0.3×0.3) | S2 보수부 들뜸(0.3×0.3) |

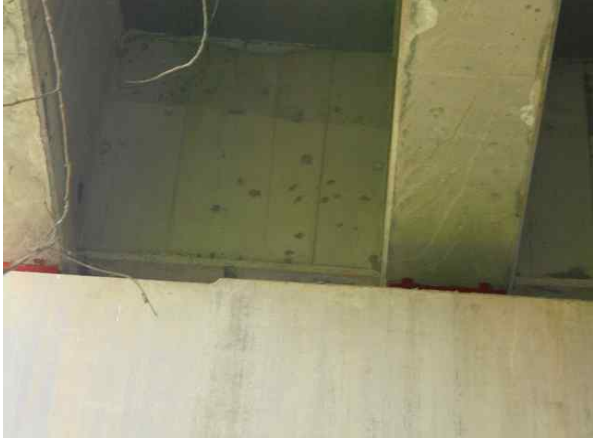
| S6 채균열(0.3mm/0.1m) | S6 박락(0.5×0.1) |

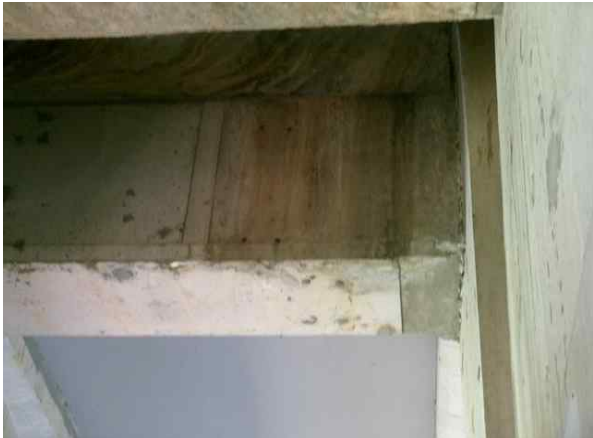
| S6 누수흔적(0.3×0.5) | S7 박리(0.3×1.0) |

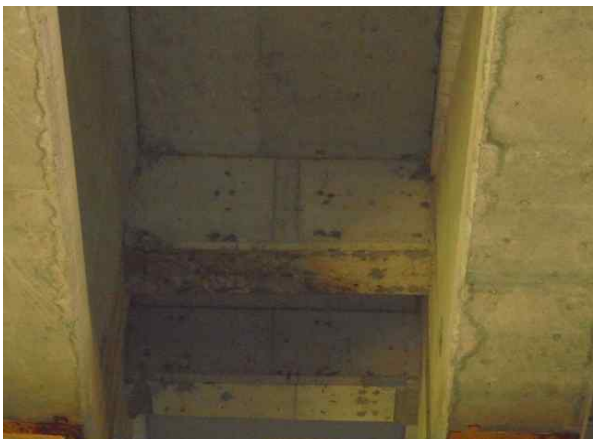
| S7 박리(0.3×1.0) | S7 보수부 박락(0.3×0.3) |

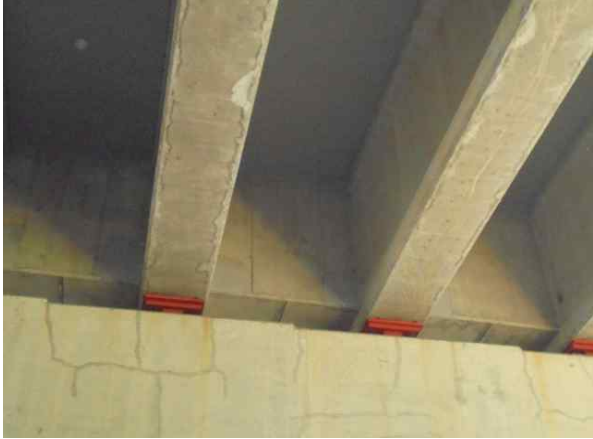
| S7 보수부 들뜸(0.3×0.3) | S7 박리(0.3×1.0) |

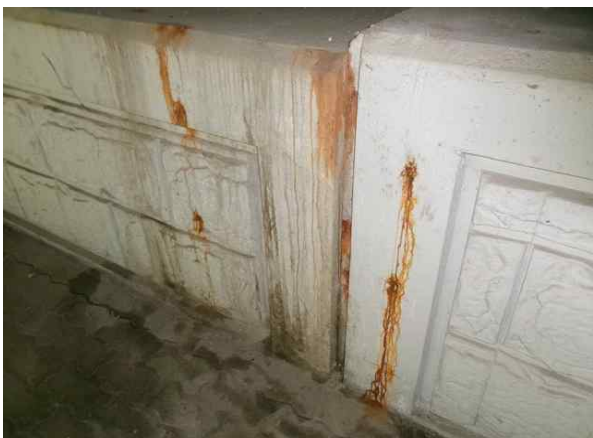
| A1 녹오염(0.1×0.8) | A1 체수흔적(0.5×1.5) |

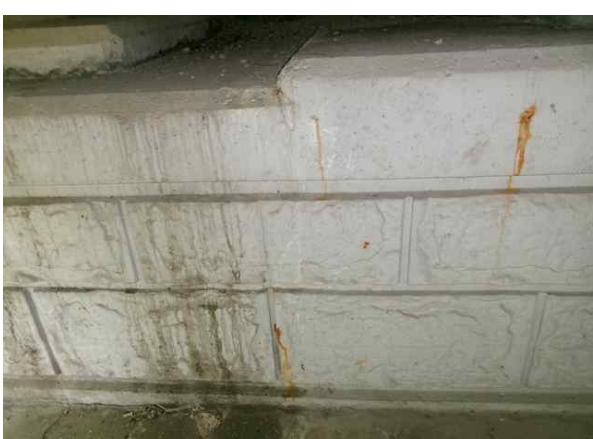
| A1 균열(0.2mm/0.6m) | A1 점검계단 고사목적치 |

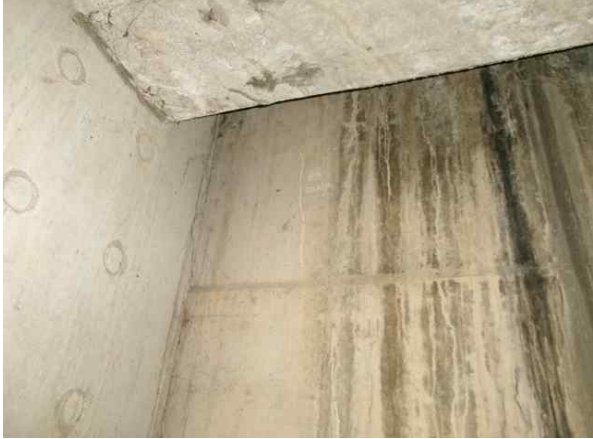
| A1 균열(0.2mm/0.4m) | A1 균열(0.2mm/0.8m) |

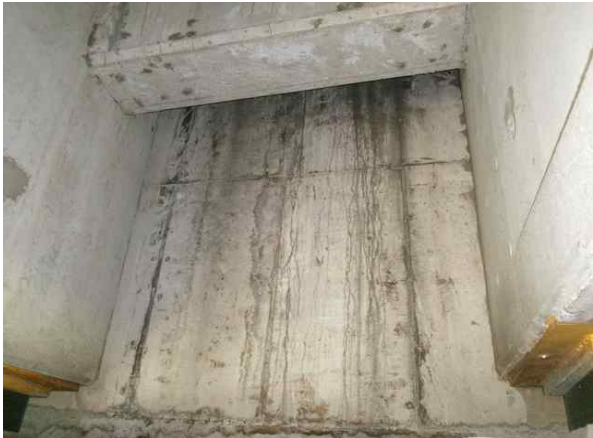
| A1 표면오염(1.0×2.0) | A1 표면오염(1.5×2.5) |

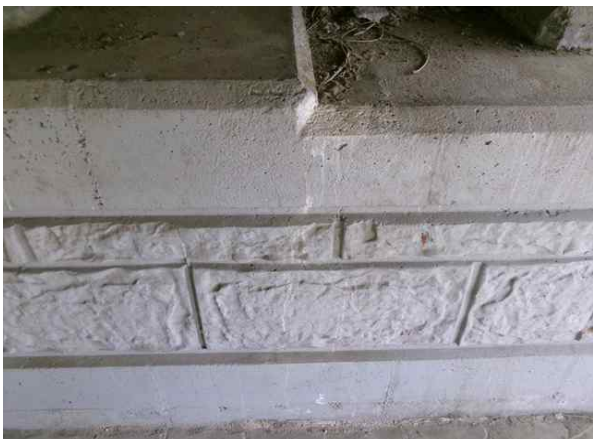
| A2 균열(0.2mm/0.6m) | A1 체수흔적(2.8×1.5) |

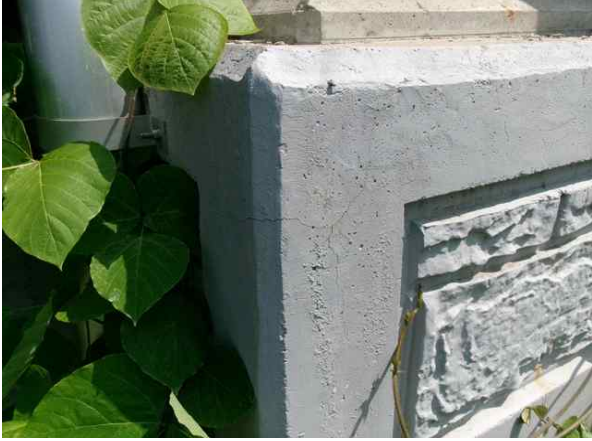
| A2 균열(0.3mm/0.3m) | A2 법면 배수로 하부 토사유실(1.5×1.2) |

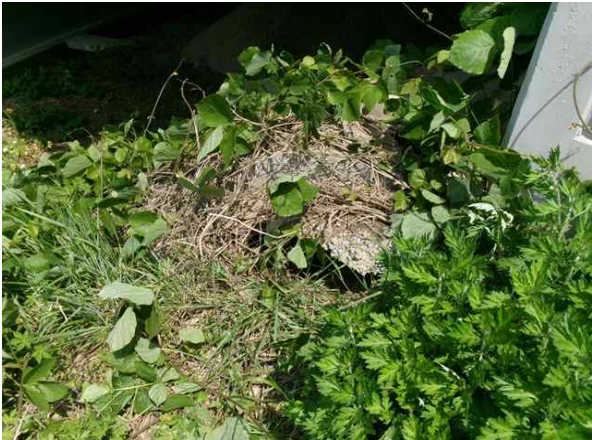
| A2 법면 배수로 하부 토사유실(1.5×1.2) | A2 점검계단 미설치 |

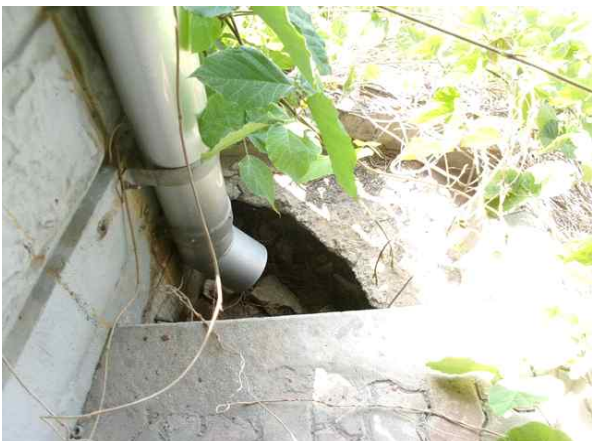
| A2 집수정 바닥콘크리트 파손(0.9×0.7) | A2 균열(0.2mm/0.9m) |

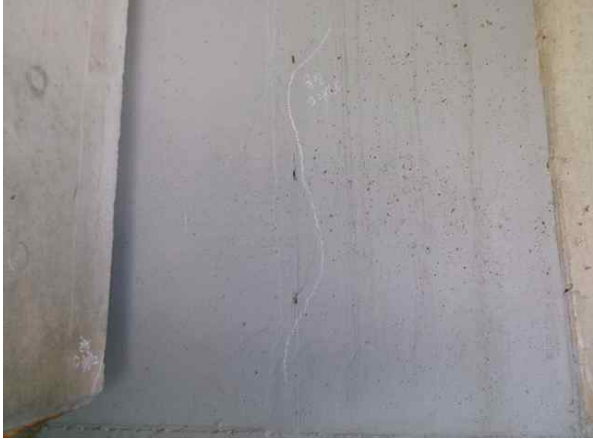
| A2 균열(0.2mm/1.0m) | A2 균열(0.3mm/2.0m) |

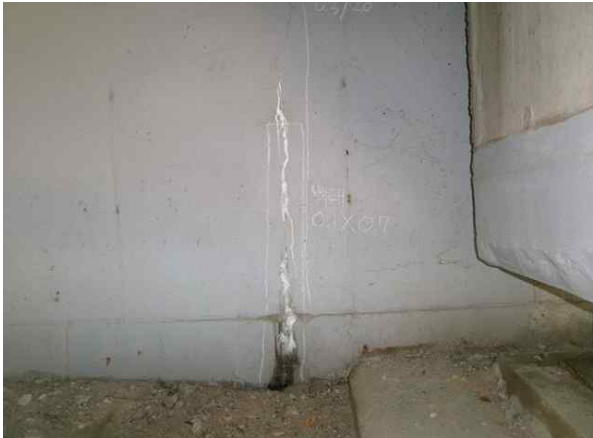
| A2 균열부백태(0.1×0.7) | A2 누수흔적(0.6×2.0) |

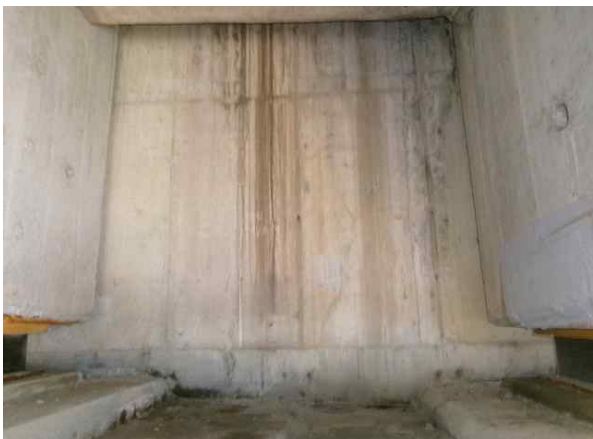
| A2 누수흔적(1.0×2.0) | A2 균열(0.2mm/1.5m) |

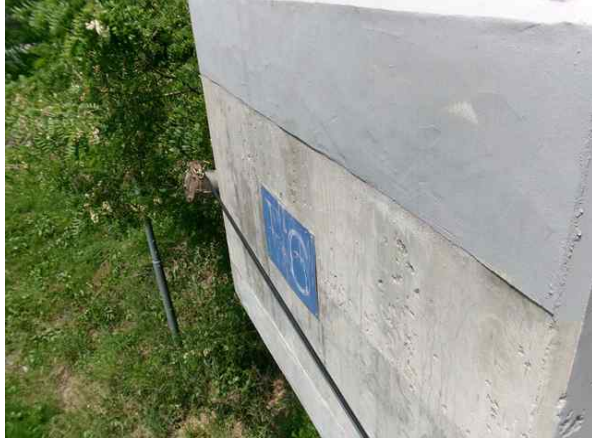
P6 코평부 누수흔적(0.2×2.0)

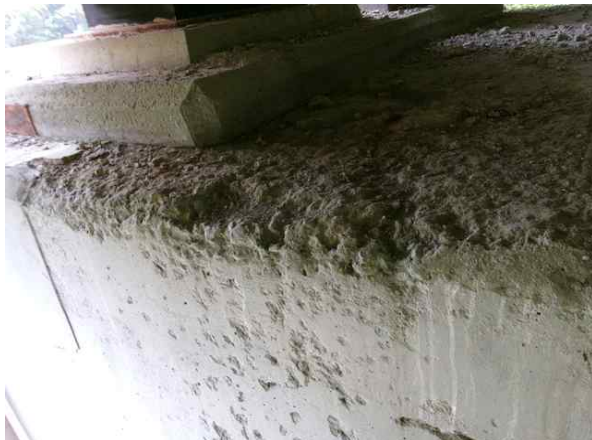
P6 코평부 박리(0.6×2.5)

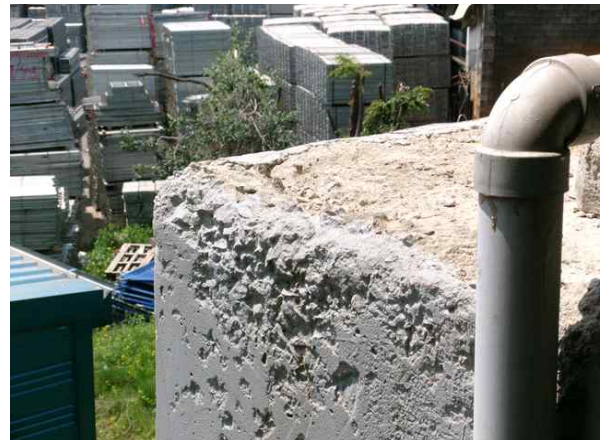
P6 코평부 박리(2.5×0.5)

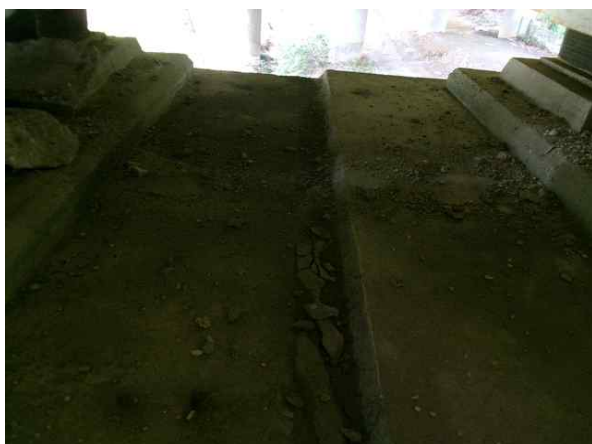
P6 코평부 상면 체수(0.5×2.5)

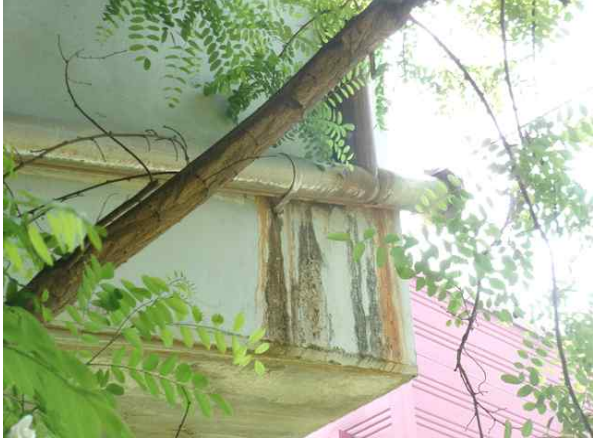
| P6 코핑부 누수흔적(0.8×0.8) | P6 코핑부 재료분리(0.4×0.3) |

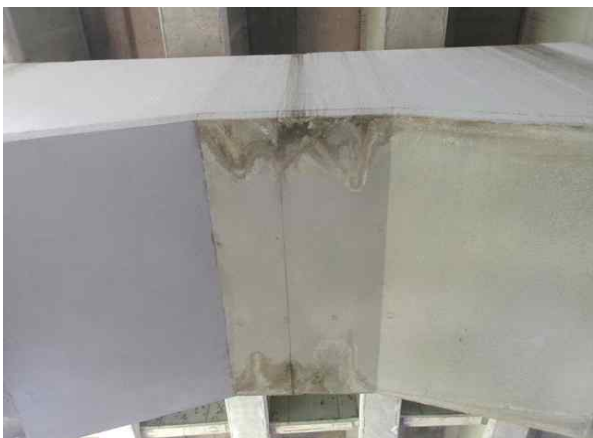
| P6 코핑부 누수흔적(1.0×0.5) | P6 코핑부 하면 철근노출(0.1×0.1) |

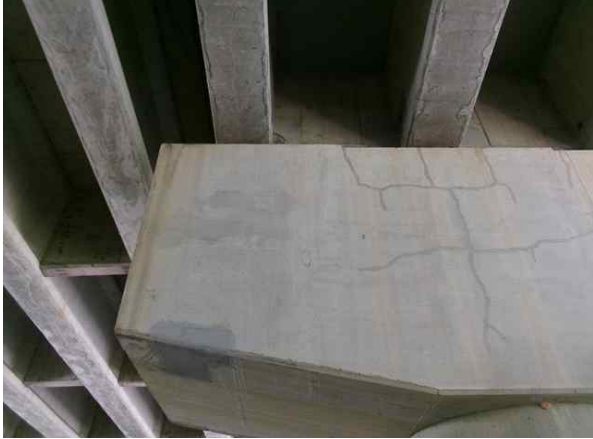
| P7 코핑부 망상균열(1.5×2.5) | P7 코핑부 망상균열(1.6×2.0) |

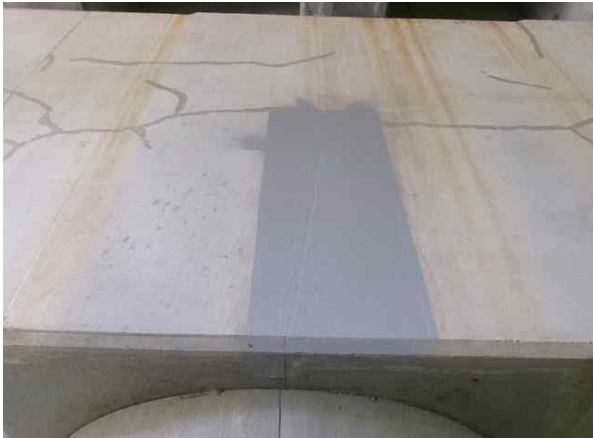
| P7 코핑부 채균열(0.2mm/1.2m) | P7 코핑부 균열(0.2mm/1.0m) |

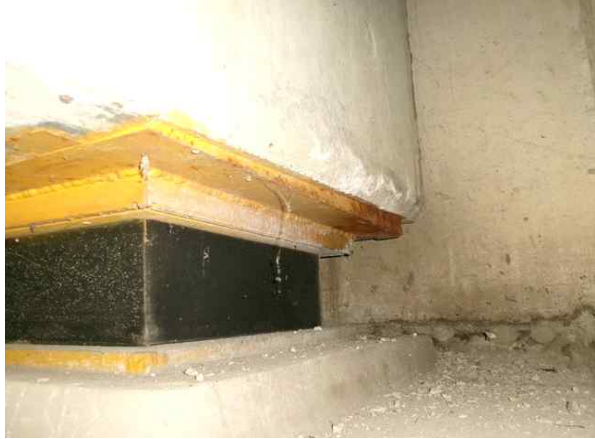
| <p>A1-SH3 본체 부식</p> | <p>A1-SH5 본체 부식</p> |

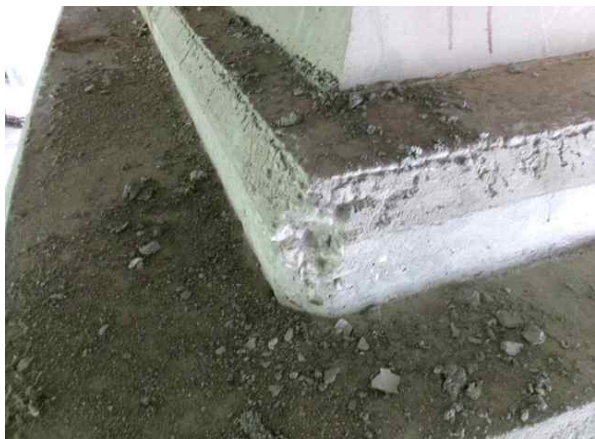
| <p>P3-SH1 물탈 박락(0.1×0.1)</p> | <p>P3-SH1 받침물탈 균열(0.5mm/0.5m)</p> |

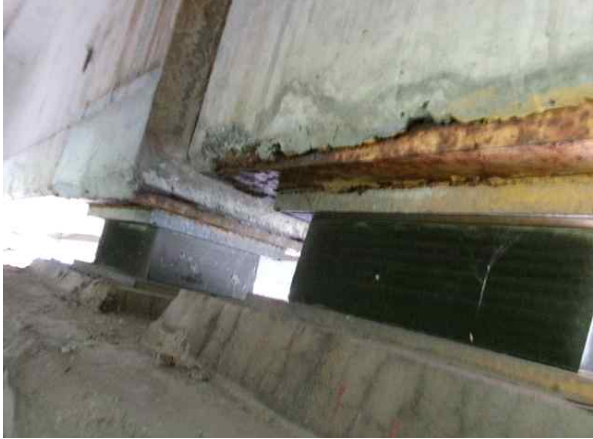
| P3-SH2 본체 부식 | P6-SH12 본체 부식 |

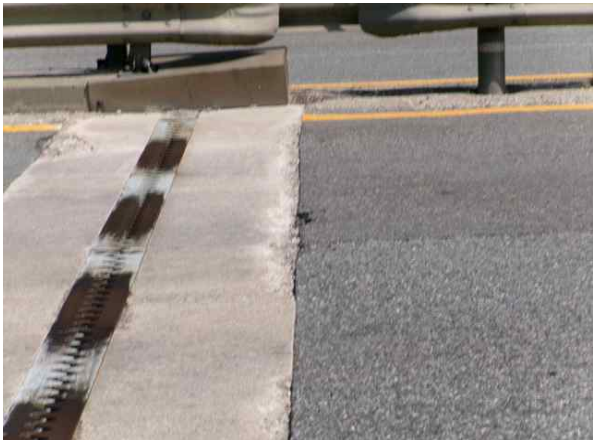
| A2 후타재 파손(0.1×3.0) | A2 후타재 파손(0.2×1.0) |

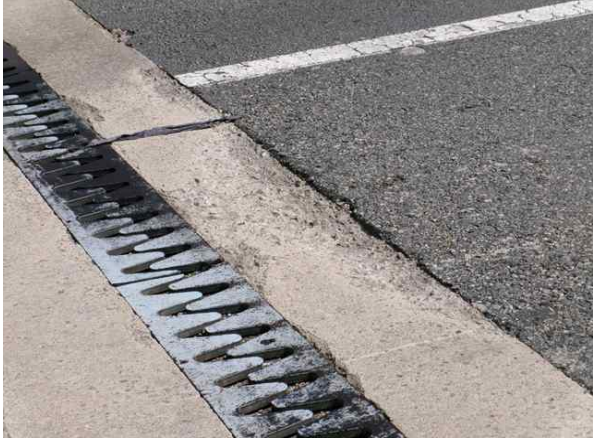
| P3 후타재 파손(0.2×1.0) | P3 후타재 파손(0.3×1.0) |

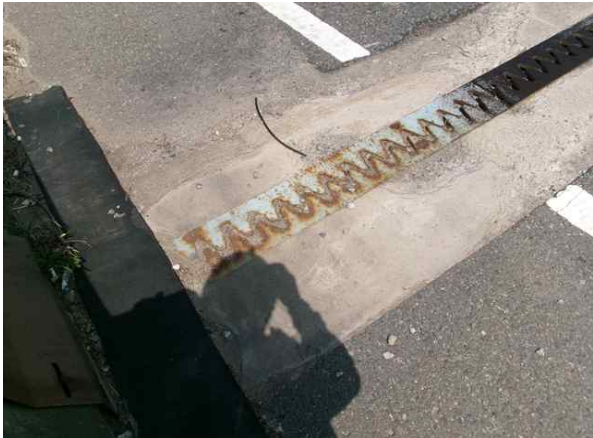
| P6 본체부식 | P6 하부 누수 |

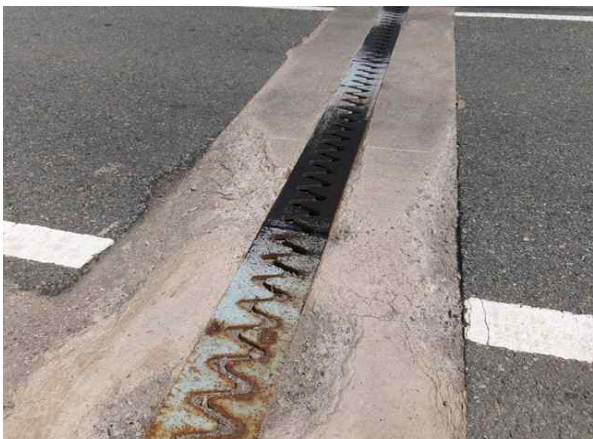
| P6 유간 토사퇴적(13.0) | P6 파수관 볼트탈락 |

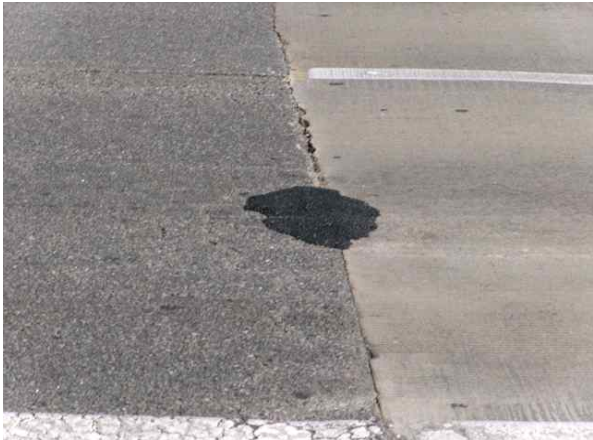
| S1 아스콘 파손 보수 | S1 아스콘 균열(18.0) |

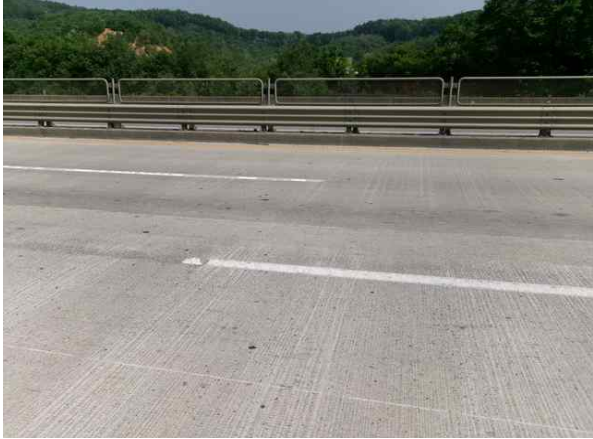
| S3 포장 망상균열(10.0×1.0) | S3 포장 균열(1.0) |

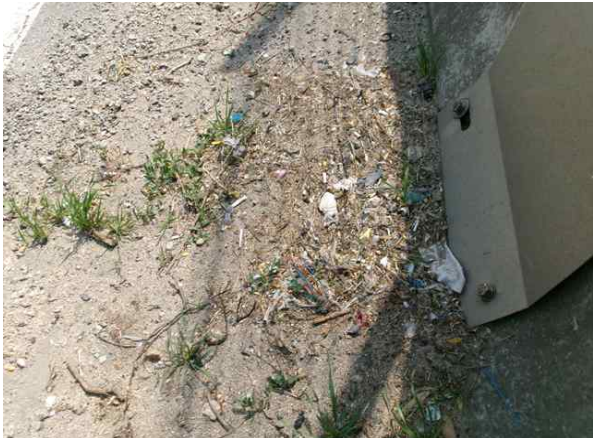
| S3토사퇴적(1.8×0.8) | S4 아스콘 균열(2.0) |

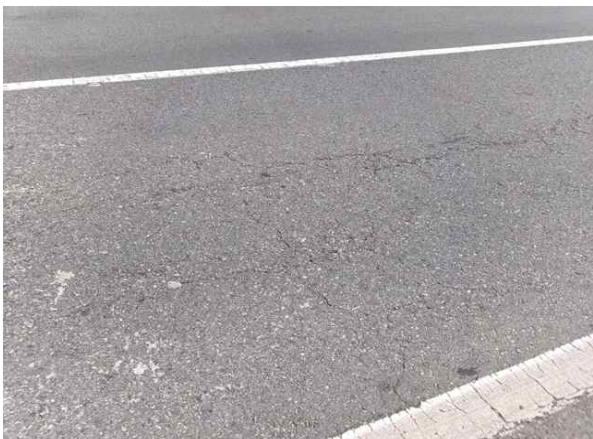
| S4 아스콘 망상균열(10.0×3.0) | S4 토사퇴적(1.0×2.0) |

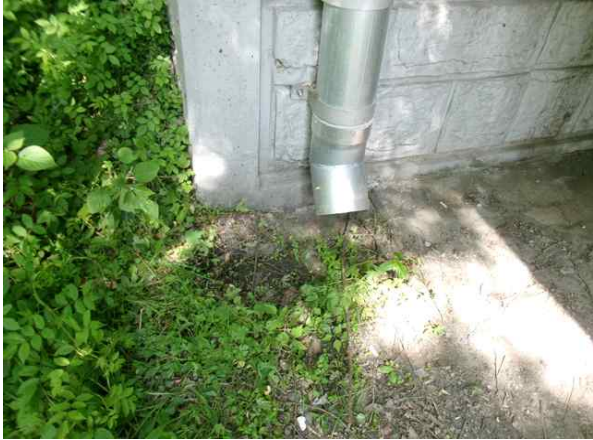
| A1 집수정 토사퇴적 | S1 배수관 길이부족 |

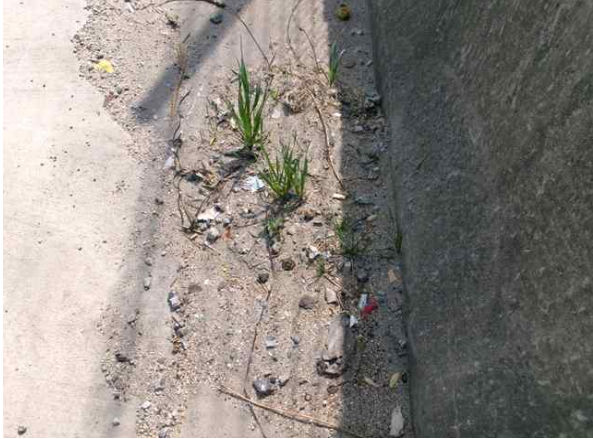
| S3 배수구 막힘 | S4 배수구 막힘 |

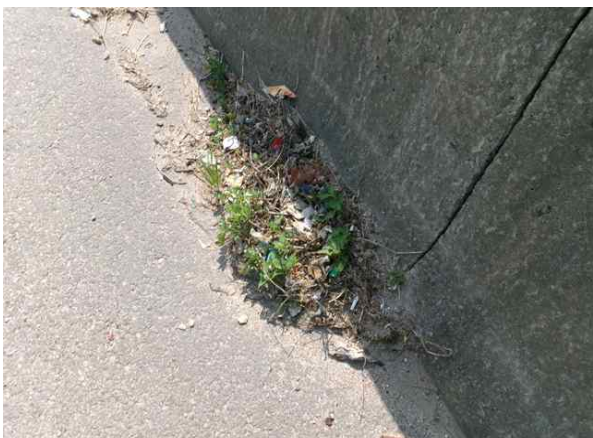
| S5 배수구 막힘 | S6 배수관 막힘 |

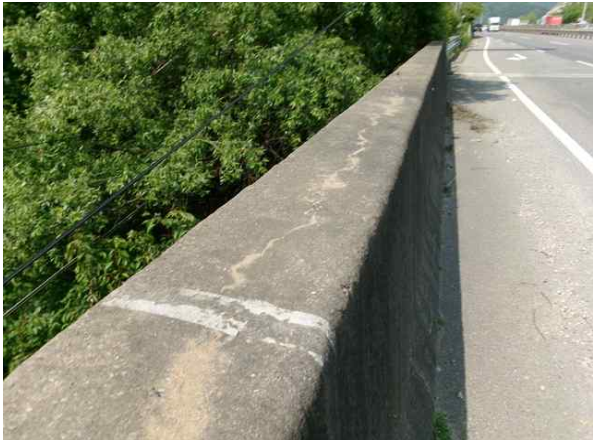
| S1 균열(0.2mm/5.0m) | S1 재균열(0.2mm/2.5m) |

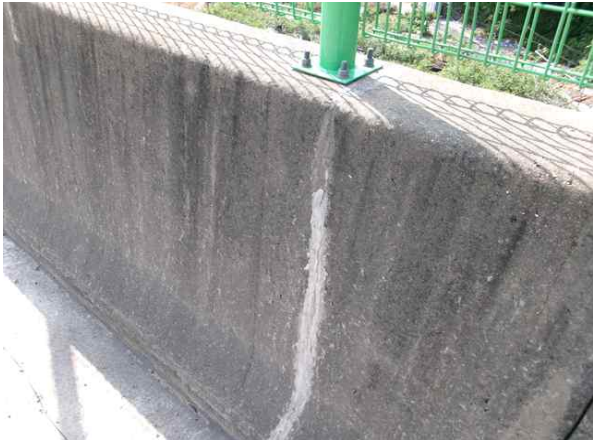
| S3 재균열 (0.2mm/2.5m) | S4 균열 (0.2mm/0.8m) |

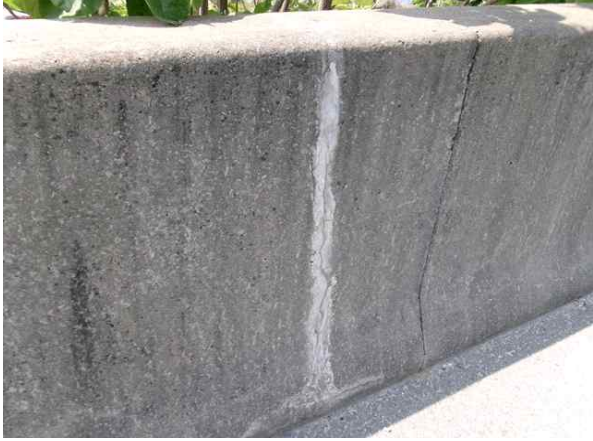
| S5 재균열 (0.2mm/2.5m) | S6 균열 (0.2mm/3.0m) |

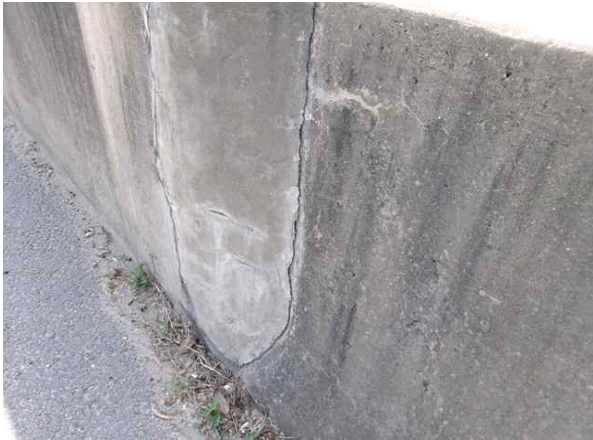
| S7 들뜸 (0.3×1.1) | S7 재균열 (0.2mm/3.0m) |

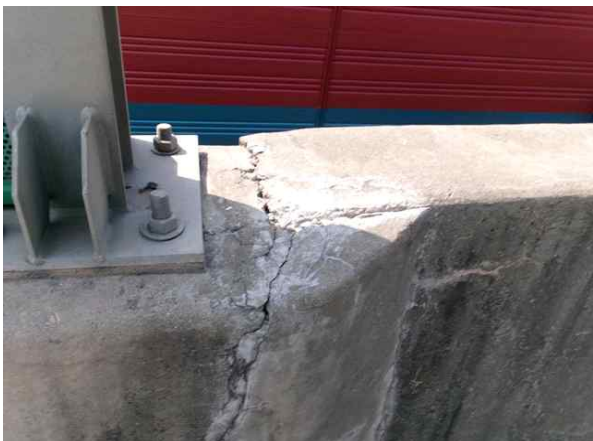
| S7 파손 (0.2×0.4) | S8 균열부 백태 (0.8) |

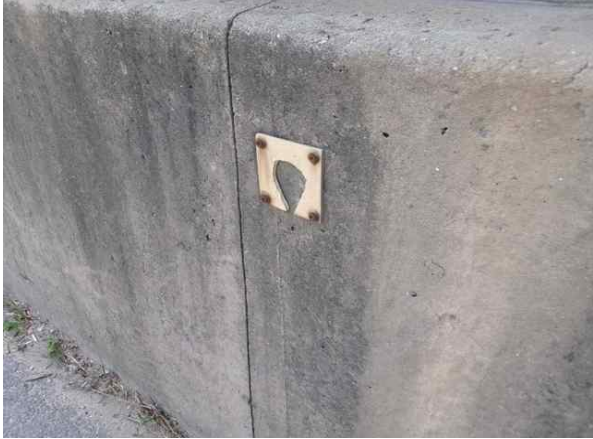
| S8 텔레이네이트 파손 | S8 망상균열(1.1×1.5) |

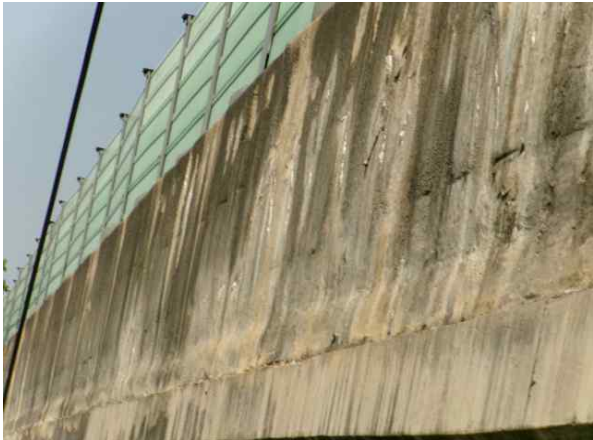
| S8 백태(0.2×1.0) | — |
