### 3. 양성교(하)

## 손상현황 사진

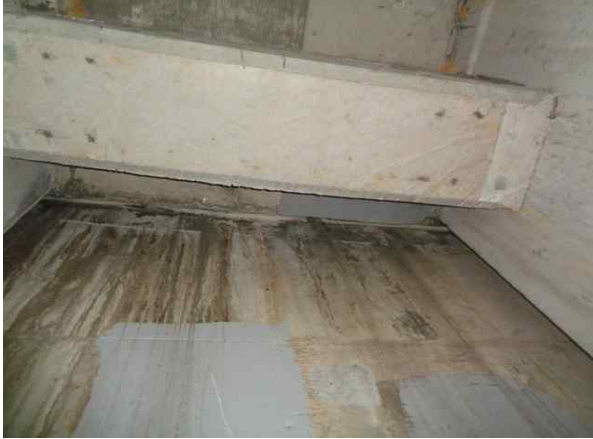
| S1 균열(0.1mm/1.7m) | S1 박락 보수 |

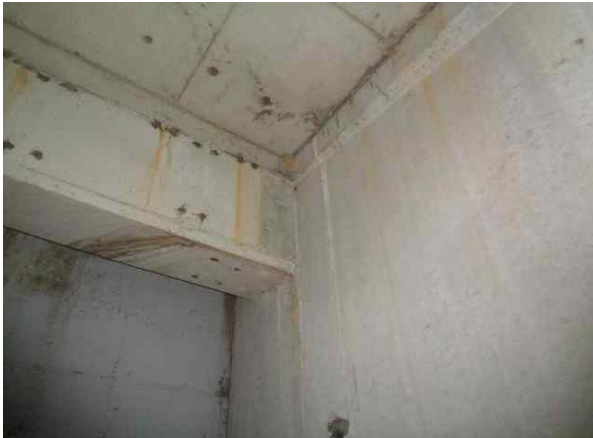
| S1 백태 (0.2×0.2) | S2 균열(0.1mm/1.6m) |

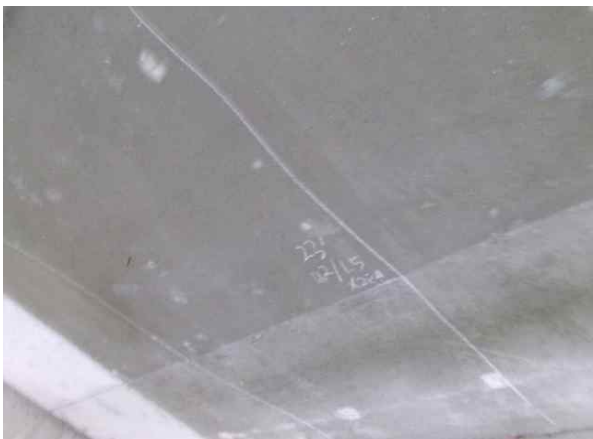
| S2 균열 보수 | S2 균열(0.2mm/1.5m) |

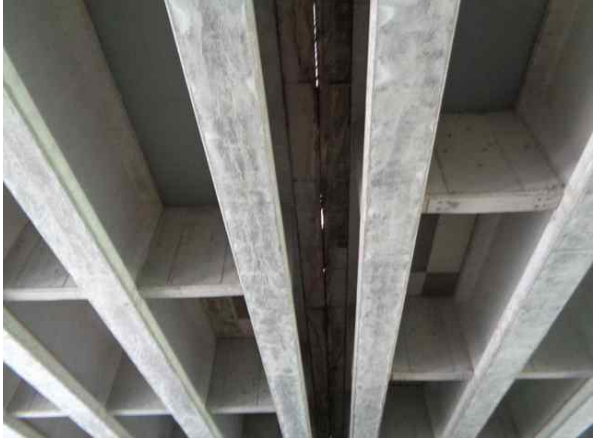
| S2 균열부 백태 보수 | S2 물끓기흠 미시공 |

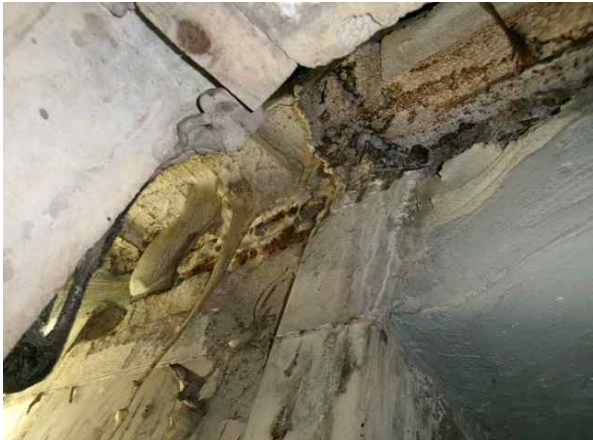
| S2 균열 보수 | S4 박락 및 철근노출(0.3×0.2) |

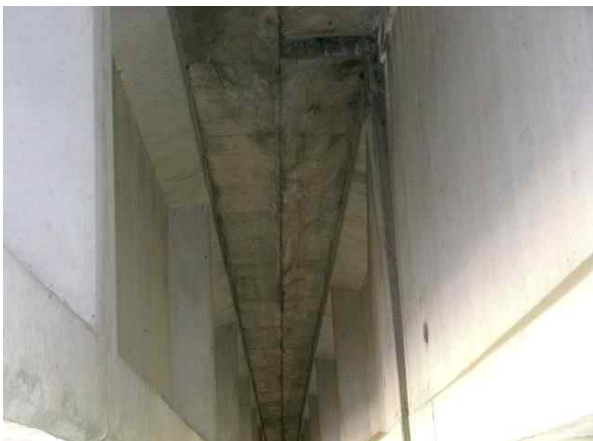
| S4 박락 보수 | S4 물끓기흠 미시공 |

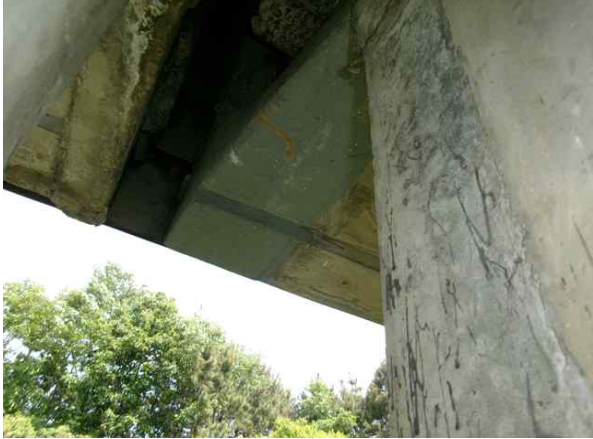
| S4 파손, 재료분리 보수 | S4 파손 (0.6×0.1) |

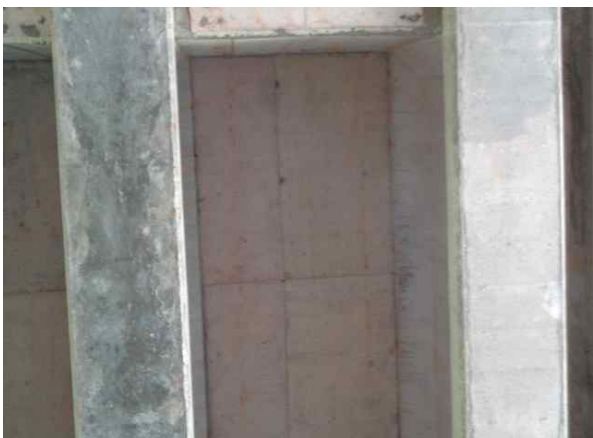
| S5 균열(0.2mm/1.6m) | S5 그을음 발생 |

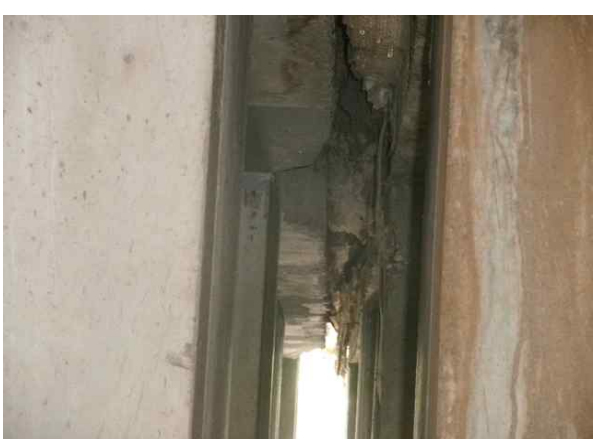
| S6 균열(0.2mm/0.3m) | S6 박락 (0.1×0.3) |

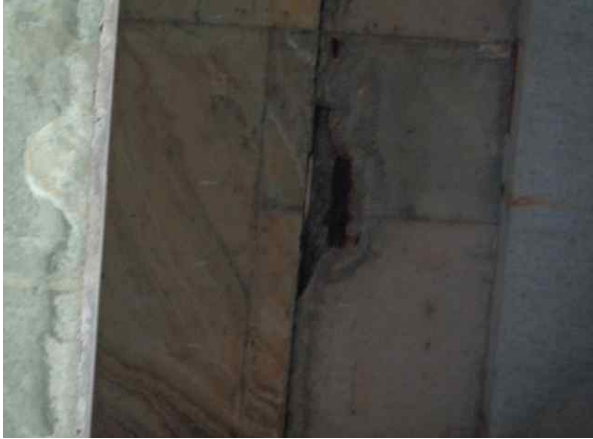
| S6 물끓기흙 미시공 | S6 파손 및 철근노출(0.2×0.6) |

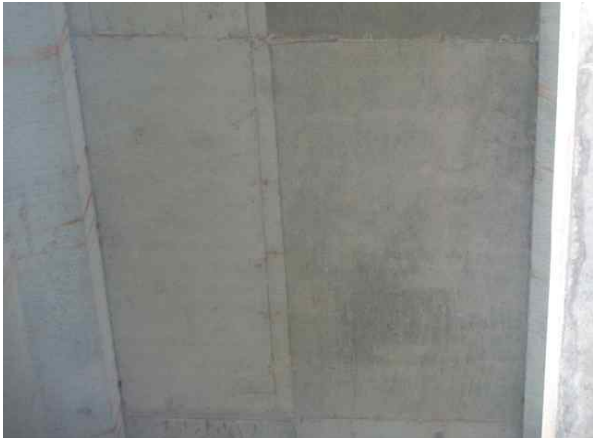
| S6 균열(0.2mm/1.6m) | S7 박락 보수 |

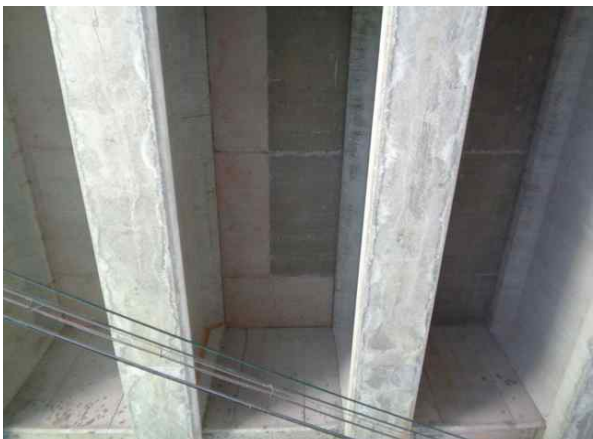
| S7 파손 (0.2×0.5) | S8 균열(0.1mm/1.6m) |

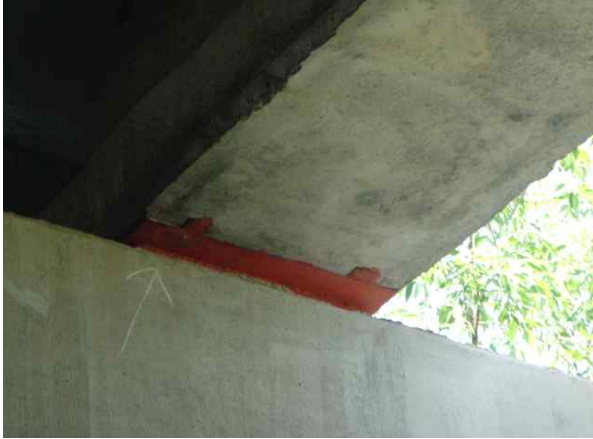
| S1-G1 백태(0.3×0.2) | S3-G1 박락(0.7×0.2) |

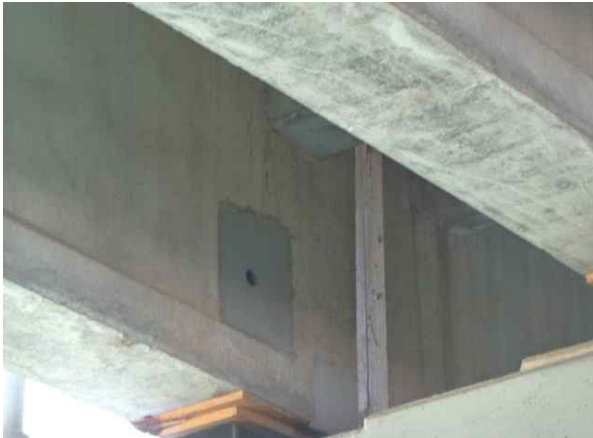
| S3-G1 박락 보수 | S3-G1 박락 및 철근노출(0.5×0.5) |

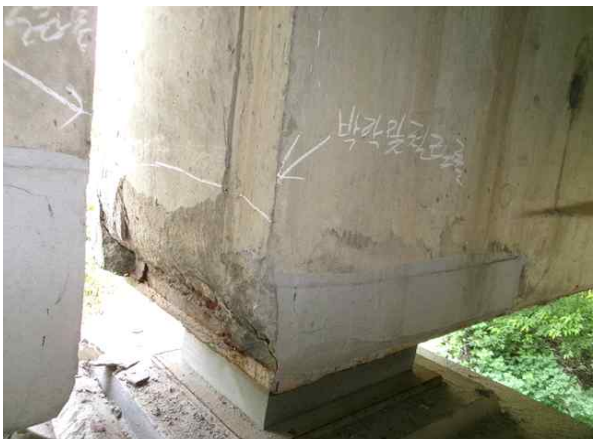
| S3-G1~6 보수부 들뜸(0.5×0.2) | S4-G1 박락 및 철근노출(0.5×0.5) |

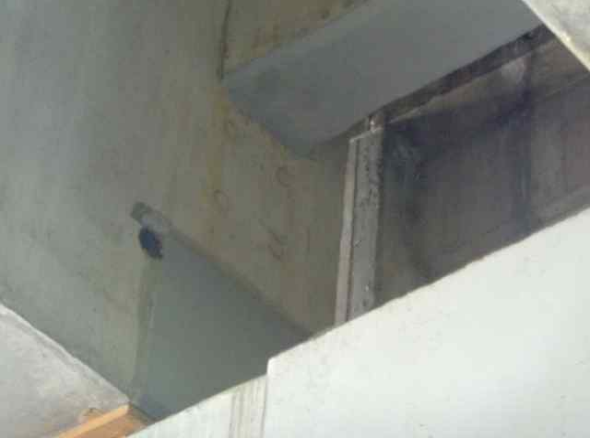
| S4-G1~6 보수부 들뜸(0.5×0.3) | S6-G1 박리 보수 |

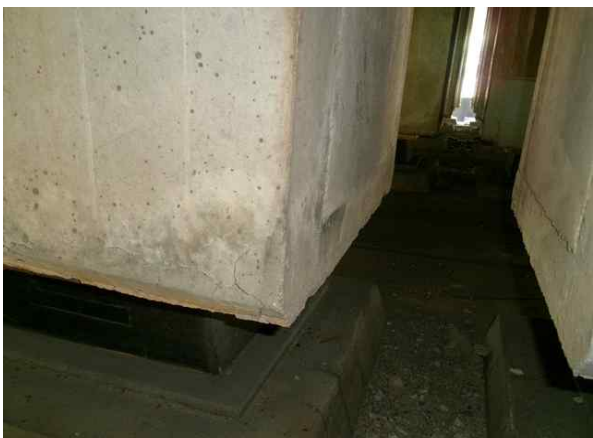
| S6-G1~5 들뜸(1.0×0.3) | S7-G2 박락(0.3×0.1) |

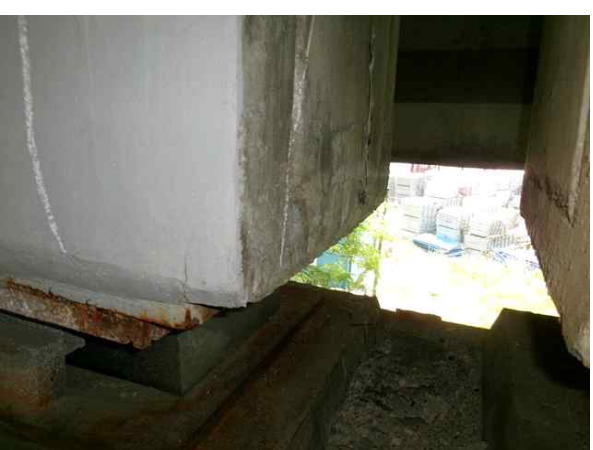
| S7-G3 균열 보수 | S7-G1~6 들뜸(1.0×0.3) |

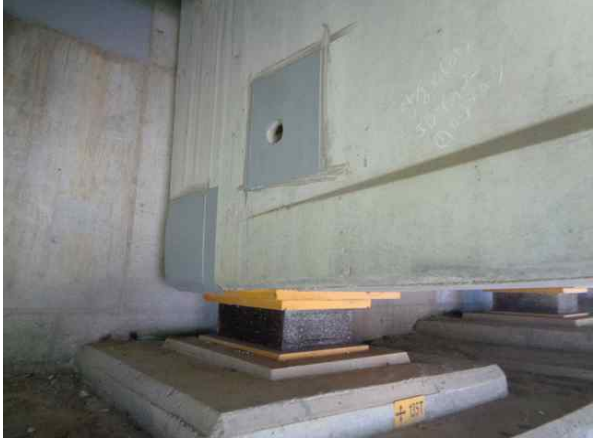
| S7-G6 들뜸(0.5×2.0) | S8-G2 박락 보수 |

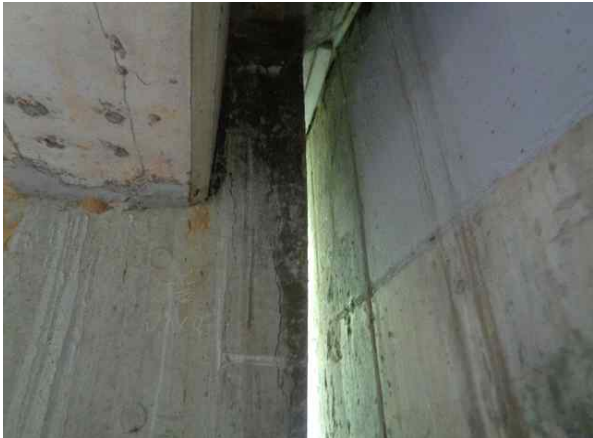
| S8-G1 들뜸(0.8×0.2) | S8-G1 들뜸(0.8×0.2) |

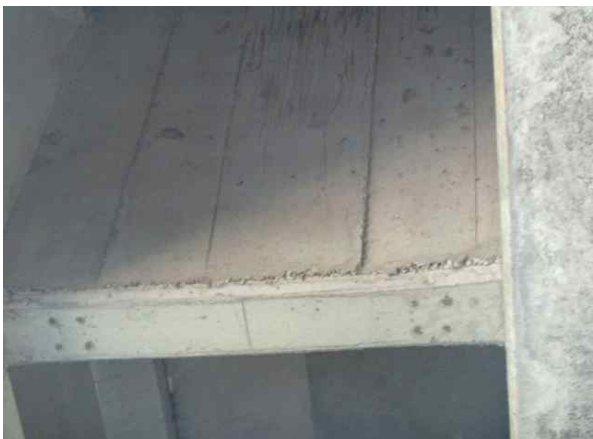
| S3 재료분리(0.1×1.5) | S3 재료분리(0.1×1.5) |

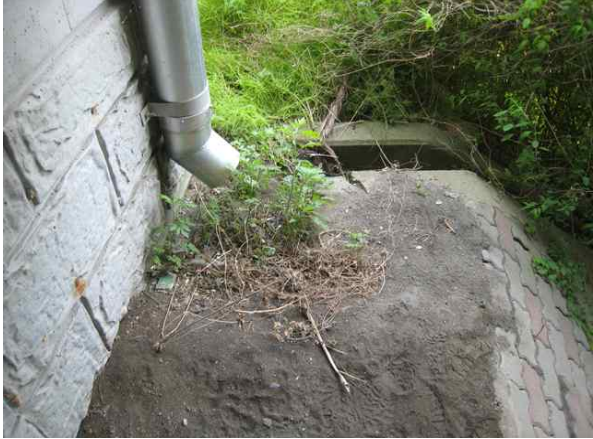
| A1 균열(0.3mm) | A1 법면배수로 토사퇴적 |

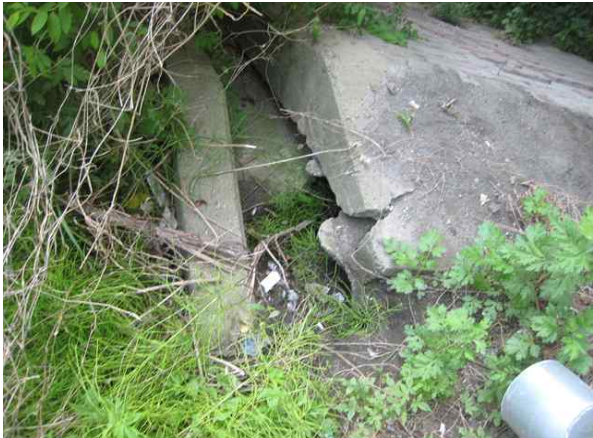
| A1 법면 배수로 파손 및 공동 | A1 법면 배수로 파손 및 공동 |

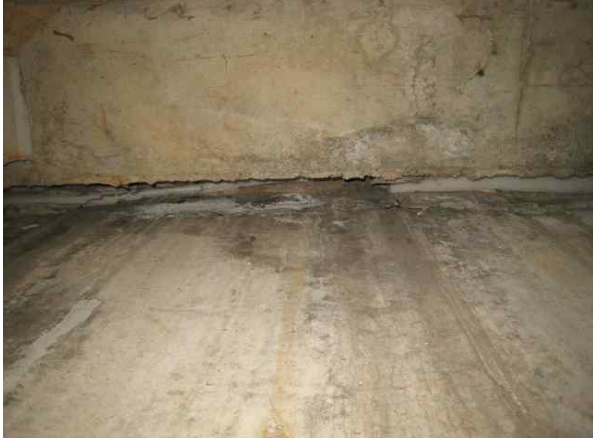
| A2 박리(0.6×0.6) | A2 파손(0.1×0.8) |

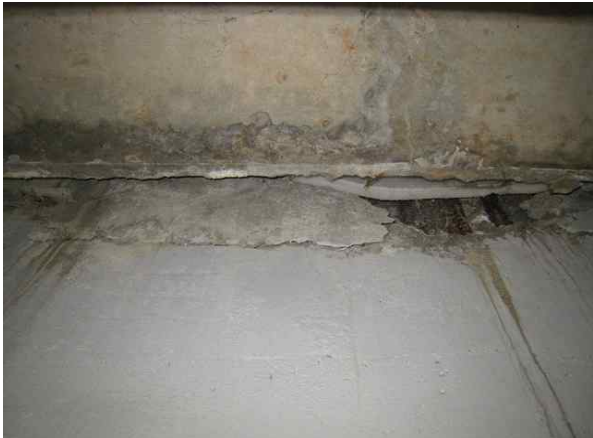
| A2 파손 및 철근노출 | A2 균열(0.3mm) |

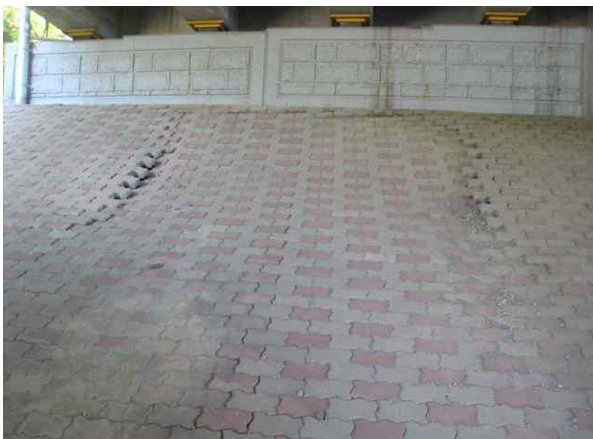
| A2 균열(0.3mm) | A2 보호블럭 침하 |

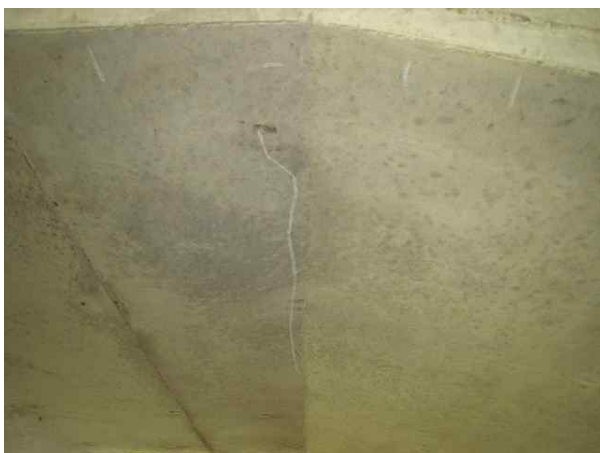
| <p>P2 코핑부 파손(0.3×0.1)</p> | <p>P2 코핑부 균열(0.2mm/0.5m)</p> |

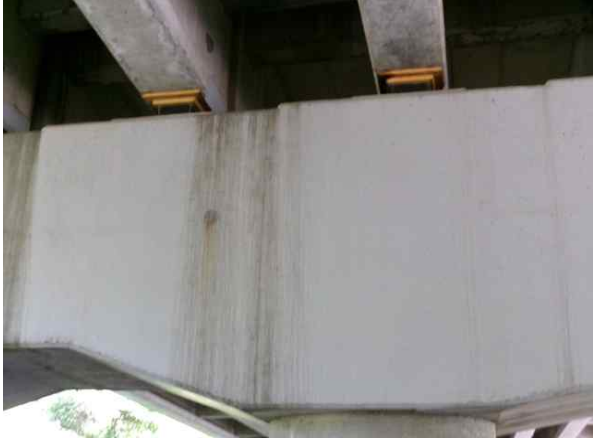
| P3 코평부 누수흔적(0.3×3.0) | P3 페콘크리트 적치 |

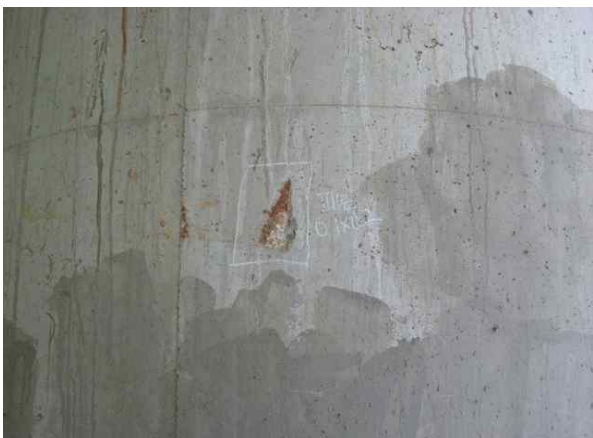
| P4 코평부 파손(0.1×0.2) | P4 코평부 파손(0.6×0.1) |

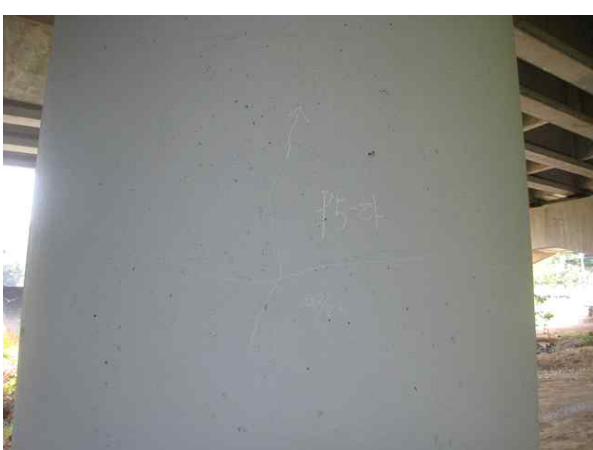
| P5 기둥부 망상균열(0.2mm) | P5 기둥부 균열(0.2mm) |

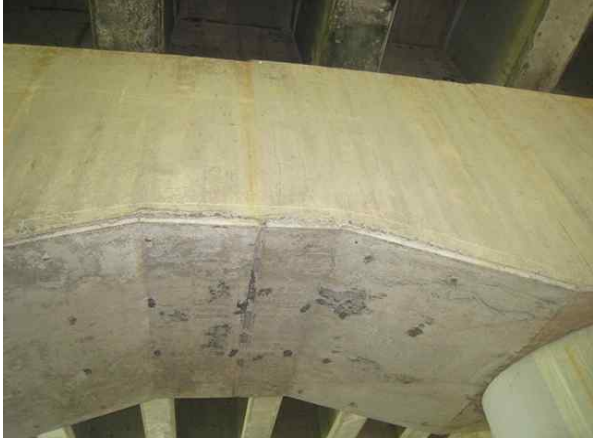
| P5 코핑부 재료분리(3.0×0.1) | P6 기둥부 균열(0.3mm) |

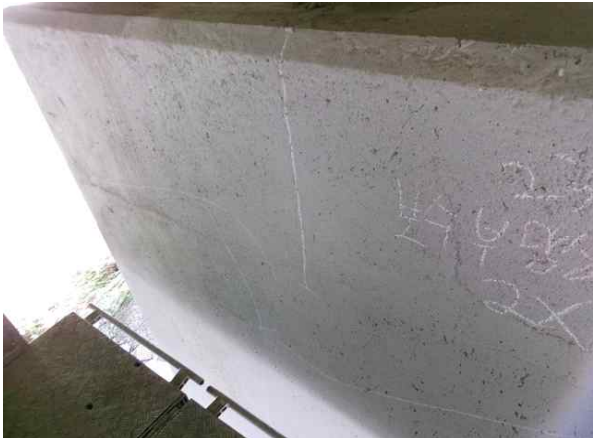
| P6 코핑부 망상균열(0.2mm) | P6 코핑부 균열부백태(0.1×0.1) |

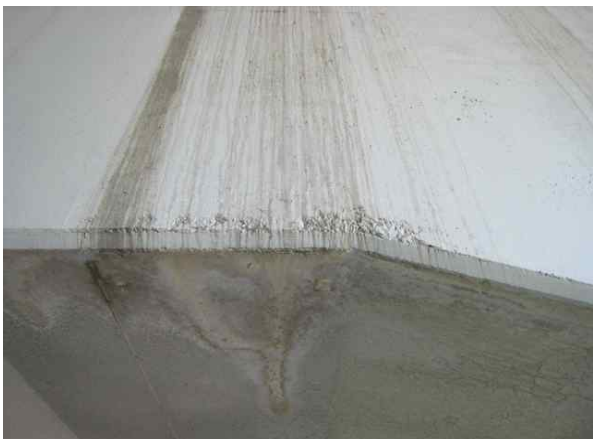
| P6 코핑부 재료분리(1.0×0.2) | P7 기둥부 균열(0.5×0.5) |

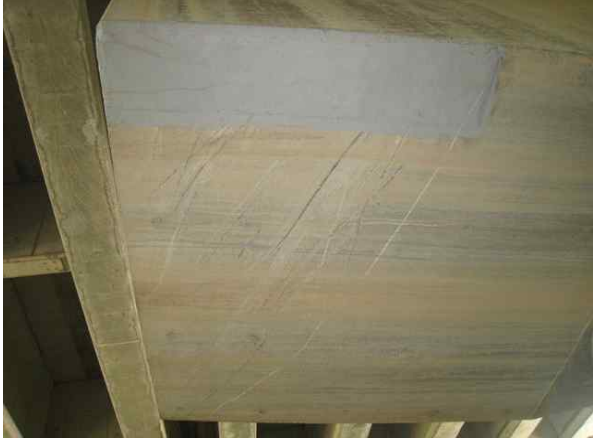
| P7 코평부 하면 균열(0.5×0.5) | A2-SH1 받침몰탈 균열(0.1mm/0.1m) |

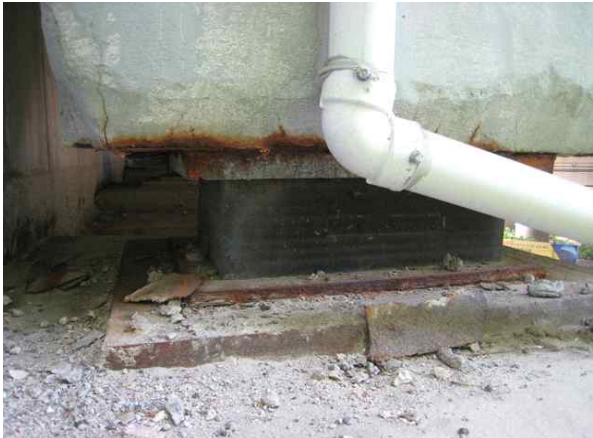
| A2-SH1 본체 부식 | P1-SH6 받침몰탈 균열(0.3mm/0.3m) |

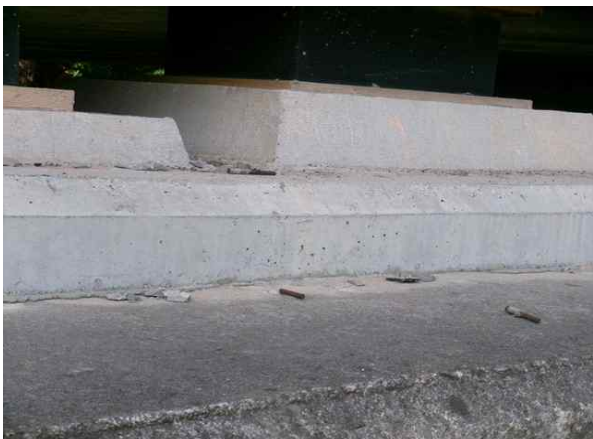
| P2-SH12 받침몰탈 균열(0.2mm/0.1m) | P3-SH5 본체 부식 |

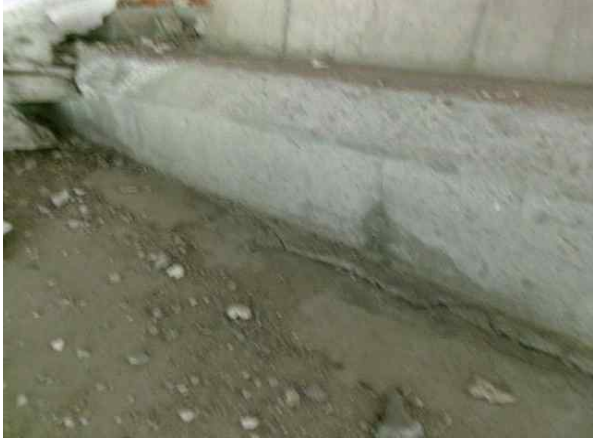
| P3-SH6 받침몰탈 균열(0.2mm/0.1m) | P4-SH6 몰탈 파손(0.1×0.5) |

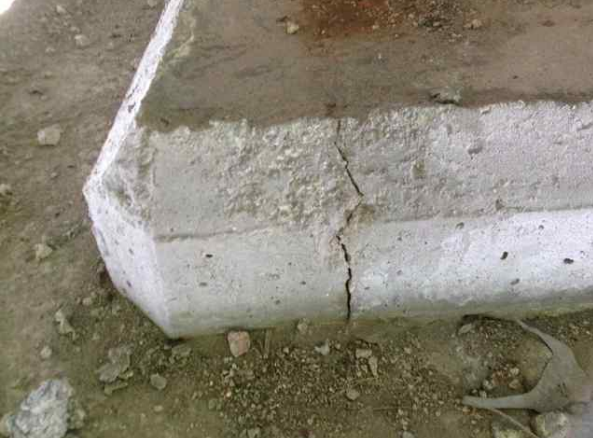
| P6-SH12 받침몰탈 균열(1.0mm/0.2m) | A1 차수판 볼트탈락 |

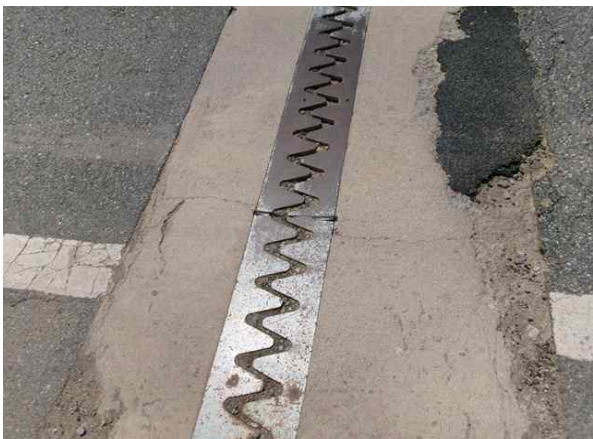
| A1 후타재 균열(0.2mm/0.4m) | A1 후타재 파손(0.1×4.0) |

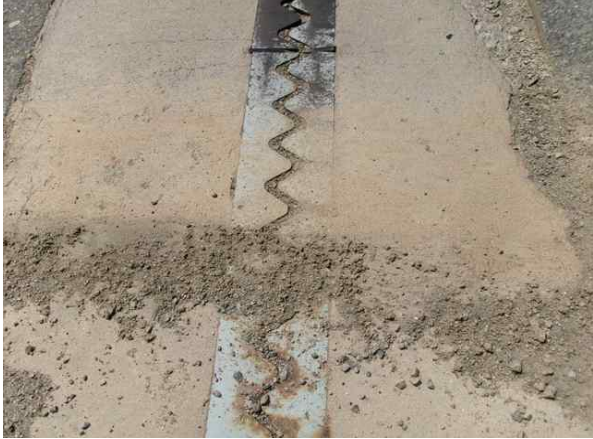
| A2 유간 토사퇴적(13.0) | A2 차수판 볼트탈락 |

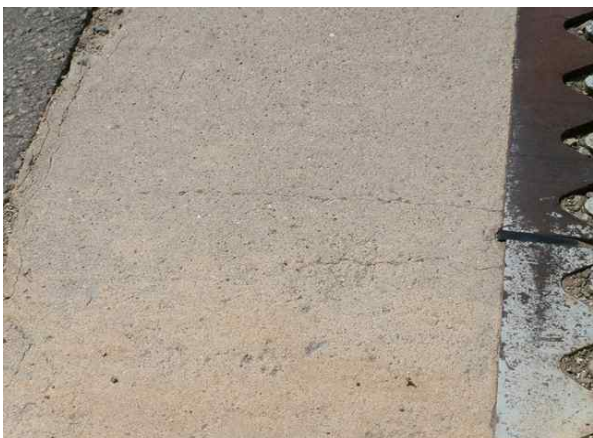
| A2 후타재 균열(0.2mm/0.5m) | A2 후타재 파손(0.1×0.8) |

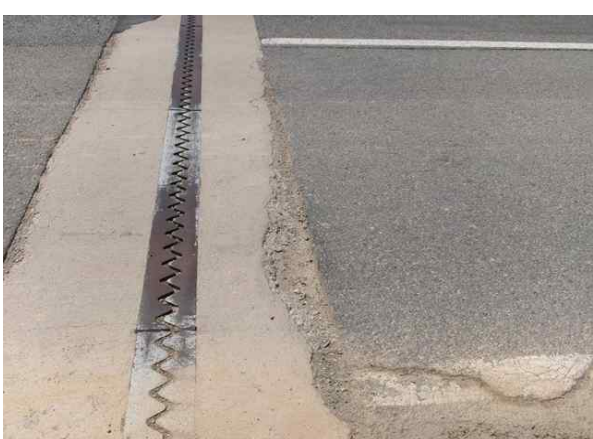
| A2 후타재 파손(0.1×2.0) | P3 신축이음 본체 탈락 |

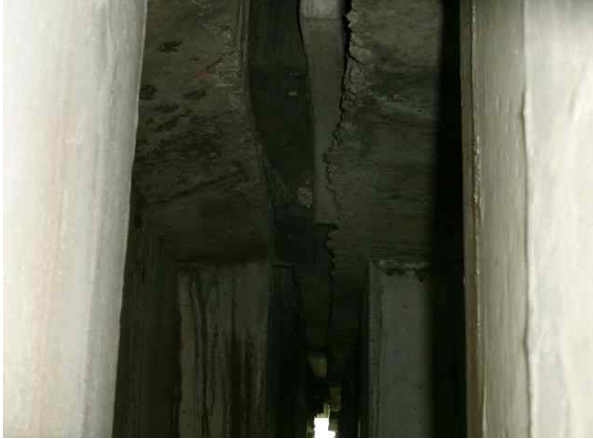
| P3 신축이음 하부 누수 | P3 유간 토사퇴적(13.0) |

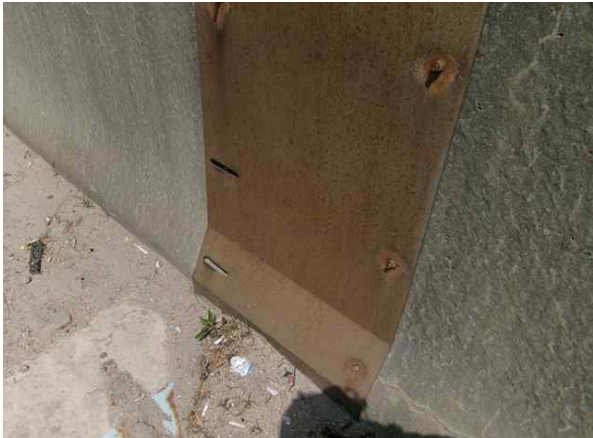
| P3 차수판 볼트탈락 | P3 후타재 균열(0.2mm/0.4m) |

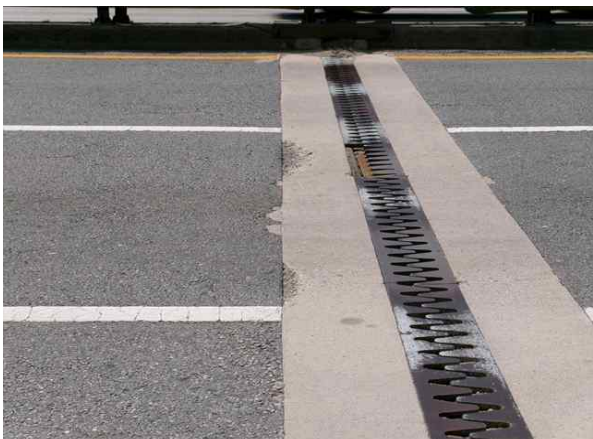
| P3 후타재 파손(0.2×0.5) | P6 후타재 파손(0.1×2.0) |

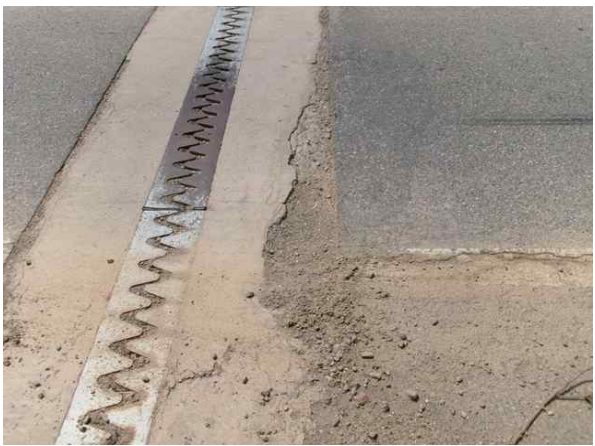
| P6 후타재 박리(0.1×1.2) | P6 후타재 파손(0.1×1.2) |

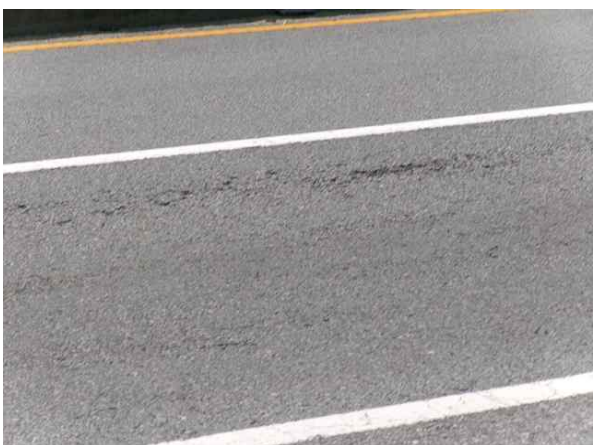
| S1 아스콘 균열(4.0) | S1 아스콘 마모(2.0×0.6) |

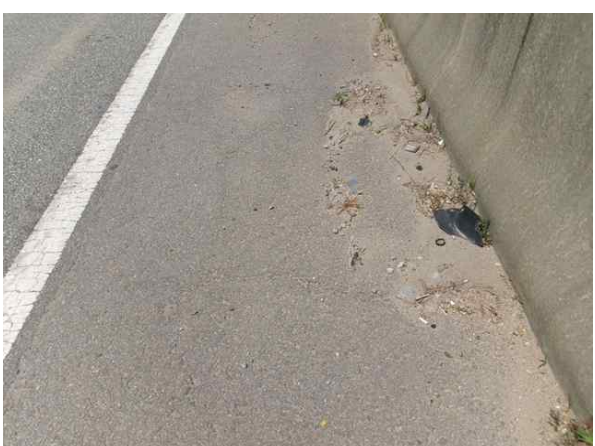
| S1 아스콘 균열(20.0) | S2 아스콘 균열(1.4) |

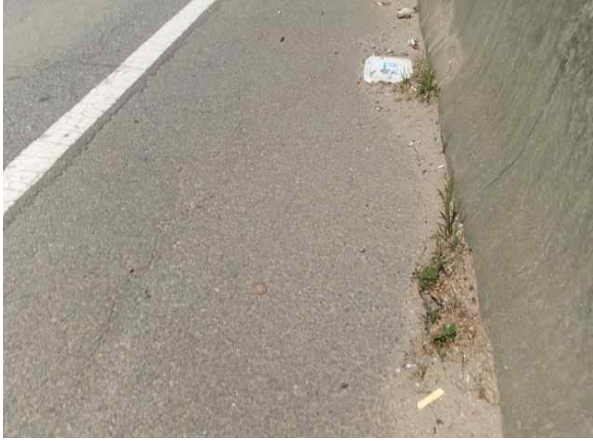
| S3 아스콘 균열(7.0) | S4 아스콘 망상균열(1.5×11.0) |

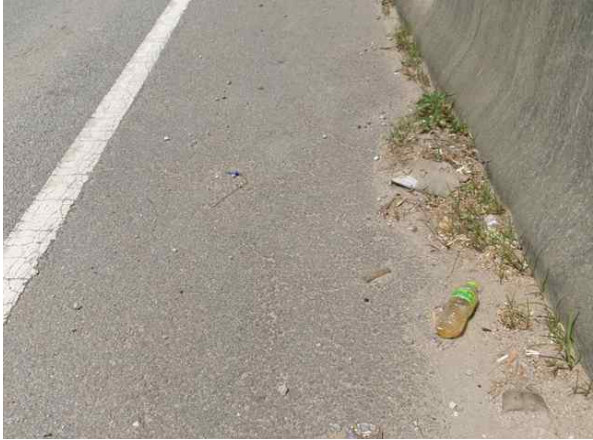
| S4 아스콘 망상균열(2.0×2.0) | S5 아스콘 망상균열(1.5×9.0) |

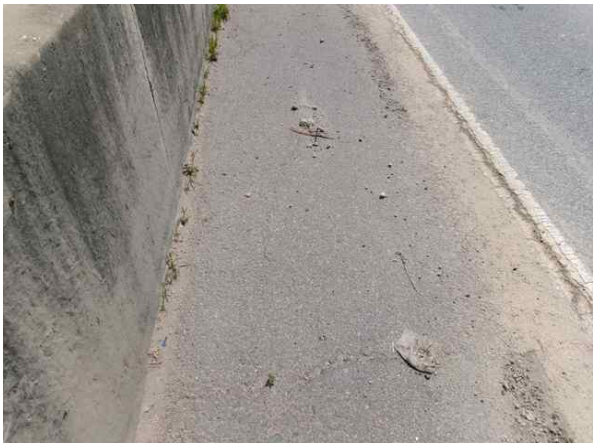
| S5 아스콘 균열(5.0) | S6 아스콘 망상균열(1.5×5.0) |

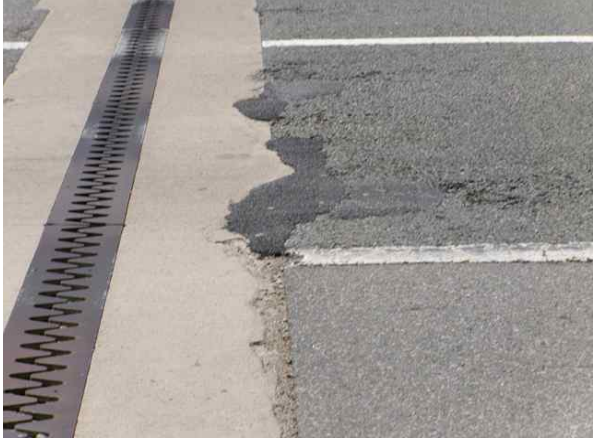
| S6 아스콘 균열(1.5) | S6 아스콘 패임 보수 |

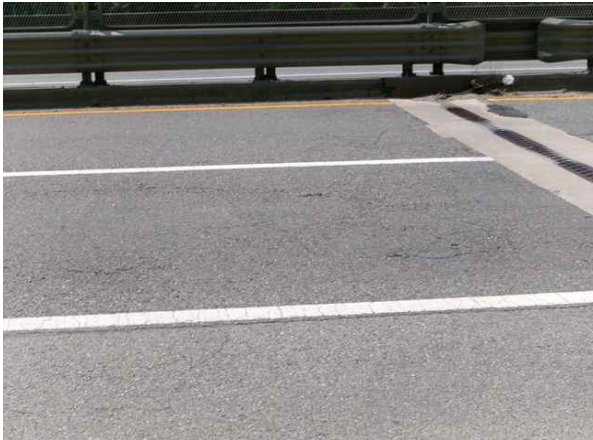
| S6 포장 균열(30.0) | S7 아스콘 망상균열(0.2×0.2) |

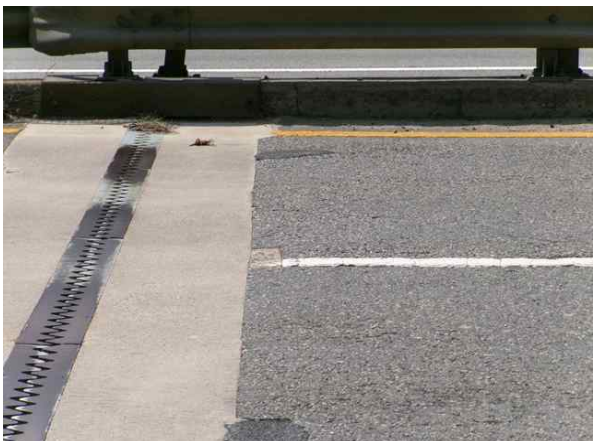
| S7 포장 균열(1.5) | S8 아스콘 패임 보수 |

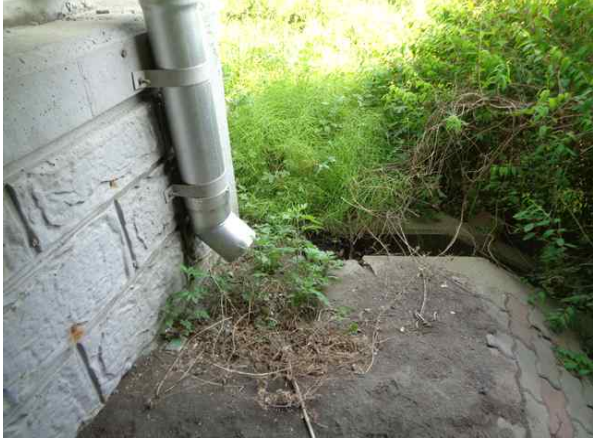
| <p>S1 배수관 길이부족</p> | <p>S1 배수구 막힘</p> |

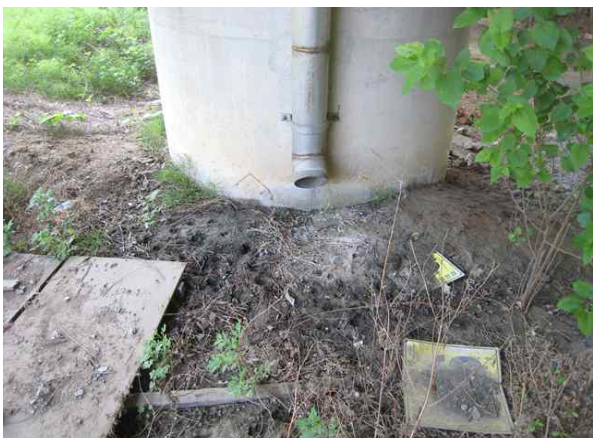
| <p>P2 배수관 길이부족</p> | <p>S3 배수구 막힘</p> |

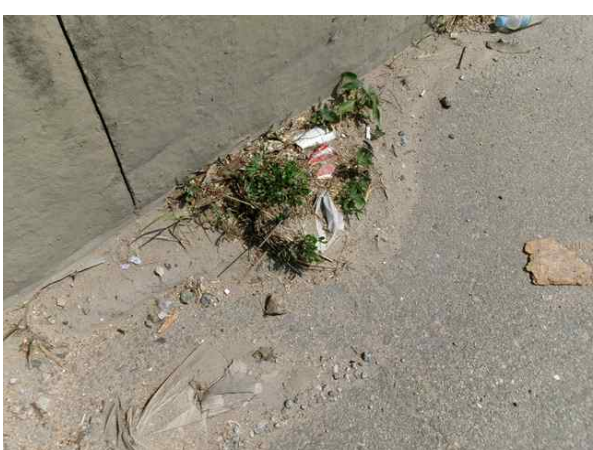
| <p>S6 배수구 막힘</p> | <p>S7 배수구 막힘</p> |

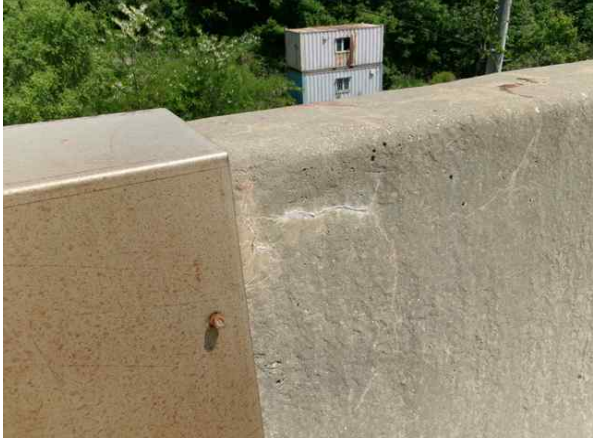
| <p>S1 균열부 백태(0.1×0.2)</p> | <p>S1 균열부 백태(0.2×1.0)</p> |

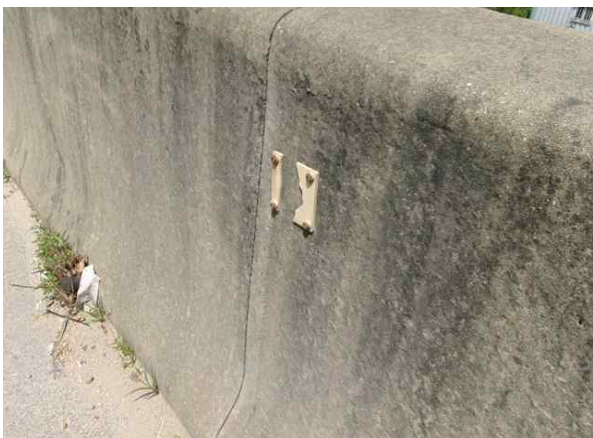
| <p>S1 텔레이네이트 파손</p> | <p>S1 백태(0.1×0.2)</p> |

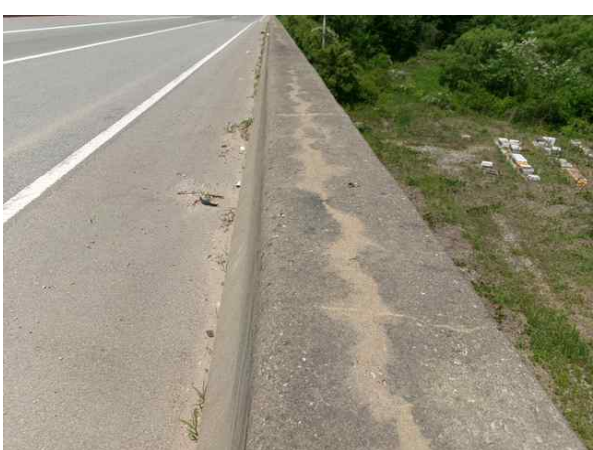
| <p>S1 파손(0.3×0.3)</p> | <p>S2 균열(0.1mm/5.0m)</p> |

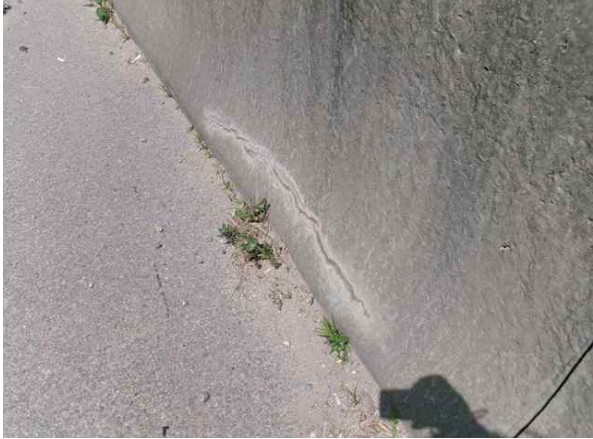
| S2 균열(0.3mm/0.8m) | S3 망상균열(0.2×25.0) |

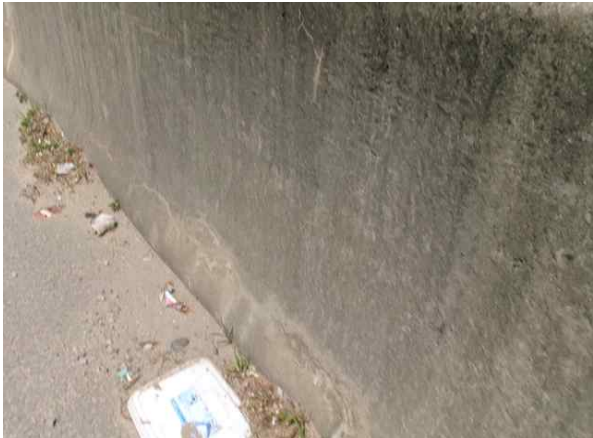
| S4 균열(0.2mm/2.0m) | S4 망상균열(1.2×1.0) |

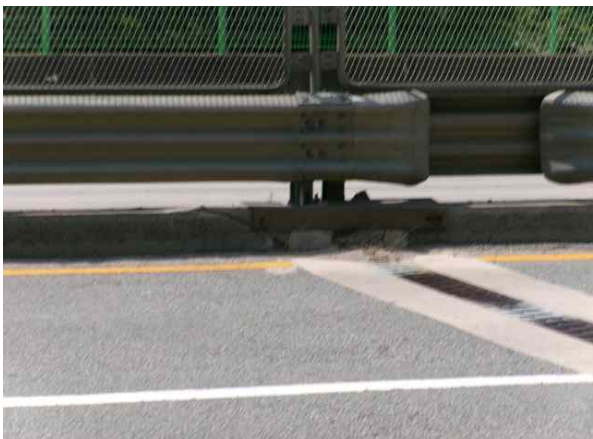
| S4 중분대 파손(0.2×0.6) | S5 망상균열(1.2×1.2) |

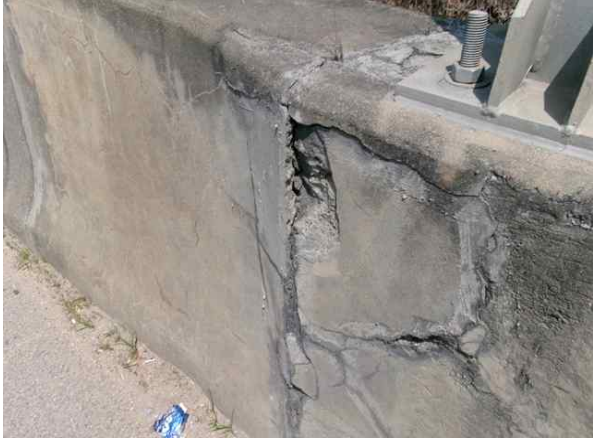
| <p>S5 보수부 들뜸 및 파손(0.8×1.5)</p> | <p>S5 중분대 파손(0.5×2.0)</p> |

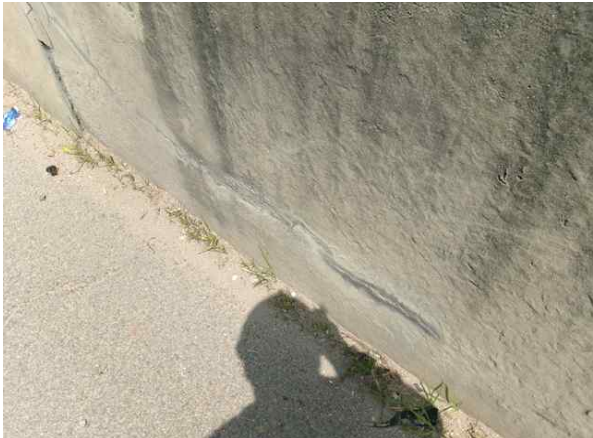
| <p>S5 충분리(0.1×1.0)</p> | <p>S4 균열(0.1mm/0.3m)</p> |

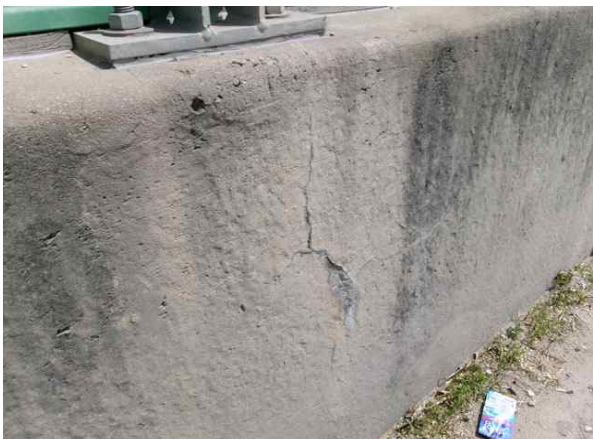
| <p>S6 균열부 백태(0.1×0.5)</p> | <p>S6 델리네이트파손</p> |

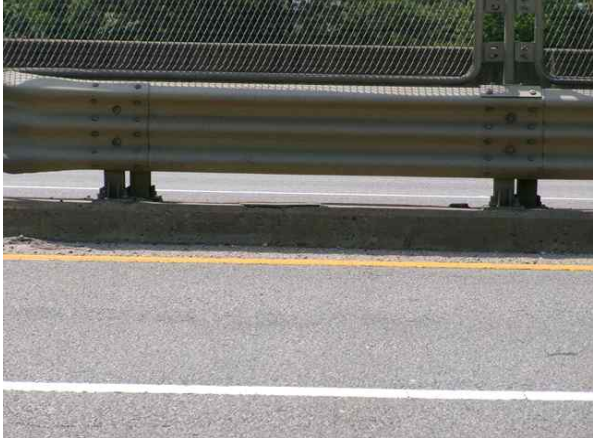
| S6 중분대 파손(0.3×0.6) | S7 균열부 백태(0.1×0.2) |

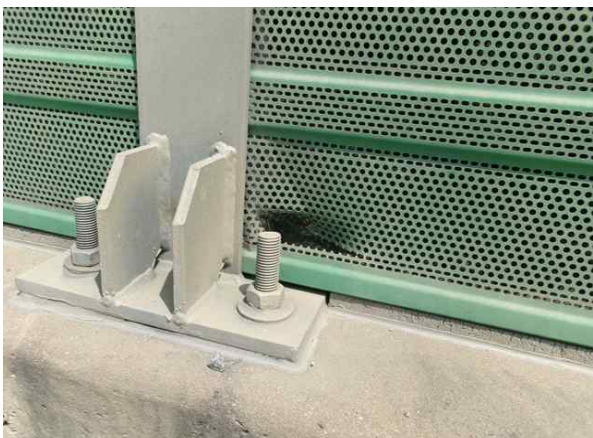
| S7 방음벽 파손 | S7 균열(0.1mm/0.5m) |

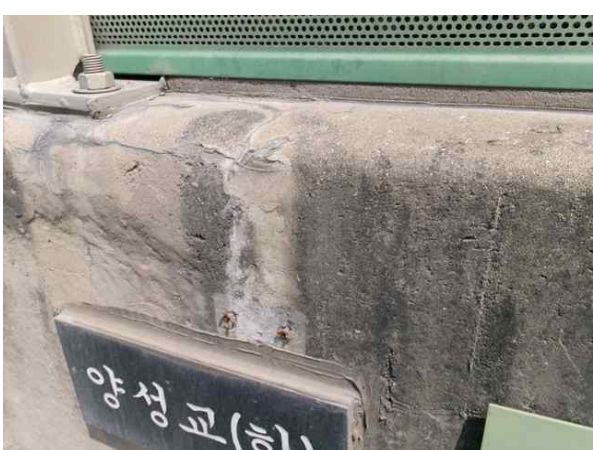
| S8 균열부 백태(0.2×30.0) | S8 텔리네이트 파손 |

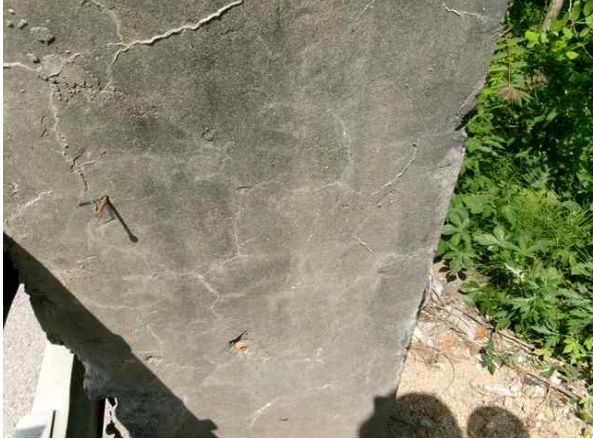
| <p>S5 망상균열(1.0×1.0)</p> | <p>S5 박락(0.2×0.2)</p> |

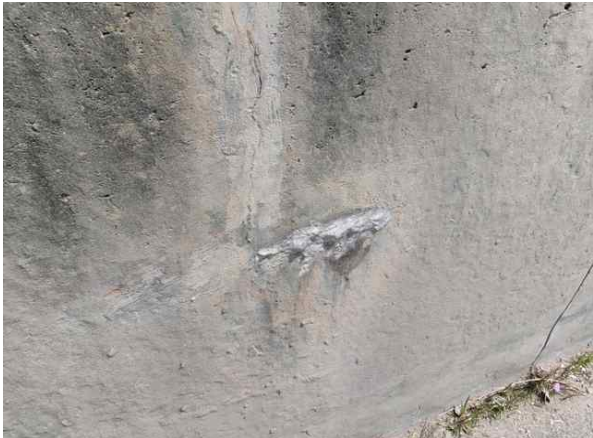
| <p>S8 백태(0.1×0.2)</p> | <p>S8 철근노출(0.1×0.1)</p> |
