## 2. 천안2교

## 손상현황 사진

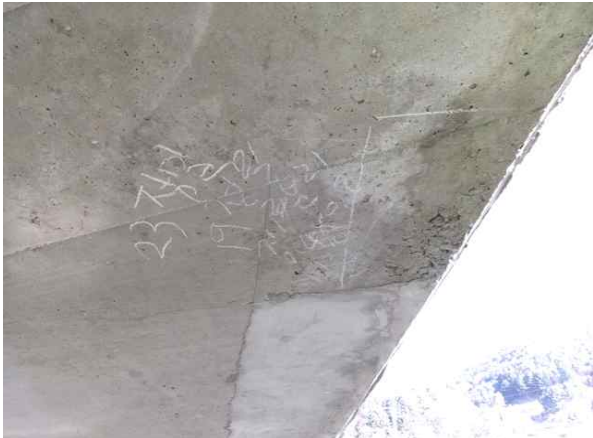
| S1 재료분리 (0.4m×0.2m) | S1 파손 (0.3m×2.0m) |

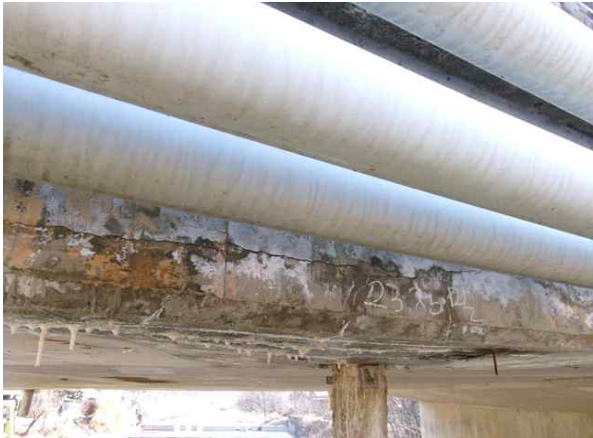
| S2 파손 (2.0m×0.3m) | S2 파손 및 철근노출 (0.3m×0.3m) |

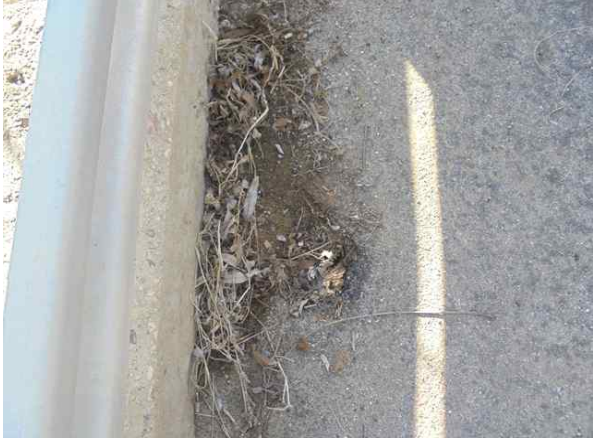
| <p>S1 배수구 상태 양호</p> | <p>S2 배수관 상태 양호</p> |

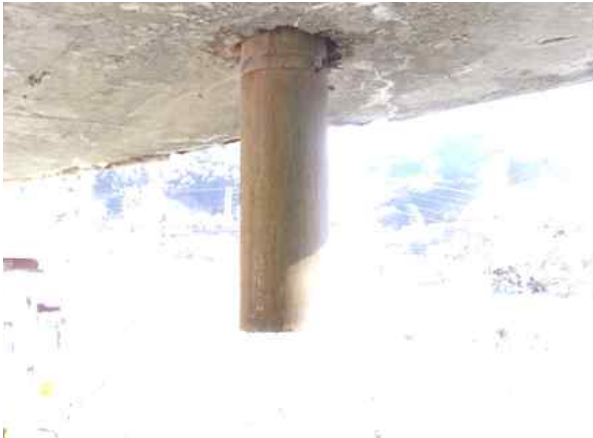
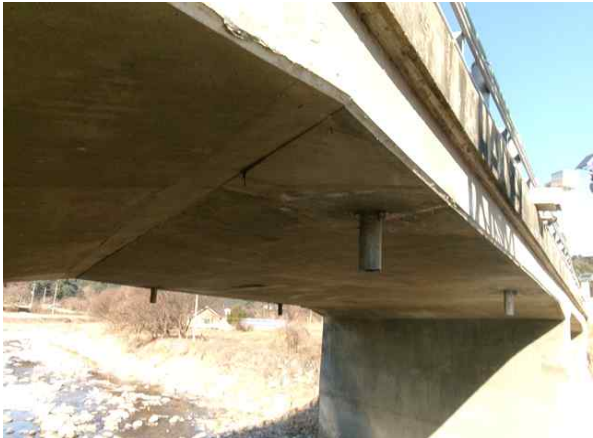
| <p>배수관 상태 양호</p> | <p>배수관 상태 양호</p> |

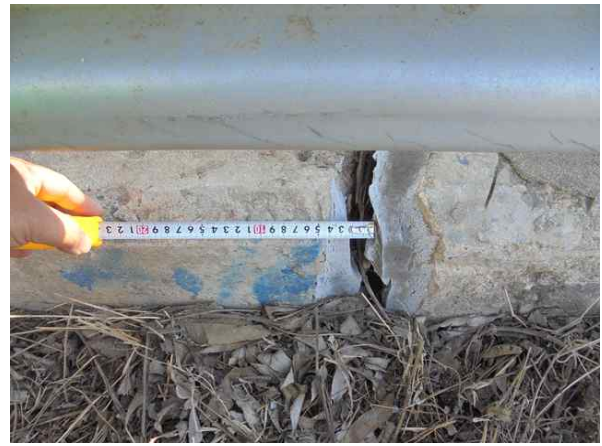
S1 연석 이격 (30.0mm)

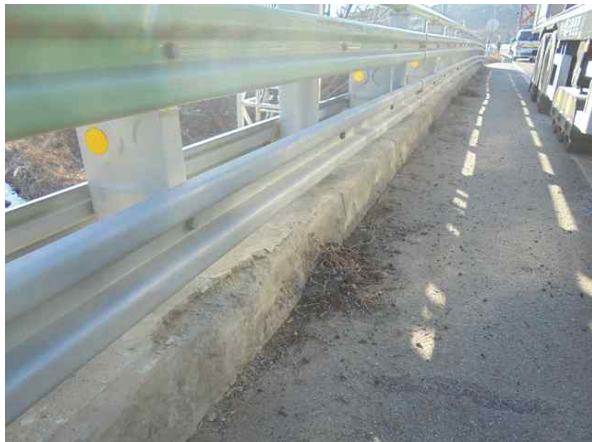
S1 연석 표면박리 (0.7m×12.5m)

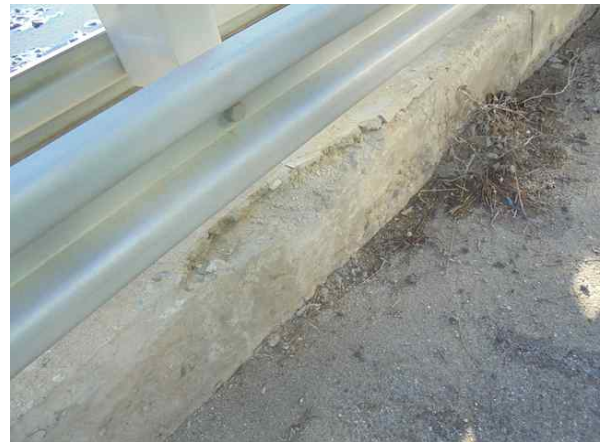
S1 연석 표면박리 (0.7m×12.5m)

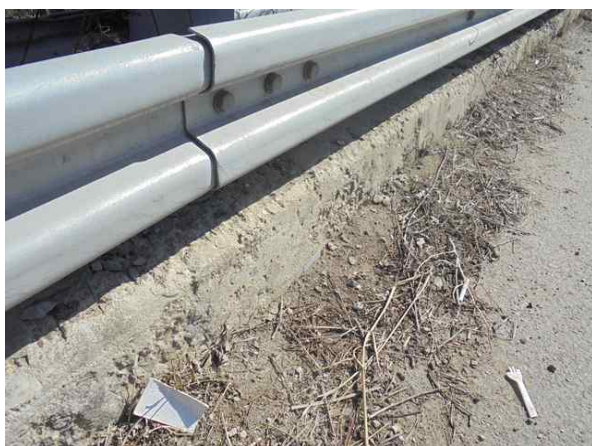
S1 접속부 연석 파손 (0.2m×0.2m×2EA)

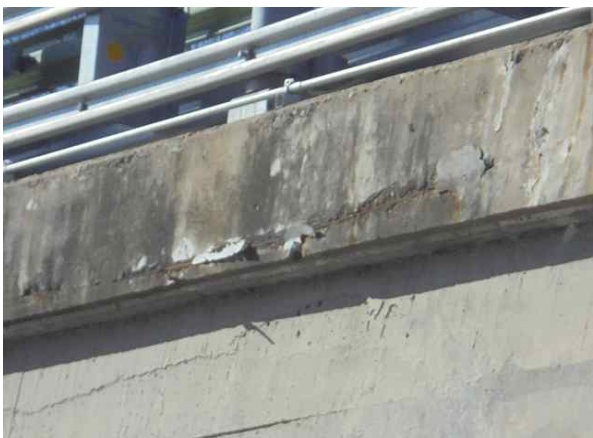
| <p>S2 외측 철근노출 (0.1m×3.0m)</p> | <p>S2 연석 표면박리 (0.7m×15.0m)</p> |
