### 3. 도 곡 2 교

바닥판하면 손상현황

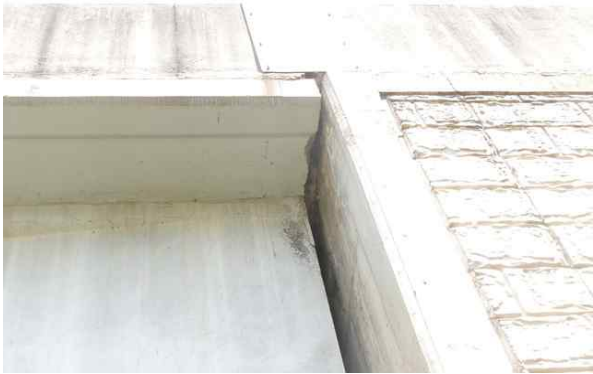
| S1 파손(0.4×0.1) | S2 망상균열(0.4×2.0) |

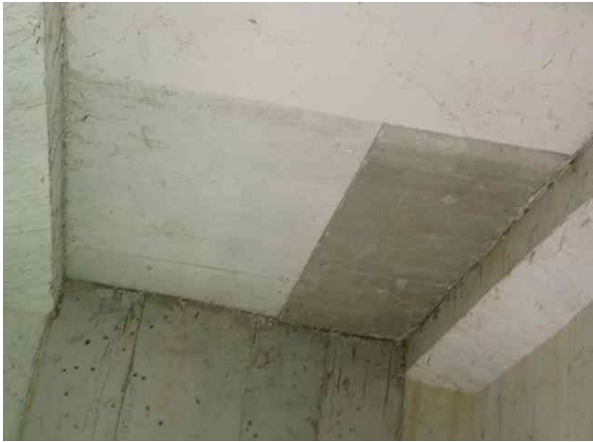
| S2 망상균열(0.4×2.0) | S2 망상균열(1.5×2.5) |

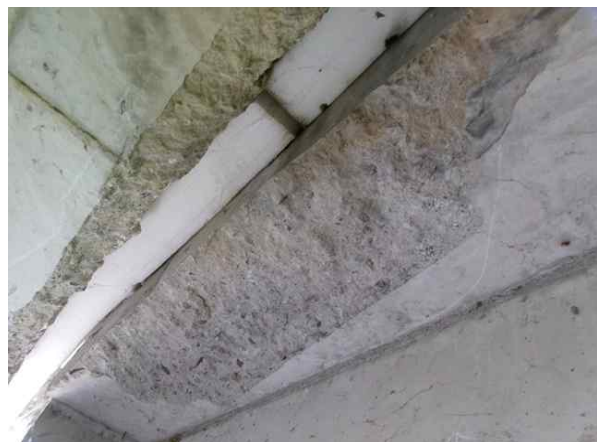
S3 파손(0.4×1.0)

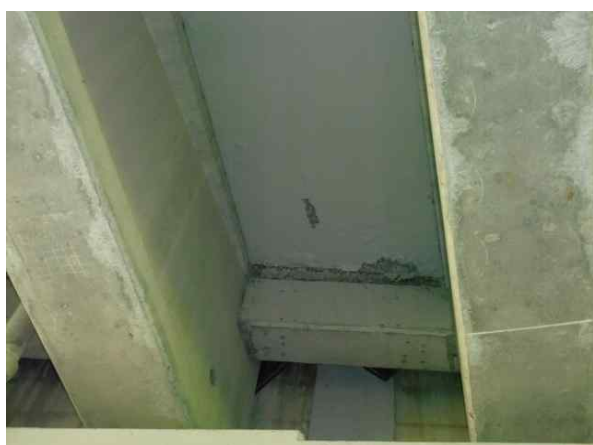
S4 보수부 박리(0.2×0.3)

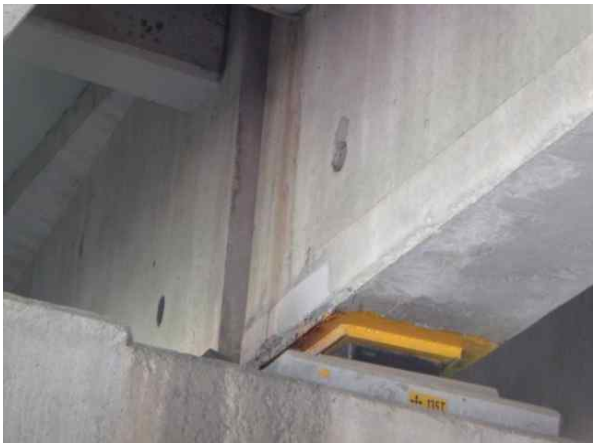
| S2-G7 보수부 박락(0.1×0.2) | S2-G8 보수부 박락(0.2×0.2) |

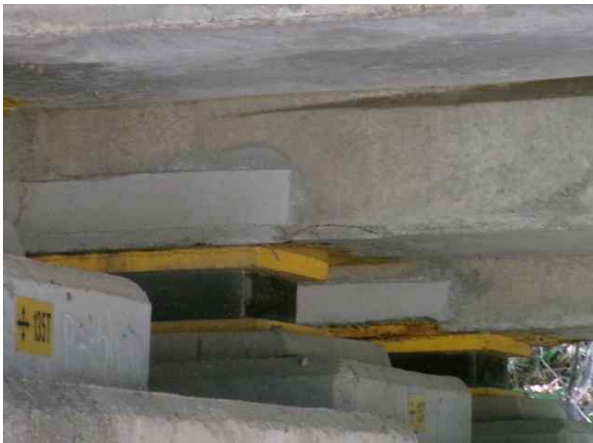
| S2-G8 보수부 박락(0.2×0.2) | S3-G1 인양홀 파손(0.1×0.1) |

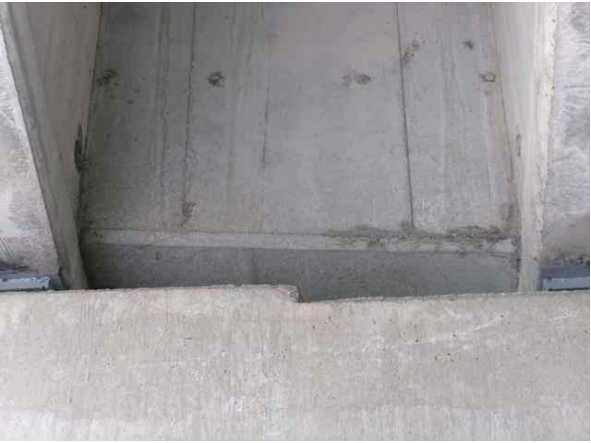
| S2 보수부 박리(0.2×0.2) | S1 균열(0.3mm/0.3m) |

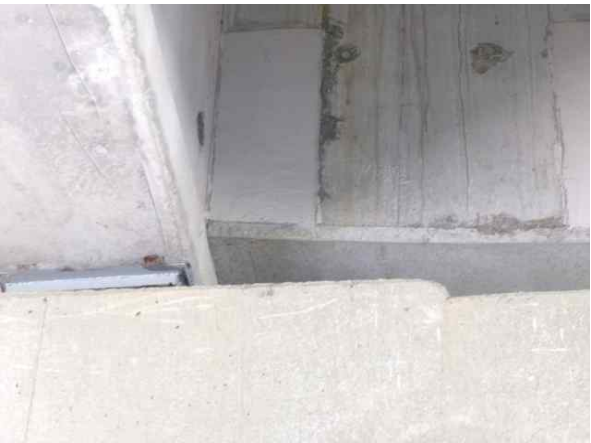
| S1 균열(0.3mm/0.3m) | S1 균열(0.3mm/0.3m) |

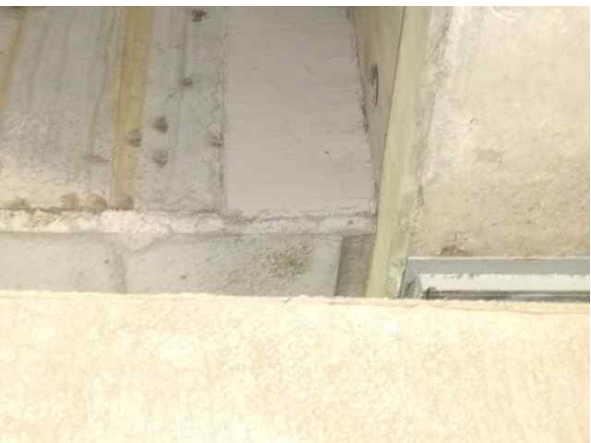
| S2 들뜸(0.2×0.3) | S2 들뜸(0.2×0.3) |

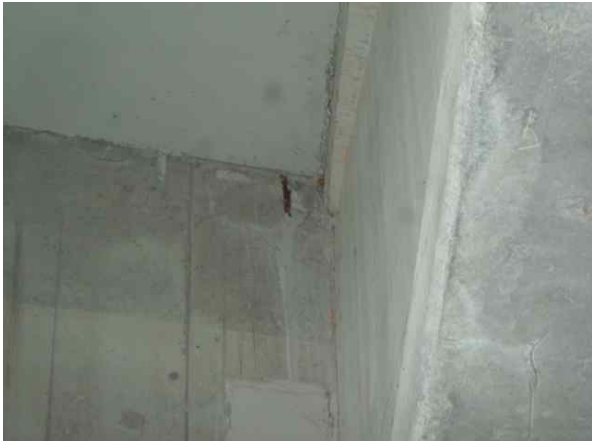
S2 박락 및 철근노출(0.2×0.3)

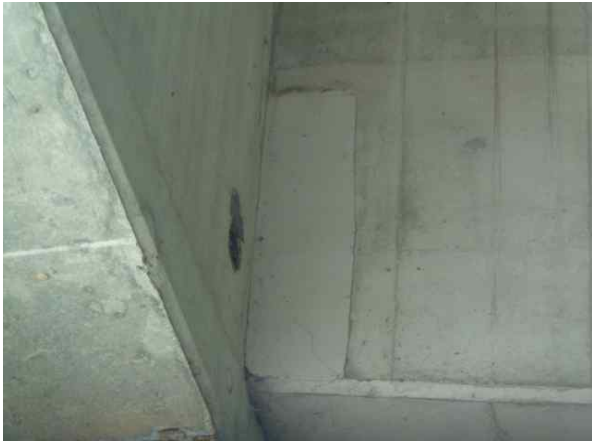
S3 균열(0.2mm/0.2m)

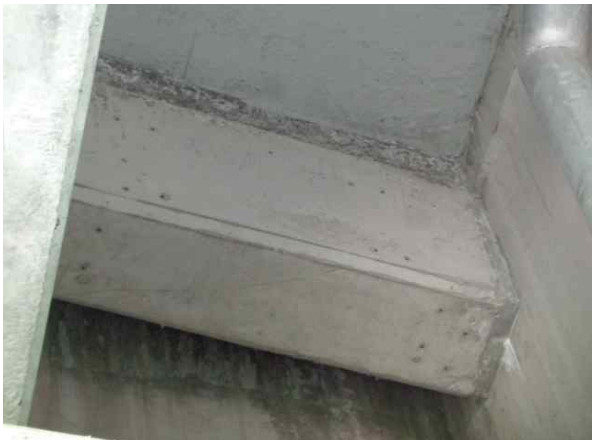
S7 백태(1.5×0.1)

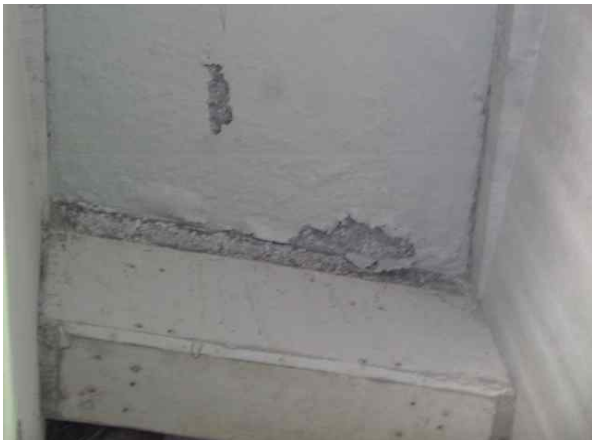
S7 백태(1.5×0.1)

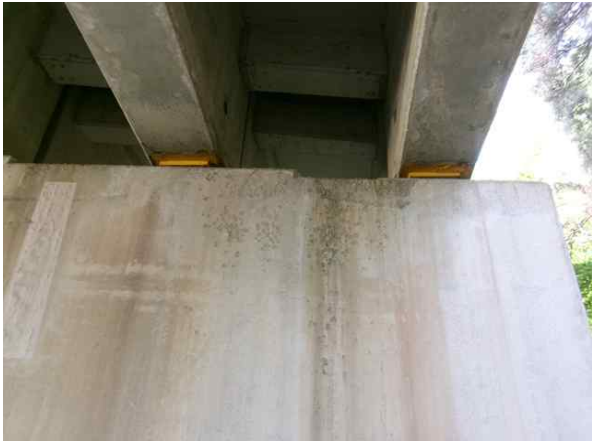
| P2 박리(1.5×2.5) | P2 철근노출(0.2×0.5) |

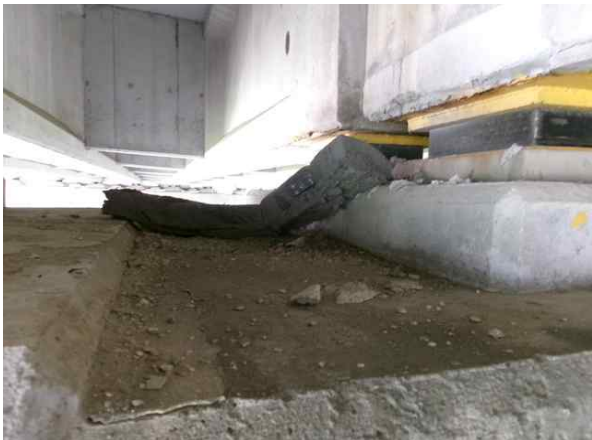
| P2 폐콘크리트 적치(1.5×2.5) | P3 균열(0.1mm/0.3m) |

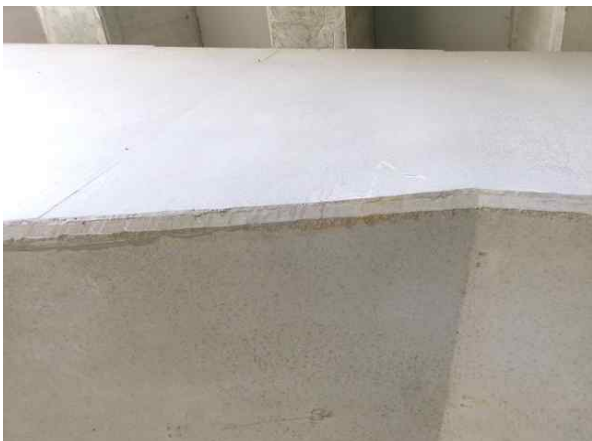
| P3 박리(1.5×0.1) | P3 파손(0.1×0.1) |

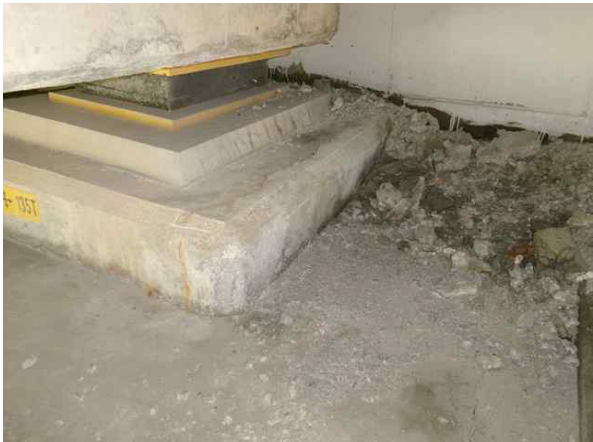
| A1-SH4 받침콘크리트 파손(0.3×0.8) | A1-SH4 받침콘크리트 박리(0.1×0.1) |

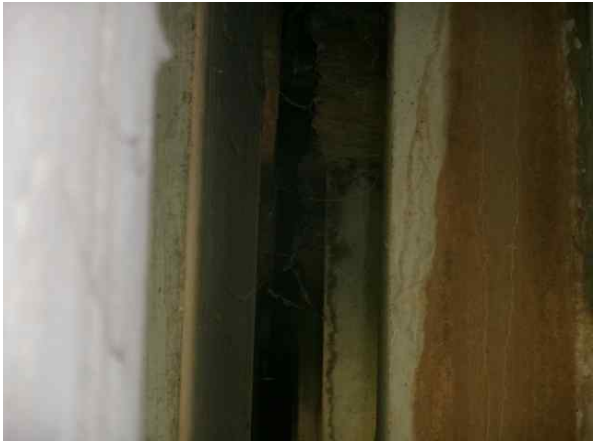
| P2 신축이음 하부누수(0.4×0.2) | P2 유간 토사퇴적(1.9) |

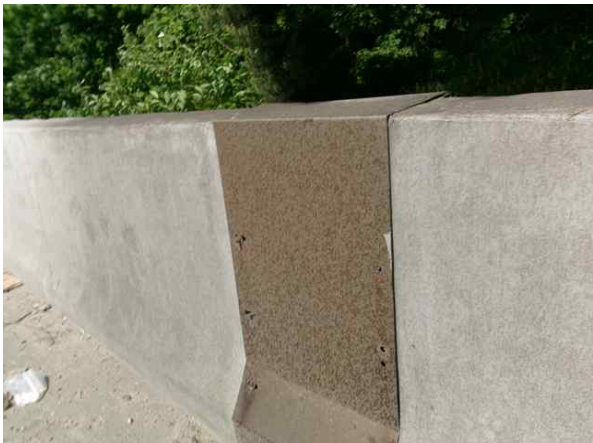
| P2 차수판 볼트탈락 | P2 후타재 균열(0.1mm/0.3m) |

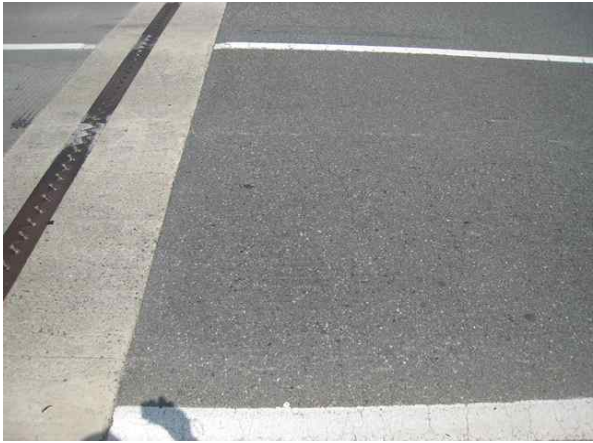
| S1 접속부 아스콘 균열(3.0) | S1 접속부 아스콘 패임 |

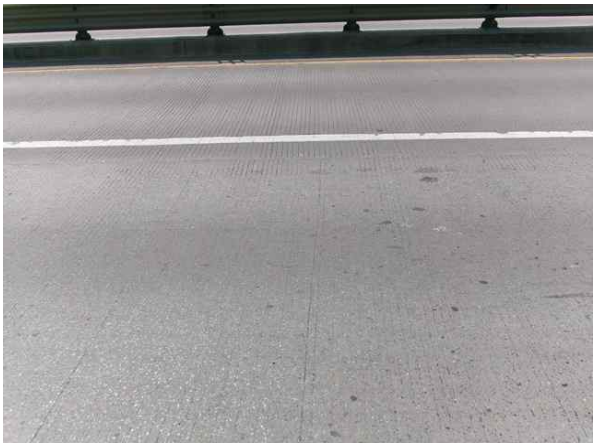
| S1 포장 균열 | S1 포장 망상균열 |

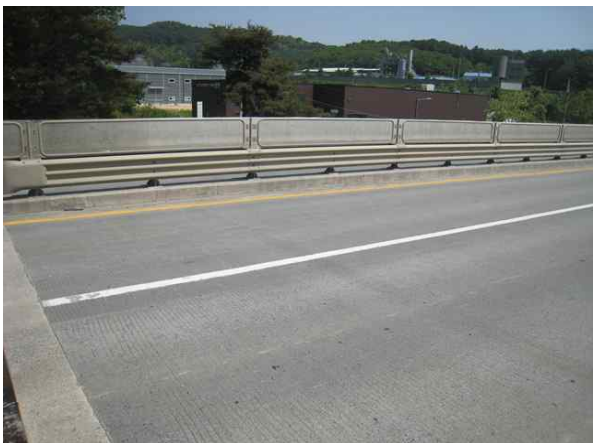
| S2 포장 망상균열 | S3 포장 마모 |

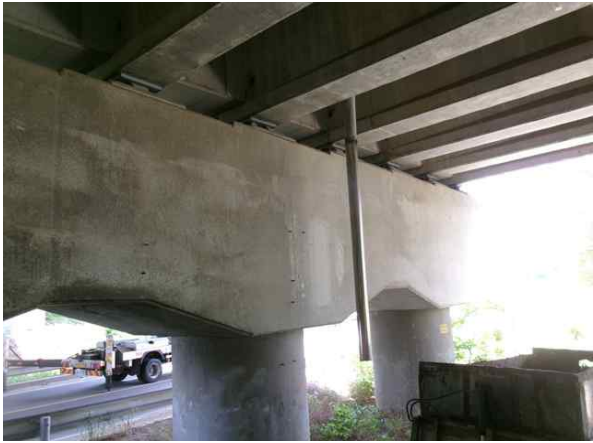
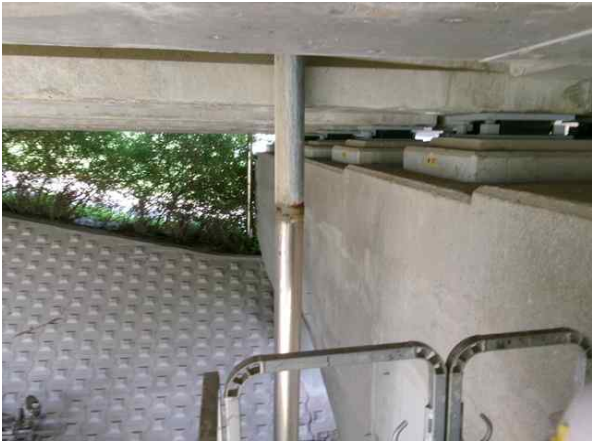
| P1 배수관 고정볼량(손상 경미) | P1 배수관 고정볼량(손상 경미) |

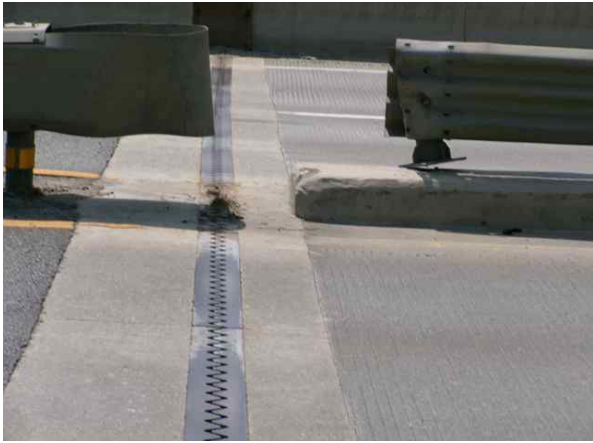
| S1 중분대 파손(0.2×0.2) | S1 차광막탈락(2.0) |

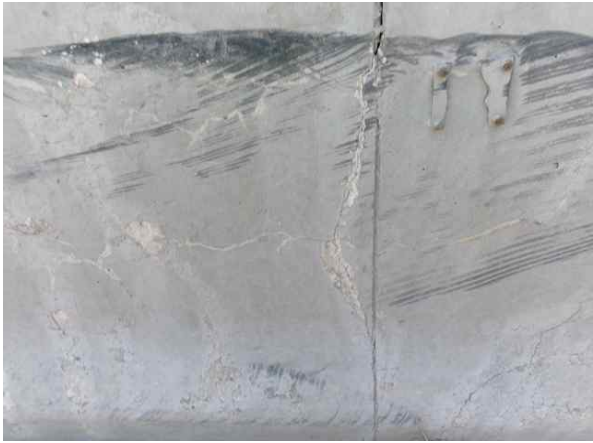
| S4 균열(0.3mm/1.2m) | S4 보수부 박리(0.1×0.1) |

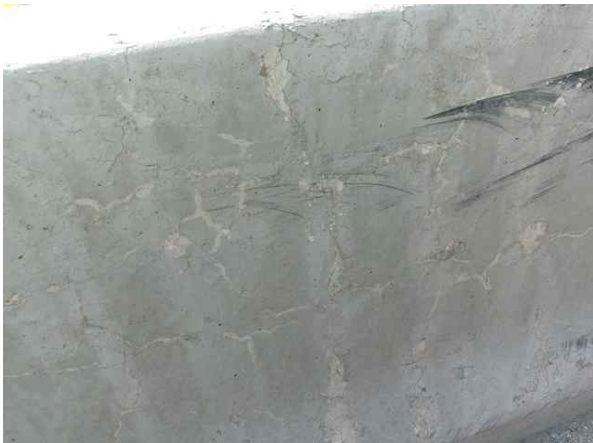
| S4 균열(0.2mm/0.8m) | S4 접속부 용벽 균열(0.3mm/1.0m) |

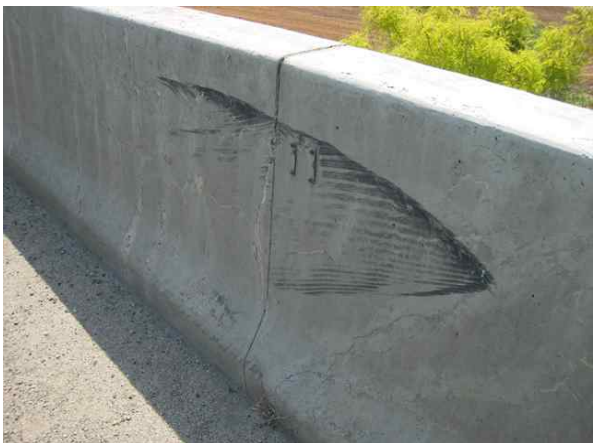
| S4 접속부 보수부 박리(0.1×0.3) | S4 접속부 균열(0.2mm/0.5m) |

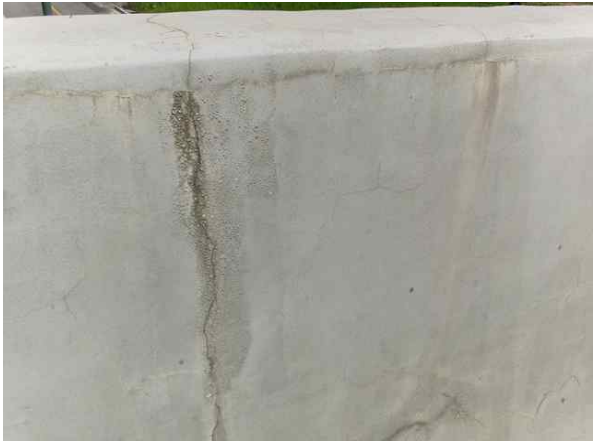
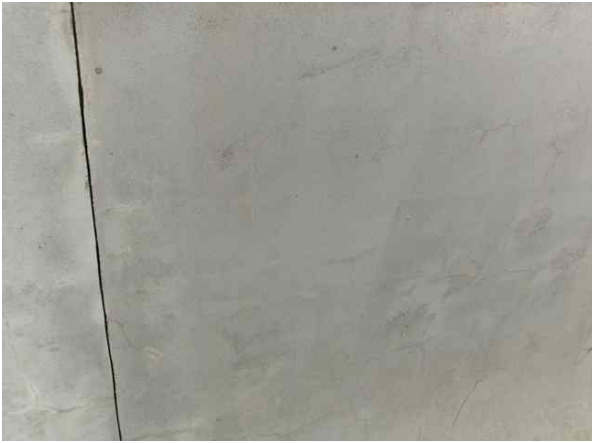
| S1 보수부 망상균열 (0.3×2.0) | S1 보수부 망상균열 (0.3×2.0) |

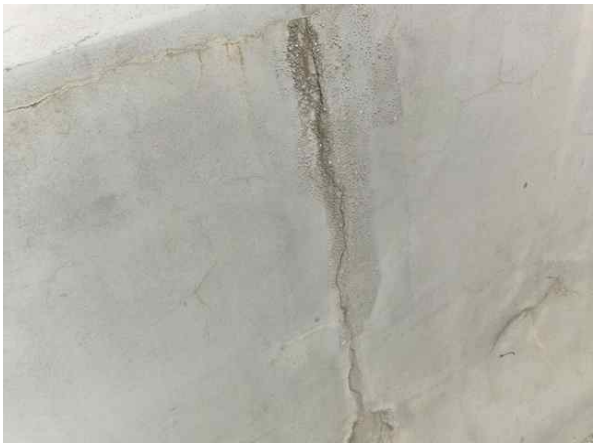
| S1 채균열 (0.1mm/1.2m) | S1 채균열 (0.2mm/1.4m) |
