**2017년 상반기 시설물 정기점검 용역**  
**정 기 점 검 사 진 첵**  
**[2종 절토사면 손상현황 사진첩]**

**2017. 06.**

**新 대구부산고속도로주식회사**  
**New DAEGU BUSAN Expressway Co., Ltd.**

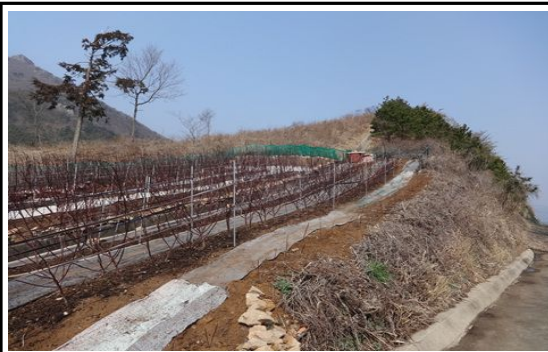
10.87K 자연사면 불법경작

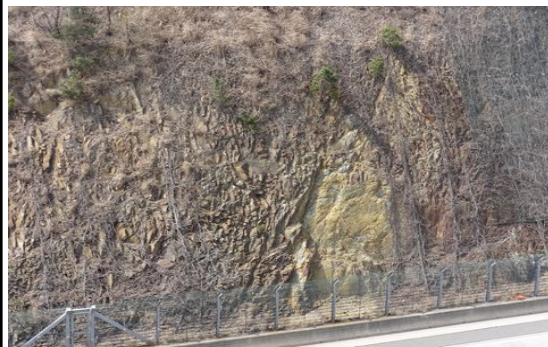
10.91K 1단 심한풍화

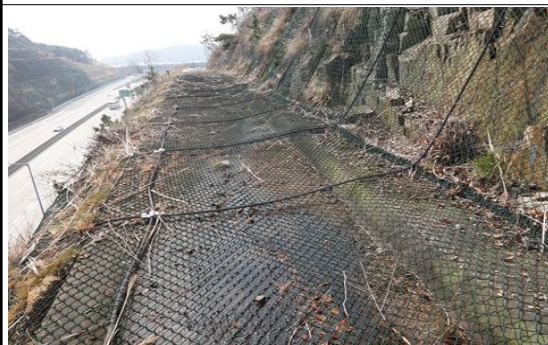
10.97K 1소단배수로 토사퇴적

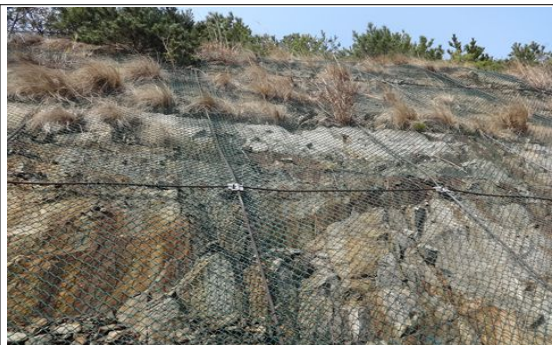
10.99K 2단 이완암

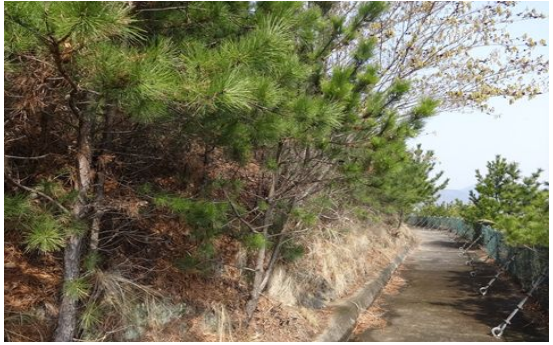
| 11.01K 3단 수목 | 11.05K 2단 수목 |

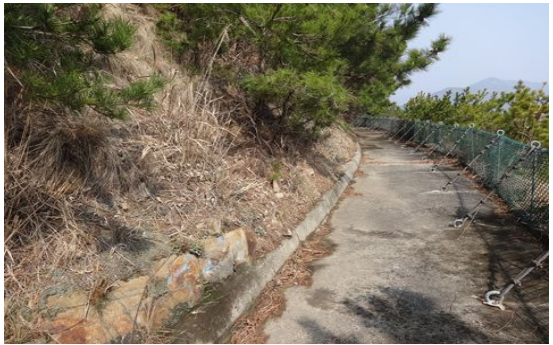
| 11.03K 3단 암노출 | |

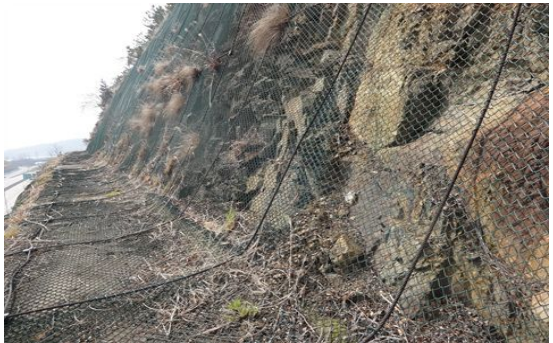
| 11.05K 2단 이완암 | |

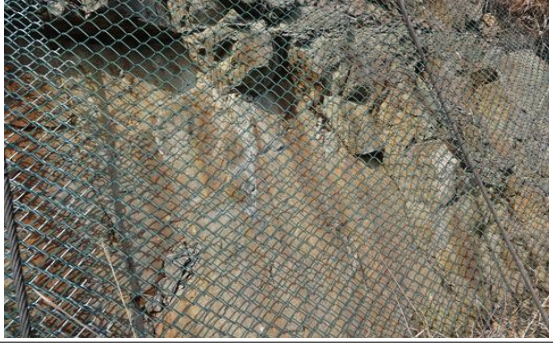
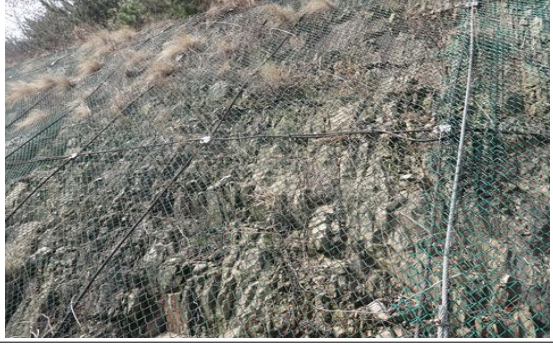
| 11.05K 2단 절리부 누수 | 11.09K 2단 이완암 |

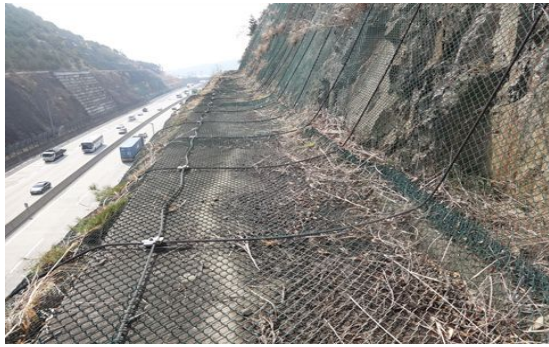
| 11.11K 1소단배수로 균열 0.3 | 11.11K 1소단배수로 토사퇴적 |

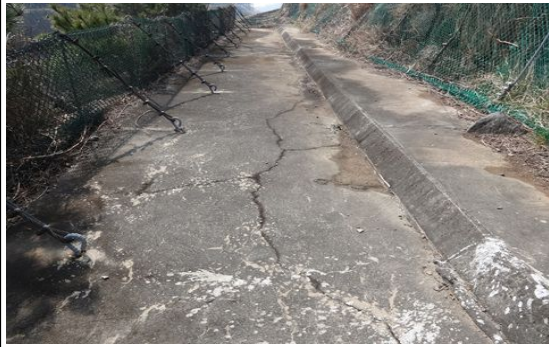
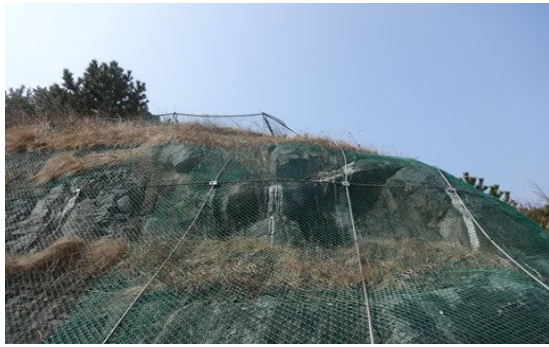
| 11.13K 1소단배수로 균열 1.0 | 11.13K 2단 노두부 |

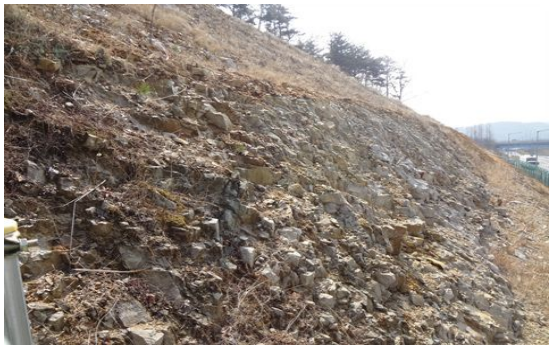
| 대구절토 2 (부산기점 10.73~11.21Km / 10공구 10+420~10+900) | |
|---|---|
| 10.60~10.65K 1단 심한풍화, 뜬돌 | |

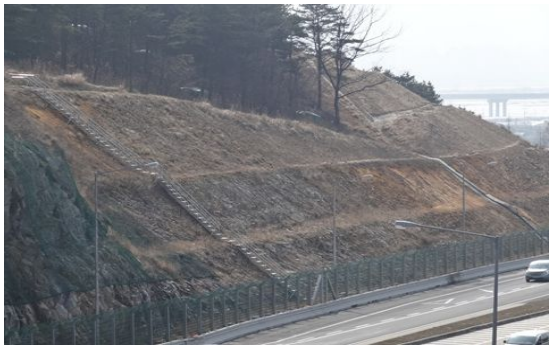
| 대구절토 2 (부산기점 10.73~11.21Km / 10공구 10+420~10+900) | |
|---|---|
| 10.62K 1단 뜬돌 및 세굴 | |

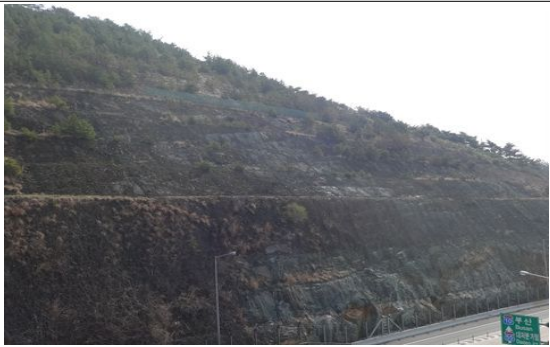
| 대구절토 2 (부산기점 10.73~11.21Km / 10공구 10+420~10+900) | |
|---|---|
| 10.72~85K 1~2단 심한파쇄 및 뜬돌 | |

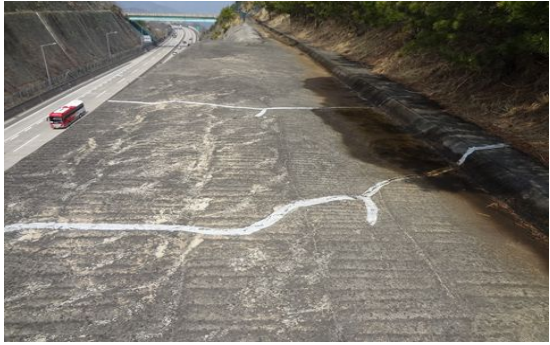
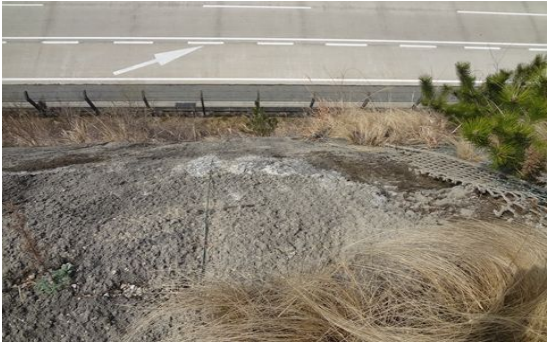
| 10.89K 1소단 배수로 재균열 0.3 | 10.90K 1단 백태 |

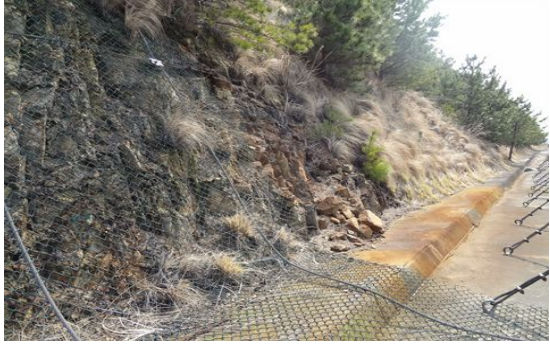
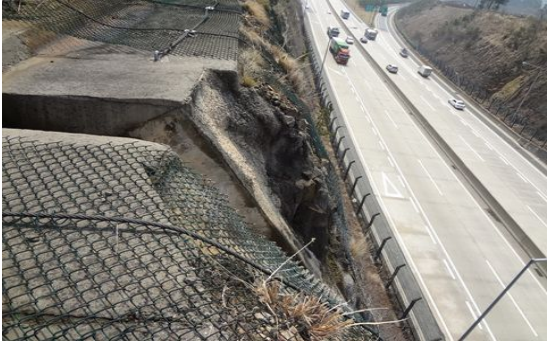
| 10.93K 2단 이완암 | 10.99K 1단 이완암 |

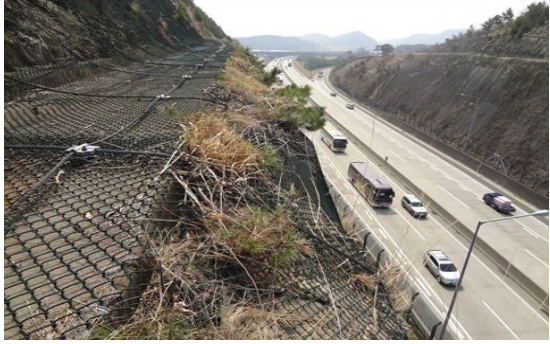
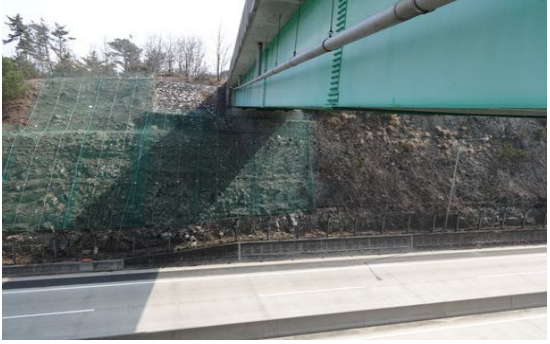
| 대구절토2 11.04K 1단 이완암 | 11.11K 1단 이완암 |

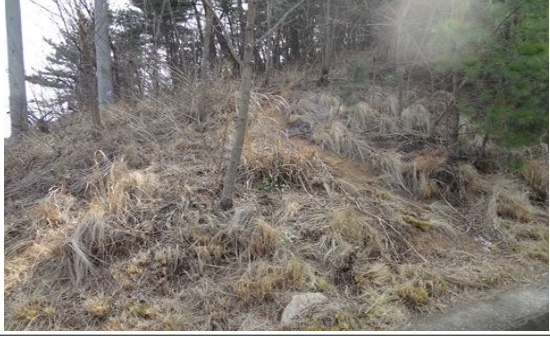
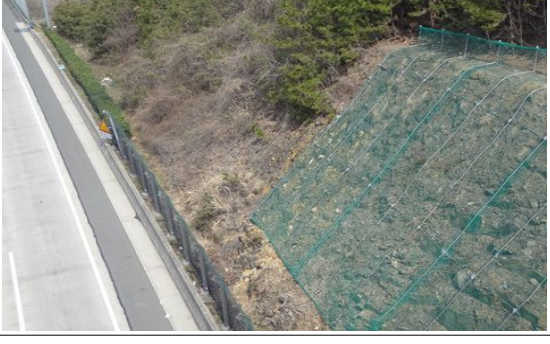
| 11.11K 상단 표층유실 | 11.14K 1단 심한풍화 |

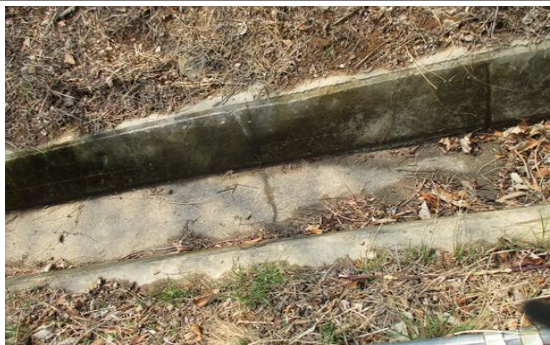
| 부산절토 3 (부산기점 12.45~12.75Km / 10공구 STA.8+880~9+180) | |
|---|---|
| 12.52K 산마루측구 균열 0.1 | 12.54K 2소단배수로 균열 0.5 |

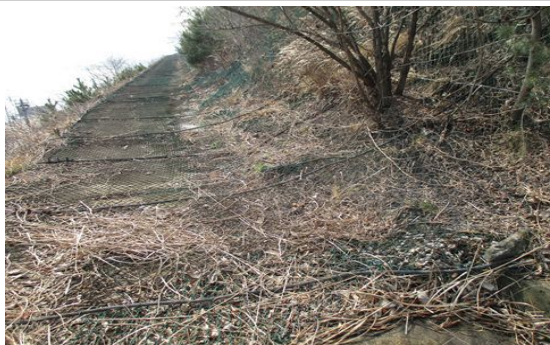
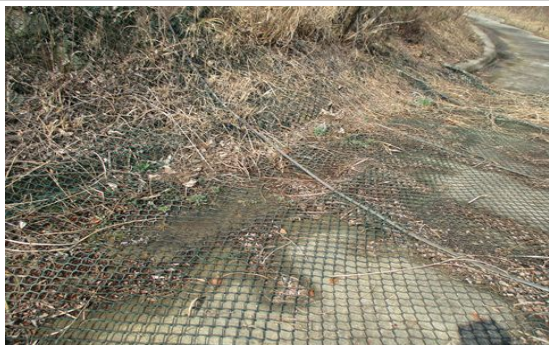
| 부산절토 3 (부산기점 12.45~12.75Km / 10공구 STA.8+880~9+180) | |
|---|---|
| 12.55K~12.68K 1소단배수로 토사퇴적 | |

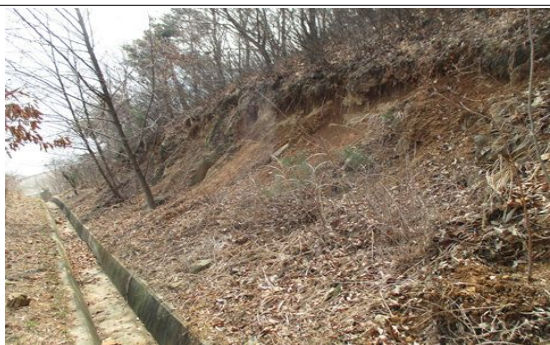
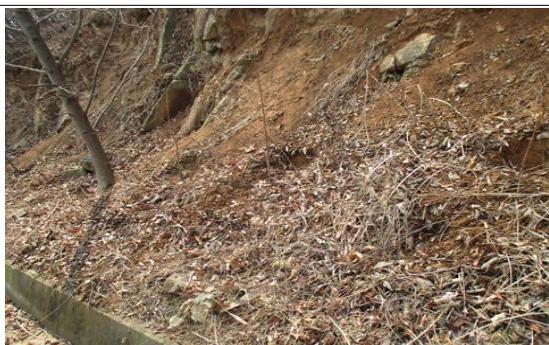
| 부산절토 3 (부산기점 12.45~12.75Km / 10공구 STA.8+880~9+180) | |
|---|---|
| 12.58K~12.63K 자연사면 상부자연사면 표층붕괴 | |

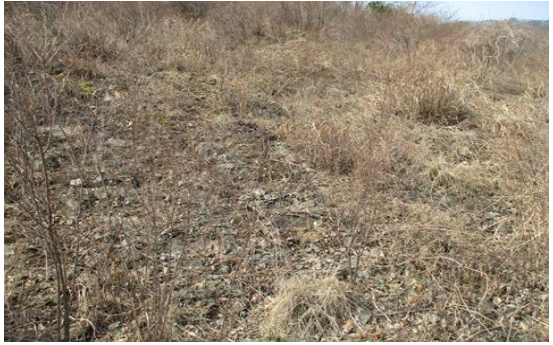
| 12.61K 5단 이완암 | 12.61K~12.63K 2단 이완암 |

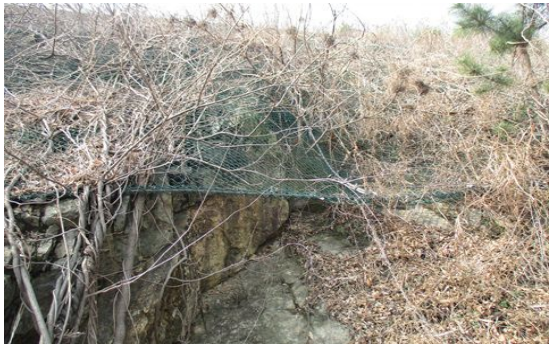
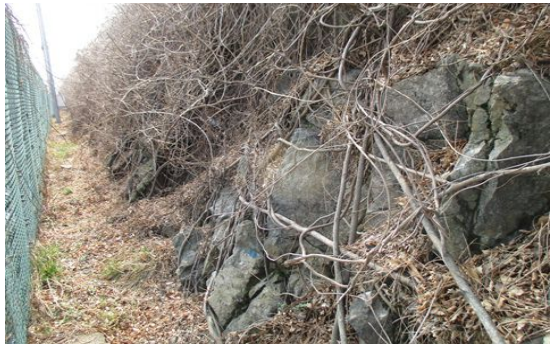
| 12.65K 1단 이완암 | |

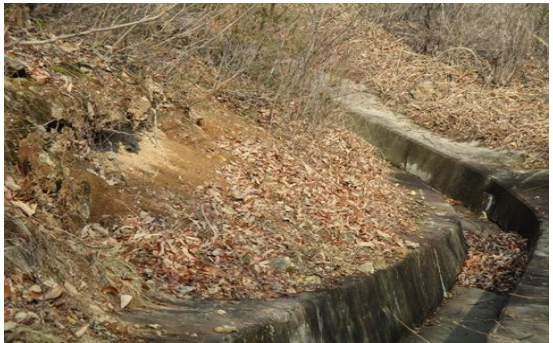
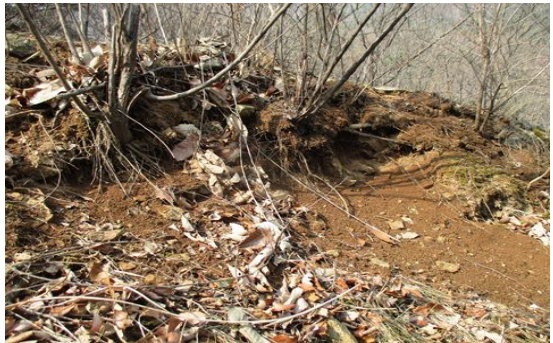
| 12.70K 자연사면 표층유실 | |

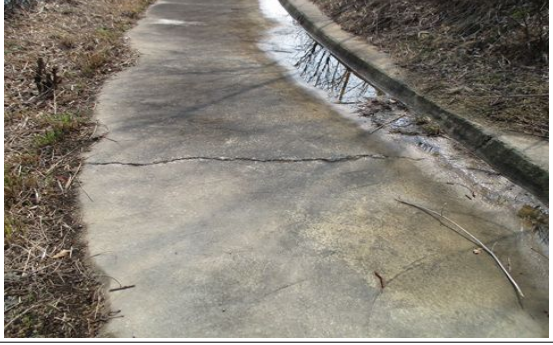
| 12.70K 1소단배수로 균열 0.5 | 1소단배수로 전경 |

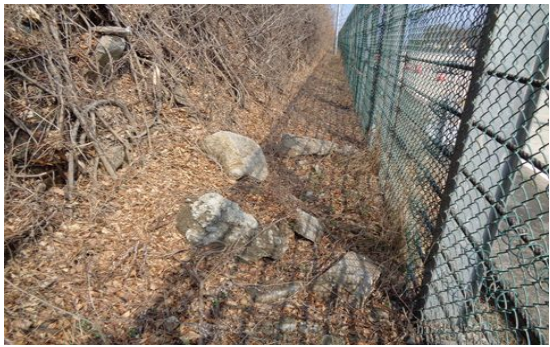
| 부산절토 4 (부산기점 12.97~13.23Km / 10공구 STA.8+400~8+660) | |
|---|---|
| 13.02K 1단 하부 낙석퇴적 | 13.08K 산마루측구 체수 |

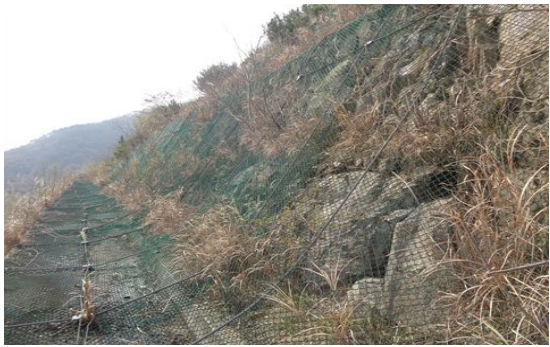
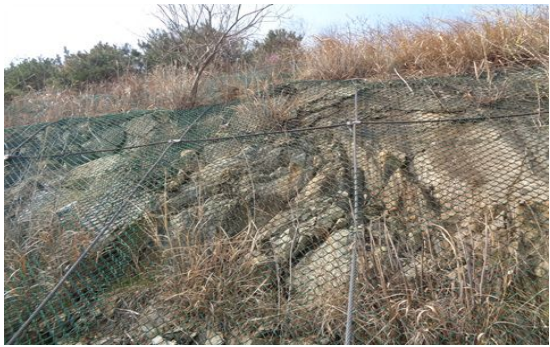
| 부산절토 4 (부산기점 12.97~13.23Km / 10공구 STA.8+400~8+660) | |
|---|---|
| 13.03K 2단 이완암 및 뜯돌 | |

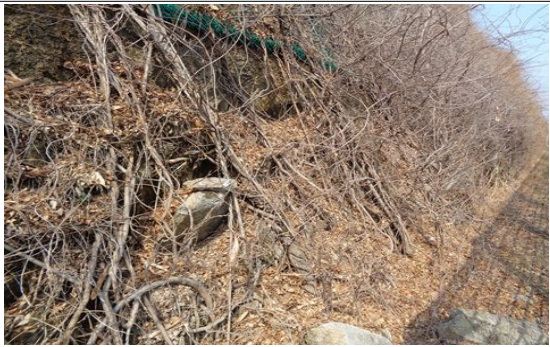
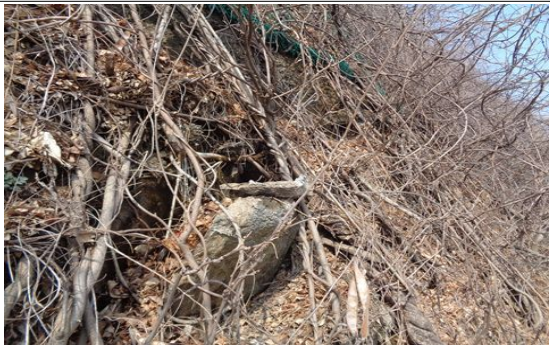
| 부산절토 4 (부산기점 12.97~13.23Km / 10공구 STA.8+400~8+660) | |
|---|---|
| 13.04K 1단 이완암 및 켜기파괴 우려 | |

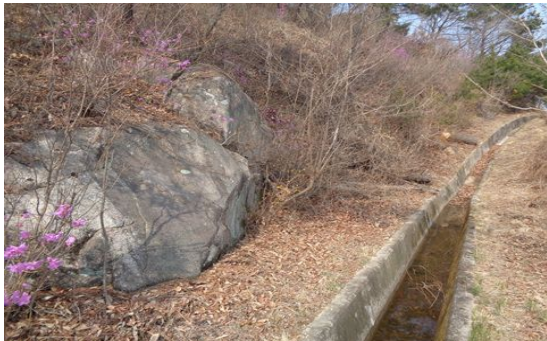
| 13.08K 자연사면 암괴 | |

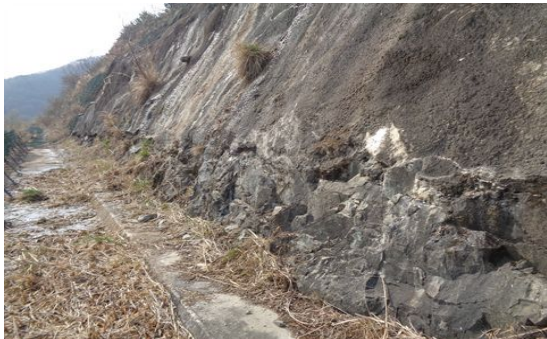
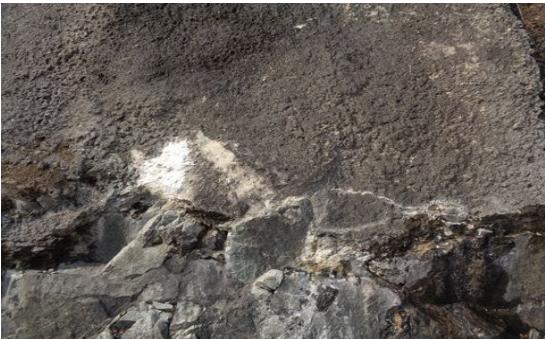
| 13.11K 2단 숏크리트 백태 | |

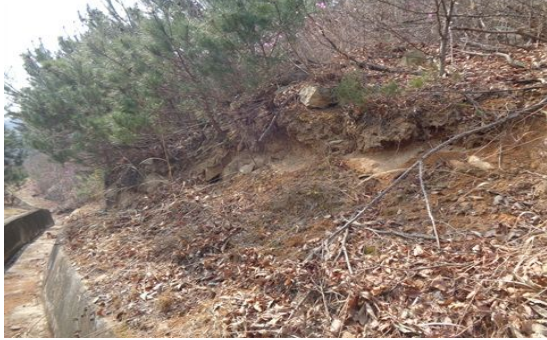
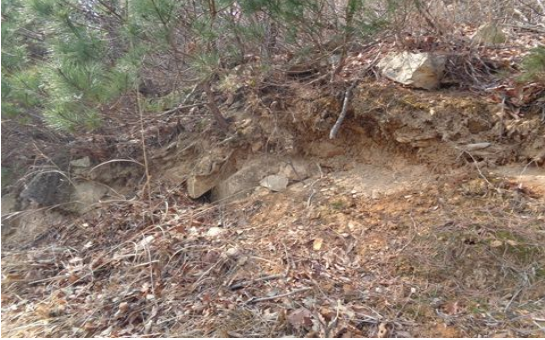
| 13.11K 자연사면 표층유실 | |

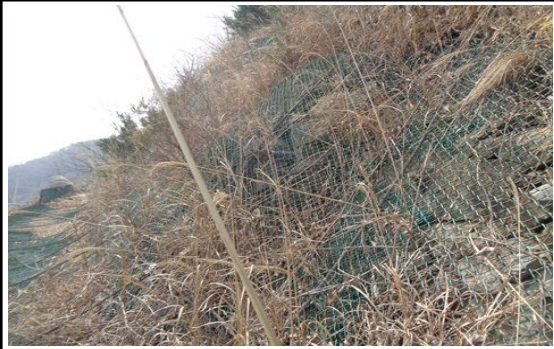
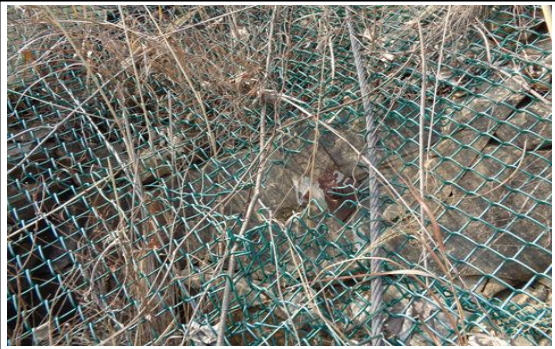
| 13.13K 2단 이완암방지망 파손 | |

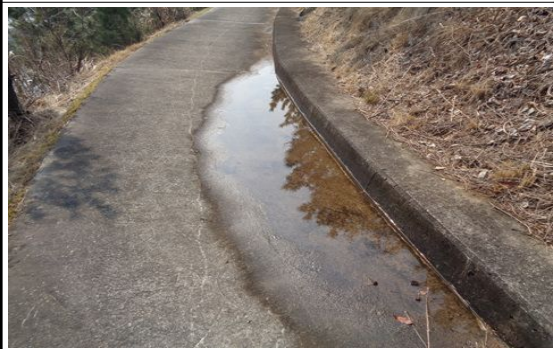
| 13.13K 2소단배수로 채수 | 13.14K 1단 하부 낙석퇴적 |

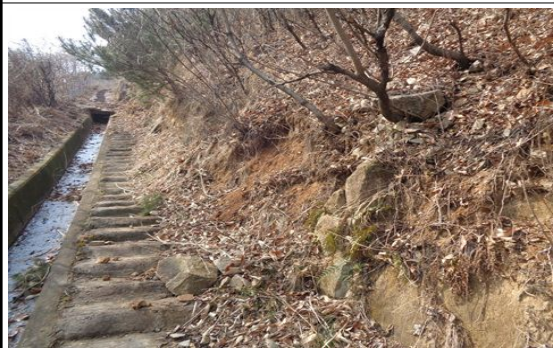
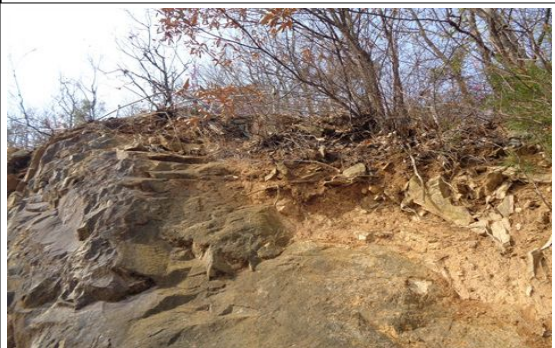
| 13.23K 자연사면 표층유실 및 뜯돌 | |

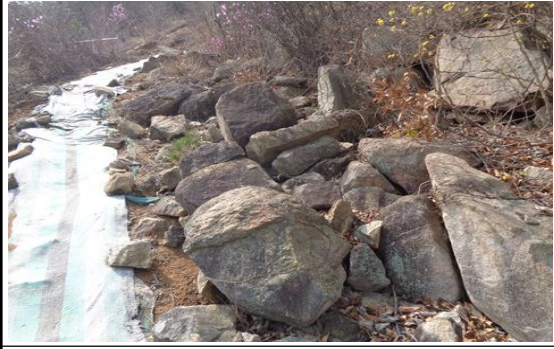
| 13.15K 자연사면 암괴다수 | 하부 전경 |

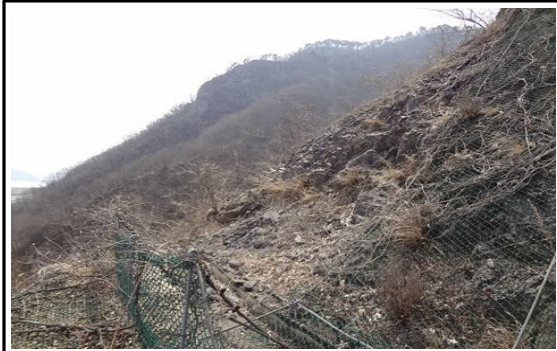
| 부산절토 5 (부산기점 21.92~22.28Km / 9공구 10+620~10+980) | |
|---|---|
| 21.95K 2단 이완암 | |

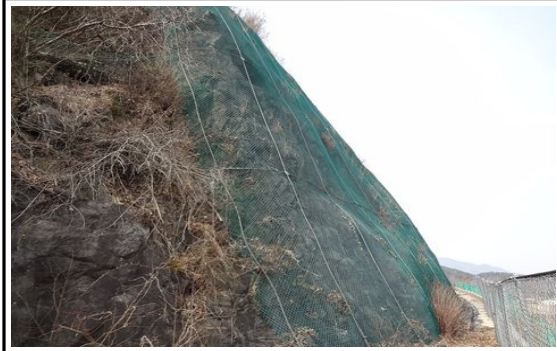
| 부산절토 5 (부산기점 21.92~22.28Km / 9공구 10+620~10+980) | |
|---|---|
| 22.08K 1단 이완암 | |

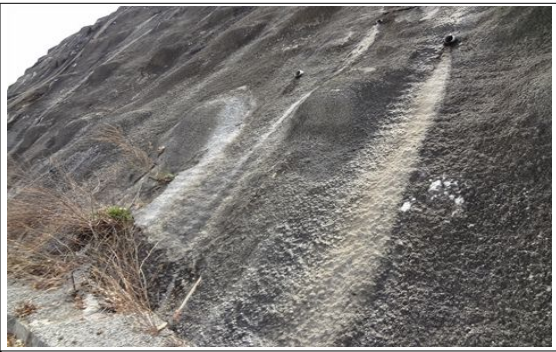
| 부산절토 5 (부산기점 21.92~22.28Km / 9공구 10+620~10+980) | |
|---|---|
| 22.04K 1단 계단식옹벽 손상 | 22.10K 2단 백태 |

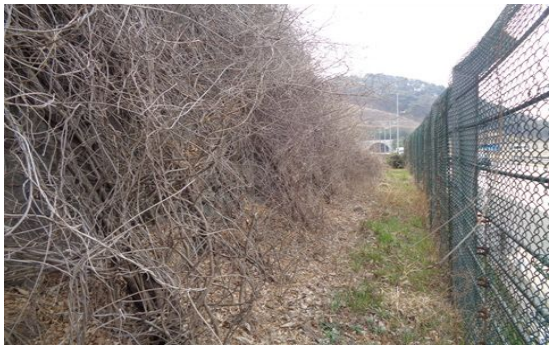
| 대구절토 6 (부산기점 27.73~28.09Km / 9공구 STA.4+810~5+170) | |
|---|---|
| 27.76K 1단 심한파쇄 | |

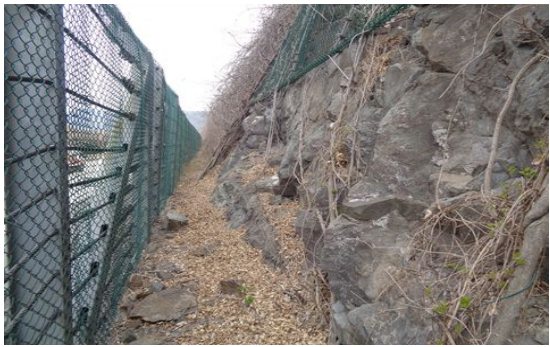
| 대구절토 6 (부산기점 27.73~28.09Km / 9공구 STA.4+810~5+170) | |
|---|---|
| 27.82K 1단 이완암 | |

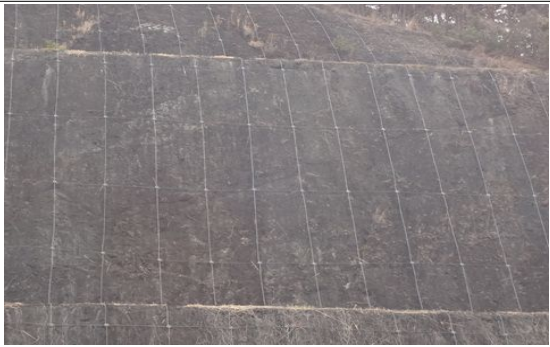
| 대구절토 6 (부산기점 27.73~28.09Km / 9공구 STA.4+810~5+170) | |
|---|---|
| 27.86K 2단 이완암 | |

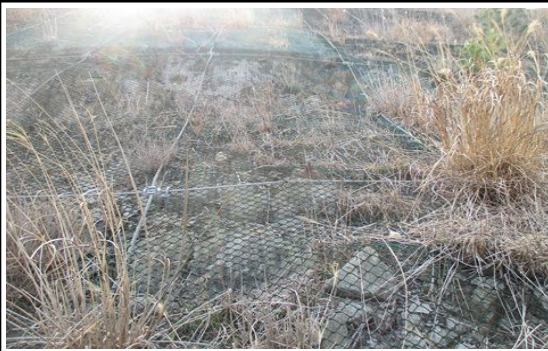
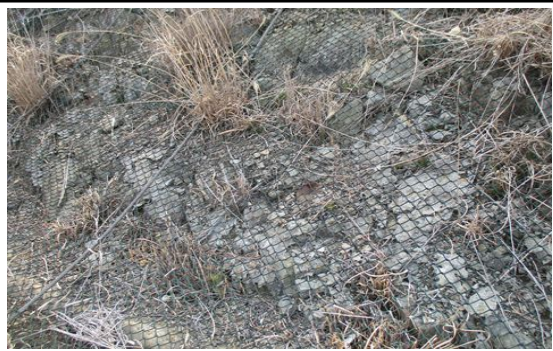
30.02K 3단 뜯돌 및 이완암

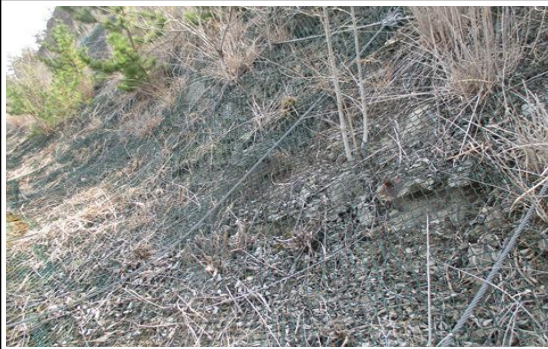
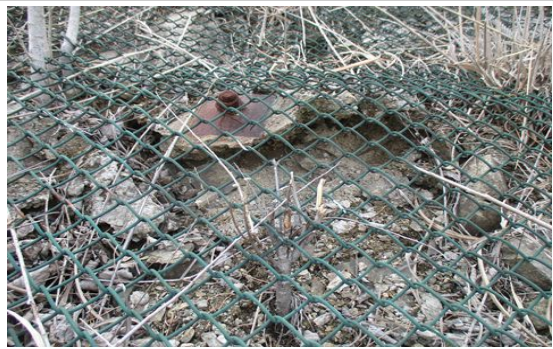
30.07K 3단 락볼트 두부 노출 다수

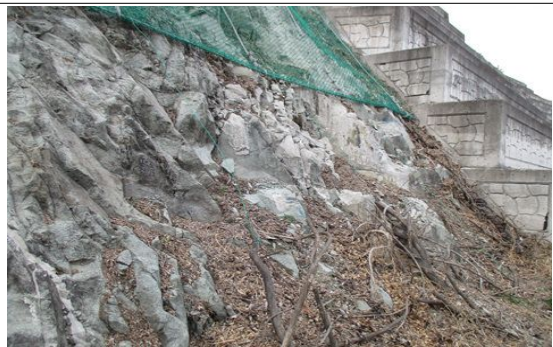
30.89K 1단 이완암 및 뜯돌

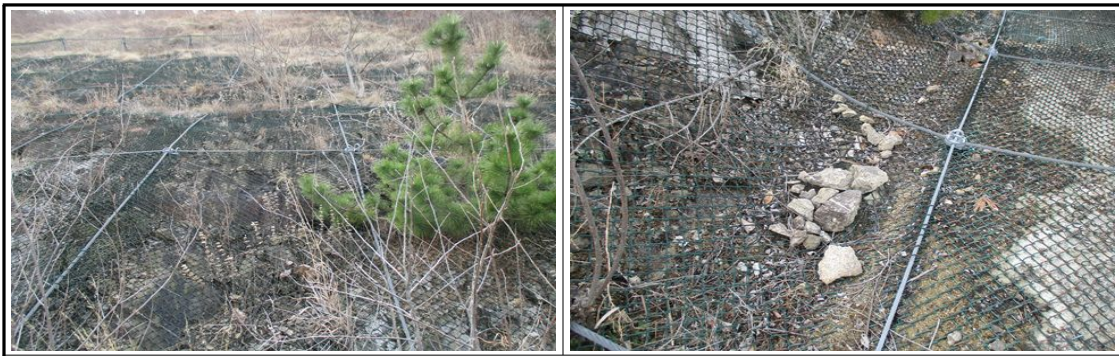
30.91K~30.97K 2단 이완암 및 하부 낙석퇴적

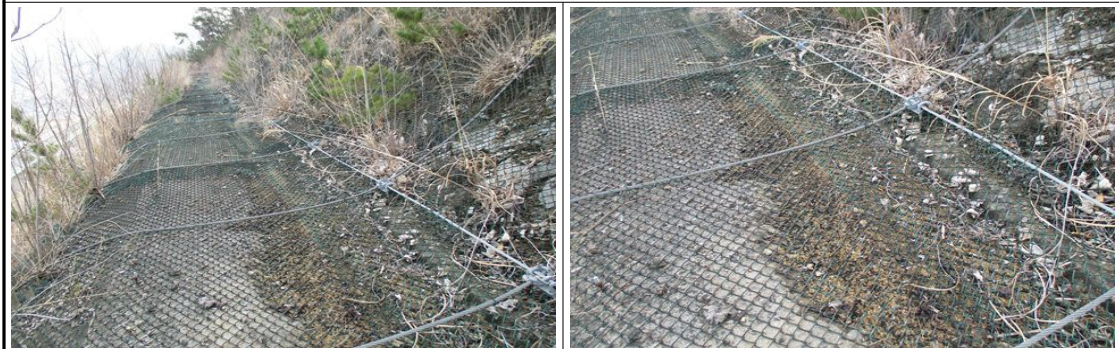
30.92K~30.99K 2소단배수로 토사퇴적

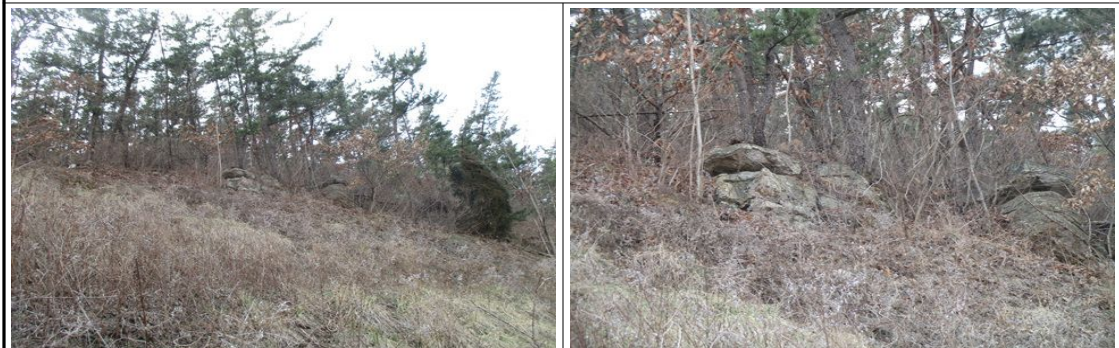
30.93K 자연사면 암괴

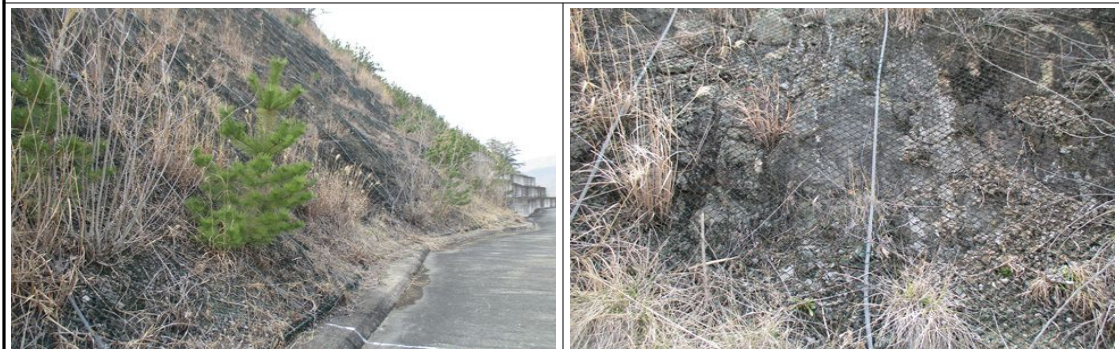
30.94K 2단 이완암

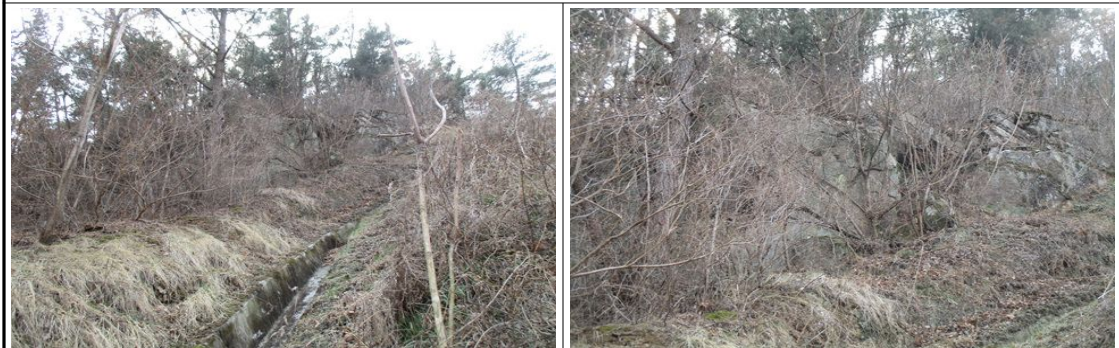
31.00K 자연사면 암반

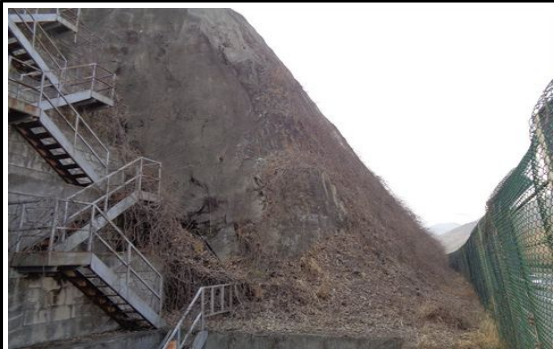
| 부산절토 8 (부산기점 31.16~31.36Km / 9공구 STA.1+540~1+740) | |
|---|---|
| 31.16K 1단 이완암 | |

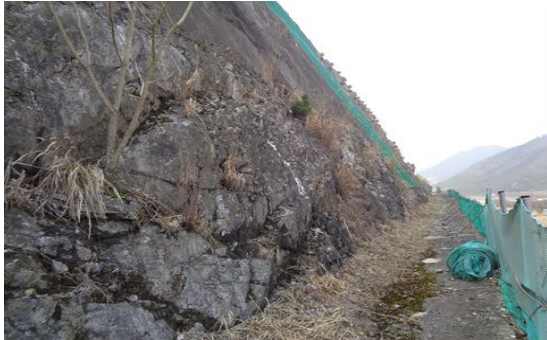
| 부산절토 8 (부산기점 31.16~31.36Km / 9공구 STA.1+540~1+740) | |
|---|---|
| 31.20K 2단 낙석위험 | |

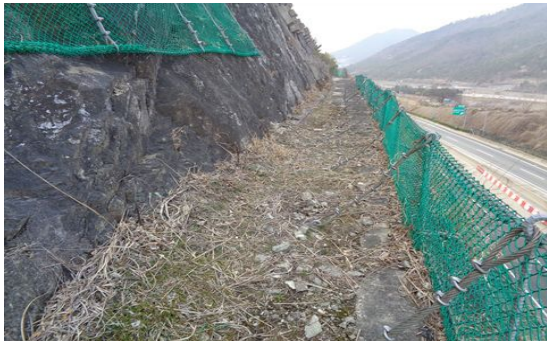
| 31.25K 2단 이완암 | 31.23K 3단 이완암 |

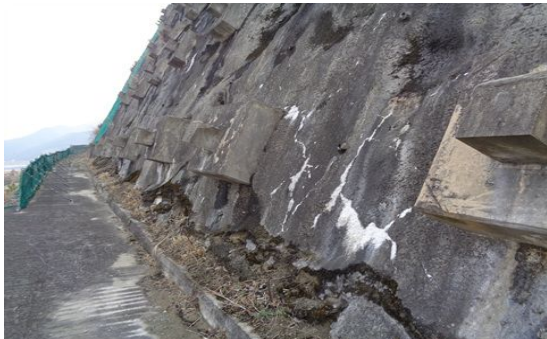
| 31.27K 1소단배수로 낙석 및 토사퇴적 | 31.30K 배후도로 균열 |

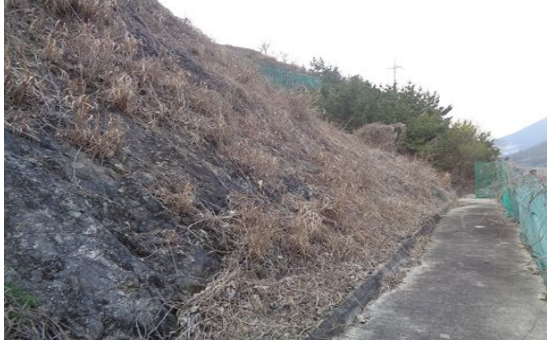
| 31.30K 2단 숏크리트 백태 | |

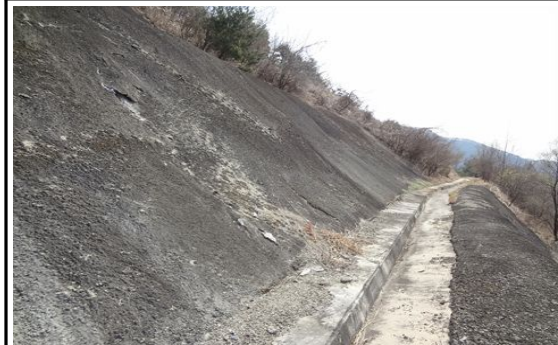
| 대구절토 9 (부산기점 46.17~46.87Km / 7공구 STA.5+780~6+480) | |
|---|---|
| 46.45K 3단 들뜸, 숏크리트 균열 | |

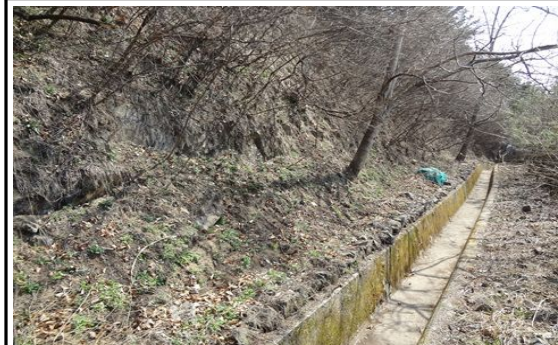
| 대구절토 9 (부산기점 46.17~46.87Km / 7공구 STA.5+780~6+480) | |
|---|---|
| 46.46K 자연사면 녹생토유실 | 46.49K 1단 숏크리트 균열 |

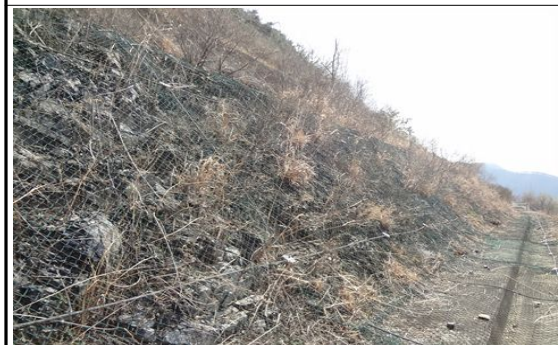
| 대구절토 9 (부산기점 46.17~46.87Km / 7공구 STA.5+780~6+480) | |
|---|---|
| 46.49K 3단 이완암 | |

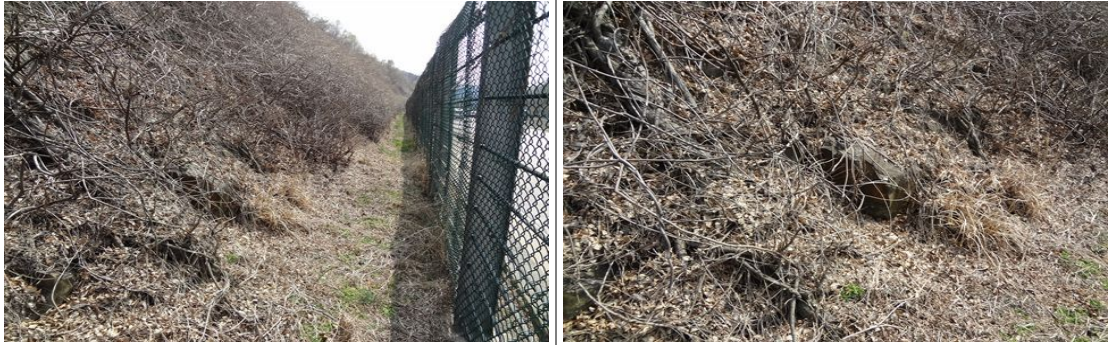
| 46.52K 1단 이완암 | |

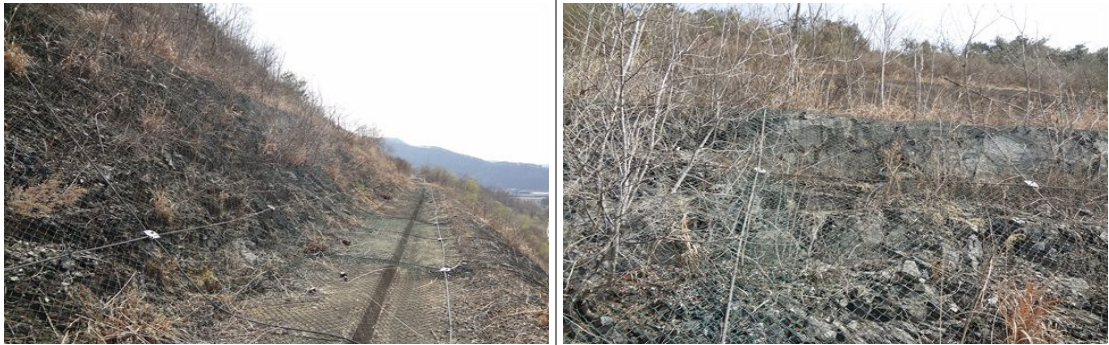
| 46.49K 3단 이완암 | |

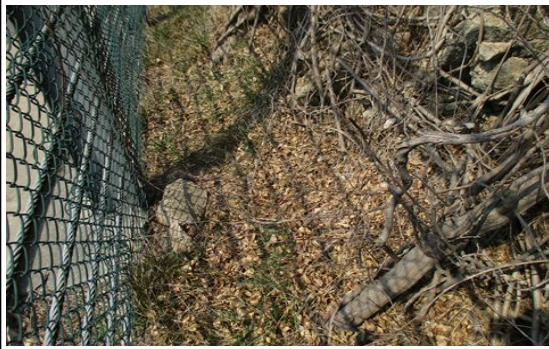
54.08K 1단 이완암 및 탈락

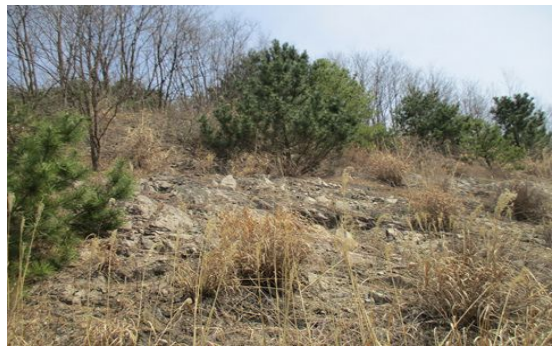
54.13K 4단 이완암

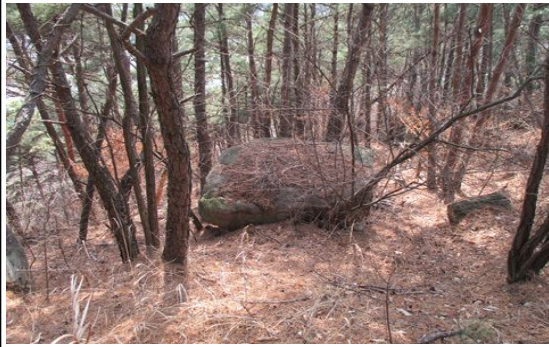
54.16K 자연사면 암괴

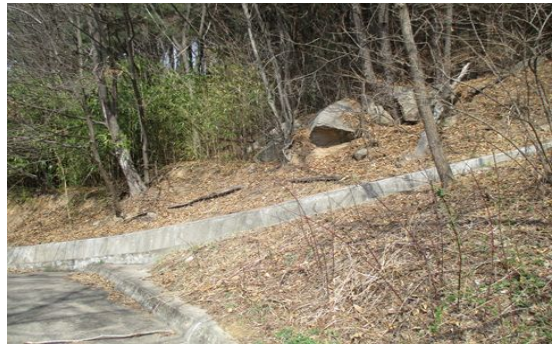
54.18K 자연사면 암괴

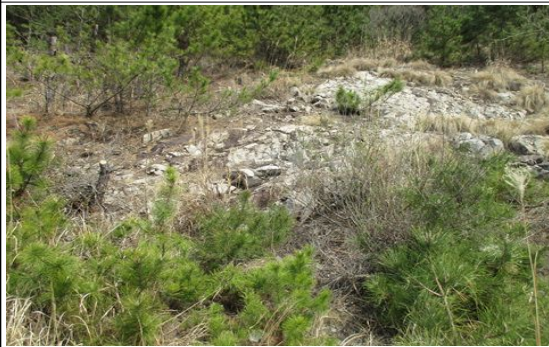
대구절토10 54.19K 6단 이완암

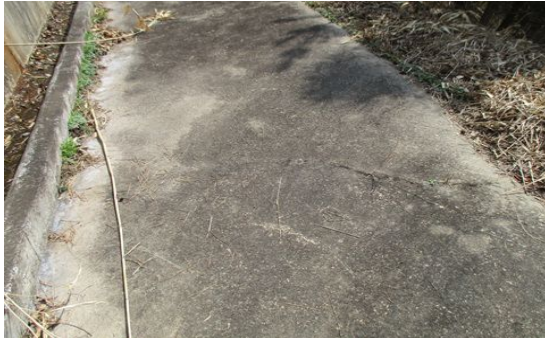
| 54.19K 5단 이완암 | 54.28K 1단 누수 |

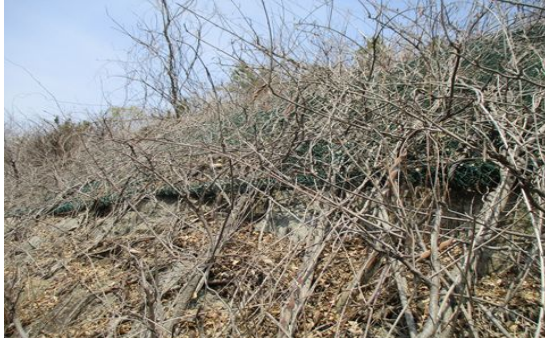
| 54.30K 1단 이완암 | 54.30K 1단 이완암 및 낙석위험 |

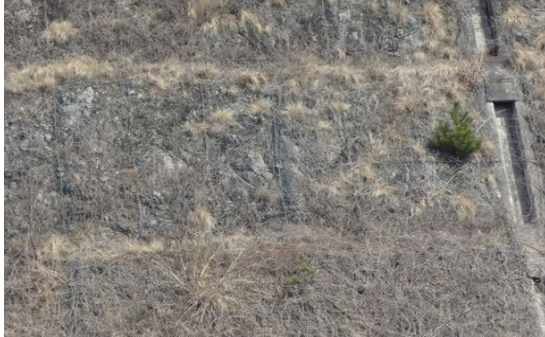
| 54.37K 1단 암괴탈락 | 54.41K 1단 이완암 |

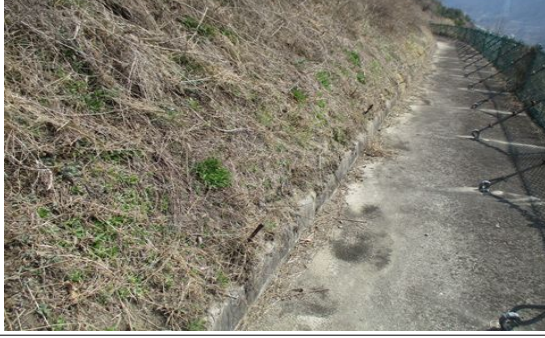
| 54.40K 2단 녹생토 유실우려 | |

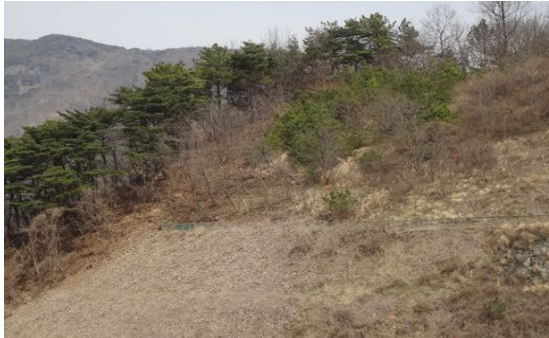
| 54.50K 2단 수목전도 | 배후도로 전경 |

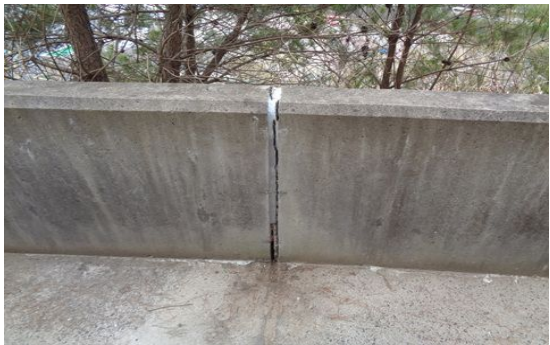
| 대구절토 11 (부산기점 56.56~56.91Km / 6구 STA.7+840~8+190) | |
|---|---|
| (1/3) STA.0+120 2소단배수로<br>월류방지벽 및 실란트 파손 | (1/3) STA.0+120~140 1소단배수로 체수 |

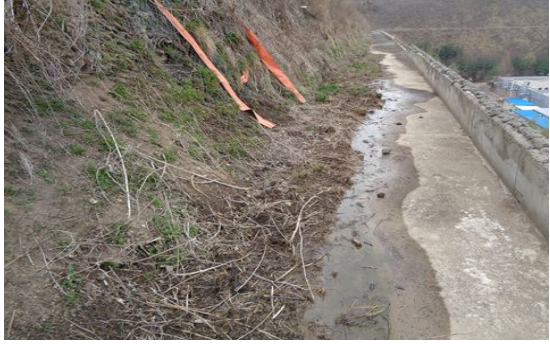
| 대구절토 11 (부산기점 56.56~56.91Km / 6구 STA.7+840~8+190) | |
|---|---|
| (1/3) STA.0+120~140 1소단배수로<br>토사퇴적 | (1/3) STA.0+040 1소단배수로 균열 |

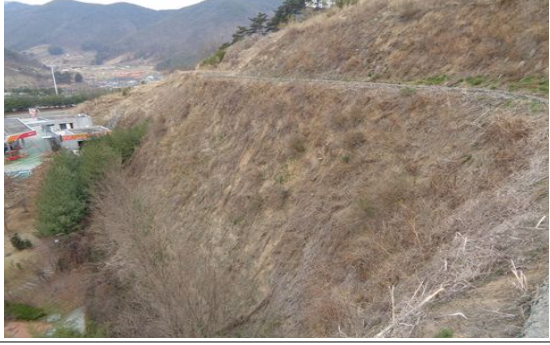
| 대구절토 11 (부산기점 56.56~56.91Km / 6구 STA.7+840~8+190) | |
|---|---|
| (1/3) STA.0+120 1단 녹생토 유실 | |

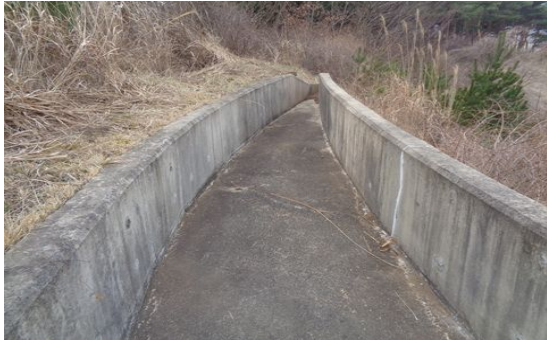
| (2/3) STA.0+190 2소단배수로 균열 | (2/3) STA.0+020 수직도수로 파손 |

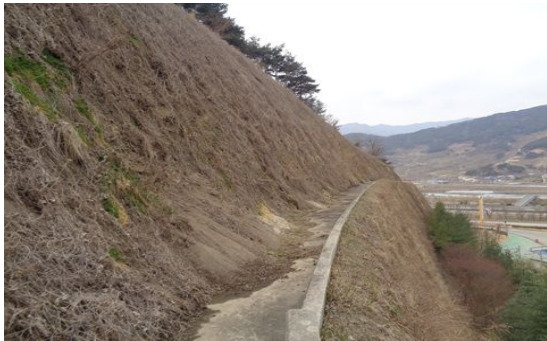
| (3/3) STA.0+040 2단 녹생토 유실 | |

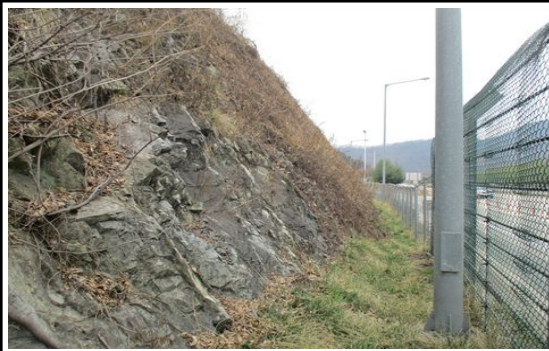
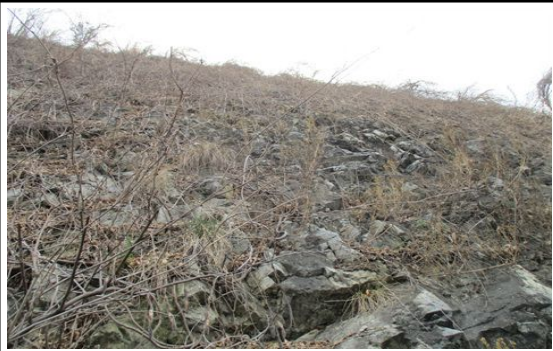
56.99~57.01K 1단 낙석위험

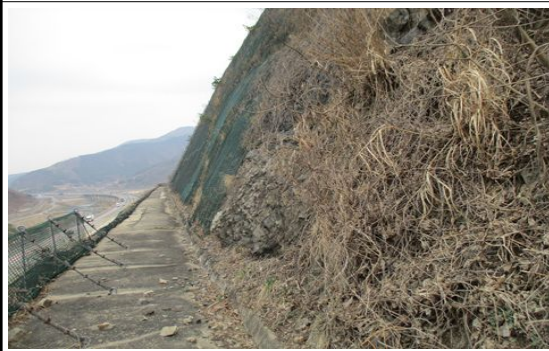
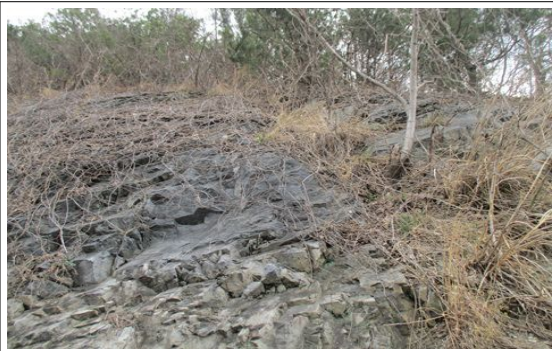
57.02~57.04K 2단 이완암 및 뜬돌

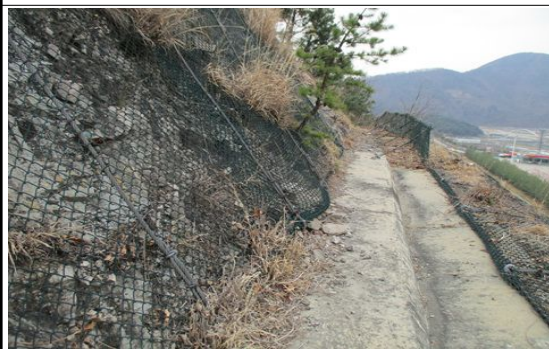
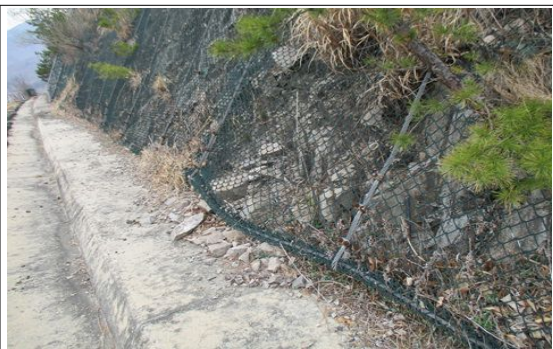
57.09K 3단 이완암 및 하부 퇴적

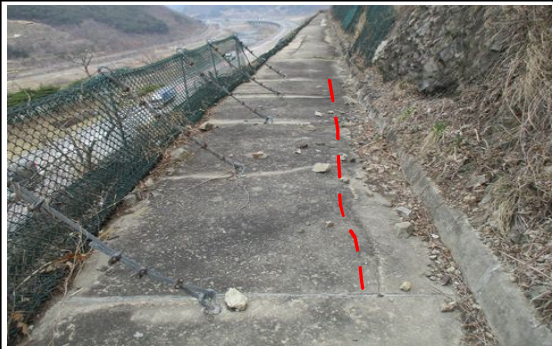
| 57.08K 1단 하부 낙석퇴적 | 57.12K 1단 이완암 및 낙석퇴적 |

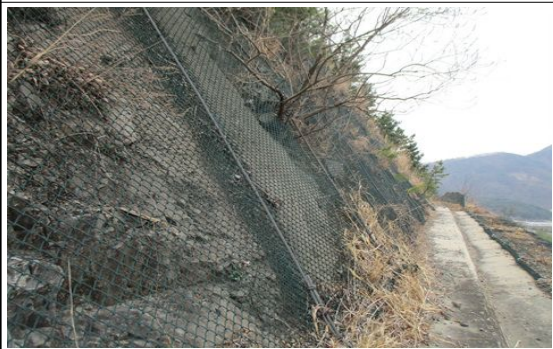
| 57.10K 3단 낙석퇴적 배부름 | |

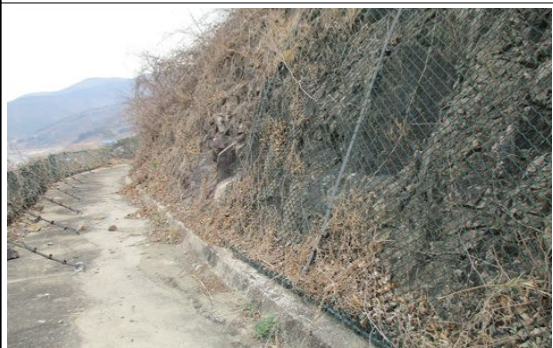
| 57.15K 2단 뜯돌 | |

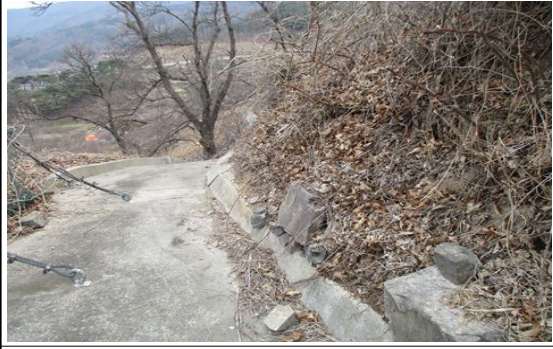
| 57.16K 2단 이완암 및 뜯돌 | |

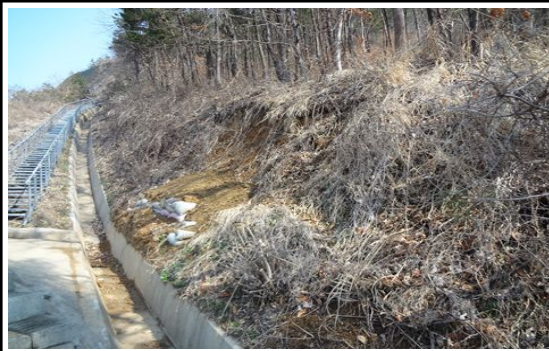
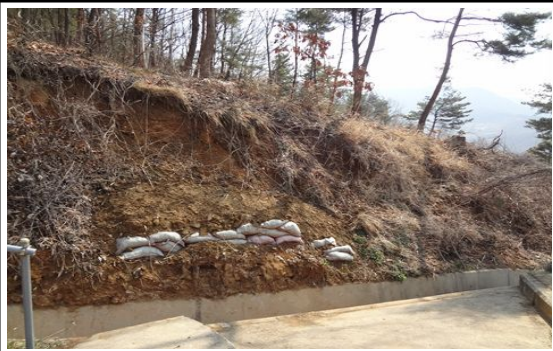
59.37K 자연사면 표층유실

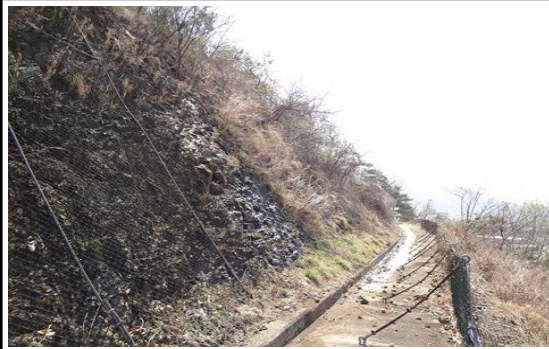
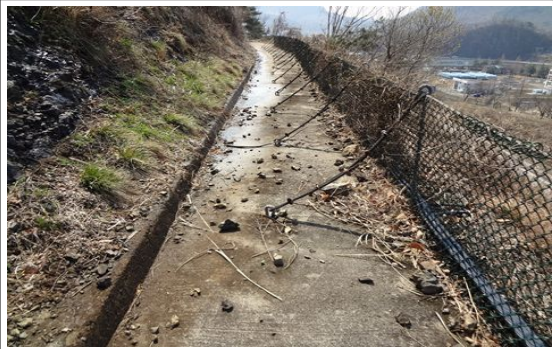
59.38K 2단 이완암

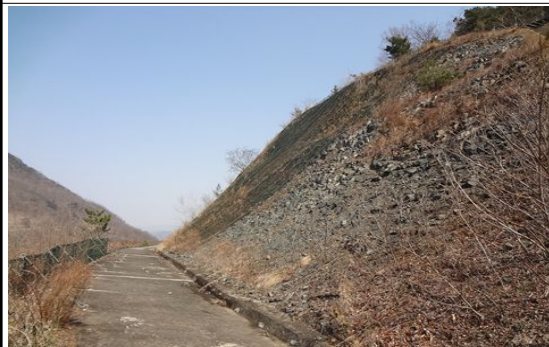
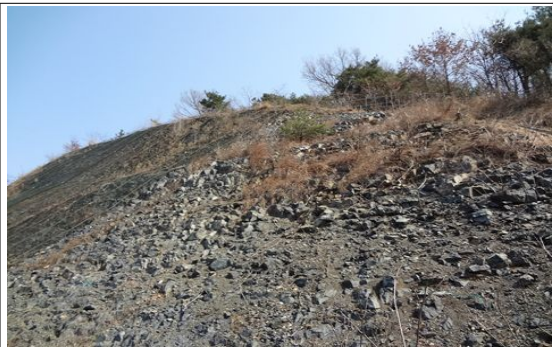
59.42K 3단 이완암

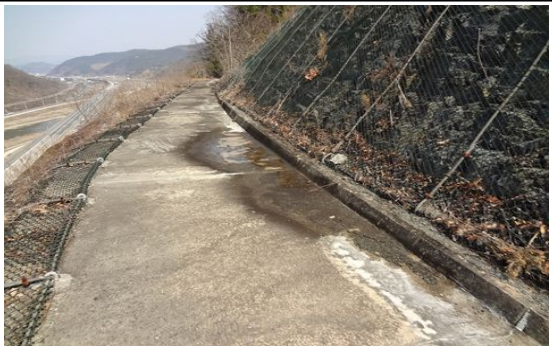
| 59.51K 3소단배수로 균열 0.5 | 59.53K 2소단배수로 체수 |
