**2017년 상반기 시설물 정기점검 용역**  
**정 기 점 검 사 진 첵**  
**[2종 절토사면 손상현황 사진첩]**

**2017. 06.**

**新 대구부산고속도로주식회사**  
**New DAEGU BUSAN Expressway Co., Ltd.**

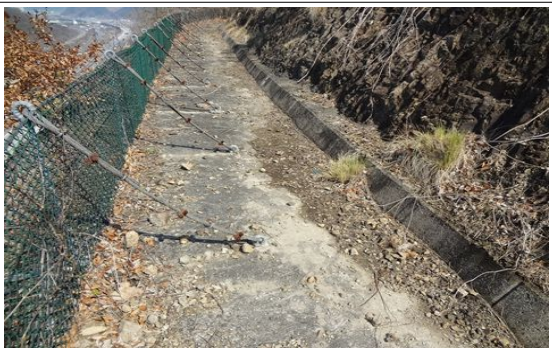
| 59.49K 4단 이완암, 퇴적 | |

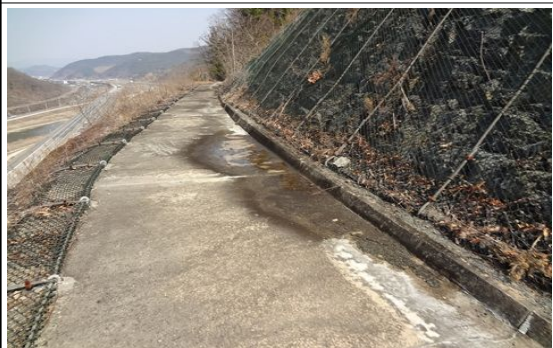
| 59.53K 2소단배수로 체수 | 59.57K 산마루측구 균열 |

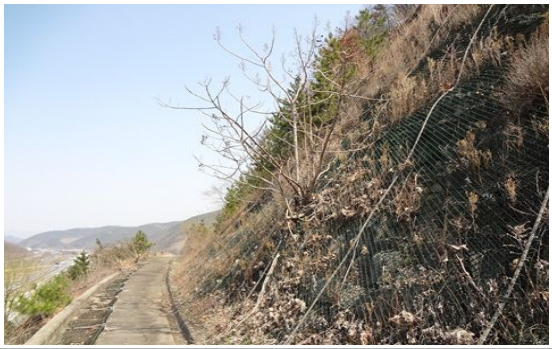
| 59.59K 1단 수목 | 59.55K 2단 수목 |

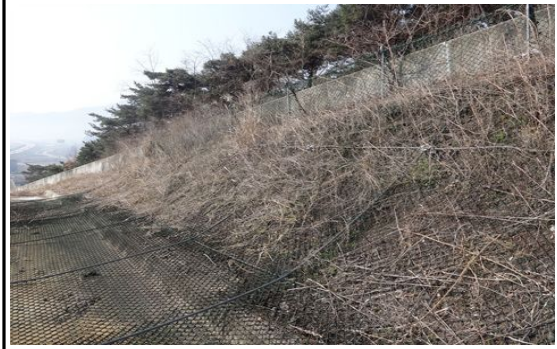
| 부산절토 14 (부산기점 10.86~11.23Km / 4공구 STA.10+220~10+520) | |
|---|---|
| 66.07K 2단 이완암 | 66.04K 1소단배수로 준열 3.0 |

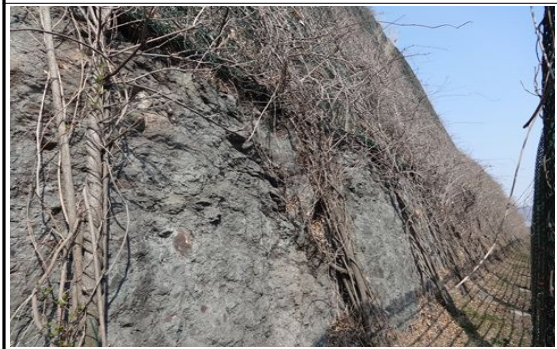
| 부산절토 14 (부산기점 10.86~11.23Km / 4공구 STA.10+220~10+520) | |
|---|---|
| 66.13K 1단 이완암 | 66.14K 2단 이완암 |

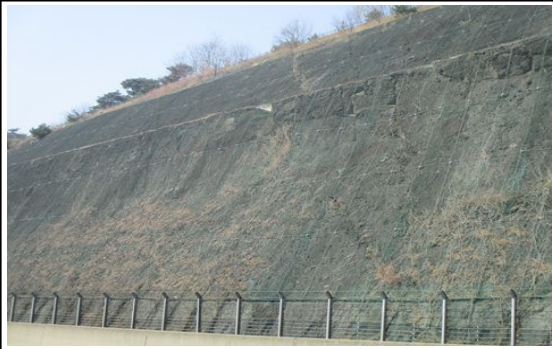
| 66.18K 1단 켜기형, 이완암 | |

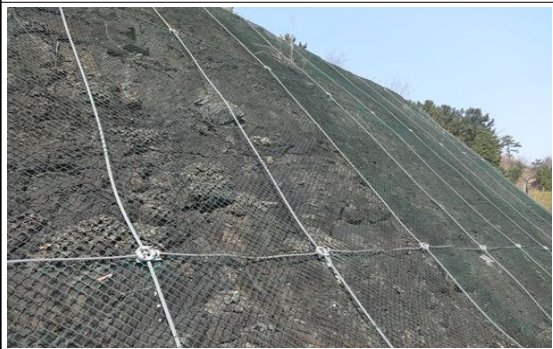
| 66.18K 2단 이완암 | 66.19K 2단 이완암 낙석위험 |

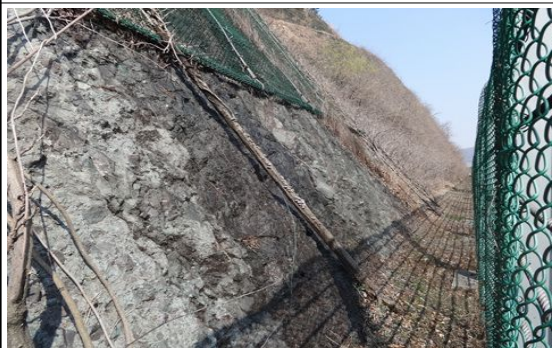
| 66.20K 1단 누수 | 66.24K 1단 수목 |

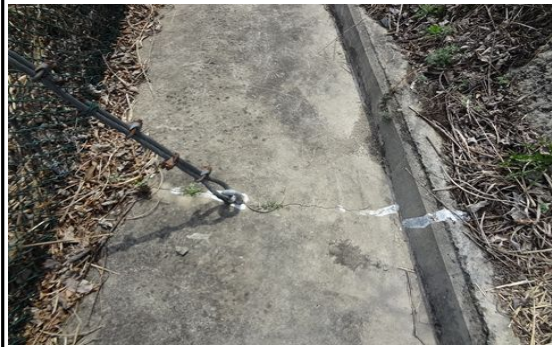
| 부산절토 15 (부산기점 70.77~71.01Km / 4공구 STA.5+450~5+690) | |
|---|---|
| 70.78K 1소단배수로 균열 | 70.80K 1소단배수로 토사퇴적 |

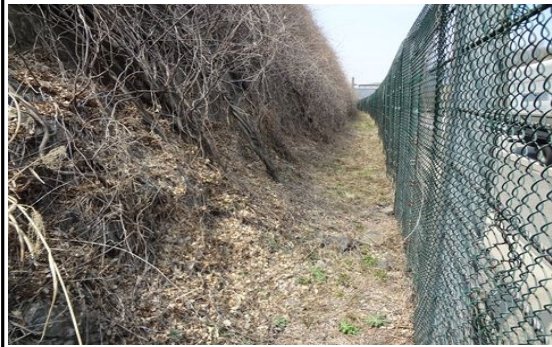
| 부산절토 15 (부산기점 70.77~71.01Km / 4공구 STA.5+450~5+690) | |
|---|---|
| 70.80K 1단 이완암, 풍화 | |

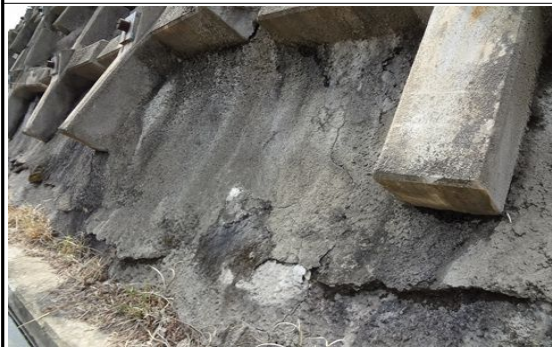
| 부산절토 15 (부산기점 70.77~71.01Km / 4공구 STA.5+450~5+690) | |
|---|---|
| 70.80K 2단 숏크리트 균열 | 70.83K 2단 이완암 |

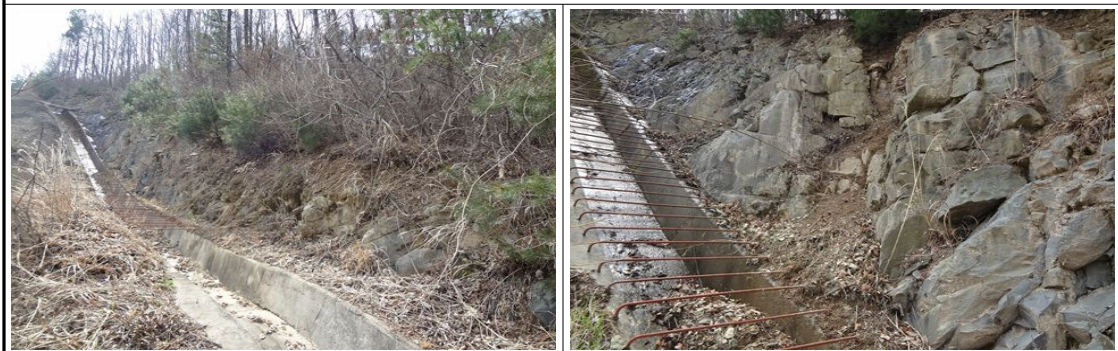
70.85~70.94K 자연사면 표층유실, 이완암

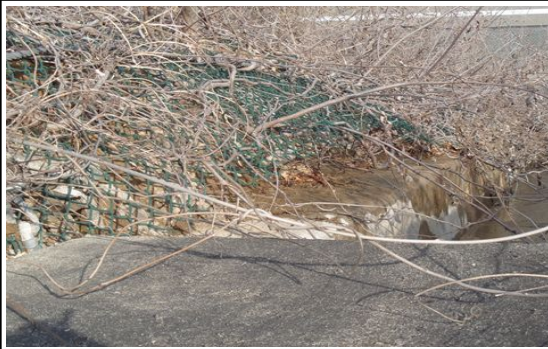
71.58K 1단 표층유실

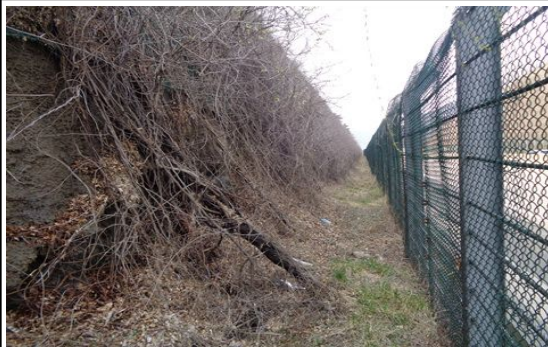
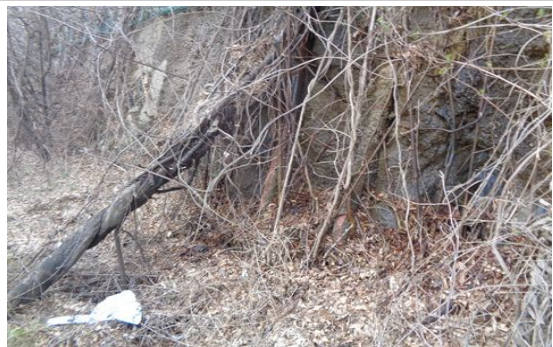
71.59K 1단 내부 유실

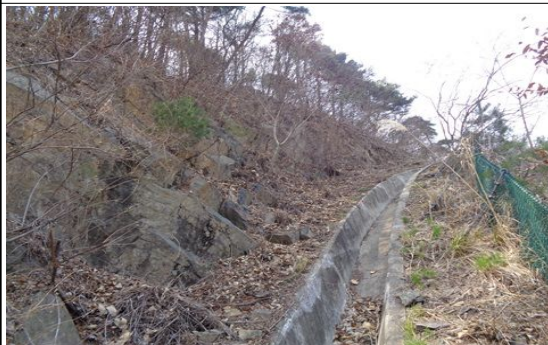
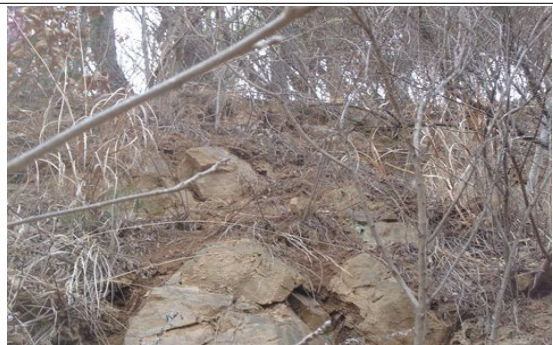
71.62~71.68K 자연사면 표층유실 및 이완암

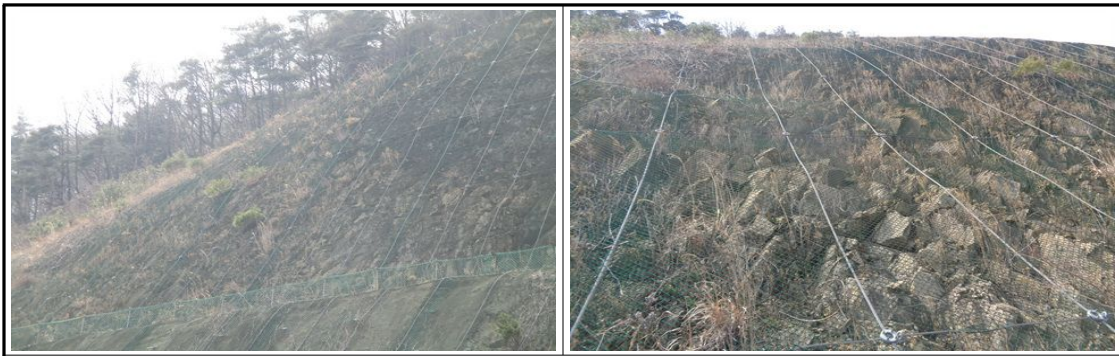
71.64K 2단 이완암

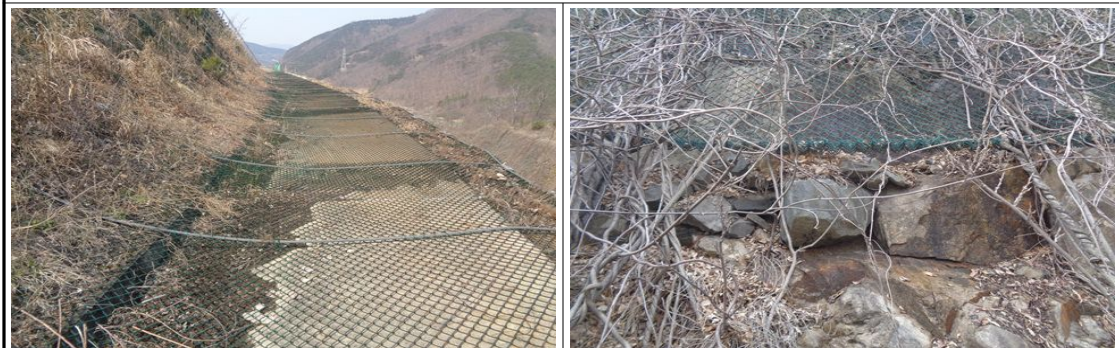
71.65~71.70K 3단 심한풍화유실

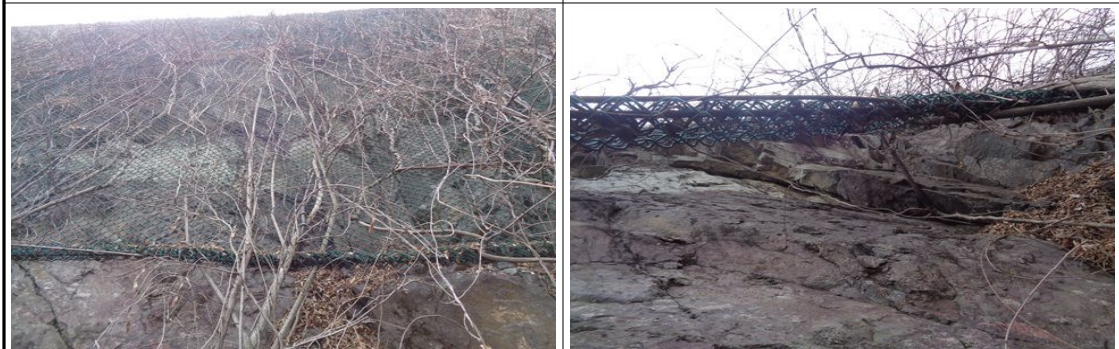
71.69K 1단 이완암

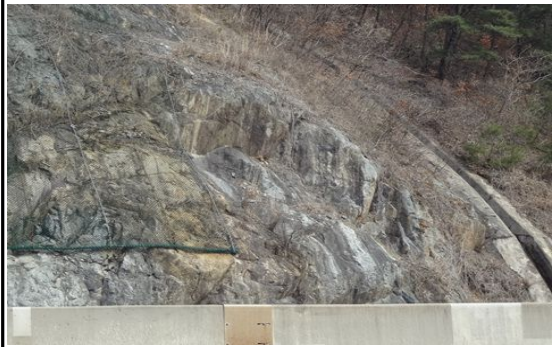
| 대구절토 17 (부산기점 72.74~73.12Km / 4공구 STA.3+340~3+720) | |
|---|---|
| 72.79K 1단 암괴 탈락 | |

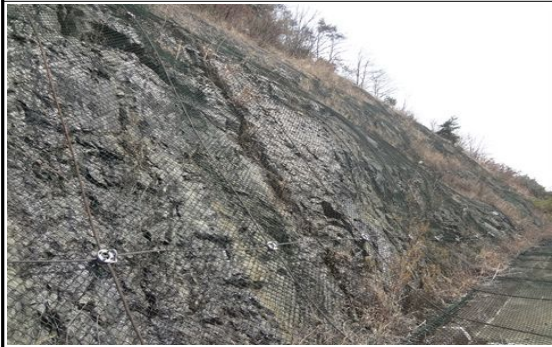
| 대구절토 17 (부산기점 72.74~73.12Km / 4공구 STA.3+340~3+720) | |
|---|---|
| 72.82K 2단 이완암 및 누수 | |

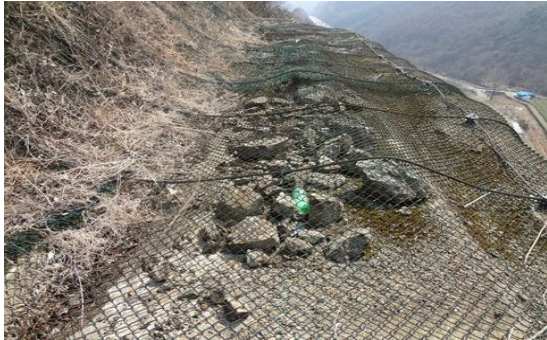
| 72.84~72.88K 2소단 배수로 낙석 및 토사퇴적 | 72.91K 1단 낙석위험 |

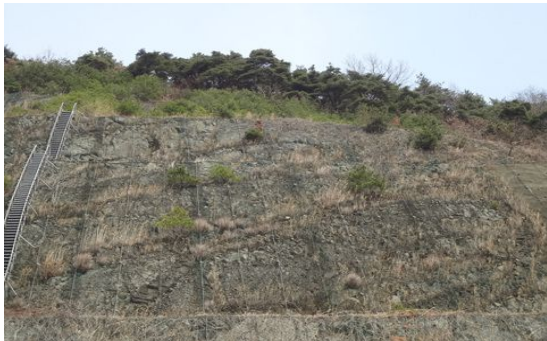
| 72.88~72.92K 3단 절리 및 이완암 | |

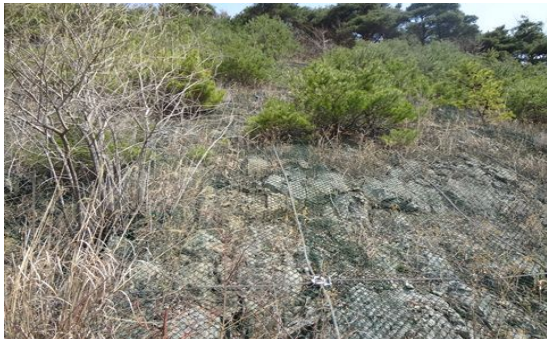
| 72.92k 4단 이완암 다수 | 72.93k 3단 이완암 |

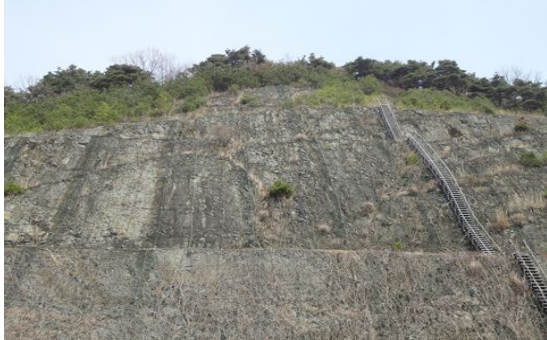
| 72.94k 2단 켜기파괴 | |

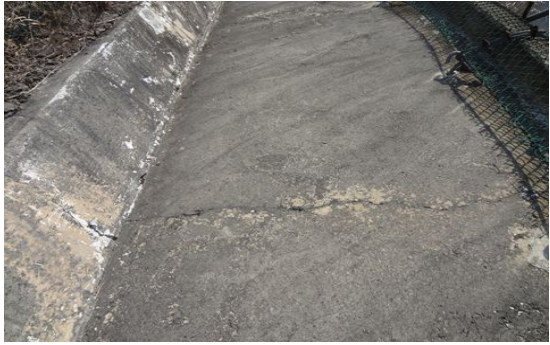
| 72.94k 3소단배수로 균열 1.0 | 72.95k 2단 이완암 및 뜯돌 |

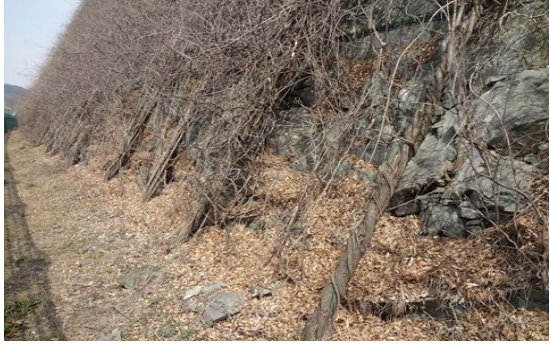
| 72.99k 1단 심한풍화, 충전물유실 및 낙석위험, 하부 토사퇴적 | 73.08k 1단 심한풍화 및 암괴탈락 |

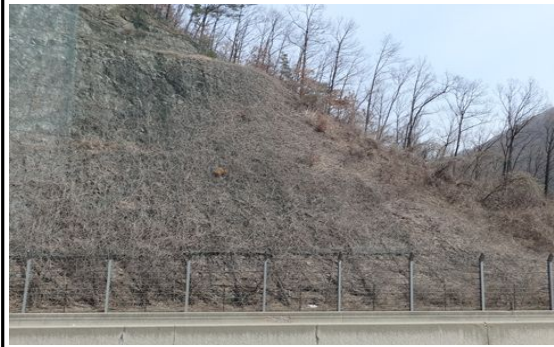
| 대구절토 18 (부산기점 73.38~73.78Km / 4공구 STA.2+680~3+080) | |
|---|---|
| 73.40K 1단 심한풍화 | |

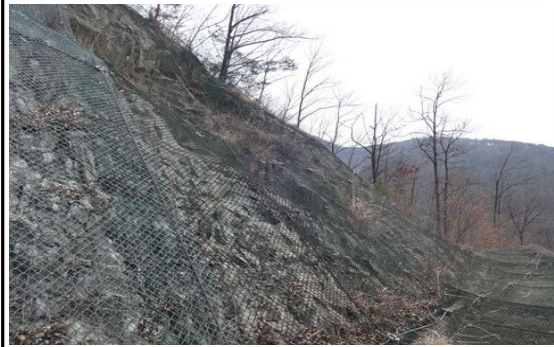
| 대구절토 18 (부산기점 73.38~73.78Km / 4공구 STA.2+680~3+080) | |
|---|---|
| 73.42K 2단 이완암 | |

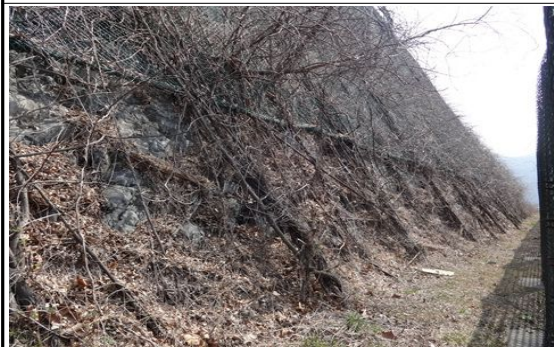
| 대구절토 18 (부산기점 73.38~73.78Km / 4공구 STA.2+680~3+080) | |
|---|---|
| 73.44K 1단 심한풍화 | 73.44K 2단 수목 및 파쇄심함 |

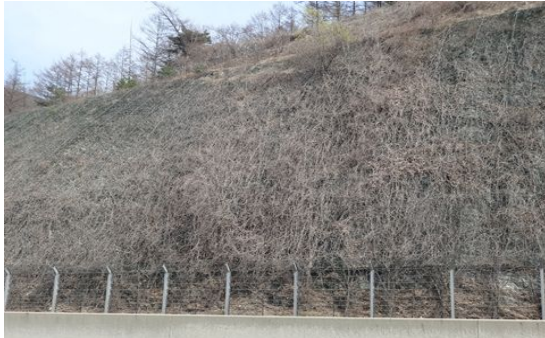
| 73.64K 1단 충전물유실 | |

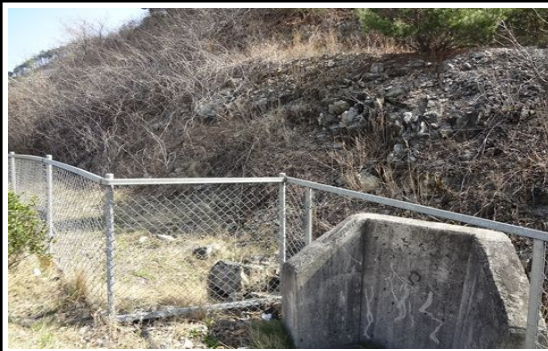
73.82K 1단 이완암

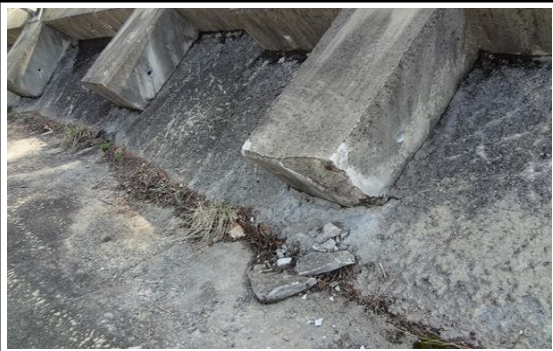
73.98K 6단 격자앵커 박락

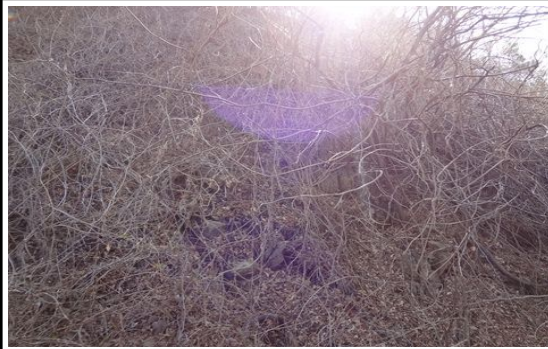
73.86K 1단 이완암

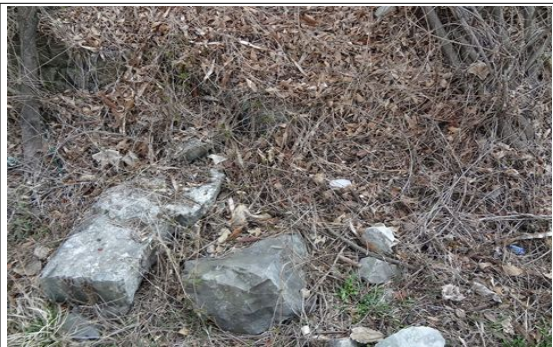
73.94K 1단 이완암

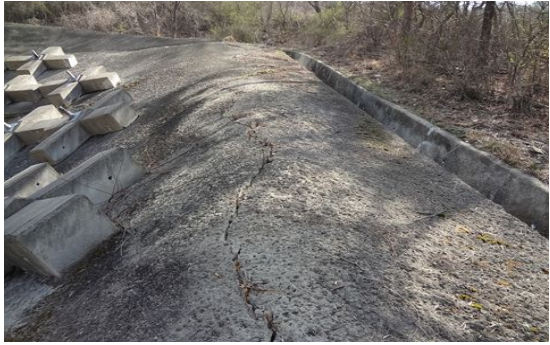
| 73.98K 6단 숏크리트 균열 | 74.00K 4단 이완암 |

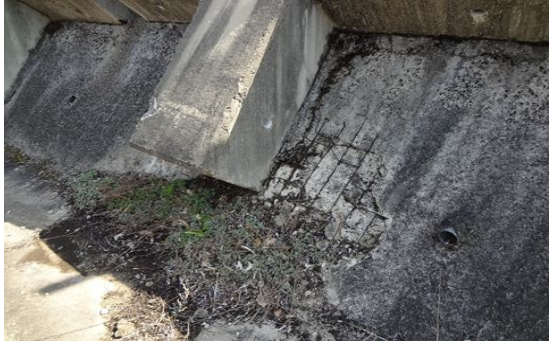
| 74.00K 5단 숏크리트 박리 | 74.02K 7단 앵커캡 망실 |

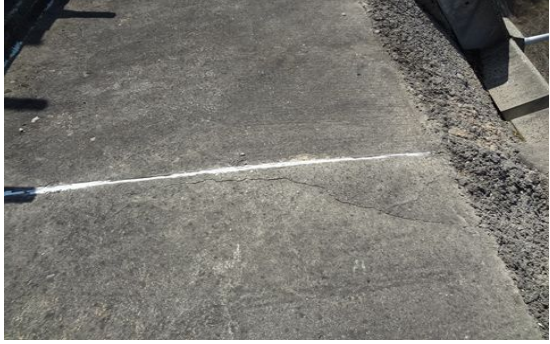
| 74.04K 6소단배수로 균열 | 74.08K 산마루측구 균열 |

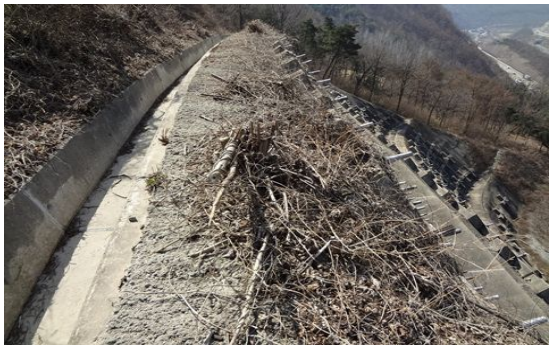
| 74.08K 7단 숏크리트 들뜸 - | |

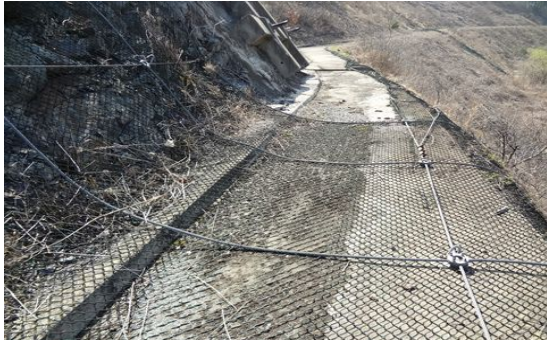
| 74.14K 1소단배수로 토사퇴적 | 74.15K 4소단배수로 균열 |

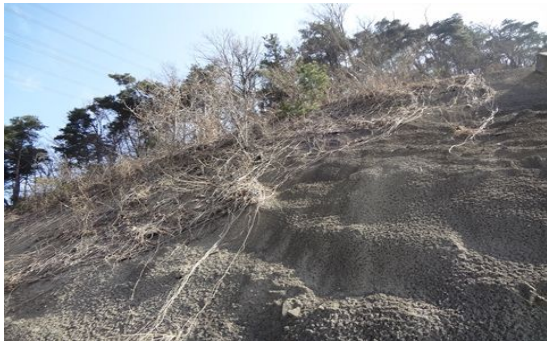
| 74.16K 5단 숯크리트 들뜸 | |

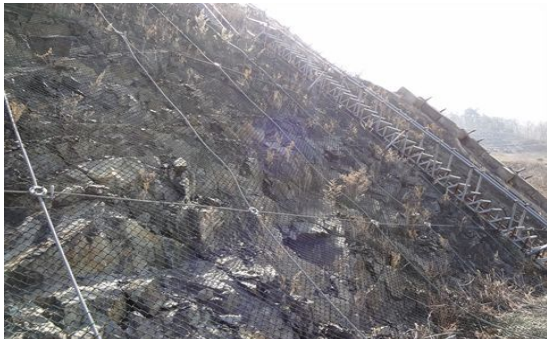
| 74.17K 2단 이완암 | |

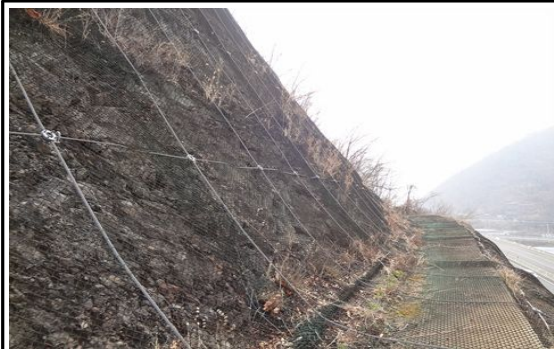
| 대구절토 20 (부산기점 76.34~76.65km / 3공구 STA.14+600~0+120(4공구)) | |
|---|---|
| 76.37K 2단 이완암 | |

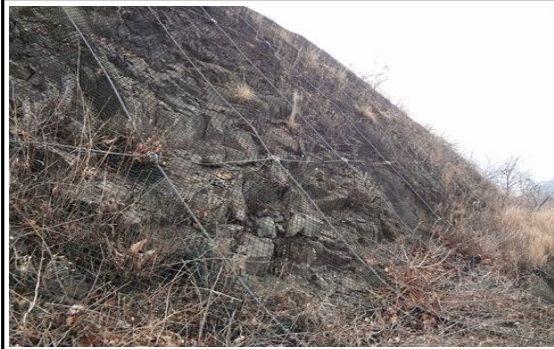
| 대구절토 20 (부산기점 76.34~76.65km / 3공구 STA.14+600~0+120(4공구)) | |
|---|---|
| 76.39K 3단 이완암 | 76.40K 1소단배수로 토사퇴적 |

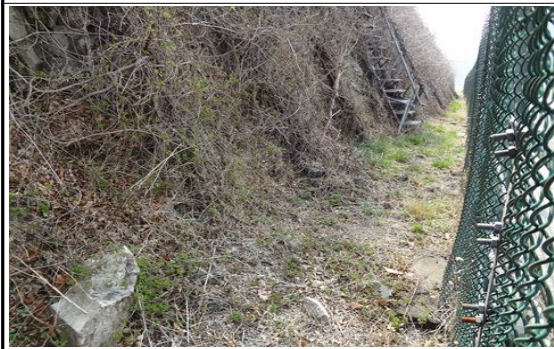
| 대구절토 20 (부산기점 76.34~76.65km / 3공구 STA.14+600~0+120(4공구)) | |
|---|---|
| 76.41K 1단 이완암, 퇴적 | |

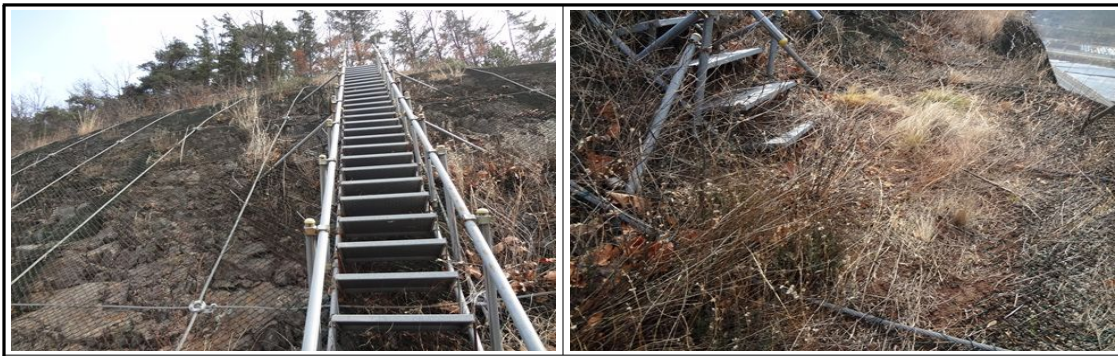
76.41K 3단 충전물유실, 퇴적

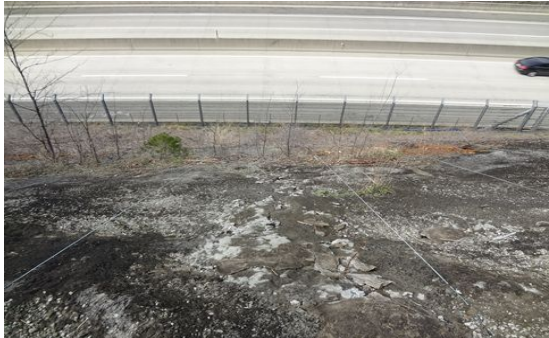
| 76.49K 1단 숯크리트 들뜸 | 76.49K 자연사면 이완암 |

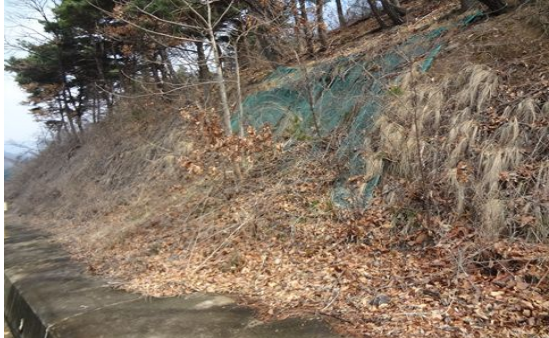
| 76.53K 자연사면 표층유실 | 76.54K 산마루측구 균열 |

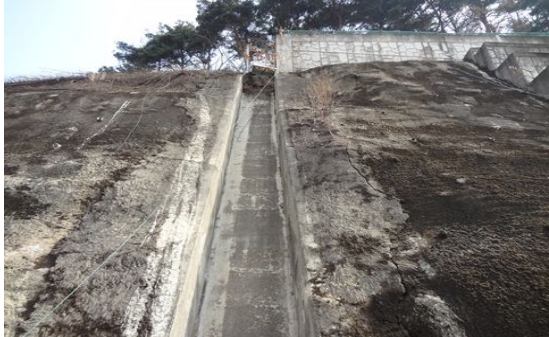
| 76.55K 2단 숯크리트 들뜸 | |

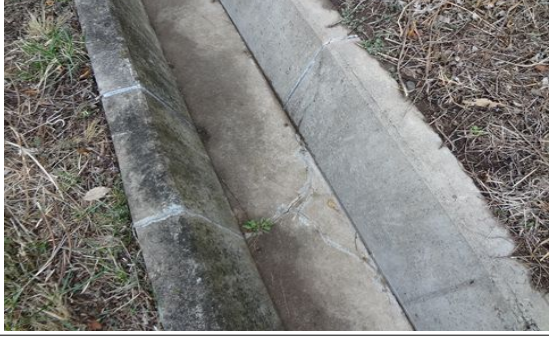
| 76.57K 산마루측구 균열 | 76.61K 자연사면 표층유실 |

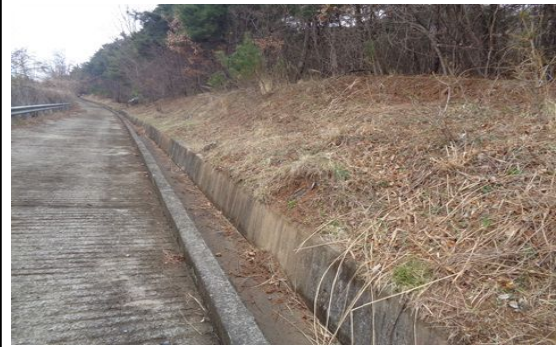
| 대구절토 21 (부산기점 77.99~78.37km / 3공구 STA.12+880~13+260) | |
|---|---|
| 78.05K 자연사면 표층유실 | |

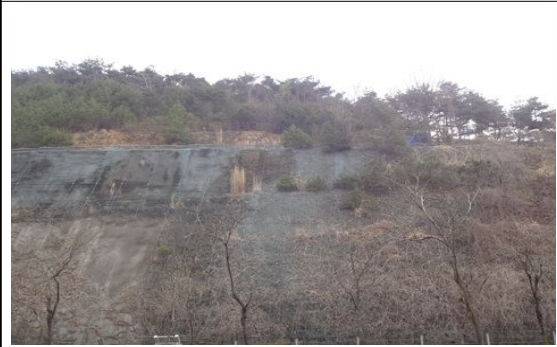
| 대구절토 21 (부산기점 77.99~78.37km / 3공구 STA.12+880~13+260) | |
|---|---|
| 78.12k 1단 심한풍화 | |

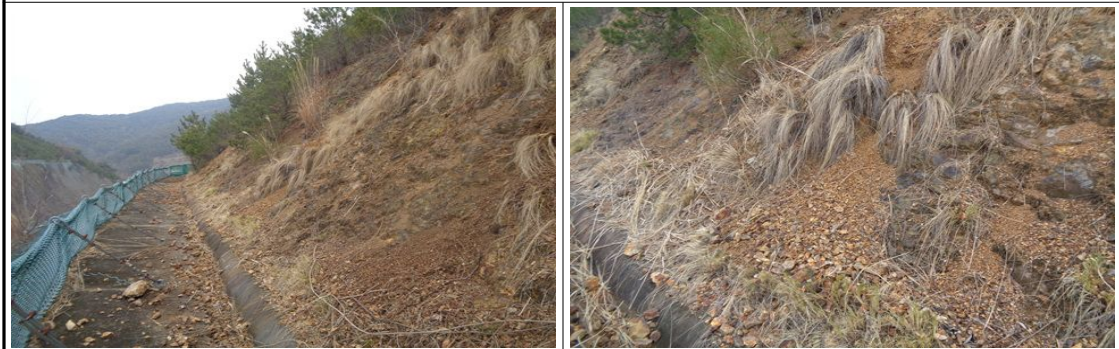
78.13K 2단 심한풍화

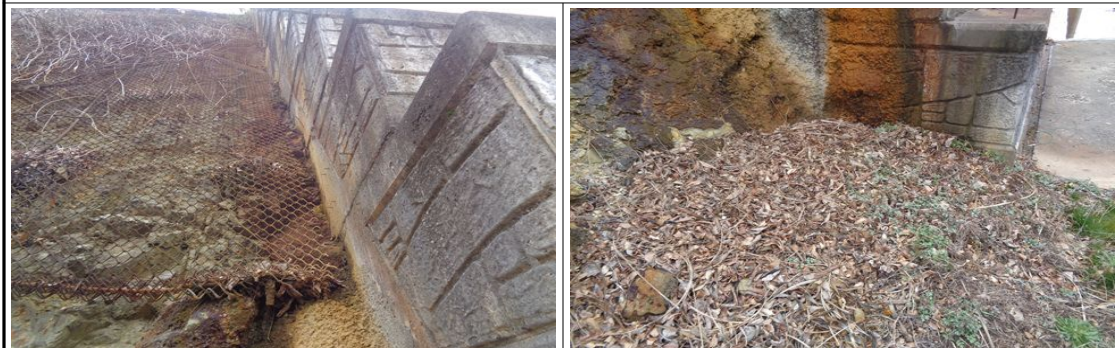
78.18K 1단 심한풍화 및 토사유실

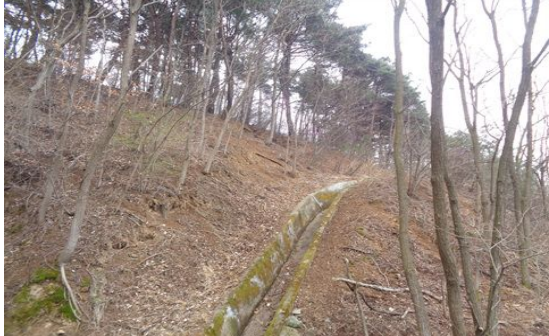
| 78.21K 자연사면 표층유실 | |

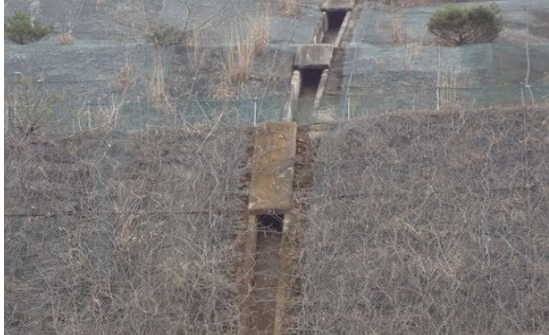
| 78.22k 1단 파쇄대 | 78.22k 상부 자연사면 심한풍화 |

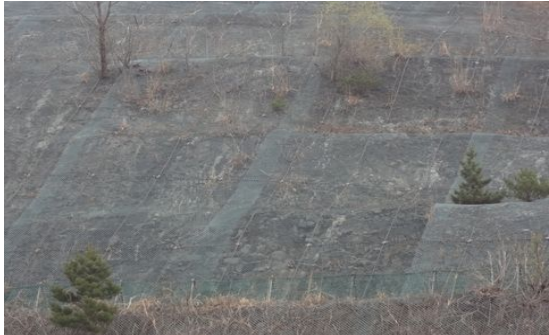
| 78.23k 2단 낙석위험 | 78.23K 2단 심한풍화 및 이완암 |

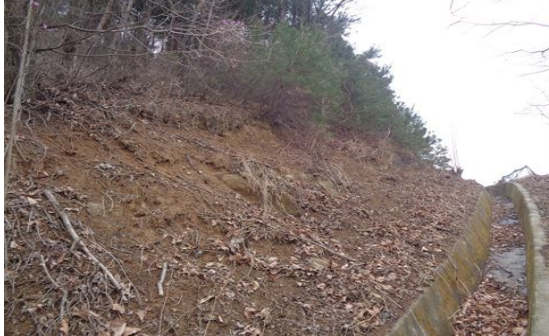
| 78.25~78.29K 자연사면 표층유실 | |

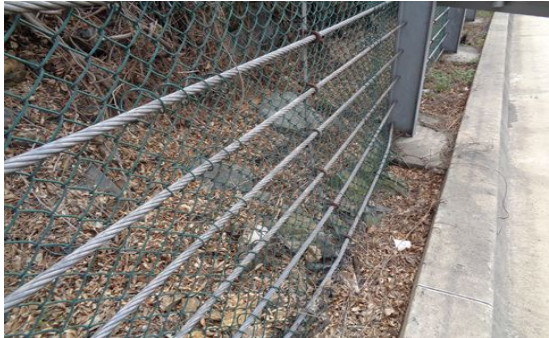
| 78.31K 1단 하부 낙석퇴적 | 78.31k 2단 자연사면 심한풍화 |

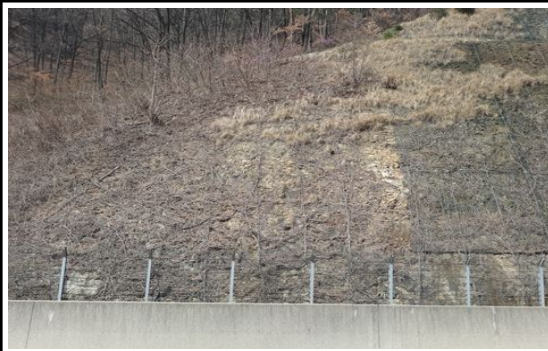
81.14K 1단 뜯돌 다수

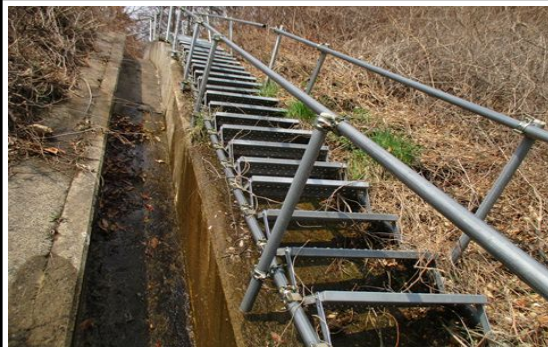
81.14K 1단 절리부 누수

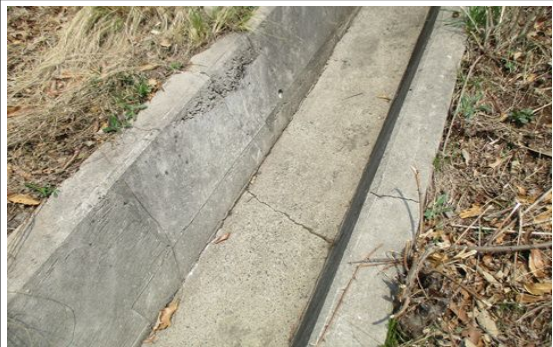
81.16K 산마루측구 균열

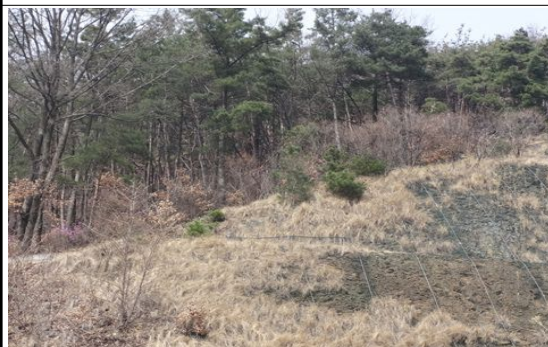
81.17K 2단 표층유실

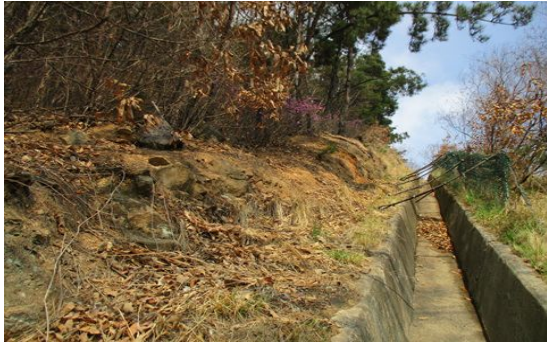
| 81.19K 자연사면 표층유실 | 81.20K 1단 누수 |

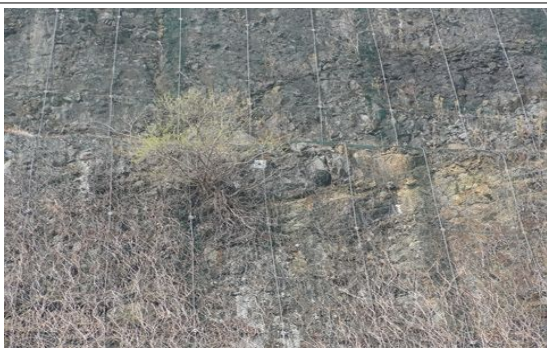
| 81.25K 1단 이완암 | 81.26K 2단 뜯돌 |

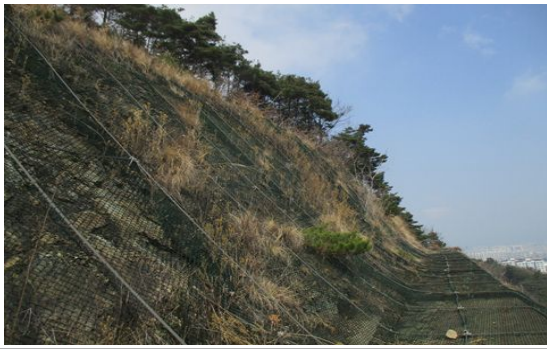
| 81.26K 3단 낙석위험 | |

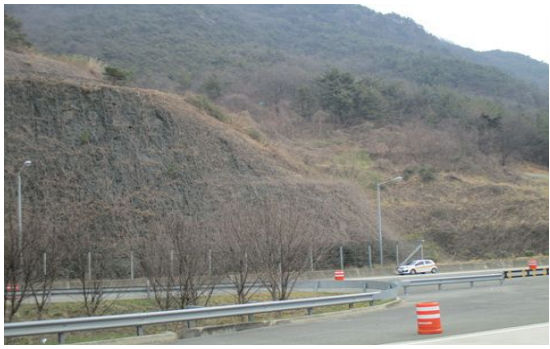
| 대구절토 23 (부산기점 26.94~27.26km / 9공구 STA.5+640~5+960) | |
|---|---|
| 26.95k 1단 심한풍화 | |

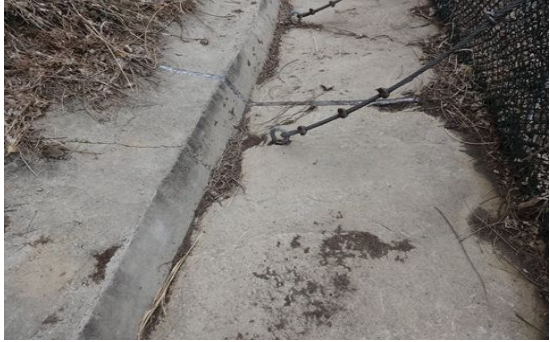
| 대구절토 23 (부산기점 26.94~27.26km / 9공구 STA.5+640~5+960) | |
|---|---|
| 26.96K 1소단배수로 균열 | 27.01K 자연사면 녹생토유실 |

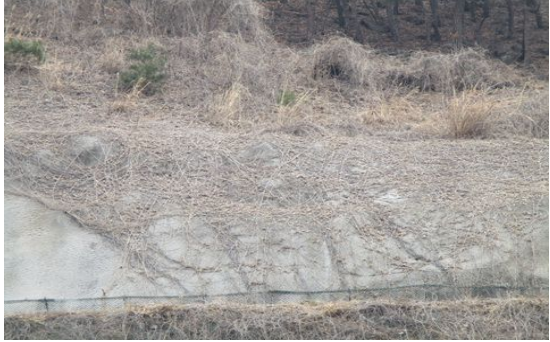
| 대구절토 23 (부산기점 26.94~27.26km / 9공구 STA.5+640~5+960) | |
|---|---|
| 27.03K 2단 표층유실 | 27.06K 자연사면 표층유실 우려 |

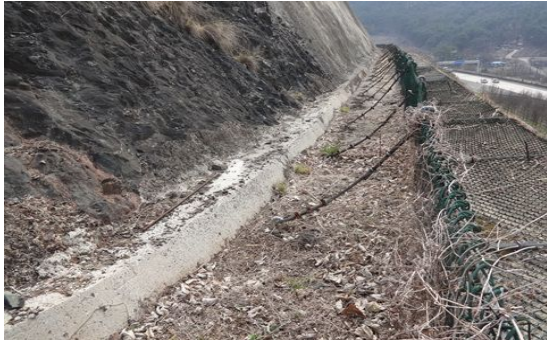
| 27.12K 1소단배수로 토사퇴적 | 27.12K 2단 이완암 |

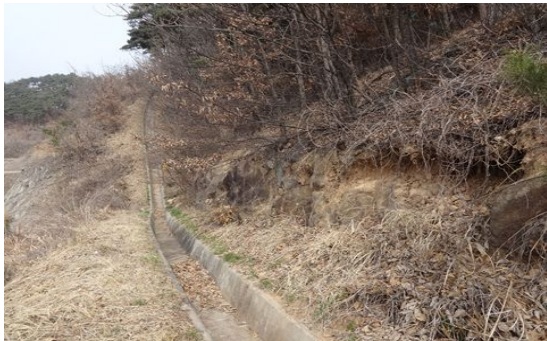
| 27.12K 자연사면 표층유실 | |

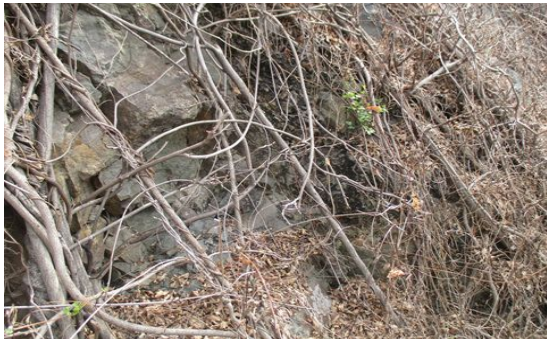
| 27.13K 1단 누수 | 27.13K 2단 심한파쇄 |

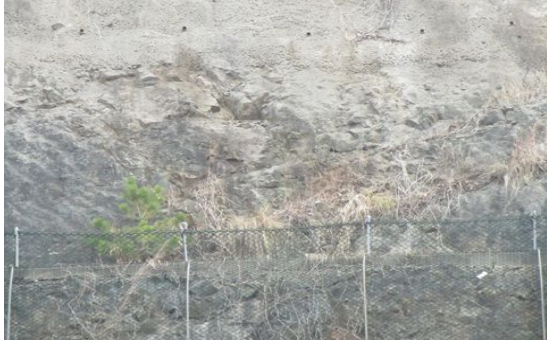
| 27.15K 2단 심한풍화 | 27.21K 1단 낙석퇴적 |

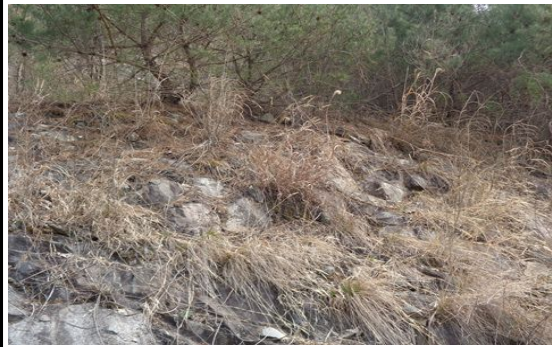
| 대구절토 24 (부산기점 49.82~50.0km / 7공구 STA.5+640~5+960) | |
|---|---|
| 49.83K 8단 이완암 | 49.84K 1소단배수로 낙석 및 토사퇴적 |

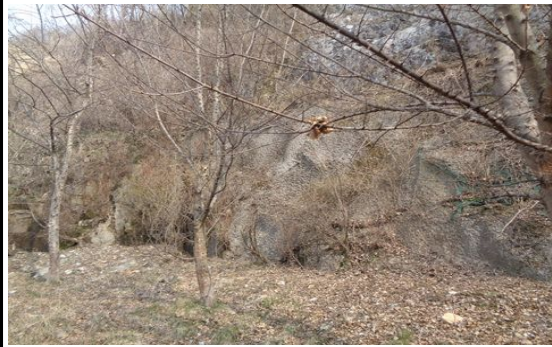
| 대구절토 24 (부산기점 49.82~50.0km / 7공구 STA.5+640~5+960) | |
|---|---|
| 49.84K 2단 숏크리트 들뜸 | |

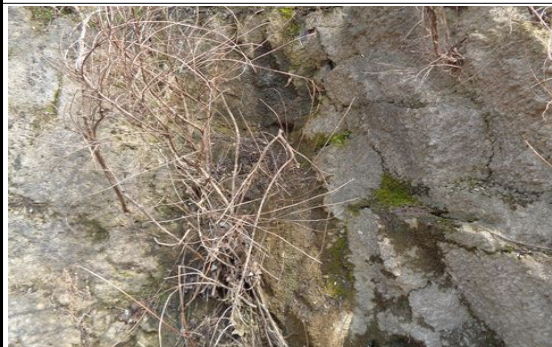
| 대구절토 24 (부산기점 49.82~50.0km / 7공구 STA.5+640~5+960) | |
|---|---|
| 49.85K 2단 절리부 누수 | 49.85K 5단 이완암 |

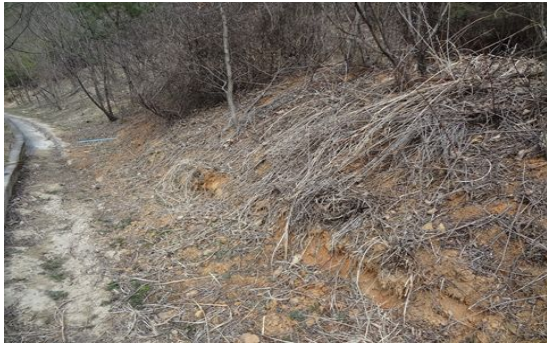
| 대구절토 25 (부산기점 50.35~50.55km / 7공구 STA.2+100~2+300) | |
|---|---|
| 50.47~50.53K 5~6단 세굴 | |

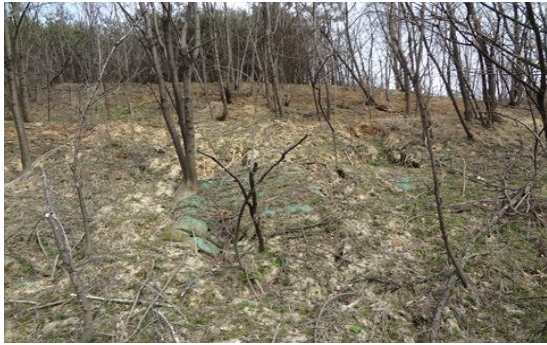
| 대구절토 25 (부산기점 50.35~50.55km / 7공구 STA.2+100~2+300) | |
|---|---|
| 50.47~50.53K 5~6단 세굴 | |

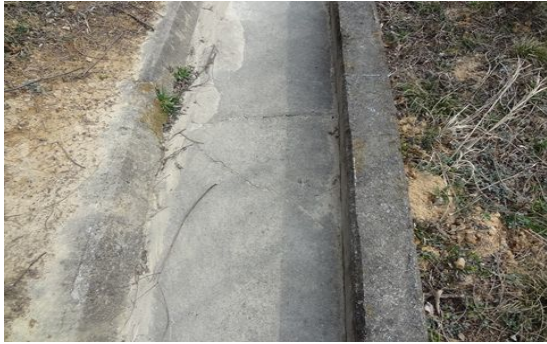
| 대구절토 25 (부산기점 50.35~50.55km / 7공구 STA.2+100~2+300) | |
|---|---|
| 50.48K 1소단배수로 균열 | 50.54K 9단 폐목적치 |

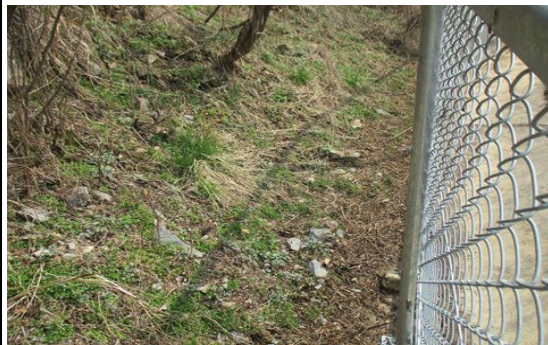
51.47K 1소단배수로 토사 및 낙석퇴적

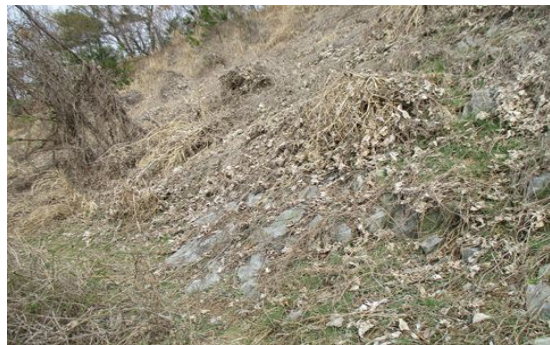
51.48K 10단 노출암반

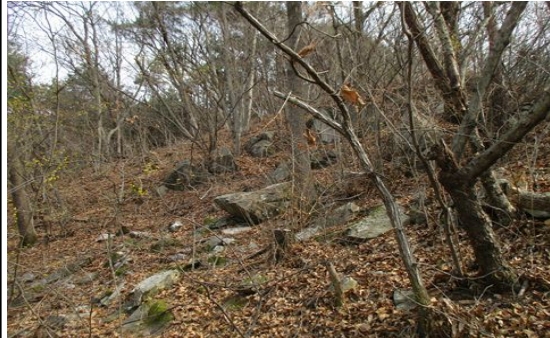
| <p>51.49K 자연사면 암괴 다수</p> | <p>51.49K 자연사면 표층유실</p> |

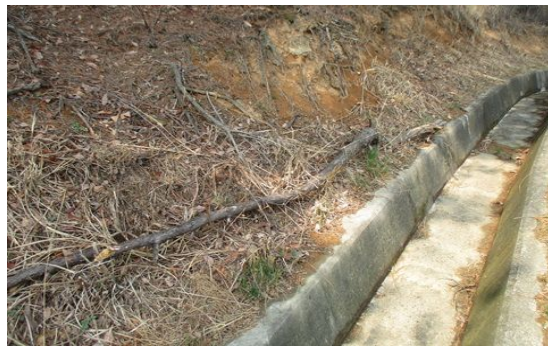
12.73K 자연사면 폐목

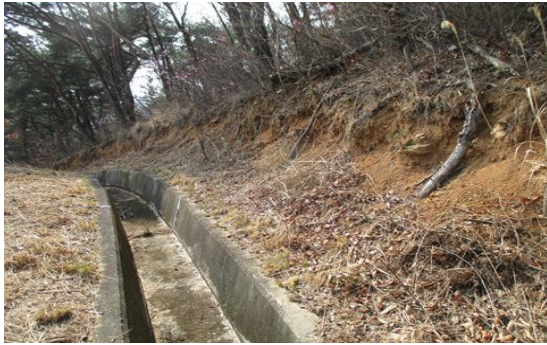
| 12.94K 자연사면 표층유실 | |

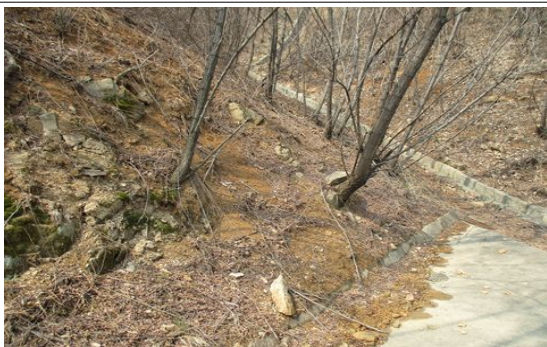
| 12.96K 3단 표층유실 | |

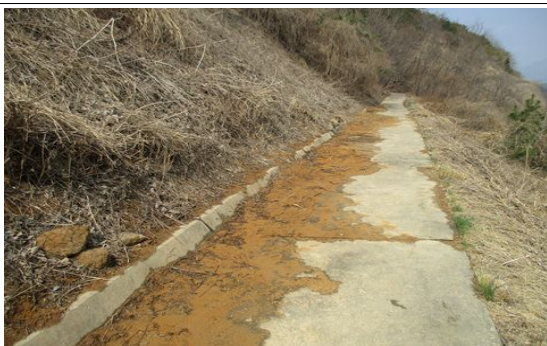
| 12.96K 1소단배수로 토사퇴적 | 1소단배수로 전경 |

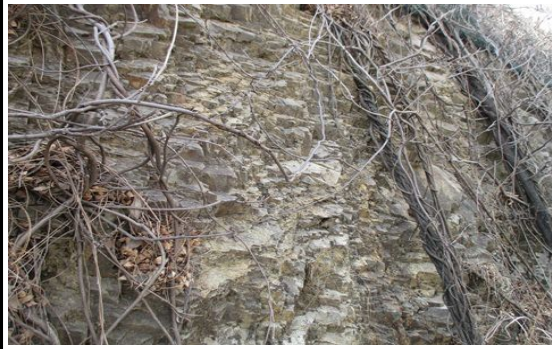
| 부산절토 28 (부산기점 16.85~17.03km / 10공구 STA.4+600~4+780)) | |
|---|---|
| 16.88~16.89K 1단 풍화 | 16.90K 1소단배수로 균열 |

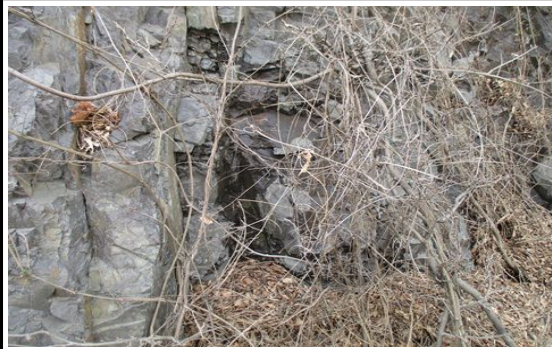
| 부산절토 28 (부산기점 16.85~17.03km / 10공구 STA.4+600~4+780)) | |
|---|---|
| 16.92K 1단 누수 | 16.97K 1소단배수로 균열 |

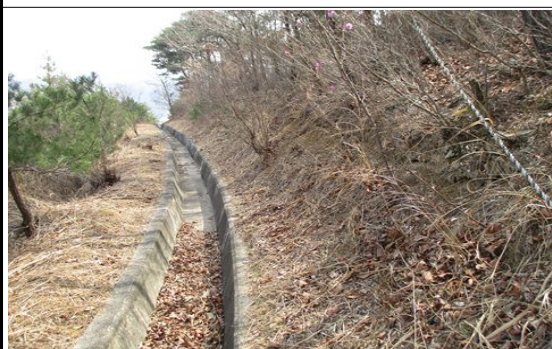
| 부산절토 28 (부산기점 16.85~17.03km / 10공구 STA.4+600~4+780)) | |
|---|---|
| 16.96K 자연사면 표층유실 | |

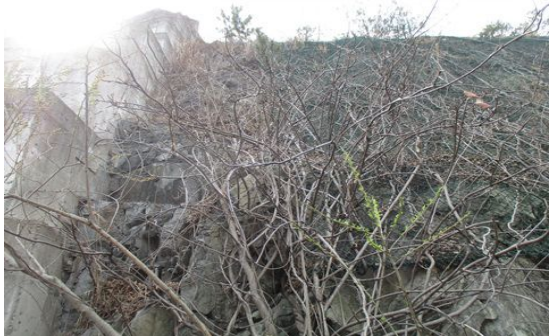
| 16.99K 1단 낙석위험 | |

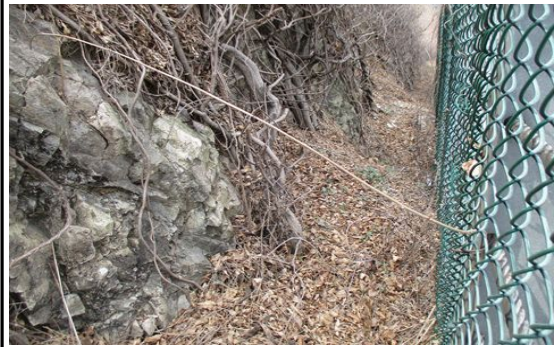
| 부산절토 29 (부산기점 17.03~17.28km / 10공구 STA.4+350~4+600) | |
|---|---|
| 17.04K 1단 하부 풍화유실 및 퇴적 | 17.09K 자연사면 토석류 |

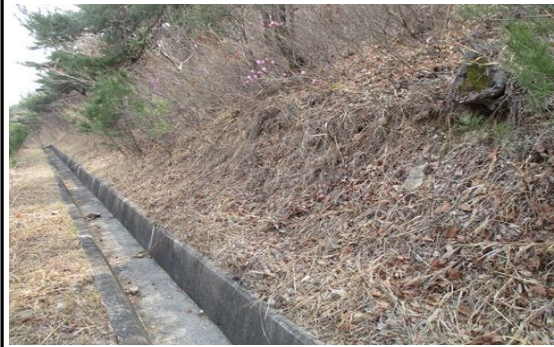
| 부산절토 29 (부산기점 17.03~17.28km / 10공구 STA.4+350~4+600) | |
|---|---|
| 17.09K 자연사면 표층유실 | |

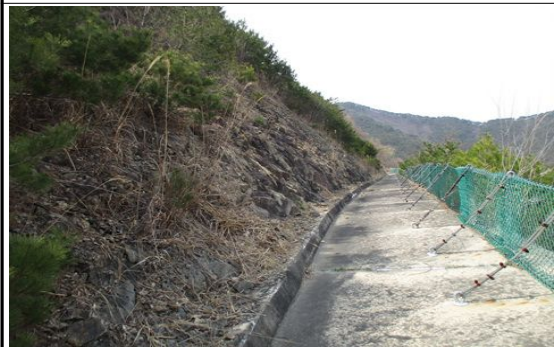
| 부산절토 29 (부산기점 17.03~17.28km / 10공구 STA.4+350~4+600) | |
|---|---|
| 17.10K 2단 뜯돌 및 이완암 | |

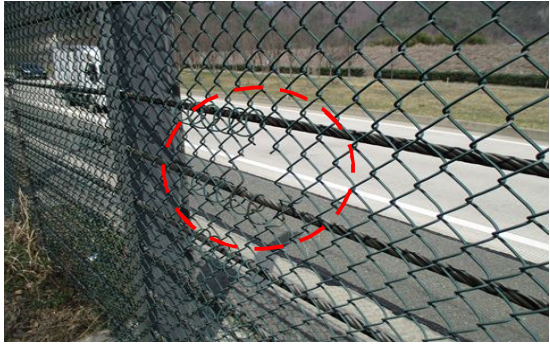
| <p>17.12K 1단 낙석방지울타리 손상</p> | <p>17.12K 1단 하부 낙석퇴적</p> |

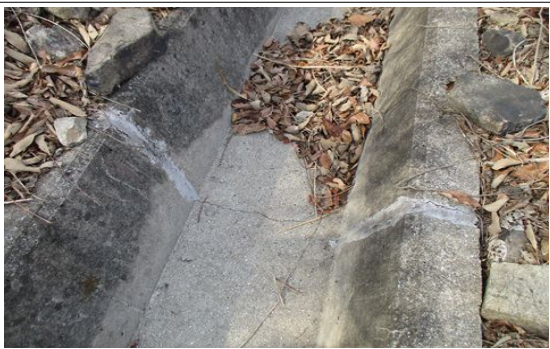
| <p>17.13K 산마루측구 균열</p> | <p>17.16K 자연사면 수목전도위험</p> |

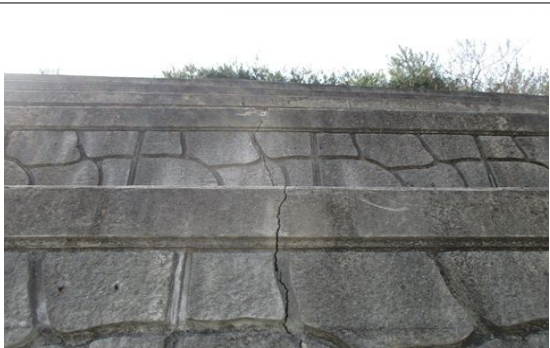
| <p>17.19K 1단 계단식옹벽 균열 0.3</p> | |

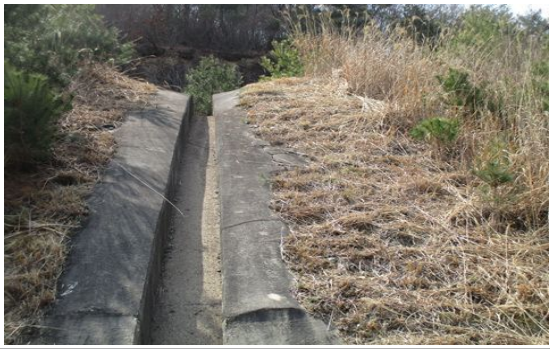
| <p>17.25K 수직도수로 파손</p> | |

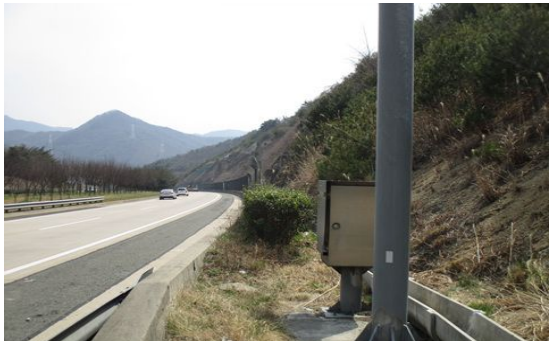
| <p>하부 전경</p> | |

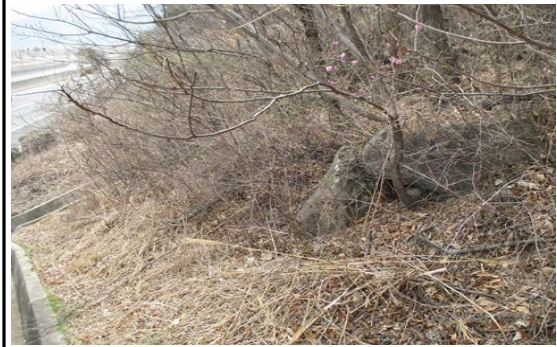
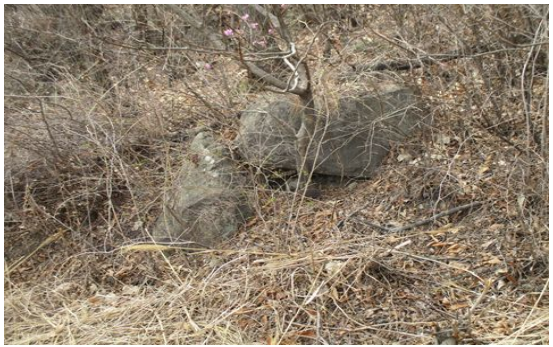
| 부산절토 30 (부산기점 19.29~19.52km / 10공구 STA.2+110~2+340) | |
|---|---|
| 19.31K 자연사면 암괴 다수 | |

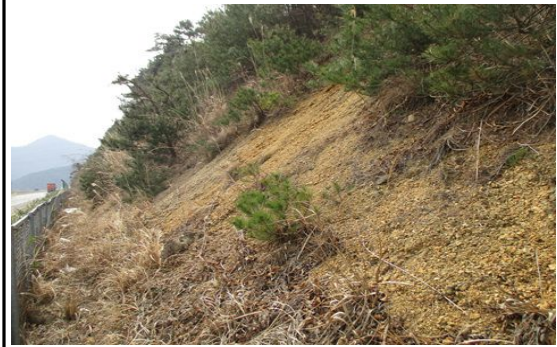
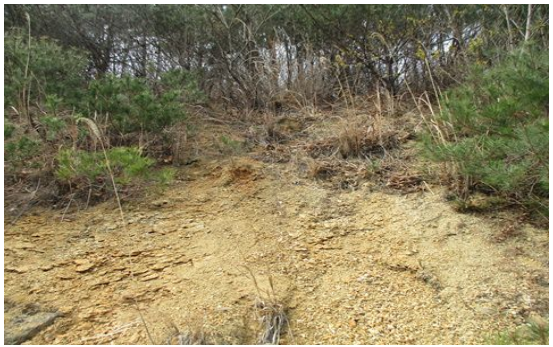
| 부산절토 30 (부산기점 19.29~19.52km / 10공구 STA.2+110~2+340) | |
|---|---|
| 19.32~19.36K 1단 표층유실 | |

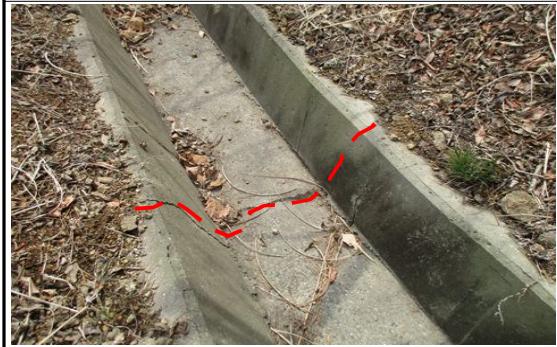
| 부산절토 30 (부산기점 19.29~19.52km / 10공구 STA.2+110~2+340) | |
|---|---|
| 19.39K 산마루측구 균열 | 19.43K 1소단배수로 균열 |

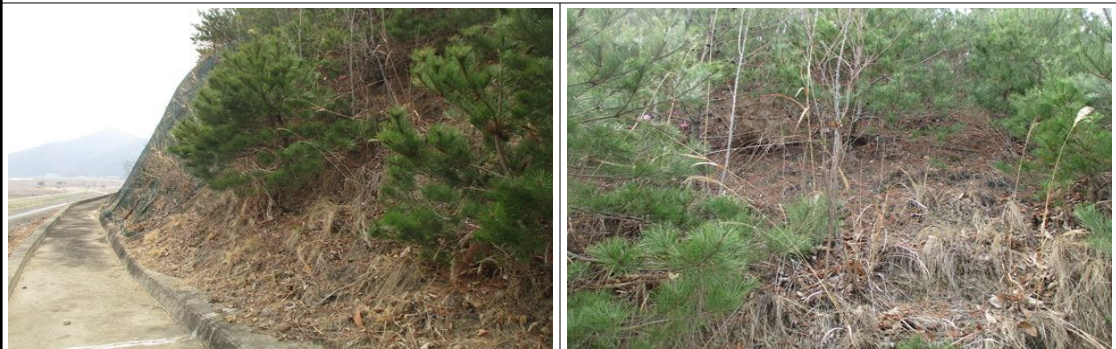
19.47K 2단 표층유실
