**2017년 상반기 시설물 정기점검 용역**  
**정 기 점 검 사 진 첵**  
**[2종 절토사면 손상현황 사진첩]**

**2017. 06.**

**新 대구부산고속도로주식회사**  
**New DAEGU BUSAN Expressway Co., Ltd.**

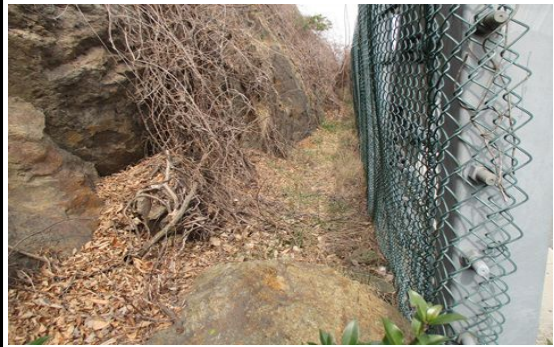
| 부산절토 31 (부산기점 19.82~19.98km / 10공구 STA.1+650~1+810) | |
|---|---|
| 19.84K 1단 낙석 | 19.85K 1단 켜기형유실우려 구간 |

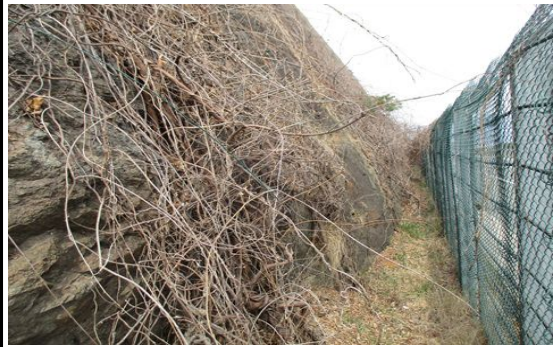
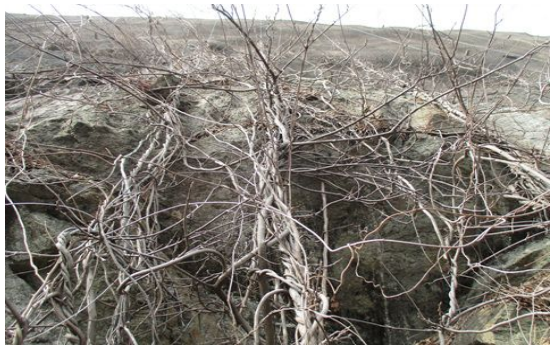
| 부산절토 31 (부산기점 19.82~19.98km / 10공구 STA.1+650~1+810) | |
|---|---|
| 19.85K 1단 이완암 | |

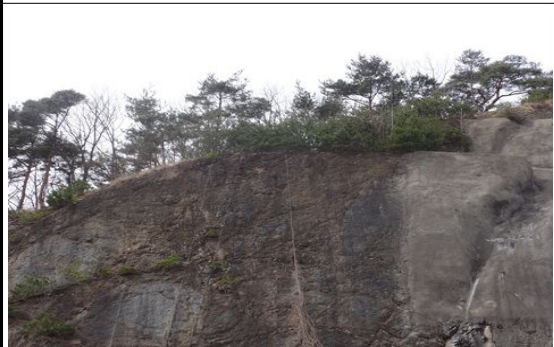
| 부산절토 31 (부산기점 19.82~19.98km / 10공구 STA.1+650~1+810) | |
|---|---|
| 19.86K 1단 심한풍화 | 19.87K 1단 이완암 및 낙석위험 |

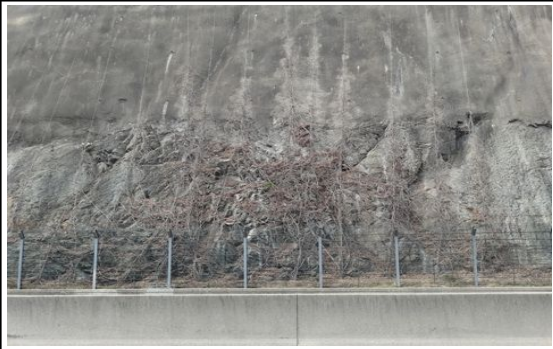
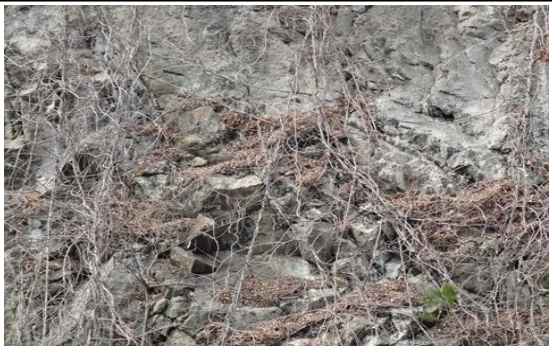
| 19.91K 1단 이완암 | |

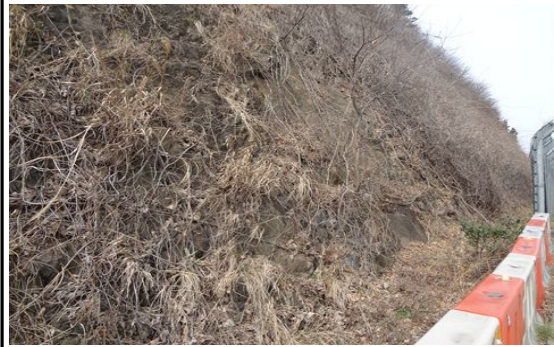
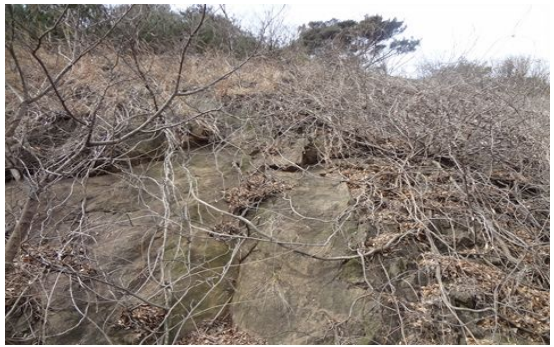
| 20.27~20.29K 1단 이완암 및 낙석위험 | |

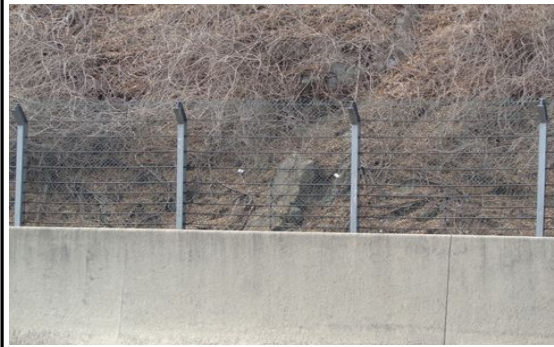
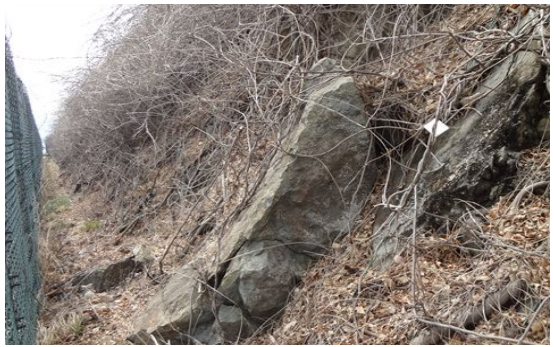
| 20.32K 1단 암괴 탈락 | |

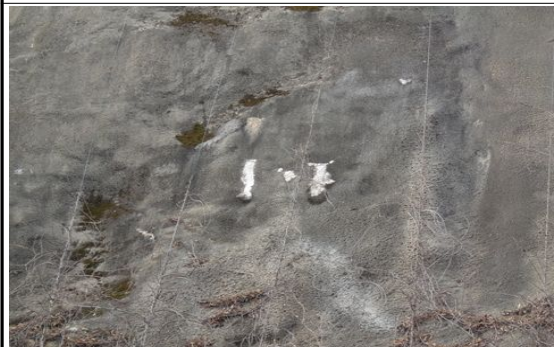
| 20.35K 1단 숯크리트 백태 | 20.36~20.37K 자연사면 암괴 |

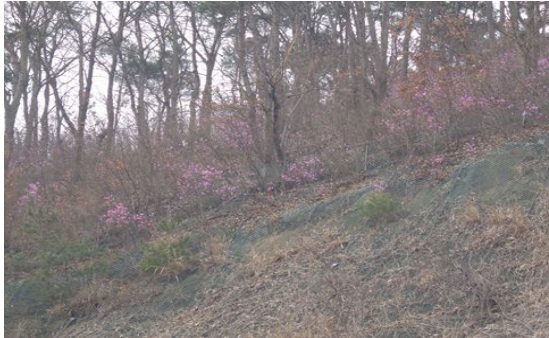
| 20.41K 자연사면 폐목 | 20.42~20.45K 1단 이완암 |

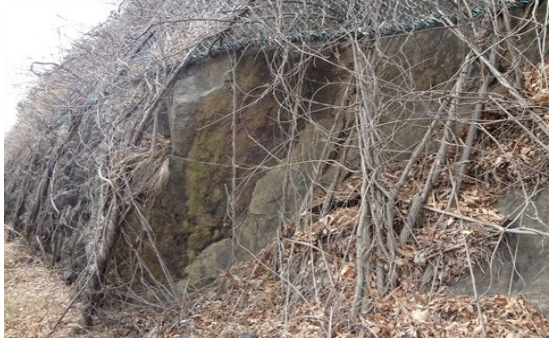
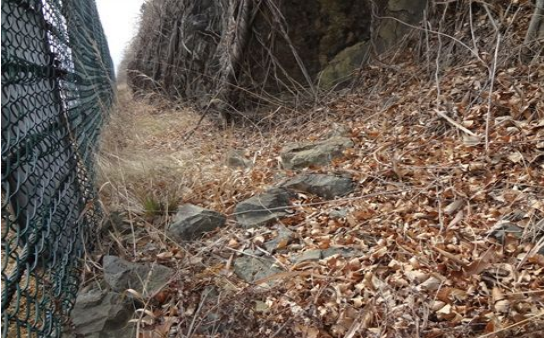
| 20.47K 1단 이완암 및 낙석퇴적 | |

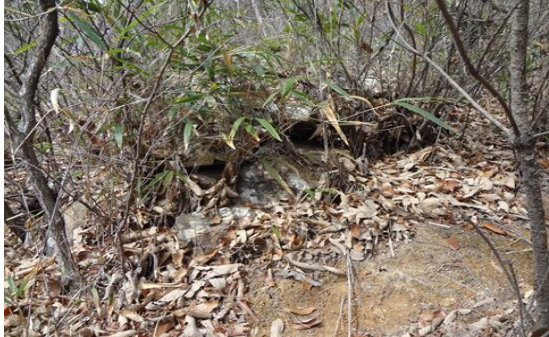
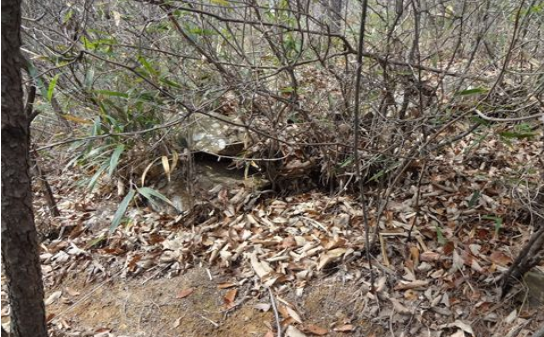
| 자연사면 전구간 암괴 다수 | |

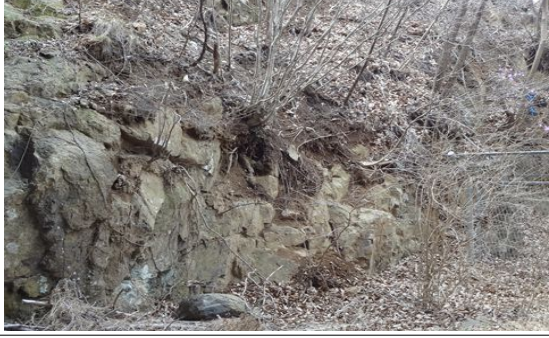
| 20.53K 1단 표층유실 | 하부 낙석방지울타리 전경 |

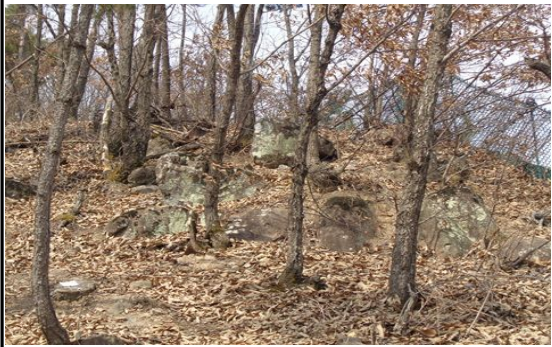
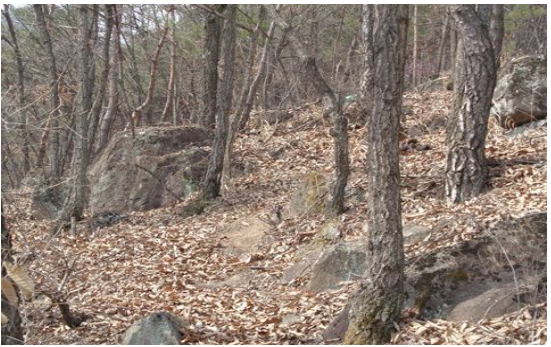
| 부산절토 33 (부산기점 20.87~21.13km / 10공구 STA.0+500~0+760) | |
|---|---|
| 20.87~21.12K 자연사면 전구간 암괴 다수 | |

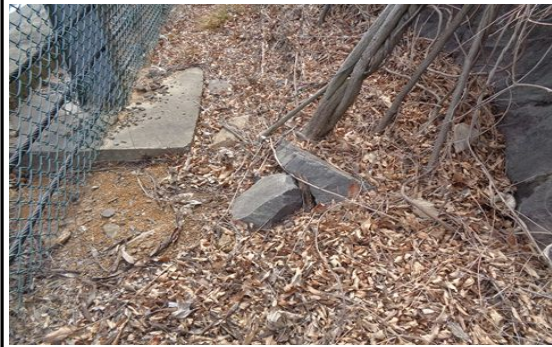
| 부산절토 33 (부산기점 20.87~21.13km / 10공구 STA.0+500~0+760) | |
|---|---|
| 20.87~21.13K 1단 하부 전구간 낙석퇴적 | 20.89K 1단 이완암 |

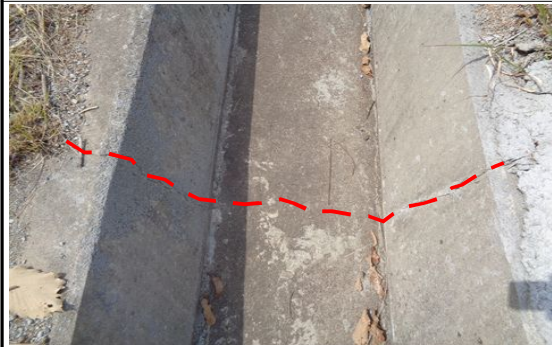
| 부산절토 33 (부산기점 20.87~21.13km / 10공구 STA.0+500~0+760) | |
|---|---|
| 20.89K 산마루측구 균열 | 20.91K 1단 이완암 |

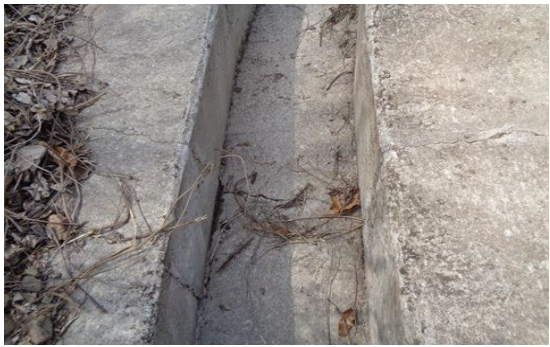
| 부산절토 34 (부산기점 21.21~21.40km / 10공구 STA.0+230~0+420) | |
|---|---|
| 21.22K 산마루측구 균열 | 21.22K 자연사면 토석류 |

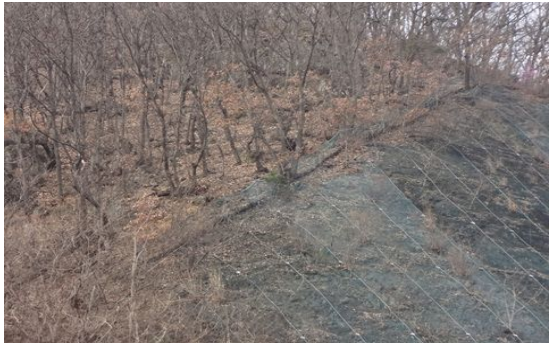
| 부산절토 34 (부산기점 21.21~21.40km / 10공구 STA.0+230~0+420) | |
|---|---|
| 21.23K 자연사면 수목전도 위험 | |

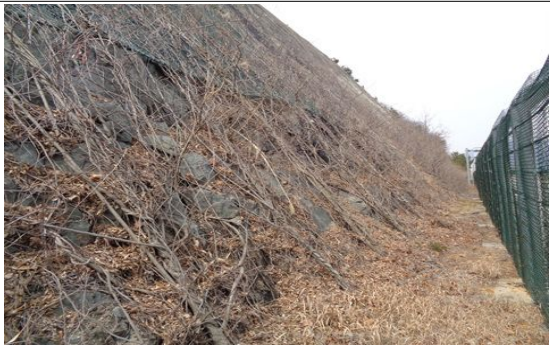
| 부산절토 34 (부산기점 21.21~21.40km / 10공구 STA.0+230~0+420) | |
|---|---|
| 21.30~21.32K 1단 이완암 | |

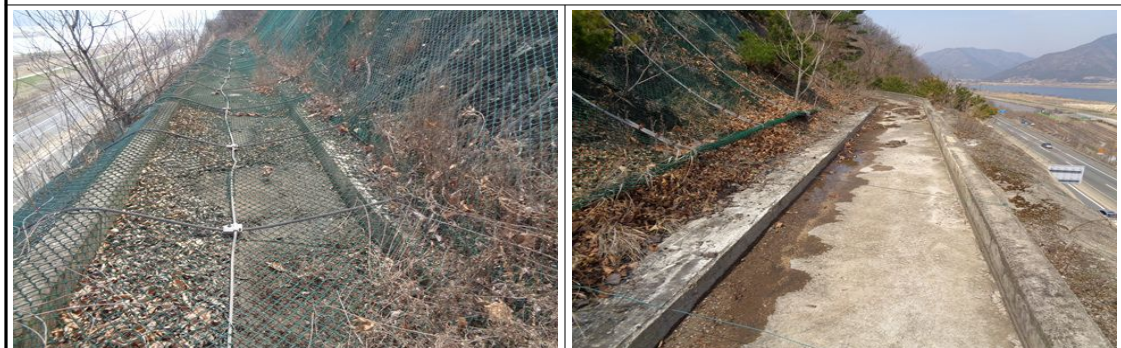
21.31K 1소단배수로 토사퇴적

21.33K 1소단배수로 채수

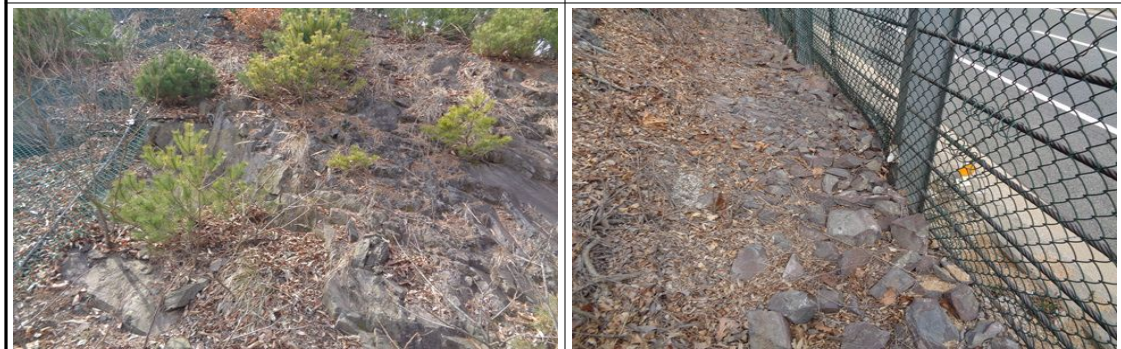
21.34~21.36K 2단 이완암

21.35K 1단 하부 낙석퇴적

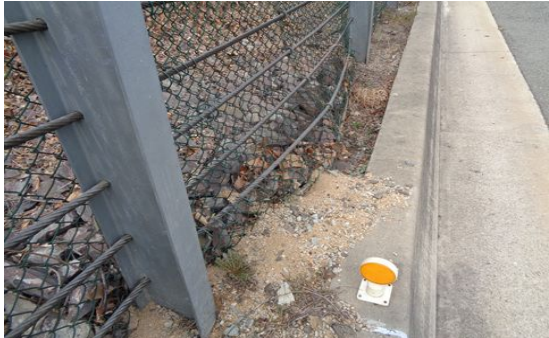
| <p>21.35K 1단 하부 낙석방지울타리 변형</p> | <p>21.36K 1단 뜯돌</p> |

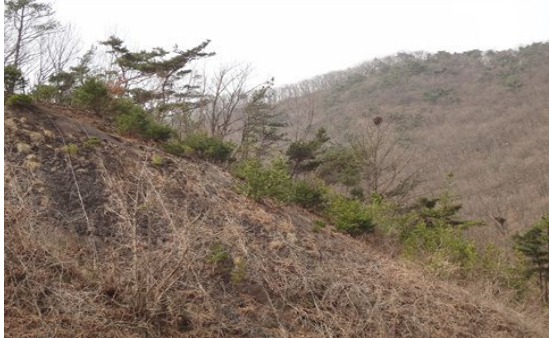
| <p>21.37K 1단 표층유실</p> | <p>1소단배수로 전경</p> |

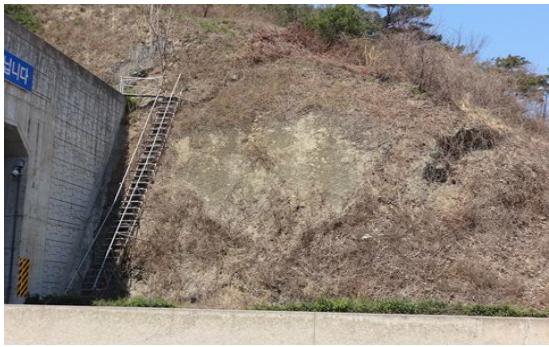
| 대구절토 35 (부산기점 22.71~22.82km / 9공구 STA.10+085~10+195) | |
|---|---|
| 22.74K 1단 녹생토유실 | |

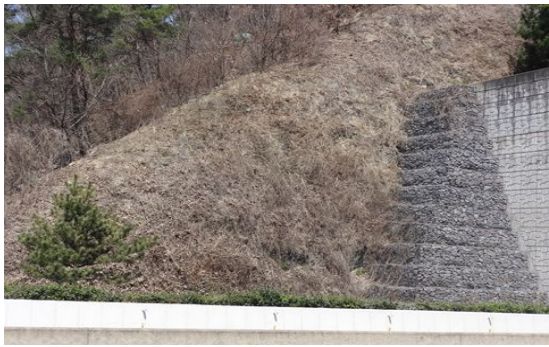
| 대구절토 35 (부산기점 22.71~22.82km / 9공구 STA.10+085~10+195) | |
|---|---|
| 22.80K 1단 녹생토유실 | |

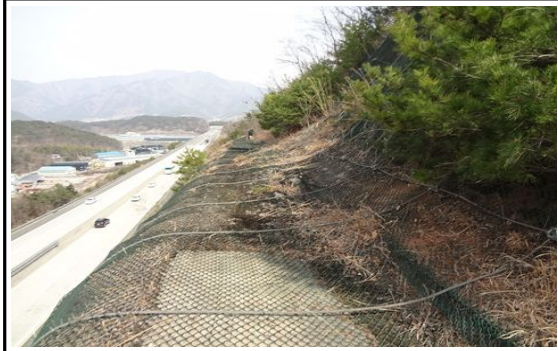
| 부산절토 36 (부산기점 23.84~24.03km / 9공구 STA.8+870~9+060) | |
|---|---|
| 23.42K 1소단배수로 토사퇴적 및 폐목적치 | |

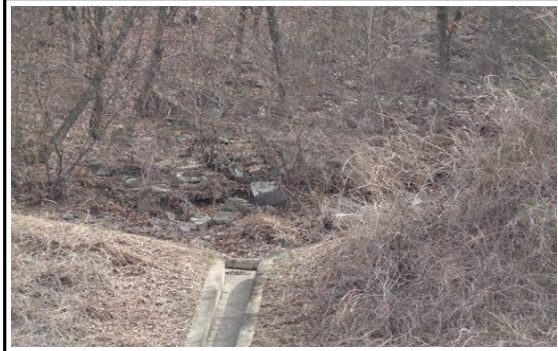
| 부산절토 36 (부산기점 23.84~24.03km / 9공구 STA.8+870~9+060) | |
|---|---|
| 23.84K 자연사면 암괴 | |

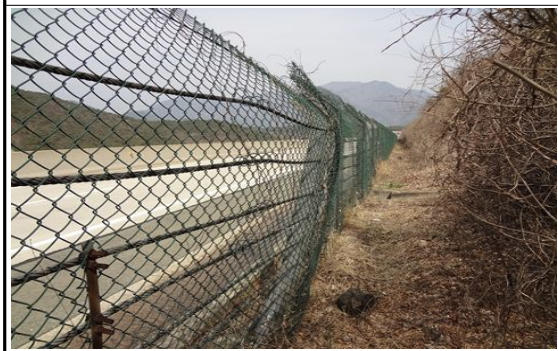
| 부산절토 36 (부산기점 23.84~24.03km / 9공구 STA.8+870~9+060) | |
|---|---|
| 23.85K 1단 낙석방지울타리 변형 | 23.90K 1단 이완암 |

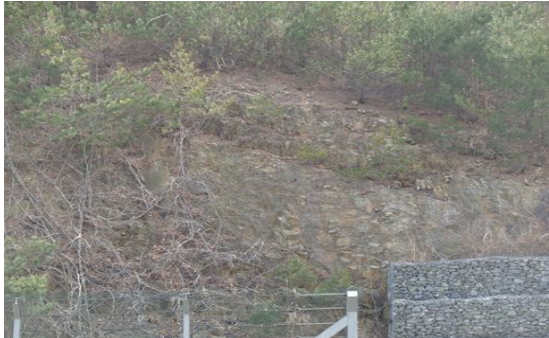
| 24.02K 1단 이완암 | 24.03K 1단 개비온 변형 |

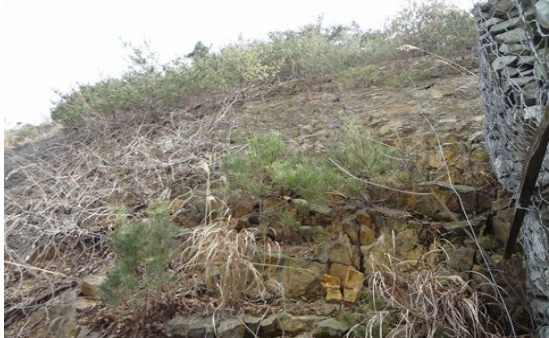
| 24.02K 1단 이완암 및 하부 퇴적 | |

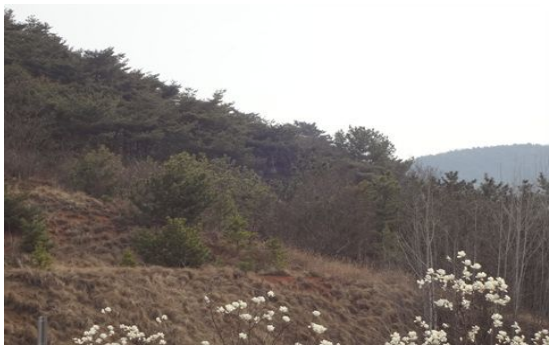
| 대구절토 37 (부산기점 28.84~29.00km / 9공구 STA.3+900~4+060) | |
|---|---|
| 28.86K 1~3단 표층유실 | |

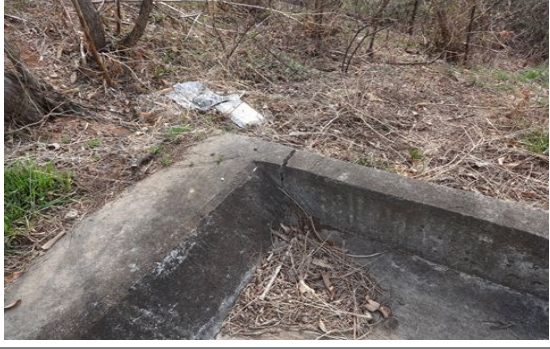
| 대구절토 37 (부산기점 28.84~29.00km / 9공구 STA.3+900~4+060) | |
|---|---|
| 28.88K 1소단배수로 파손 | 28.89K 5단 표층유실 |

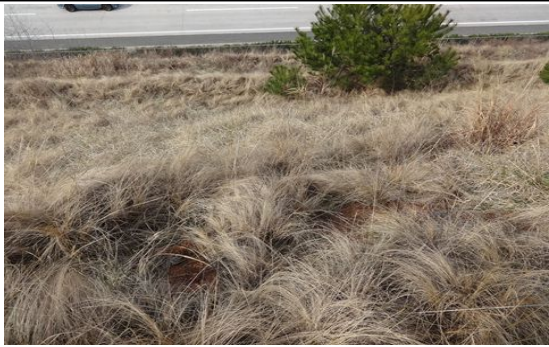
| 28.93K 3단 표층유실 | 28.95K 1소단배수로 균열 |

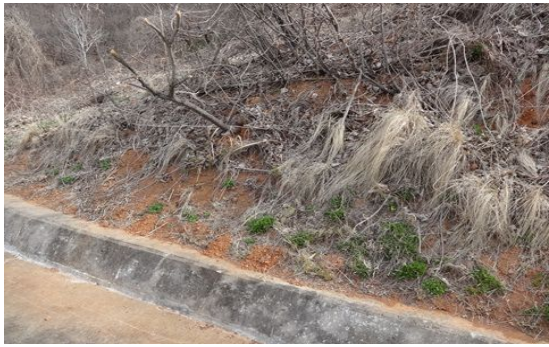
| 28.95K 5단 표층유실 | 29.00K 산마루측구 균열 |

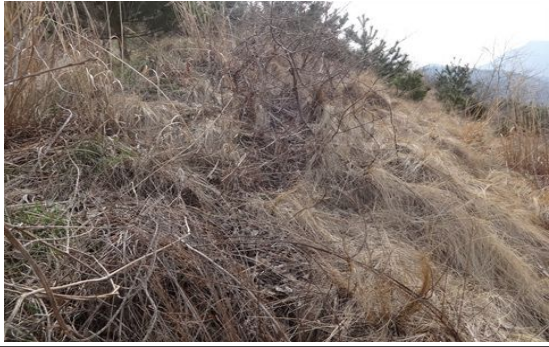
| 29.79K 3단 식생불량 | 1소단배수로 전경 |

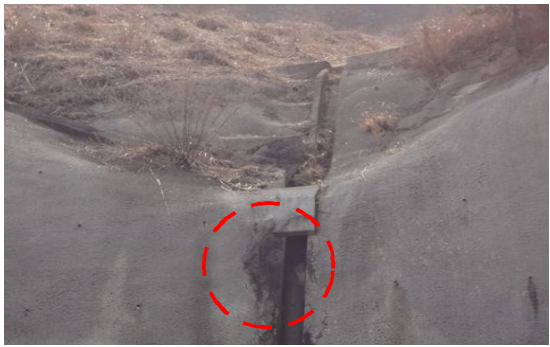
| <p>31.36K 월류방지턱 파손</p> | |

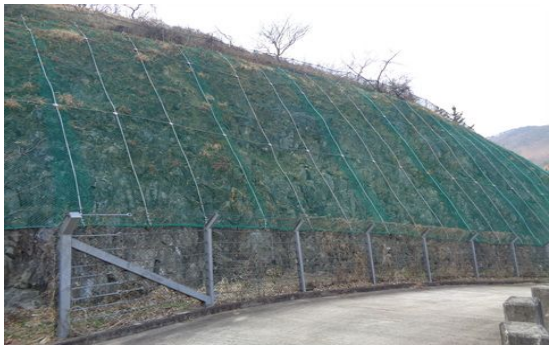
| <p>31.40K 2단 이완암</p> | |

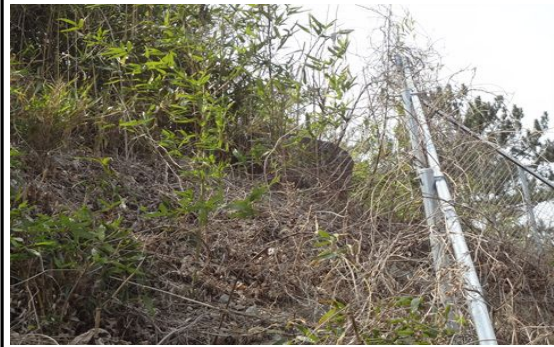
| 부산절토 39 (부산기점 54.19~54.51km / 6공구 STA.10+240~10+560) | |
|---|---|
| 54.22.K 자연사면 암괴 | 54.23k 1단 뜯돌 |

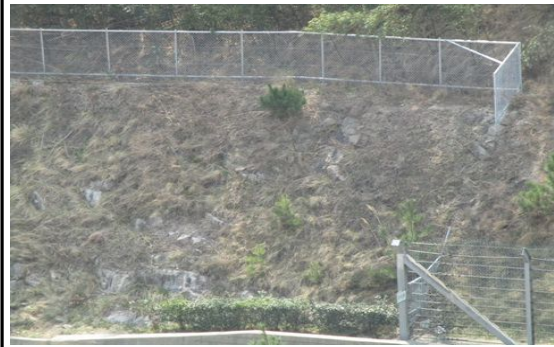
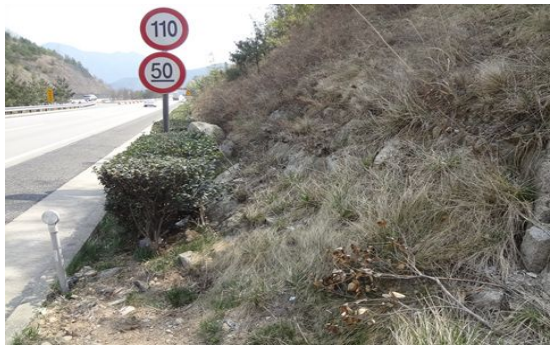
| 부산절토 39 (부산기점 54.19~54.51km / 6공구 STA.10+240~10+560) | |
|---|---|
| 54.32~54.33K 1단 이완암 및 하부 낙석퇴적 | |

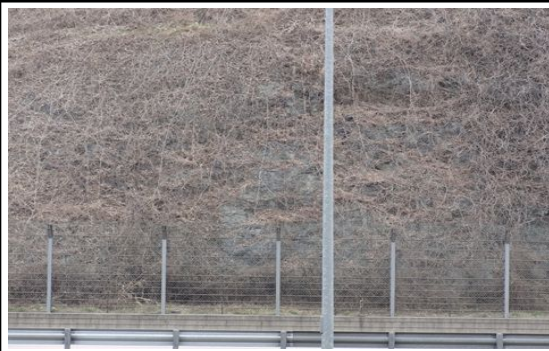
56.21K 1단 이완암

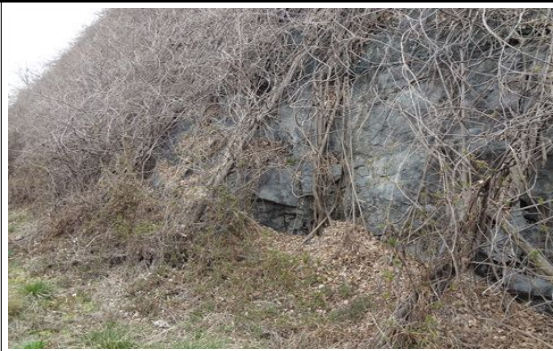
56.14K 1단 이완암

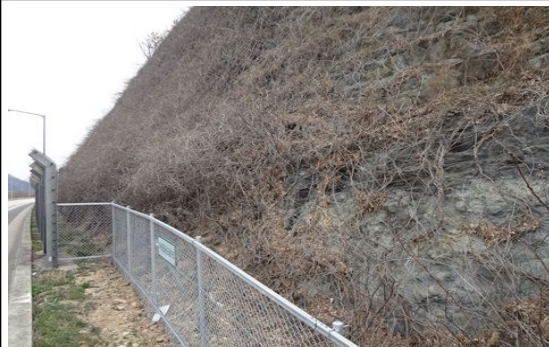
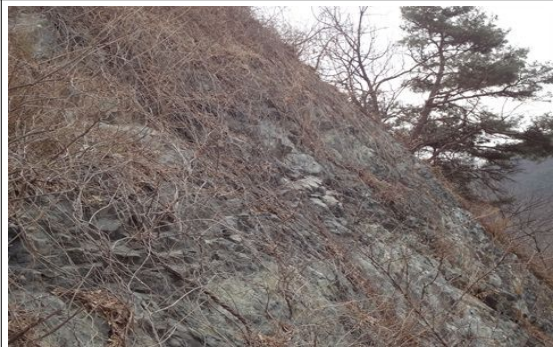
56.08K 1단 뜯돌 (낙석방지울타리 설치 연장요망)

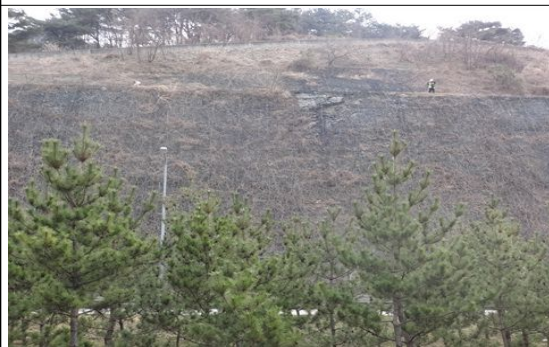
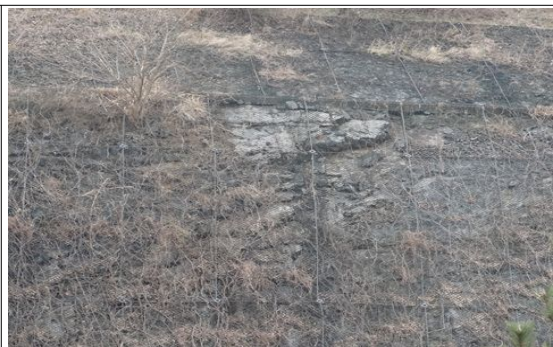
56.17K 1단 상부 심한풍화 및 이완암

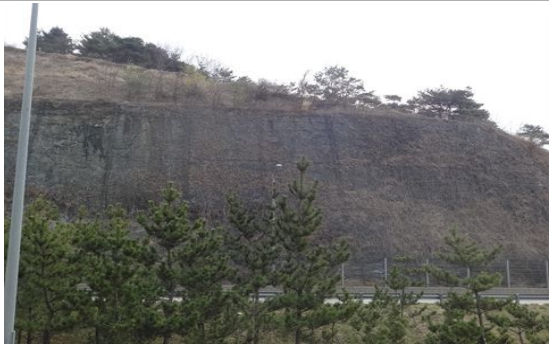
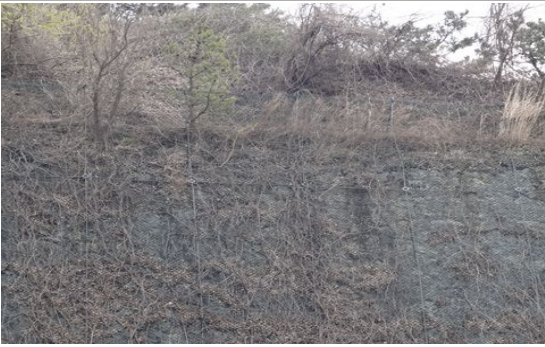
| 56.13K 1단 상부 심한풍화 | |

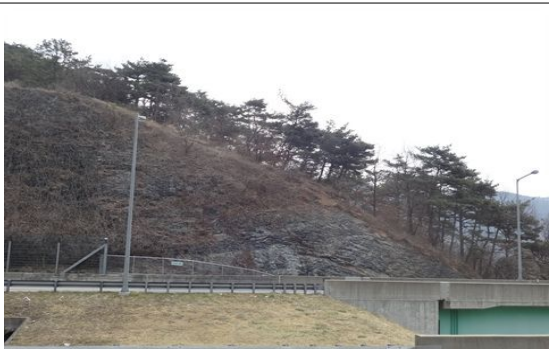
| 56.09K 1단 뜯돌 | |

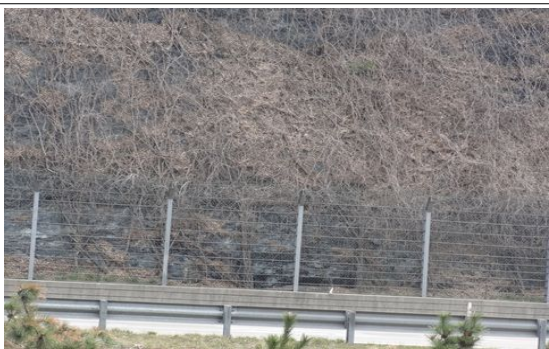
| 56.10K 1단 이완암 | 하부 전경 |

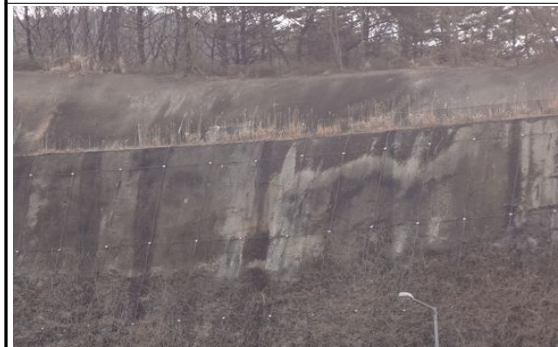
| 대구절토 41 (청도IC Ramp-G, F / 5공구 STA.청도IC Ramp-G, F) | |
|---|---|
| STA.0+280 1단 숯크리트 들뜸 | STA.0+650 2단 숯크리트 들뜸 |

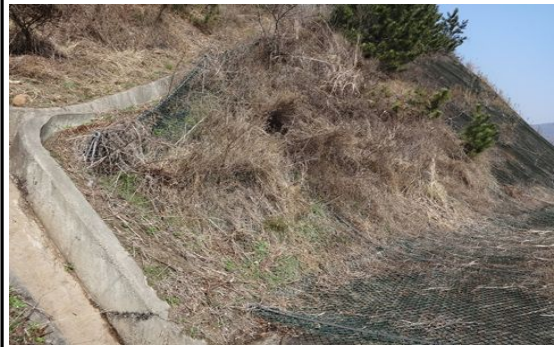
| 부산절토 42 (부산기점 66.24~66.40Km/ 4공구 STA.10+060~10+220) | |
|---|---|
| 66.25K 2단 심한풍화 | 66.28K 1소단배수로 균열 |

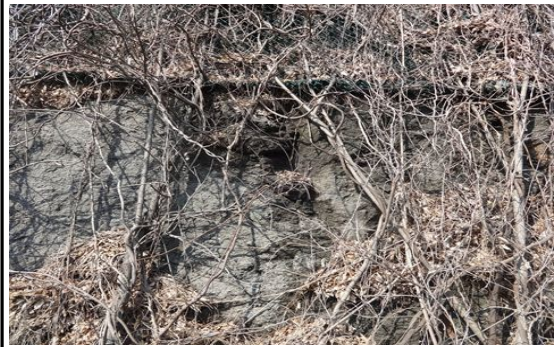
| 부산절토 42 (부산기점 66.24~66.40Km/ 4공구 STA.10+060~10+220) | |
|---|---|
| 66.30K 1단 누수 | 66.30K 2단 이완암 |

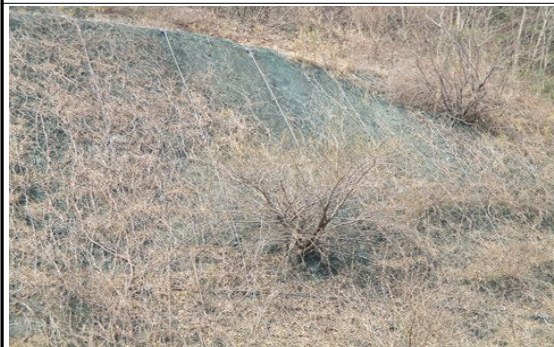
| 부산절토 42 (부산기점 66.24~66.40Km/ 4공구 STA.10+060~10+220) | |
|---|---|
| 66.38K 1단 수목 | 66.40K 자연사면 표층유실 |

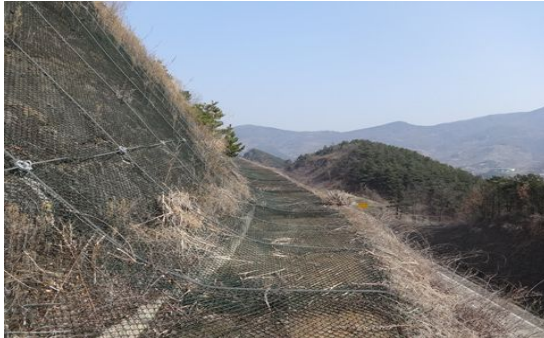
| <p>66.36K 1소단배수로 사방향 균열</p> | <p>1소단배수로 전경</p> |

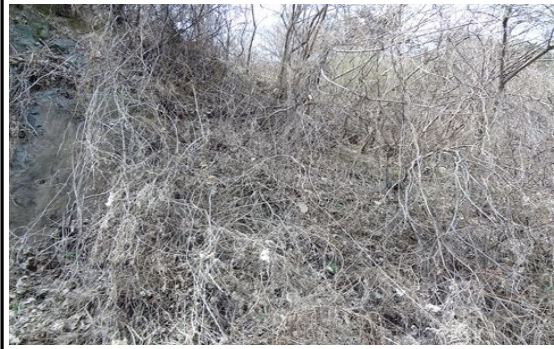
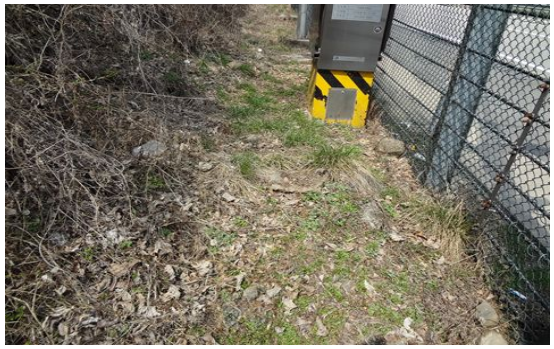
| 부산절토 43 (부산기점 70.57~70.77Km / 4공구 STA.5+690~5+890) | |
|---|---|
| 70.65K 1단 세굴, 이완암 | |

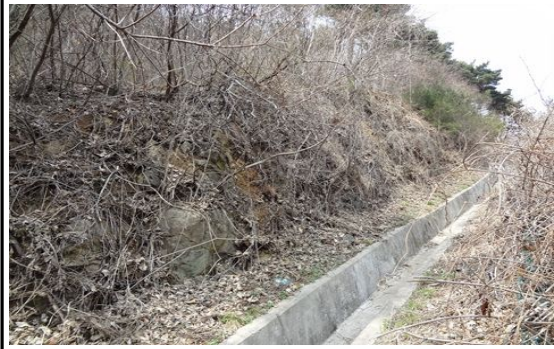
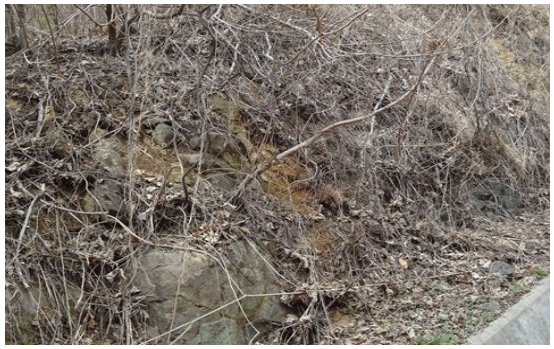
| 부산절토 43 (부산기점 70.57~70.77Km / 4공구 STA.5+690~5+890) | |
|---|---|
| 70.67K 자연사면 표층유실 | |

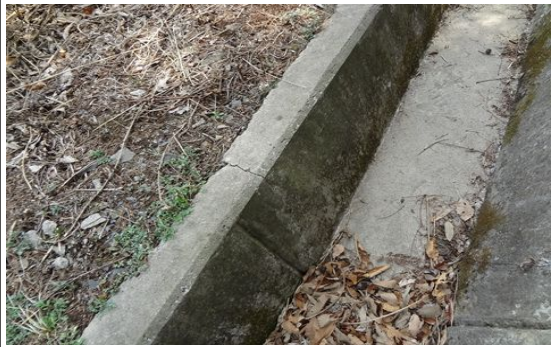
| 부산절토 44 (부산기점 71.01~71.20Km / 4공구 STA.5+260~5+450) | |
|---|---|
| 71.02K 산마루측구 균열 | 71.02K 자연사면 표층유실 |

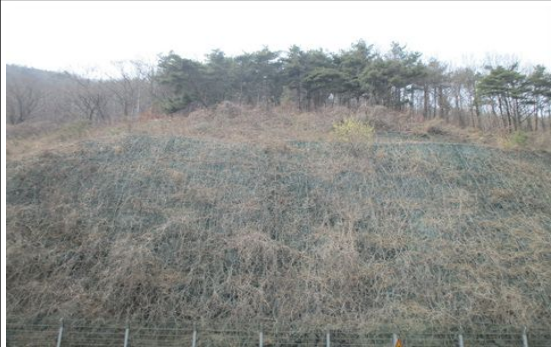
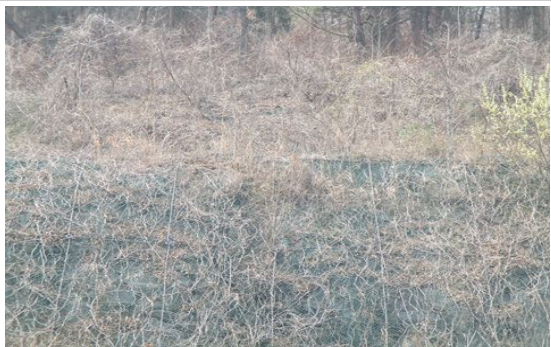
| 부산절토 44 (부산기점 71.01~71.20Km / 4공구 STA.5+260~5+450) | |
|---|---|
| 71.04K 1단 이완암 | |

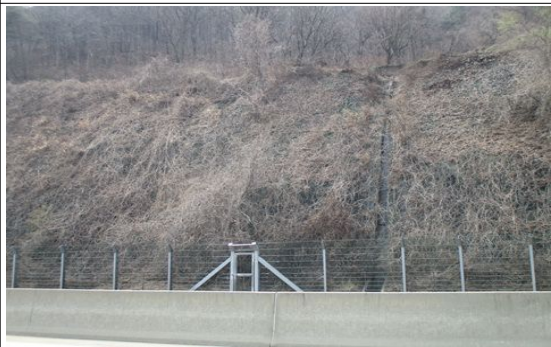
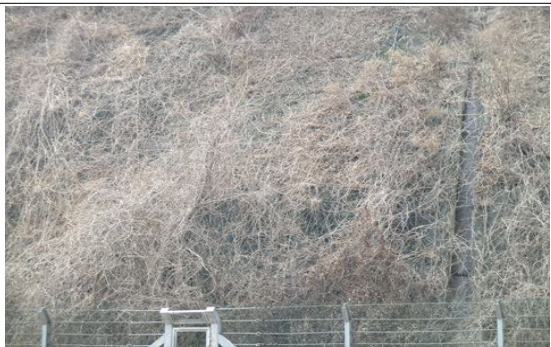
| 부산절토 44 (부산기점 71.01~71.20Km / 4공구 STA.5+260~5+450) | |
|---|---|
| 71.09K 1단 이완암 | |

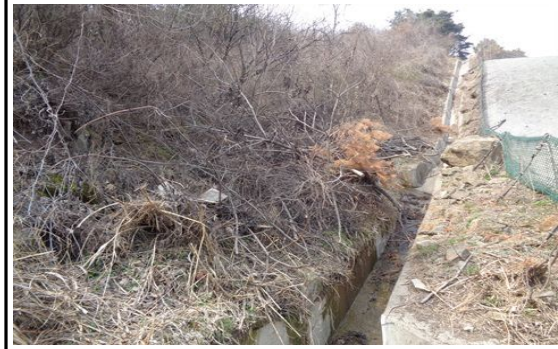
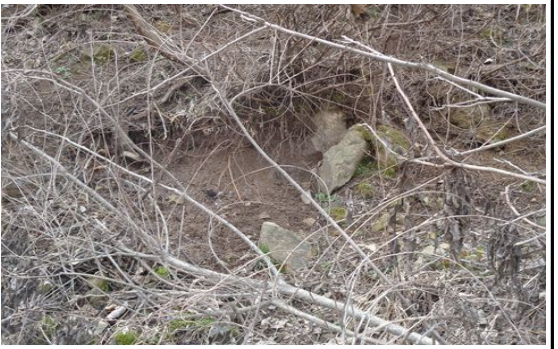
| 부산절토 45 (부산기점 71.44~71.58Km / 4공구 STA.4+880~5+020) | |
|---|---|
| 71.44K 자연사면 표층유실 | |

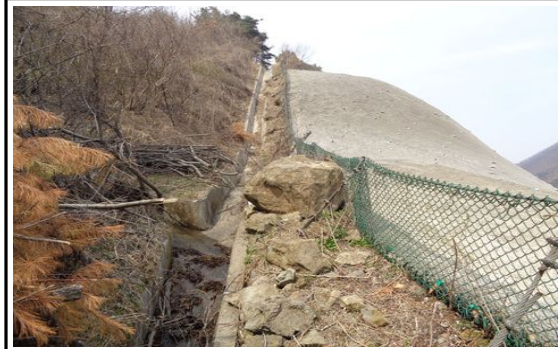
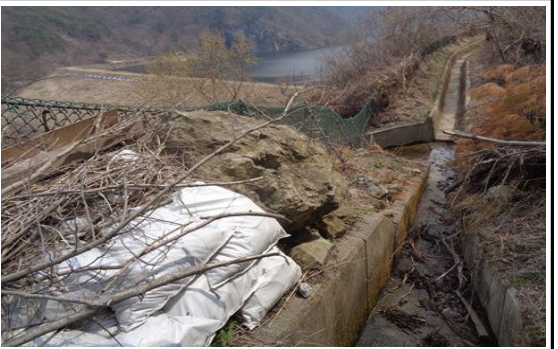
| 부산절토 45 (부산기점 71.44~71.58Km / 4공구 STA.4+880~5+020) | |
|---|---|
| 71.45K 자연사면 암괴 | |

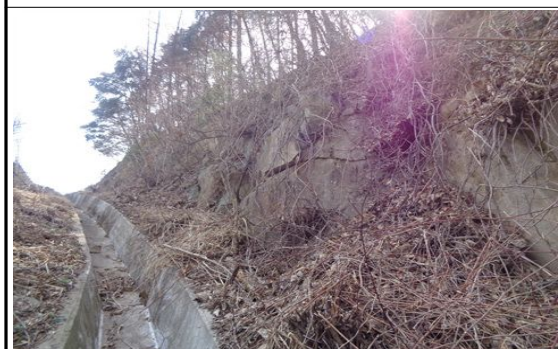
| 부산절토 45 (부산기점 71.44~71.58Km / 4공구 STA.4+880~5+020) | |
|---|---|
| 71.50~71.53K 자연사면 이완암 | 71.53~71.55K 2단 심한풍화 |

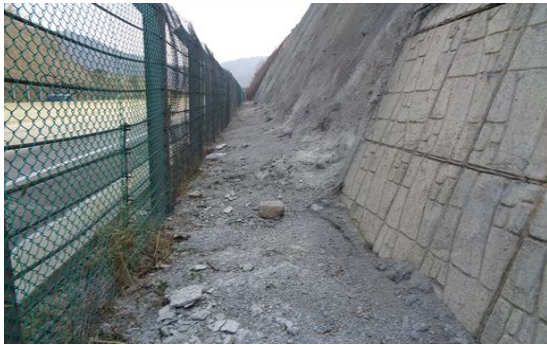
| <p>71.54K 1단 하부 낙석퇴적</p> | <p>71.55K 산마루측구 실란트 미시공</p> |

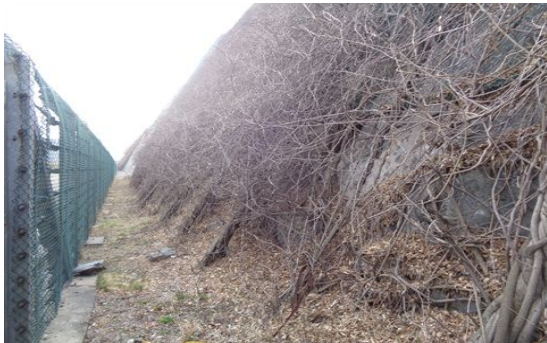
| <p>71.57K 1단 평면파괴</p> | |

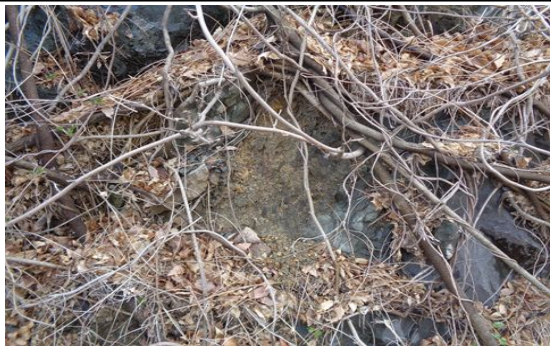
| 77.20K 1~2단 점토충전물 유실 | |

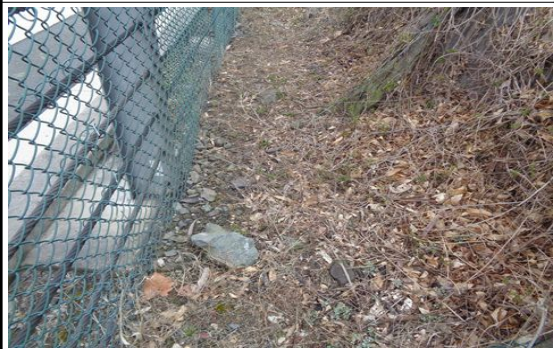
| 77.26K 1단 하부 낙석퇴적 | 산마루측구 전경 |

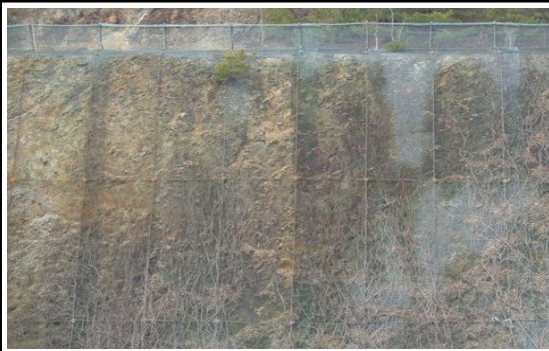
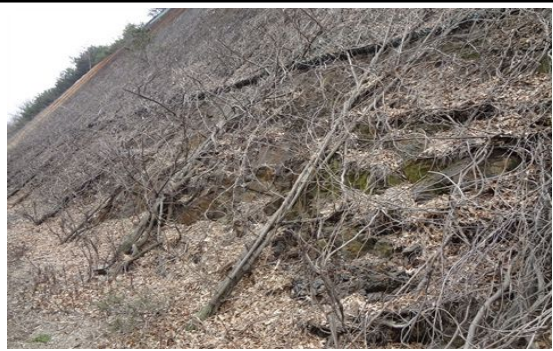
78.21~78.26K 1단 심한풍화

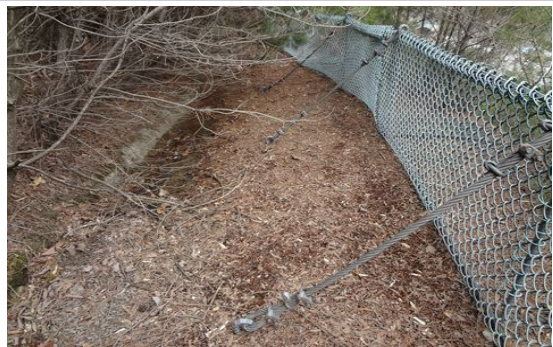
78.30k 1소단배수로 이물질 퇴적

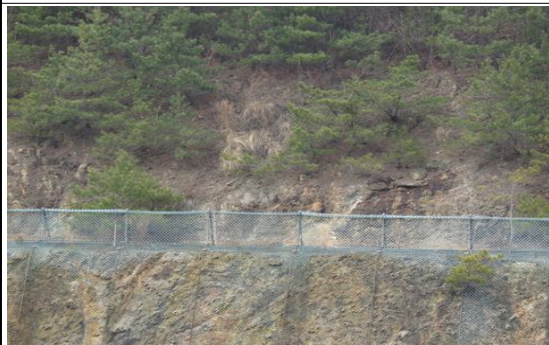
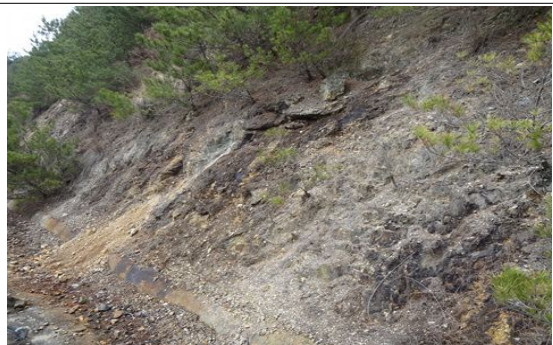
78.25~78.27K 2단 이완암 및 파쇄 심함

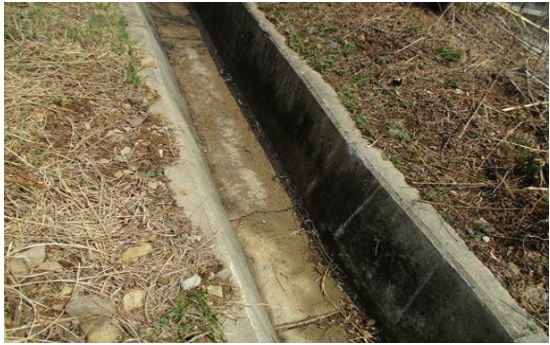
| 부산절토 48 (부산기점 80.81~81.14Km / 3공구 STA.10+110~10+440) | |
|---|---|
| 80.84K 산마루측구 균열 | 81.11K 2단 풍화 |

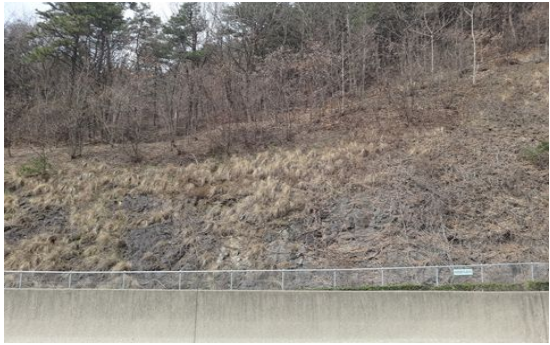
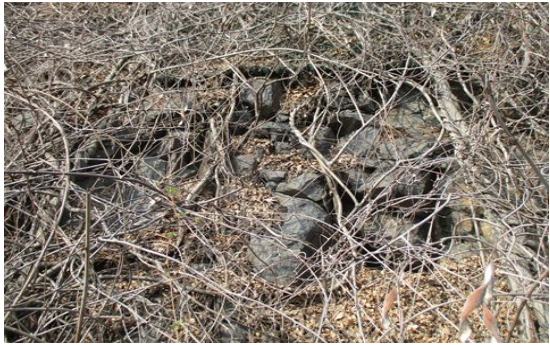
| 부산절토 48 (부산기점 80.81~81.14Km / 3공구 STA.10+110~10+440) | |
|---|---|
| 80.93K 1단 이완암 | |

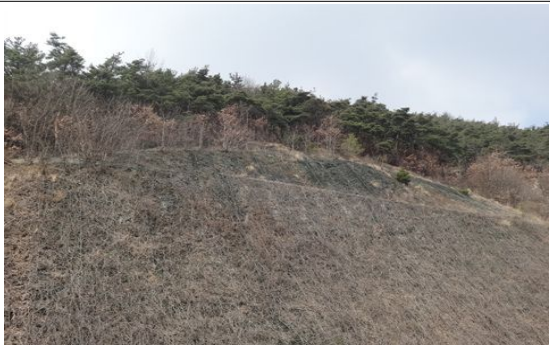
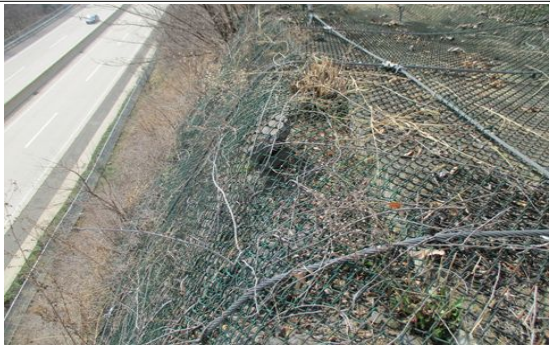
| 부산절토 48 (부산기점 80.81~81.14Km / 3공구 STA.10+110~10+440) | |
|---|---|
| 80.97K 1단 이완암 | |

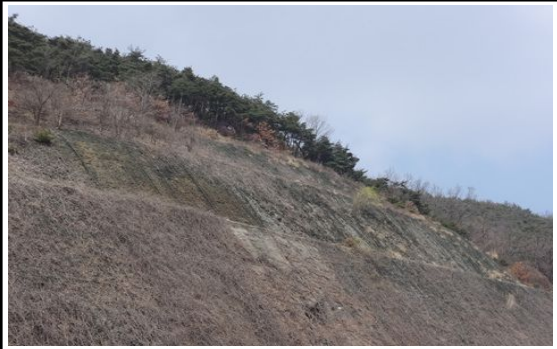
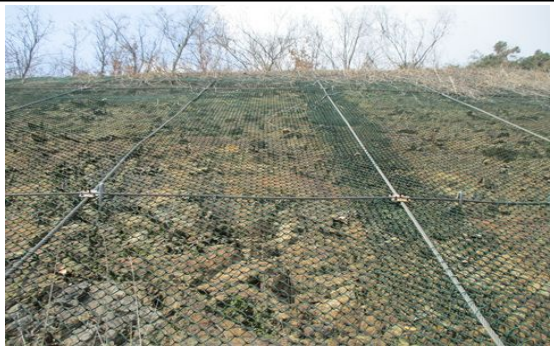
| 81.03~81.11K 2단 심한풍화 및 이완암 | |

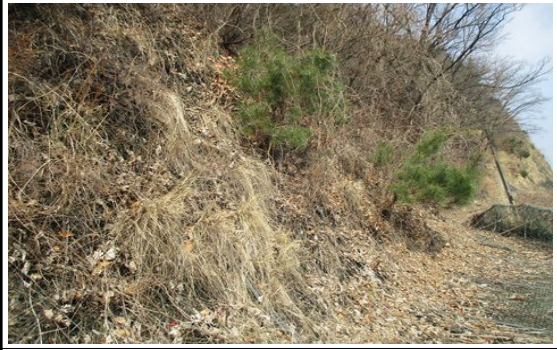
| 81.11K 2단 풍화 | 81.11K 자연사면 암괴 |

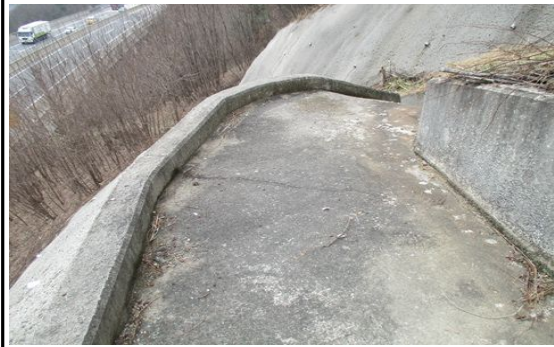
| 부산절토 49 (부산기점 81.45~81.81Km / 3공구 STA.9+440~9+800) | |
|---|---|
| 81.50K 1소단배수로 균열 0.6 | 81.53K 산마루측구 균열 |

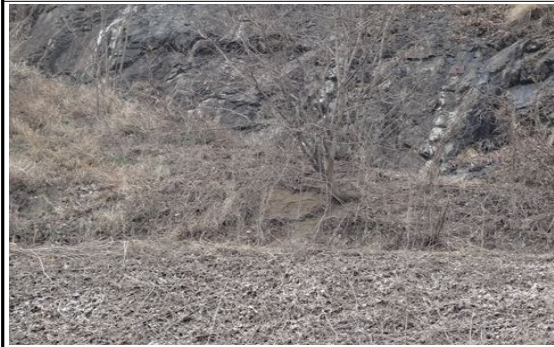
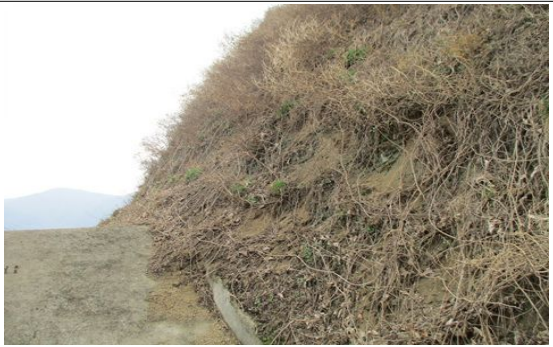
| 부산절토 49 (부산기점 81.45~81.81Km / 3공구 STA.9+440~9+800) | |
|---|---|
| 81.62K 2단 녹생토유실 | |

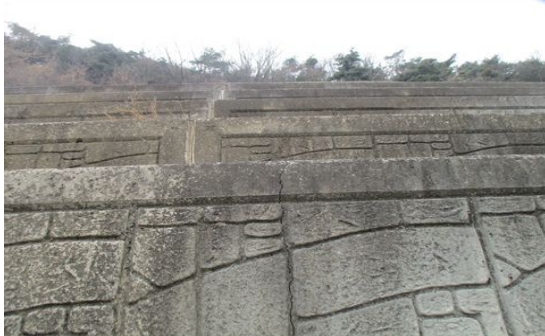
| <p>81.67K 1단 계단식옹벽 균열</p> | <p>81.75K 수직도수로 파손</p> |

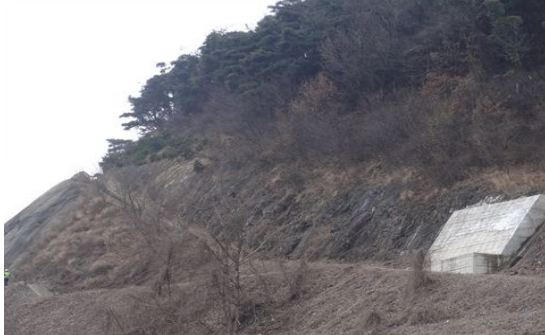
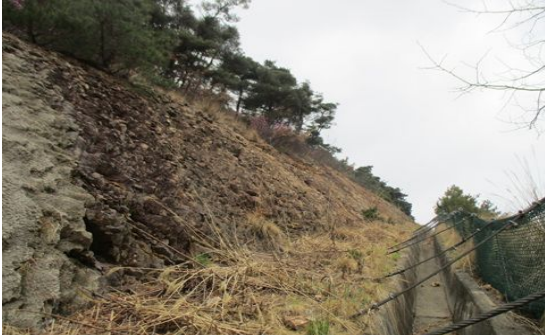
| <p>자연사면 전구간 이완암 및 표층유실</p> | |

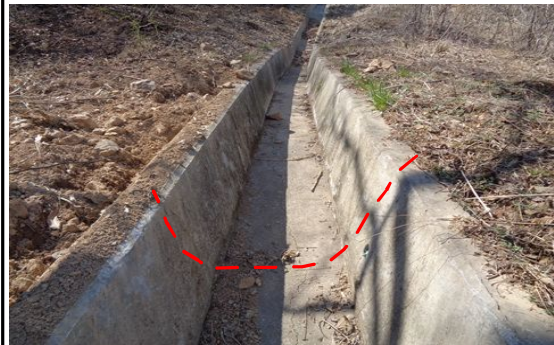
| 82.06K 산마루측구 균열 | 82.08K 1소단배수로 균열 |

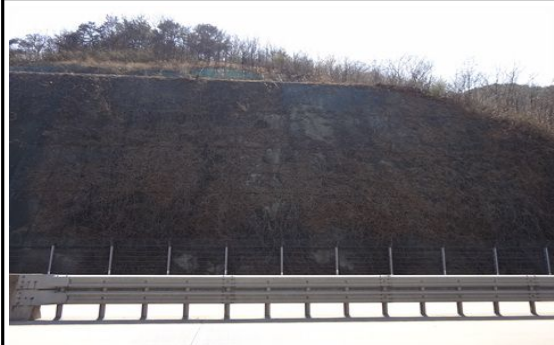
| 82.11~82.13k 전석 및 들뜸 (망내퇴적) | |

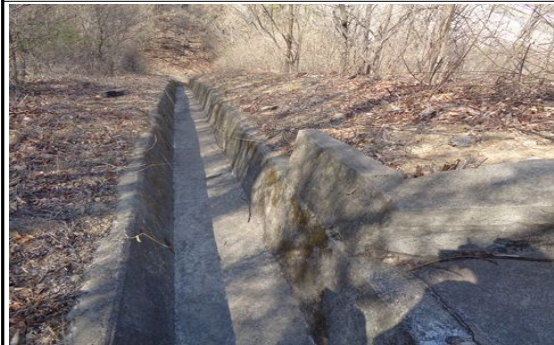
| 1소단배수로 월류방지턱 파손 | |

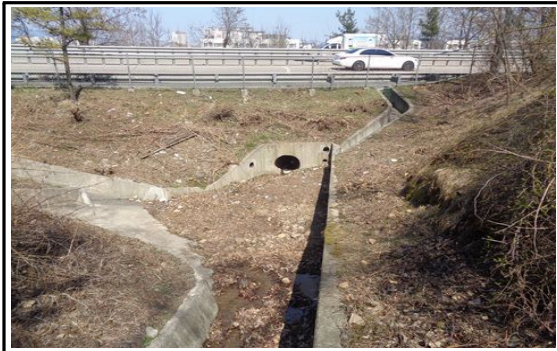
| 82.17K 하부 낙석 및 토사퇴적 | |

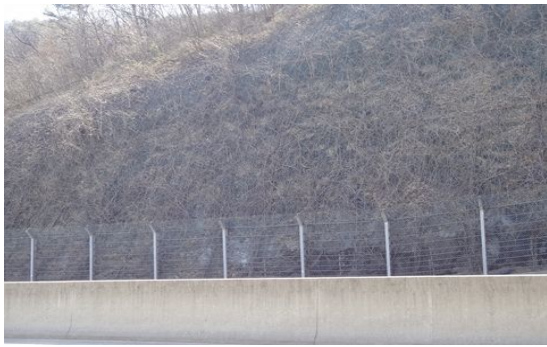
| 부산절토 51 (부산기점 82.19~82.42Km / 2공구 STA.8+830~9+060) | |
|---|---|
| 82.12k 1단 이완암 | 82.28k 1단 뜯돌 및 이완암 |

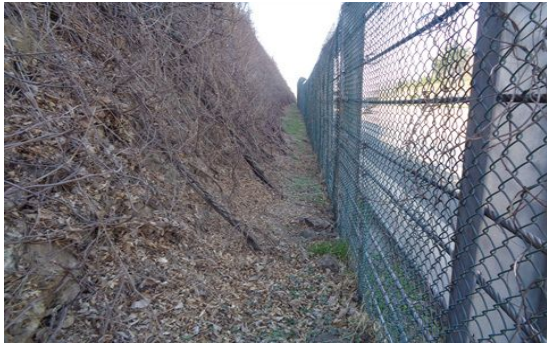
| 부산절토 51 (부산기점 82.19~82.42Km / 2공구 STA.8+830~9+060) | |
|---|---|
| 82.20~82.22K 1단 이완암 및 낙석퇴적 | |

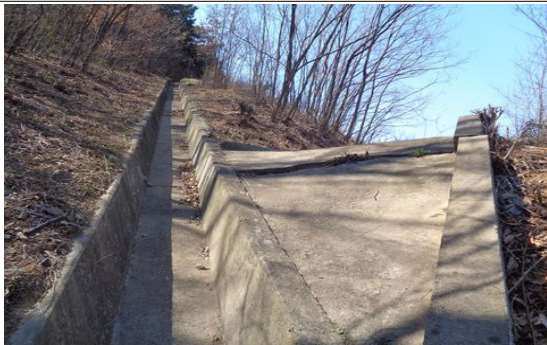
| 부산절토 51 (부산기점 82.19~82.42Km / 2공구 STA.8+830~9+060) | |
|---|---|
| 82.23K 1소단배수로 파손 | |

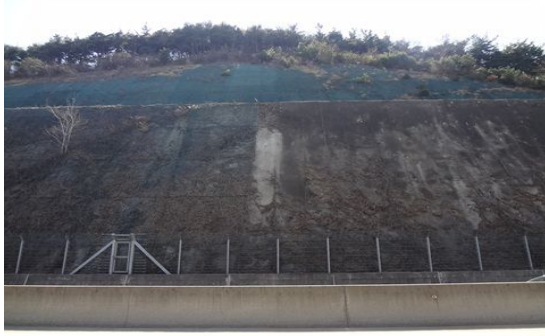
| 82.33k 1단 뜯돌 | |

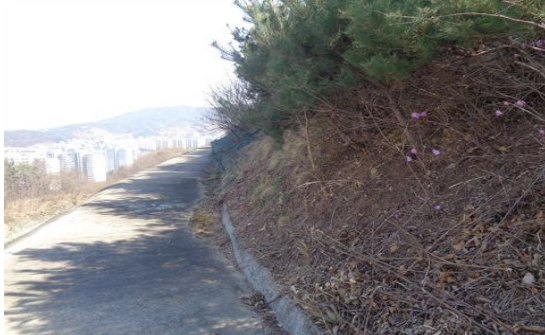
| 82.36~82.37K 2단 표층유실 | 82.38K 1소단배수로 파손 |

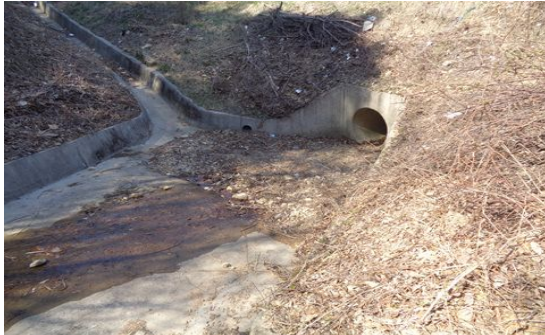
| 82.42K 하부 토사퇴적 | 산마루측구 전경 |

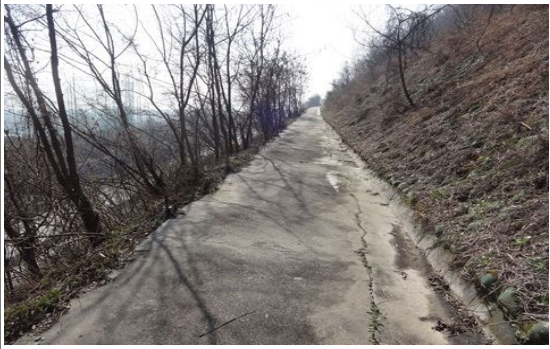
| 부산절토 52 (부산기점 83.31~83.94Km / 2공구 STA.7+310~7+940) | |
|---|---|
| 81.81K 1소단배수로 종균열 0.3~2.0 | 83.37K 1단 이완암 |

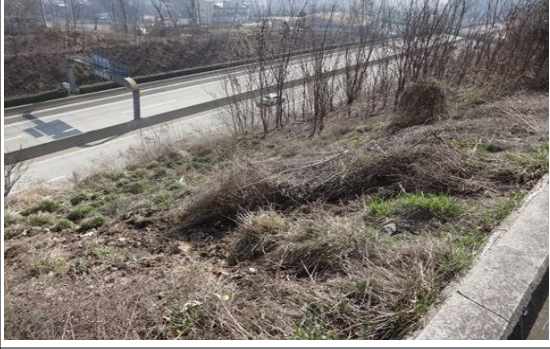
| 부산절토 52 (부산기점 83.31~83.94Km / 2공구 STA.7+310~7+940) | |
|---|---|
| 83.55K 1단 세굴 | |

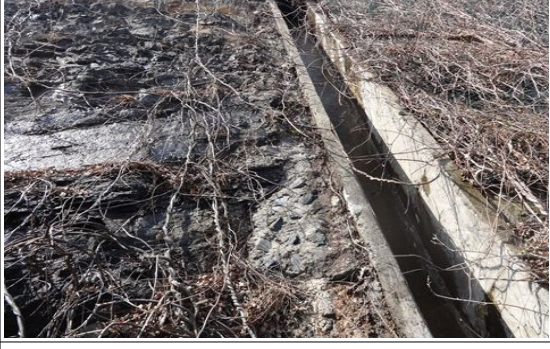
| 부산절토 52 (부산기점 83.31~83.94Km / 2공구 STA.7+310~7+940) | |
|---|---|
| 83.68K 1단 누수 | 83.68K 1소단배수로 균열 |

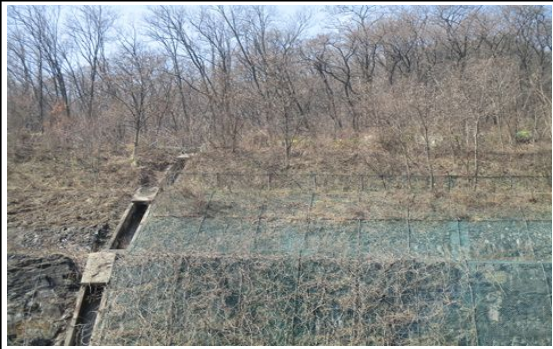
| 83.70K 2단 표층유실 | |
