**2017년 상반기 시설물 정기점검 용역**  
**정 기 점 검 사 진 첵**  
**[2종 절토사면 손상현황 사진첩]**

**2017. 06.**

**新 대구부산고속도로주식회사**  
**New DAEGU BUSAN Expressway Co., Ltd.**

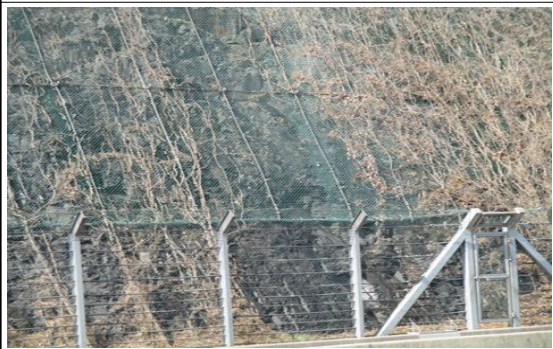
| 83.71K 1단 누수 | 83.73K 1단 이완암 발달 |

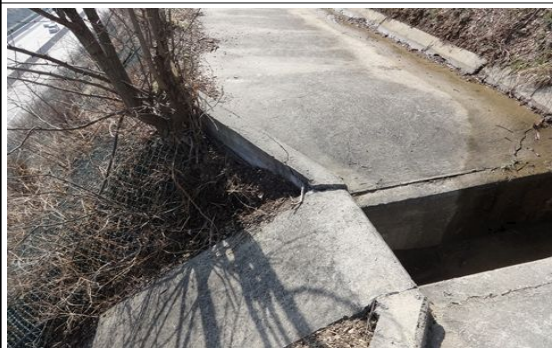
| 83.79K 3단 덮개파손 | |

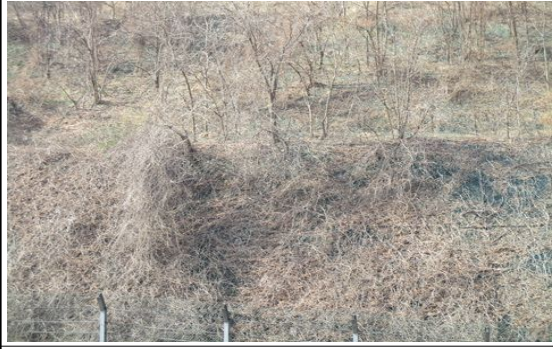
| 83.86K 1단 수목 | 83.87K 1단 누수 |

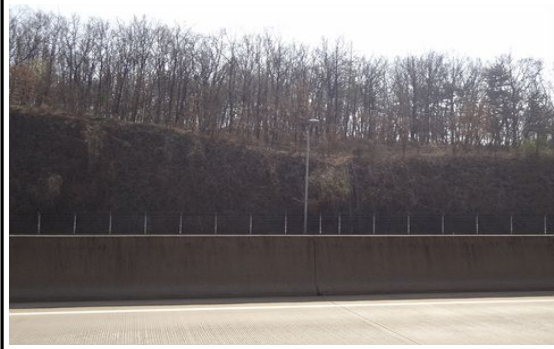
| 87.24k 1단 심한파쇄 | |

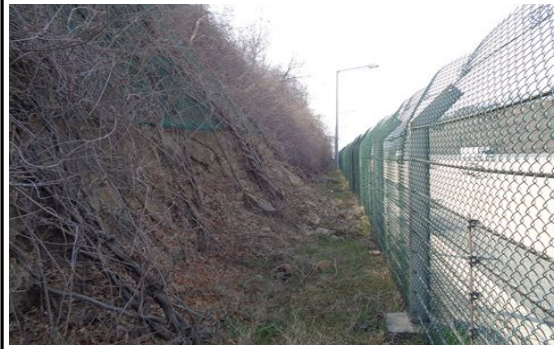
| 87.27K 유실 및 퇴적 | |

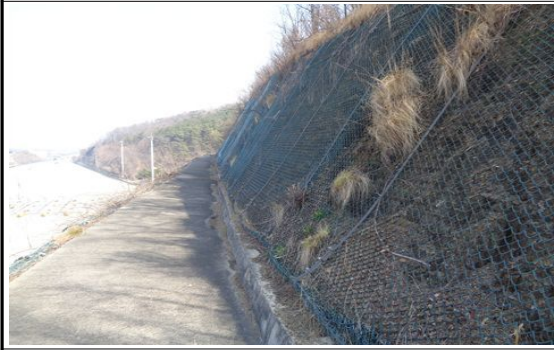
| 87.31K 2단 심한풍화 | |

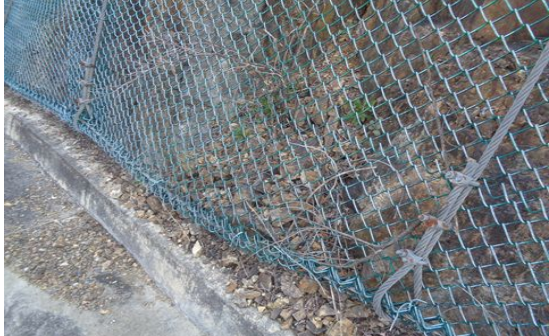
| 87.37K 2단 파쇄 및 낙석퇴적 | 87.41K 2단 누수 |

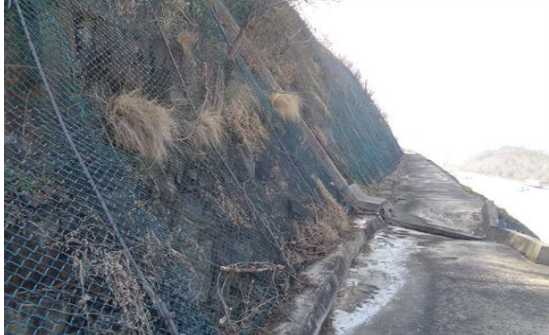
| 87.41K 2단 심한파쇄 및 낙석퇴적 | |

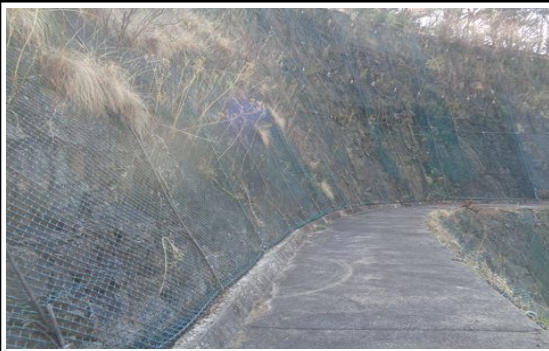
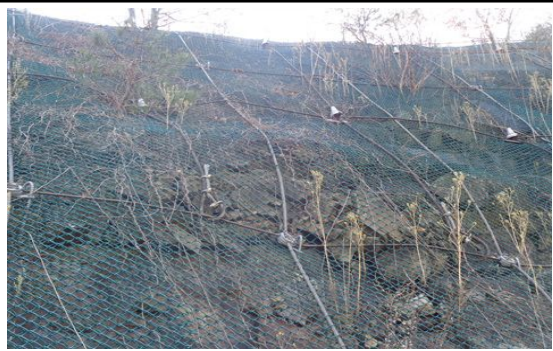
87.42~87.43K 2단 절리 및 이완암 발달

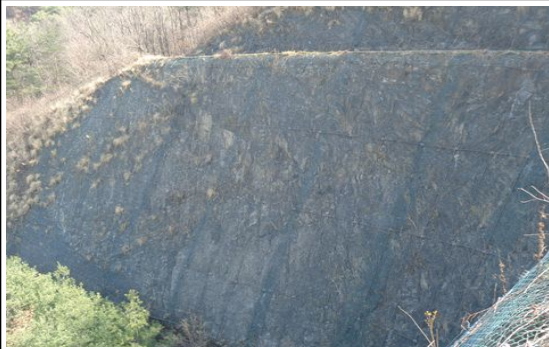
87.44K 1단 절리 및 이완암

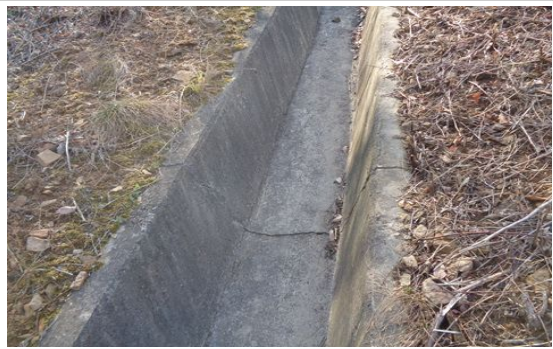
87.47K 산마루측구 균열 0.5

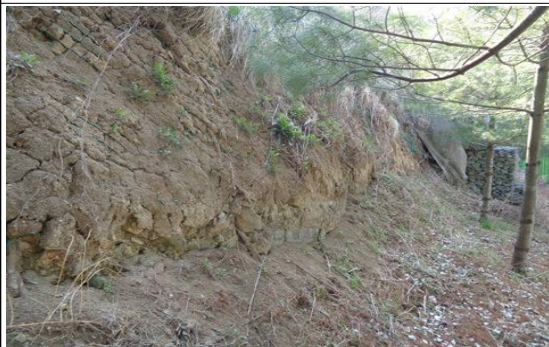
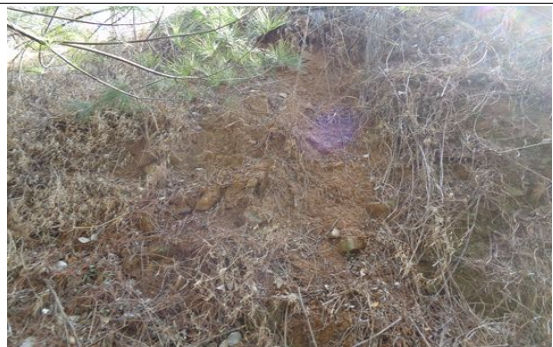
87.51~87.52K 1단 표층유실

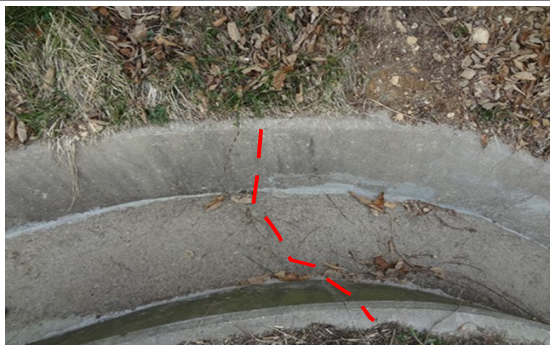
| 부산절토 55 (부산기점 14.29Km / 10공구 STA.7+349) | |
|---|---|
| STA.0+05 산마루측구 균열 0.5 | STA.0+80 갭문 배면 균열 |

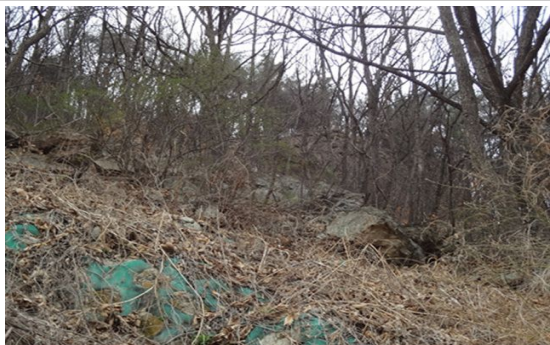
| 부산절토 55 (부산기점 14.29Km / 10공구 STA.7+349) | |
|---|---|
| STA.0+05 자연사면 암괴 | |

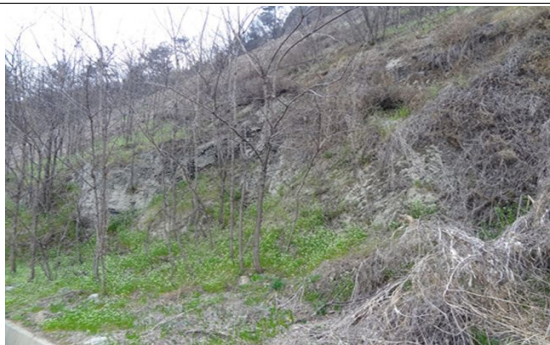
| 부산절토 55 (부산기점 14.29Km / 10공구 STA.7+349) | |
|---|---|
| STA.0+20 2단 녹생토유실 | |

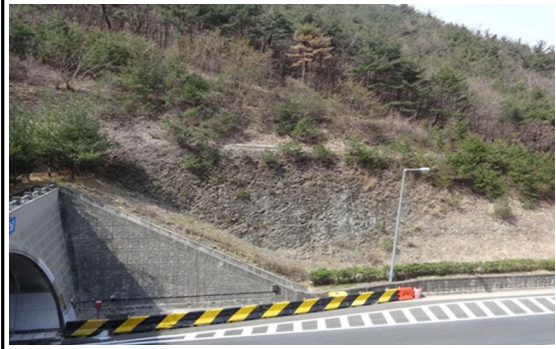
| STA.0+040 1단 뜯돌 | |

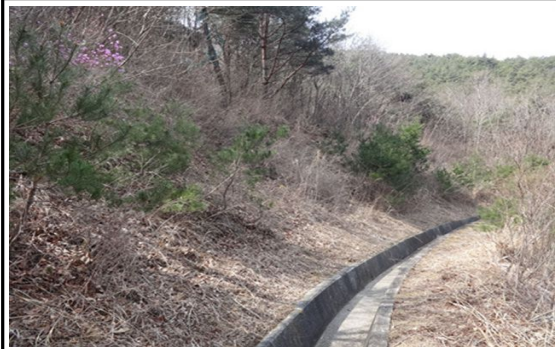
| STA.0+070 자연사면 표층유실 | |

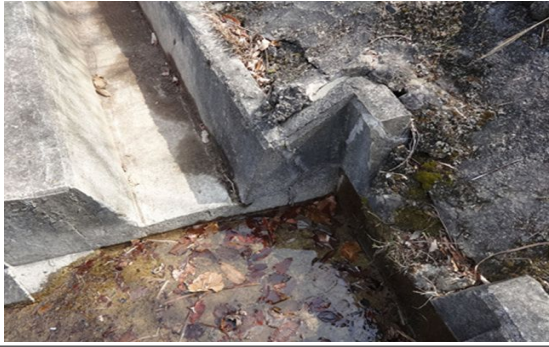
| STA.0+100 산마루측구 파손 | STA.0+130 산마루측구 균열 |

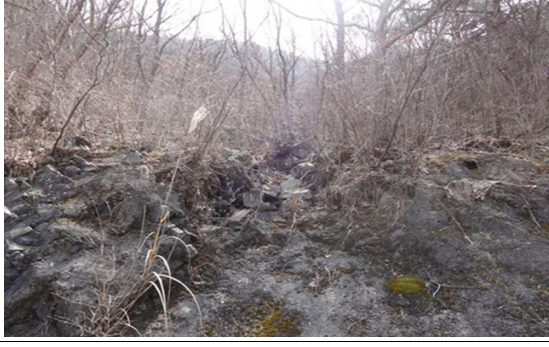
| STA.0+100 자연사면 암괴 | STA.0+110 1단 뽕돌다수 |

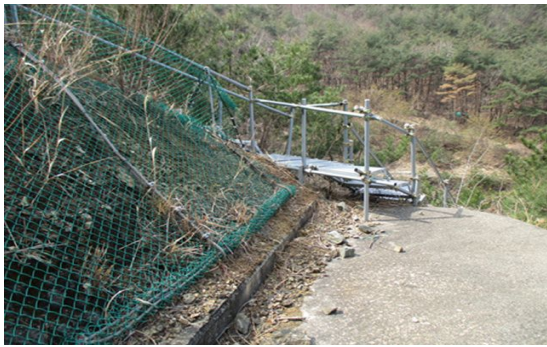
| STA.0+010 2단 표층유실 | |

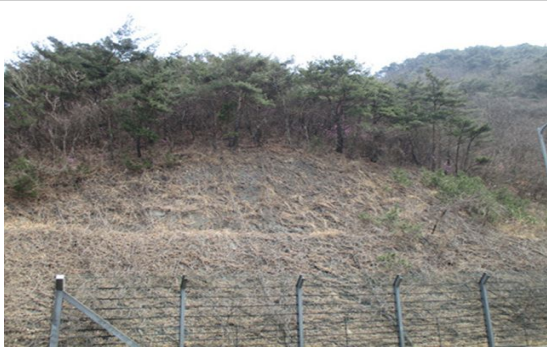
| STA.0+100~0+138 뜬돌 | |

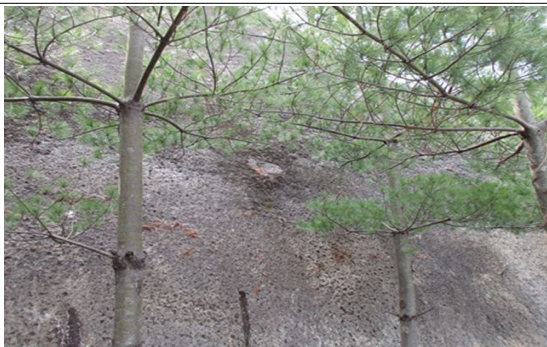
| STA.0+015 1단 숯크리트 탈락 | |

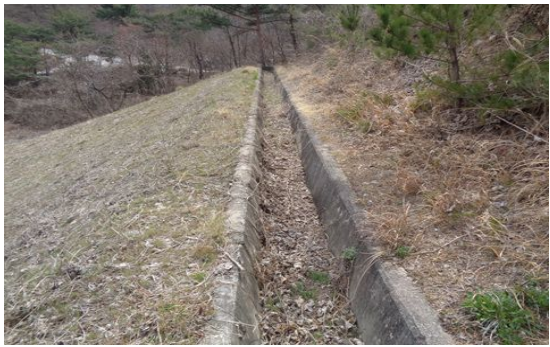
| 대구절토 58 (부산기점 24.60Km / 9공구 STA.8+265) | |
|---|---|
| <p>STA.0+0~040 배수로 전구간 토사퇴적</p> | <p>STA.0+085~100 녹생토 유실</p> |

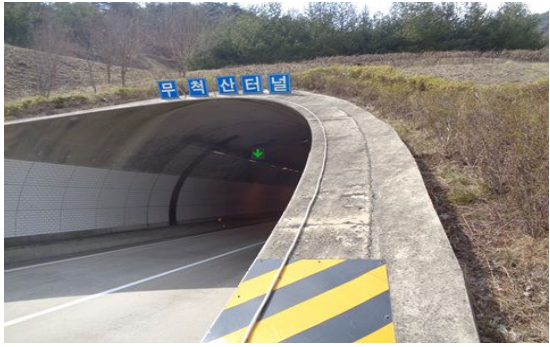
| 대구절토 58 (부산기점 24.60Km / 9공구 STA.8+265) | |
|---|---|
| STA.0+060~090 표층유실 | |

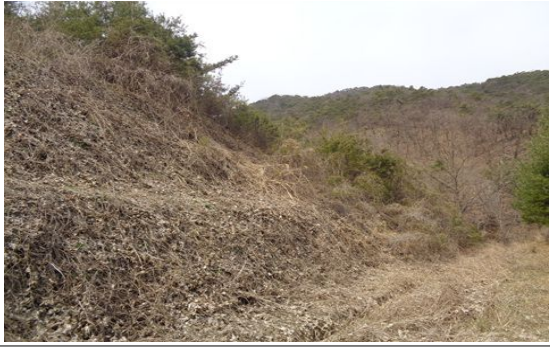
| 대구절토 58 (부산기점 24.60Km / 9공구 STA.8+265) | |
|---|---|
| STA.0+005~015 세굴 | |

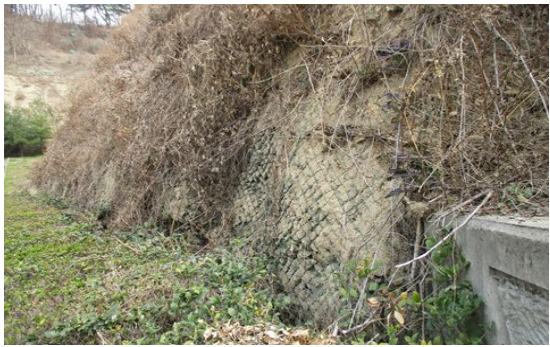
| 부산절토 59 (부산기점 27.27Km / 9공구 STA.5+600) | |
|---|---|
| STA.0+045 1단 녹생토유실 | STA.0+090 2단 수목 |

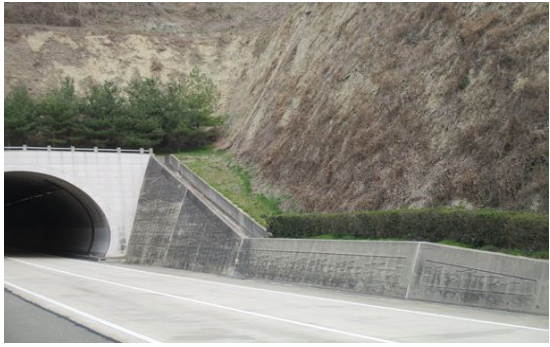
| 부산절토 59 (부산기점 27.27Km / 9공구 STA.5+600) | |
|---|---|
| STA.0+075 1단 녹생토유실 | STA.0+090 1단 녹생토 유실 |

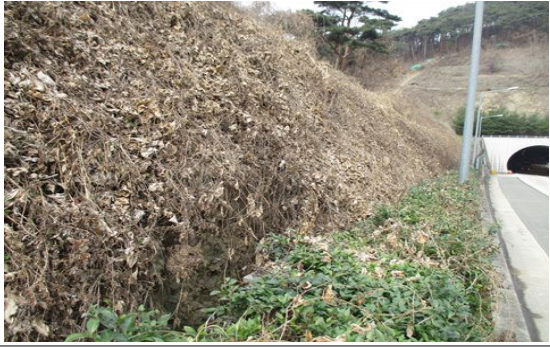
| 부산절토 59 (부산기점 27.27Km / 9공구 STA.5+600) | |
|---|---|
| STA.0+170 1단 암반노출 | |

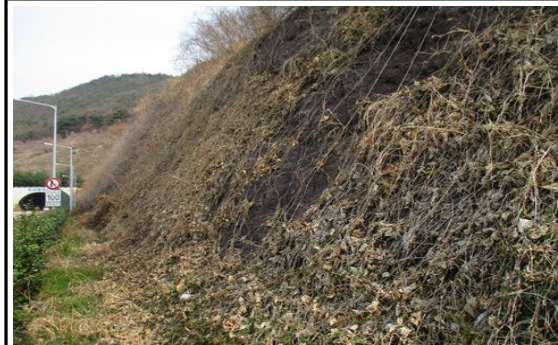
| <p>STA.0+050 1단 심한풍화</p> | |

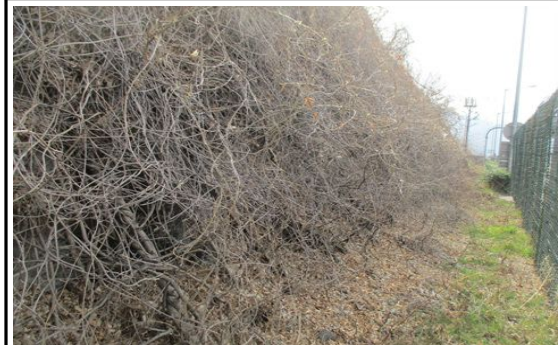
| <p>STA.0+080 1단 누수</p> | |

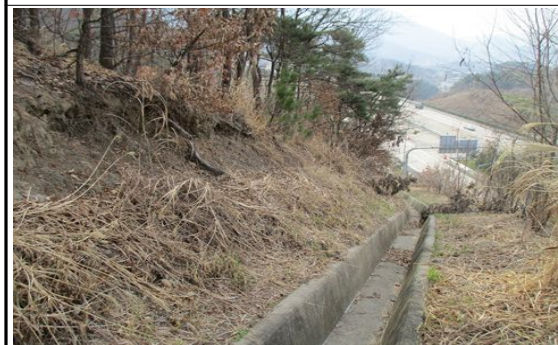
| <p>STA.0+080 자연사면 표층유실</p> | |

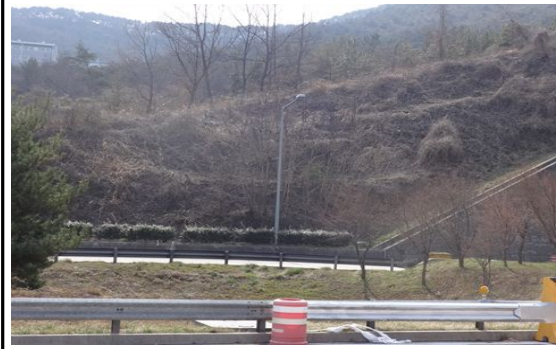
| 대구절토 61 (부산기점 33.27Km / 8공구 STA.9+125) | |
|---|---|
| STA.023+060 좌측사면 1단 녹생토유실 | |

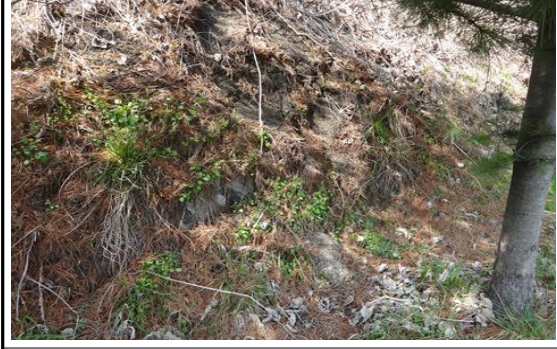
| 대구절토 61 (부산기점 33.27Km / 8공구 STA.9+125) | |
|---|---|
| STA.0+20 1단 녹생토유실 | STA.0-20 1단 녹생토유실 |

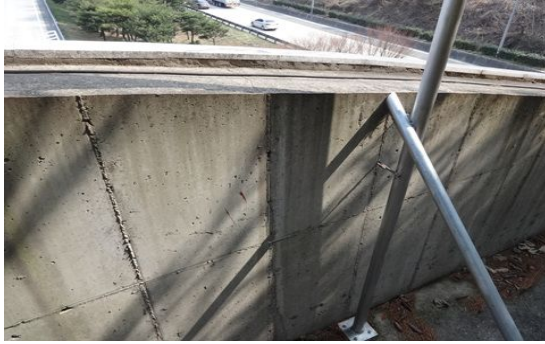
| <p>STA.0+10 갯문배면배수로 균열</p> | <p>STA.23+110 우측사면 산마루측구 균열</p> |

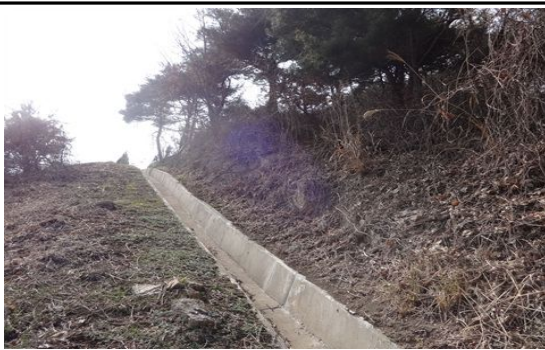
| <p>STA.0-10 자연사면 표층유실 및 이완암</p> | |

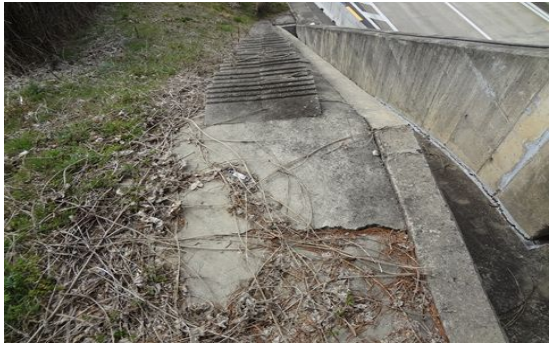
| STA.0+30 점검계단, 배수로 파손 | |

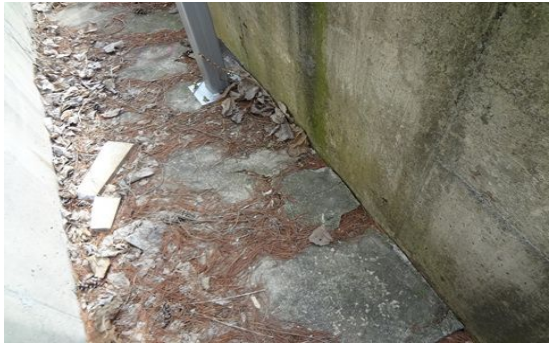
| STA.0+20 갯문배면 배수로 파손, 균열 | |

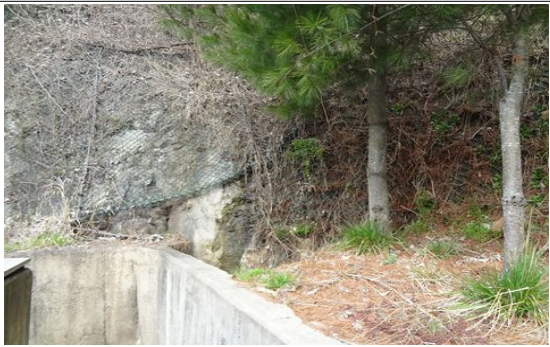
| STA.0-30 1단 배면 공동 | |

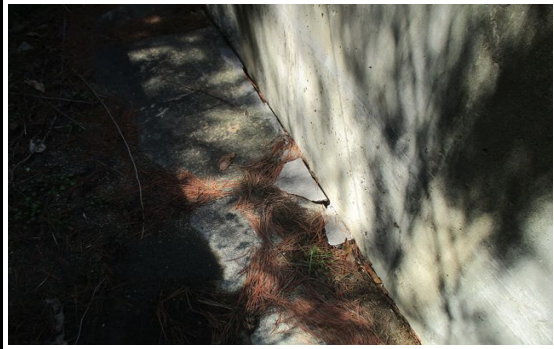
| STA.0-20 갯문배면배수로 파손 | |

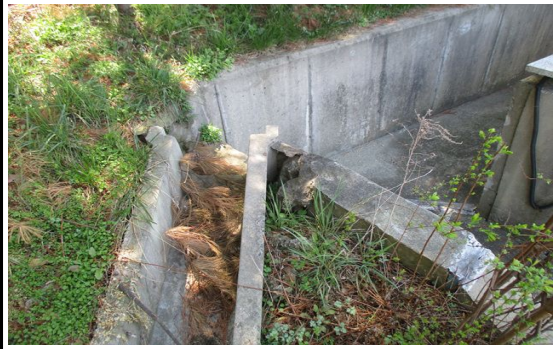
| STA.0+05 배수로 뒷채움부족 | |

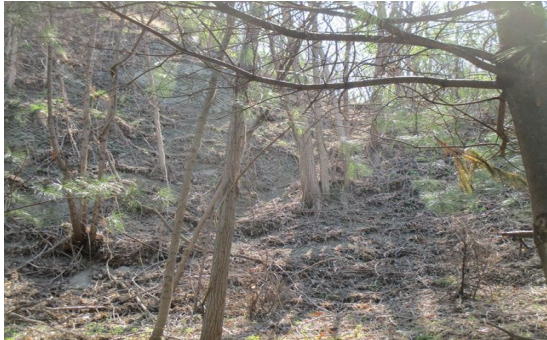
| <p>STA.0+10 2단 녹생토유실</p> | <p>STA.0-20 2단 녹생토유실</p> |

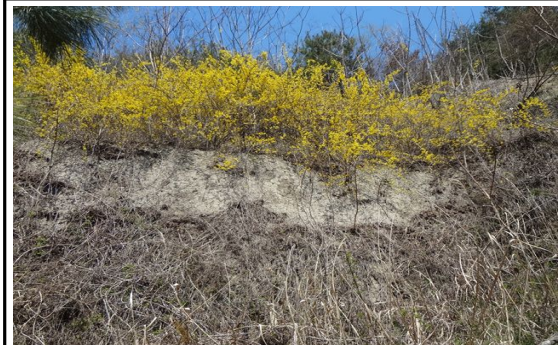
| STA.0+10~30 2단 녹생토 유실 | STA.38+530 낙석퇴적 |

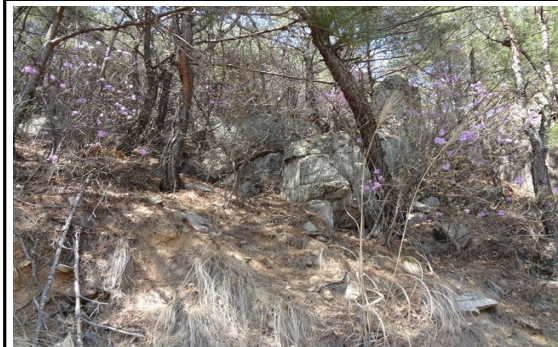
| STA.0+20 자연사면 암괴 및 전석다수 | |

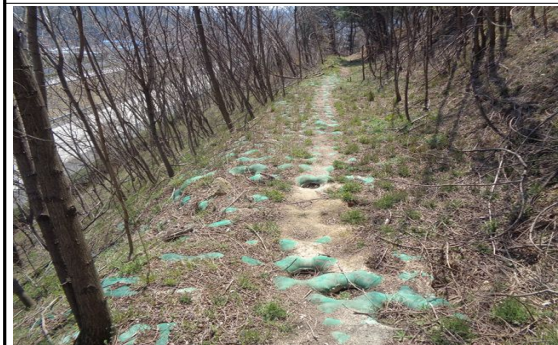
| STA.38+480 격자블럭 나무공동 | |

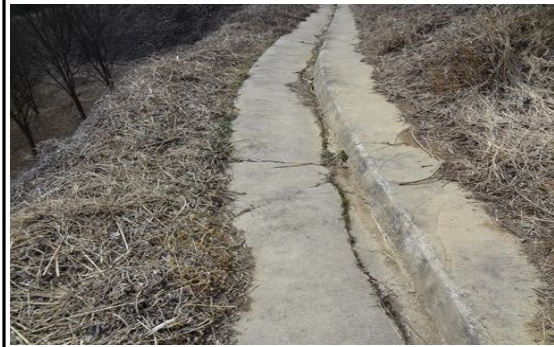
| 대구절토 65 (부산기점 50.51Km / 7공구 STA.2+080) | |
|---|---|
| STA.0+0 1소단배수로 균열 | STA.0+05 2단 세굴 |

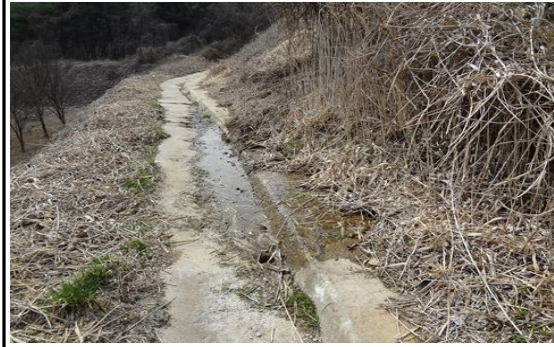
| 대구절토 65 (부산기점 50.51Km / 7공구 STA.2+080) | |
|---|---|
| STA.0+10 4단 누수 | STA.0+15 1소단배수로 균열 |

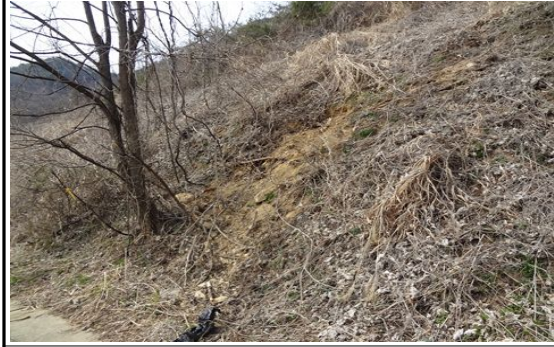
| 대구절토 65 (부산기점 50.51Km / 7공구 STA.2+080) | |
|---|---|
| STA.0+30 4단 녹생토유실 | 전경 1소단배수로 |

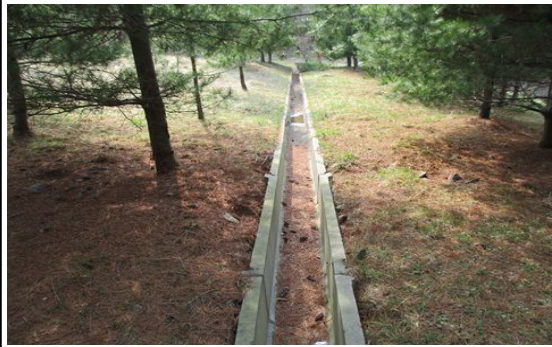
| STA.0-10 소단측구 뒷채움 부족 | |

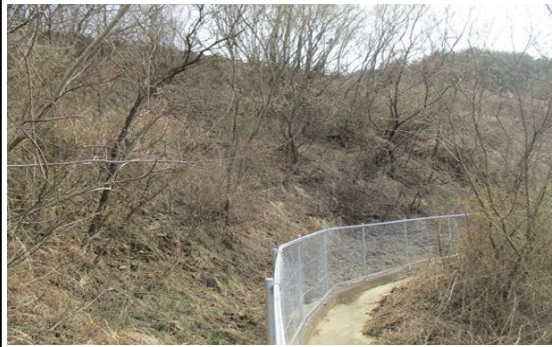
| STA.0+30 2단 표층유실 | |

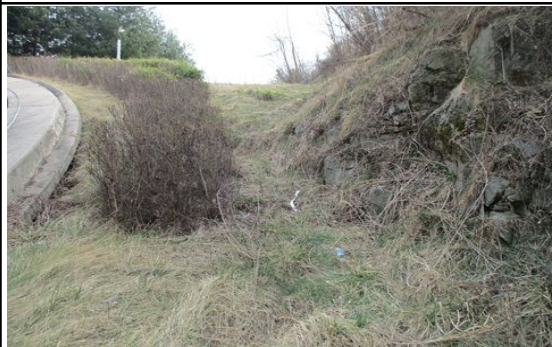
| STA.41+370 1단 세굴 | |

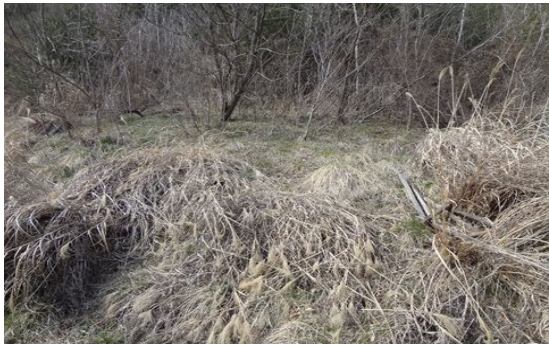
| 부산절토 67 (부산기점 51.92Km / 7공구 STA.0+660) | |
|---|---|
| STA.0+17 4단 식생불량 | STA.0+17 소단배수로 횡방향 균열 0.5 |

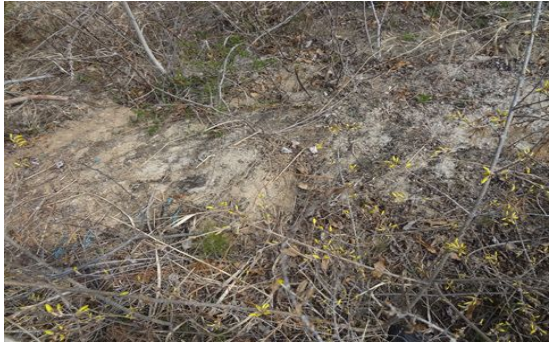
| 부산절토 67 (부산기점 51.92Km / 7공구 STA.0+660) | |
|---|---|
| STA.0-25 4단 식생불량 | STA.0-25 5단 세굴 |

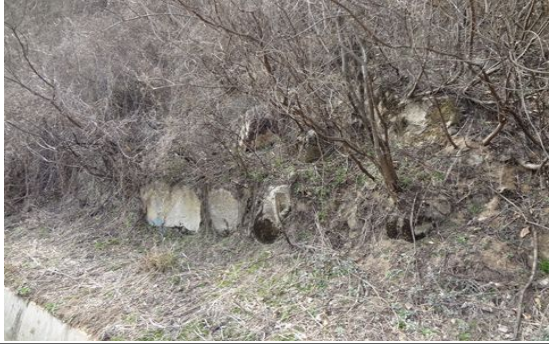
| 부산절토 67 (부산기점 51.92Km / 7공구 STA.0+660) | |
|---|---|
| STA.0-45 6단 암반노출 | |

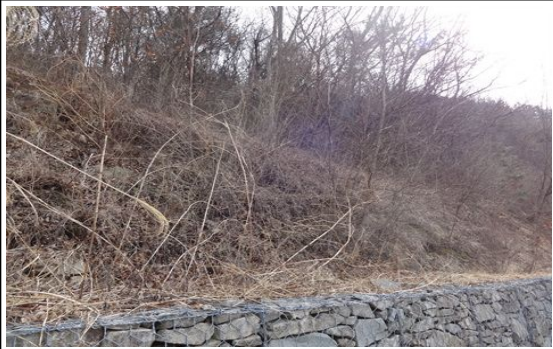
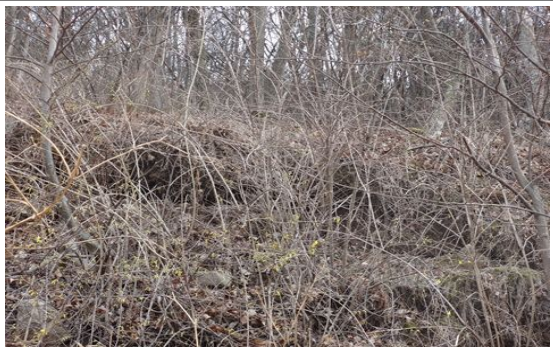
| STA.0+10 자연사면 추가유실 우려 | |

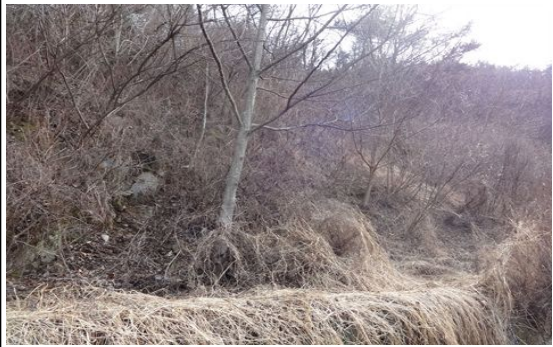
| STA.0+30 자연사면 추가유실 우려 | STA.0+40 3단 낙석위험 |

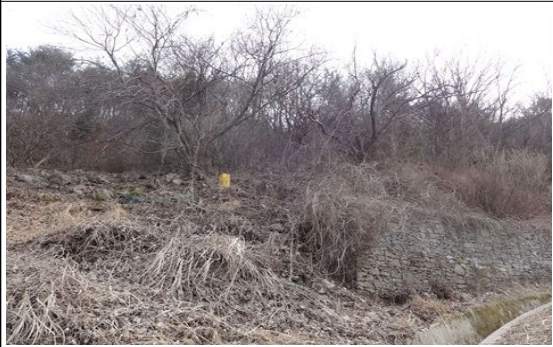
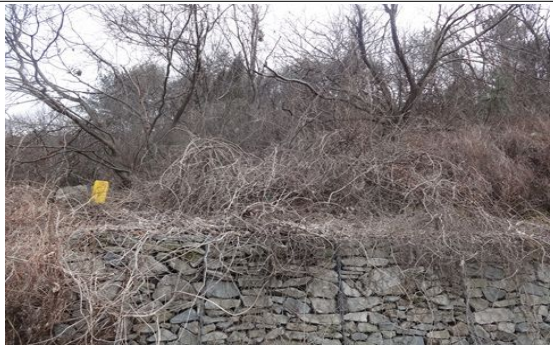
| STA.0-20 자연사면 추가유실 우려 | |

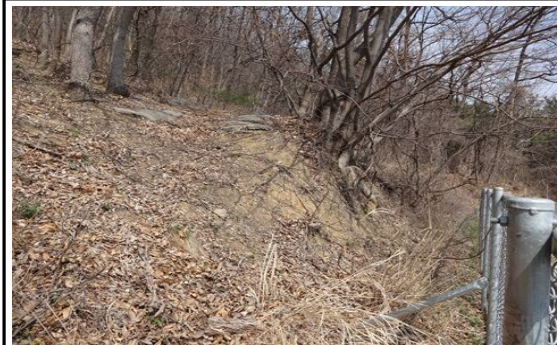
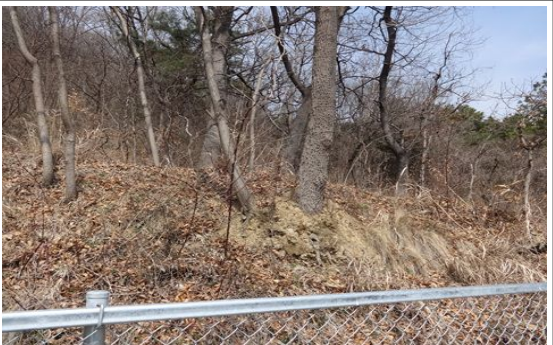
| <div>STA.0+30 자연사면 표층유실</div> | |

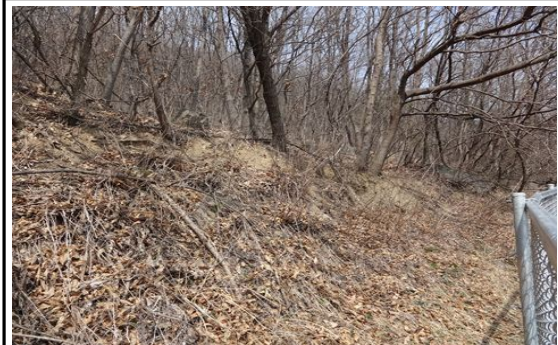
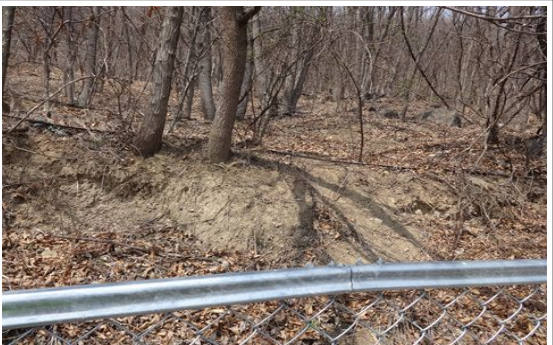
| <div>STA.0-20 자연사면 표층유실</div> | |

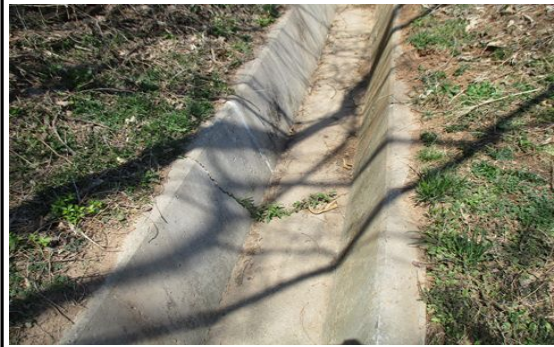
| 대구절토 70 (부산기점 68.89Km / 4공구 STA.7+530) | |
|---|---|
| STA.0+005 산마루측구 균열 | STA.58+015 자연사면 수목전도 |

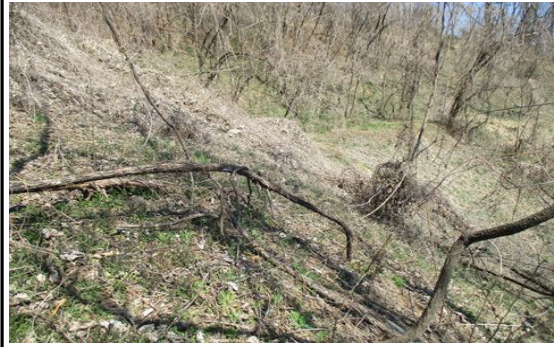
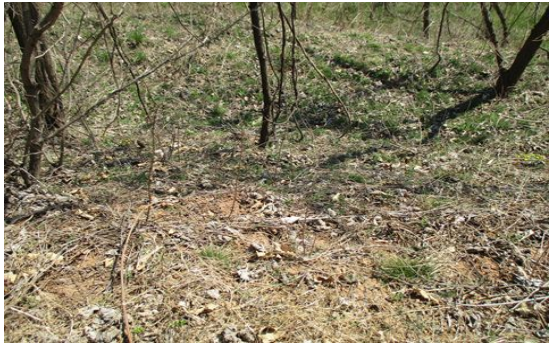
| 대구절토 70 (부산기점 68.89Km / 4공구 STA.7+530) | |
|---|---|
| STA.0+010 6단 표층유실 | |

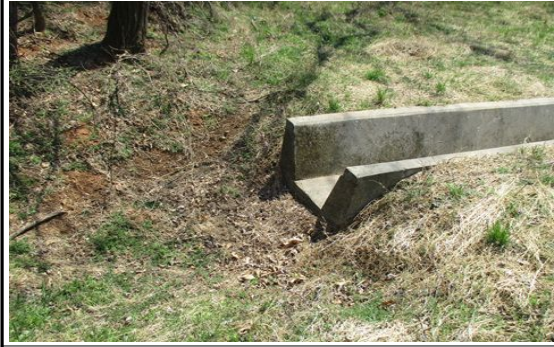
| 대구절토 70 (부산기점 68.89Km / 4공구 STA.7+530) | |
|---|---|
| STA.58+570~610 1~2단 풍화토층 | STA.58+660 산마루측구 균열 |

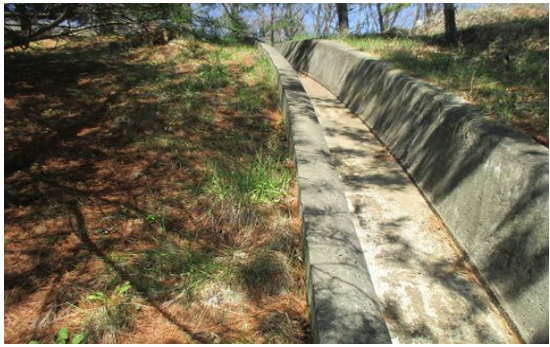
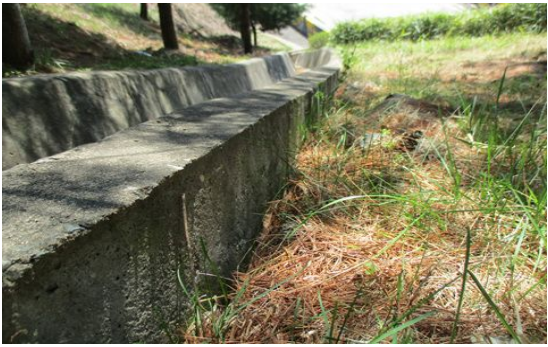
| <p>우측사면 측구 뒷채움 토사유실 전구간</p> | |

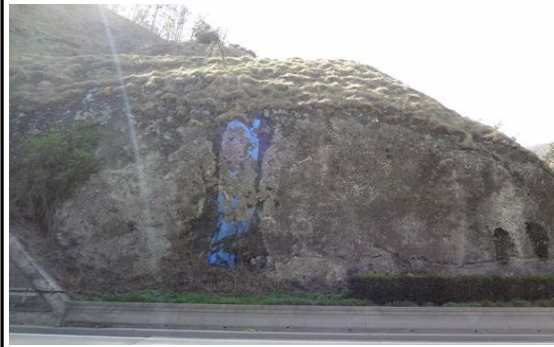
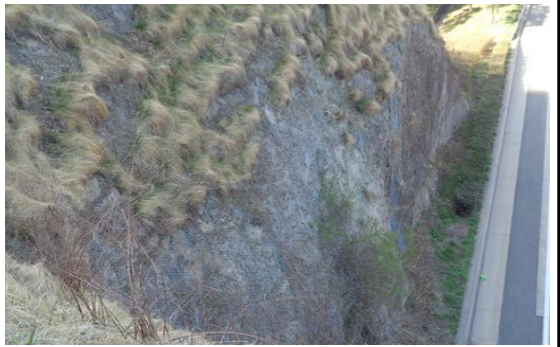
| STA.0-05 녹생토 유실 | |

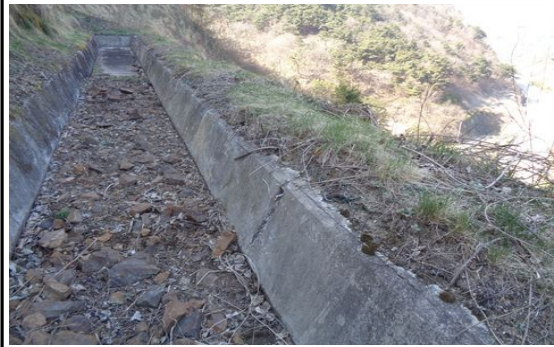
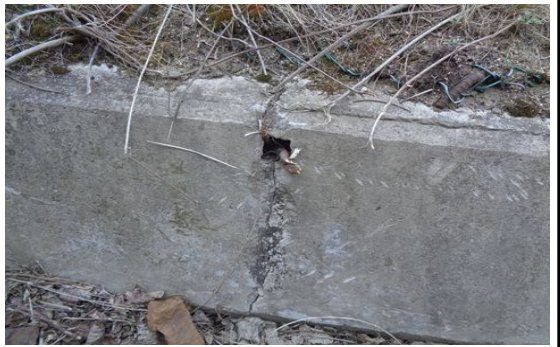
| STA.0-05 배수로 파손 | |

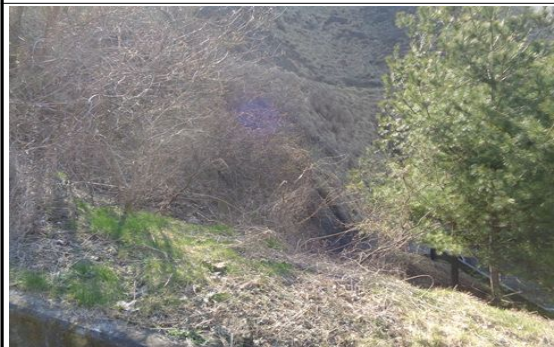
| STA.0-20 암반노출 | STA.0+0~10 배수로 내 낙석퇴적 |

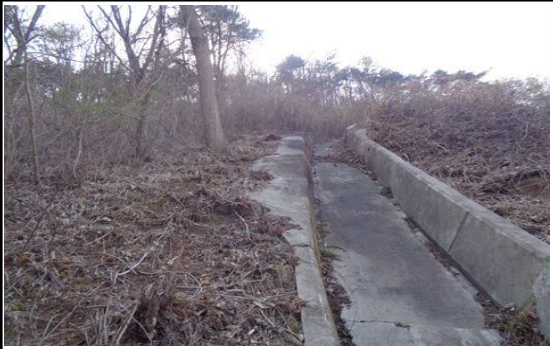
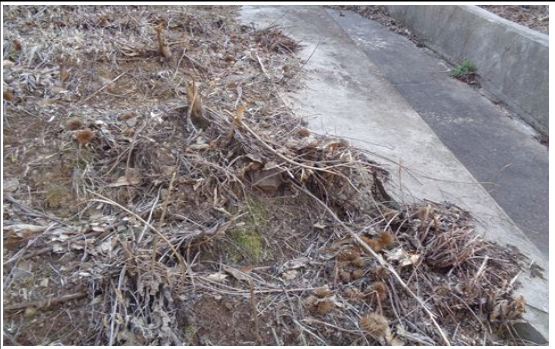
| STA.0-20 자연사면 토사구간 유실(추가유실우려) | |

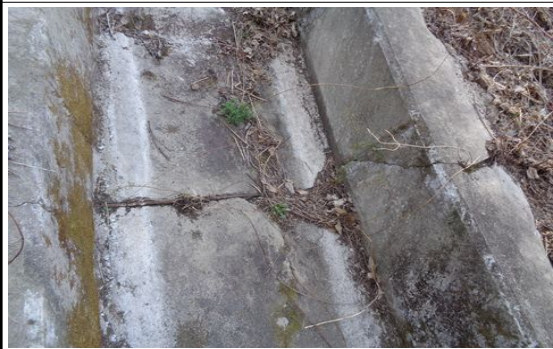
| STA.0-25 산마루측구 균열 | STA.0-30 산마루측구 균열 |

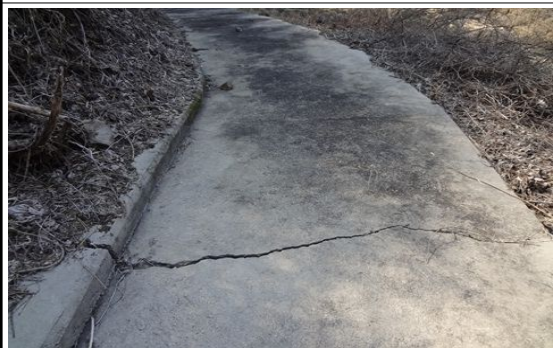
| STA.0-18 1소단배수로 파손 | STA.0-20 1단 암반노출 |

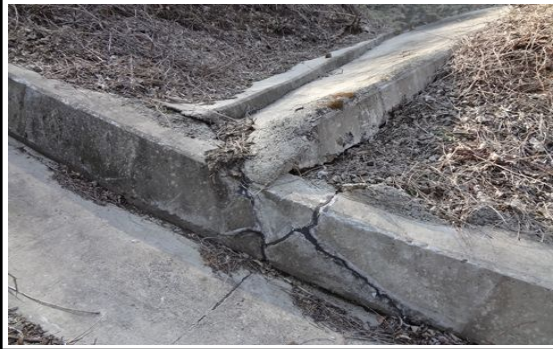
| STA.0-25 배수로 파손 | STA.0-5 녹생토 유실 |

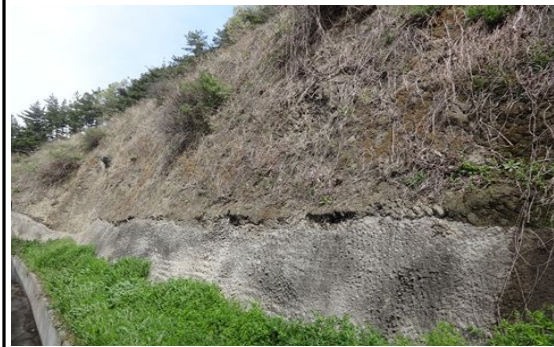
| 대구절토 72 (부산기점 78.56Km / 3공구 STA.12+690) | |
|---|---|
| STA.0-030 산마루측구 균열 | STA.0+30 1단 누수 |

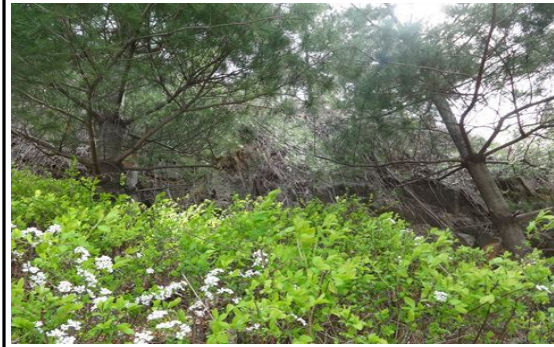
| 대구절토 72 (부산기점 78.56Km / 3공구 STA.12+690) | |
|---|---|
| STA.0+25 1단 암반노출 및 누수, 표층유실 | |

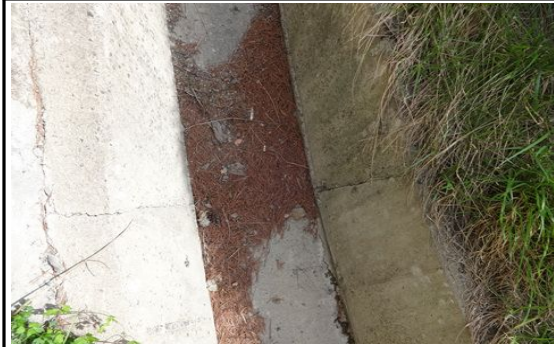
| 대구절토 72 (부산기점 78.56Km / 3공구 STA.12+690) | |
|---|---|
| STA.0+30 배수로 균열 | STA.0-30 1단 표층유실 |
