**2018년 하반기 시설물 정기점검 용역  
정 기 점 검 사 진 첵  
[2종 절토사면 손상현황 사진첩]**

**2018. 12.**

**新 대구부산고속도로주식회사**  
**New DAEGU BUSAN Expressway Co., Ltd.**

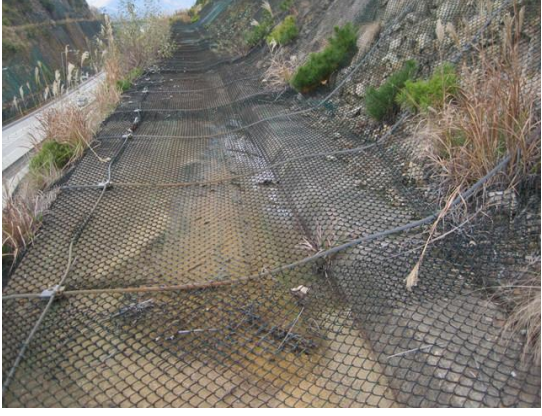
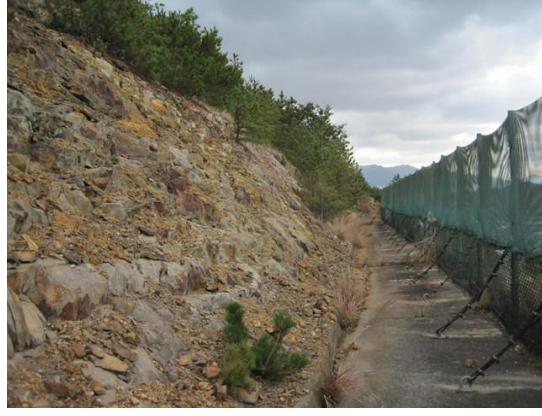
| <p>1소단배수로 균열</p> | |
