## 오천터널(하) 전 경 사 진

## 1. 라이닝-1

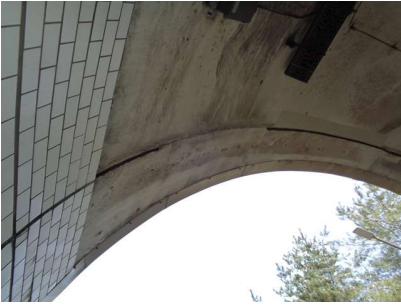
| | 1 | 천단부 조인트마감불량<br>J1 (L=2.0m) |

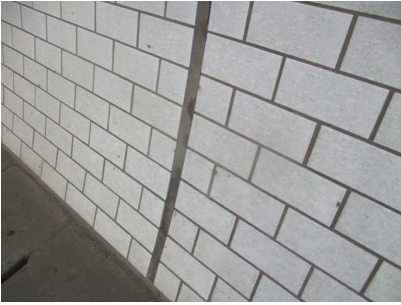
| | 2 | 측벽부 파손<br>J3(A=0.1m*0.3m) |

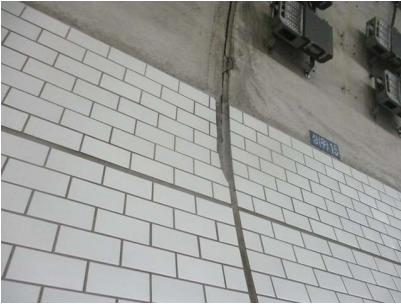
| | 4 | 타일부 타일탈락<br>SP6 6EA |

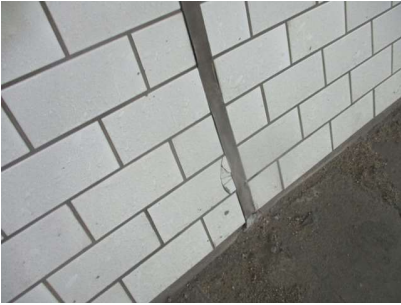
| | 5 | 타일부 타일파손<br>SP8 1EA |

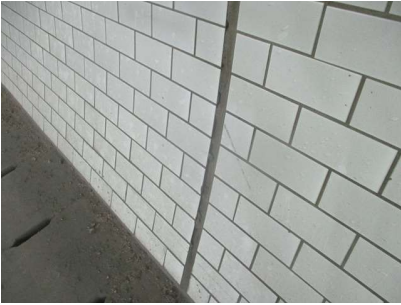
| | 6 | 측벽부 파손<br>J9(A=0.1m*1.0m) |

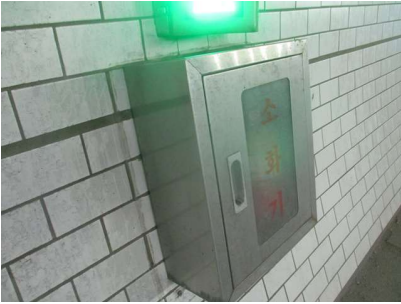
| | 7 | 타일부 소화기함파손<br>SP10 보수 |

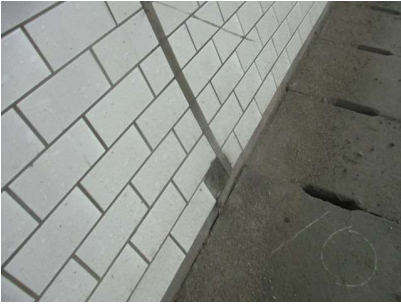
| | 8 | 타일부 타일탈락<br>SP11 1EA |

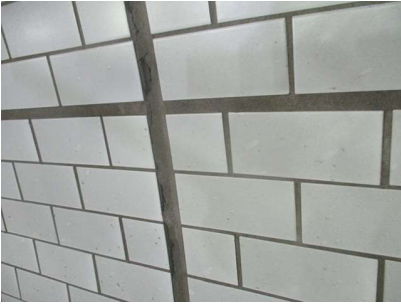
| | 9 | 측벽부 파손<br>J12(A=0.1m*1.5m) |

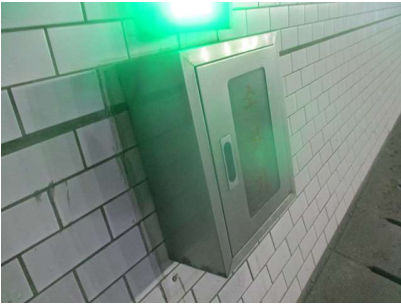
| | 10 | 타일부 소화기함파손<br>SP13 보수 |

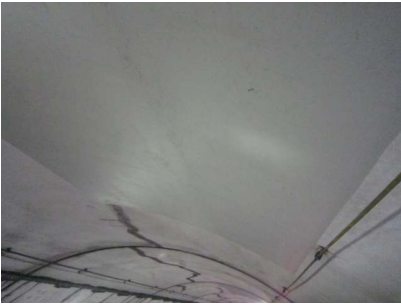
| | 11 | 천단부 파손<br>SP13 보수 |

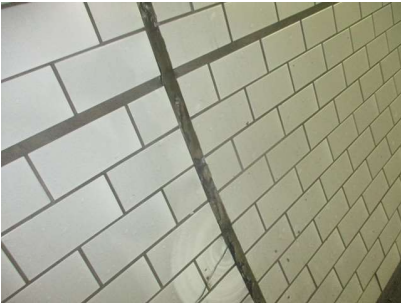
| | 12 | 측벽부 실란트파손<br>J14(L=1.0m) |

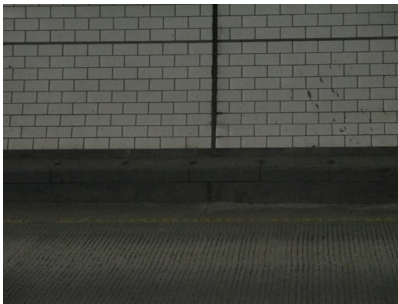
| | 22 | 측벽부 실란트들뜸<br>J22(L=4.0m) | | 23 | 측벽부 몰탈탈락<br>SP23(A=0.1m*0.7m) | | 24 | 측벽부 몰탈탈락<br>SP23(A=0.2m*0.1m*2EA) |

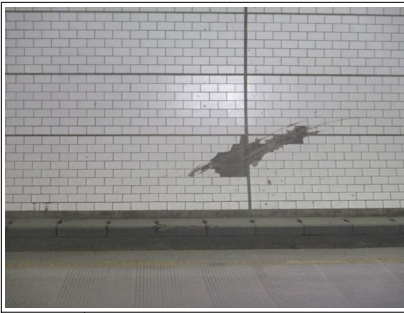
37

타일부 타일탈락  
SP35 12EA

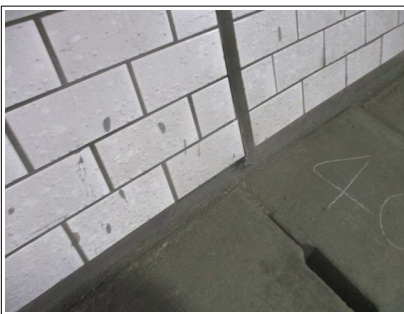
40

측벽부 몰탈탈락  
SP41(A=0.1m\*0.2m)

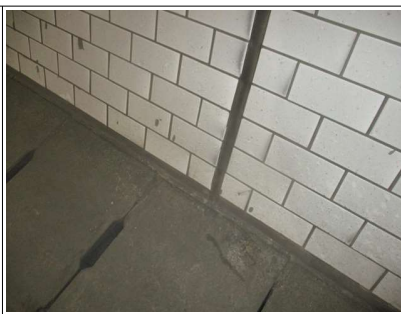
41

측벽부 몰탈탈락  
SP44 보수

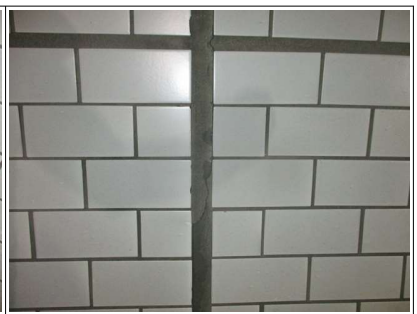
42

측벽부 파손  
J45(A=0.1m\*1.0m)

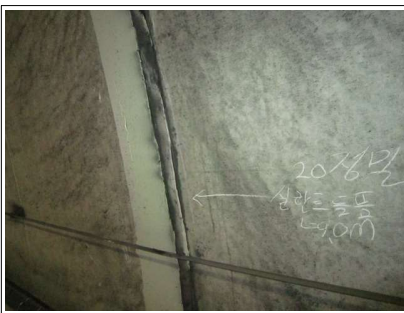
43

측벽부 실란트파손  
J46(L=9.0m)

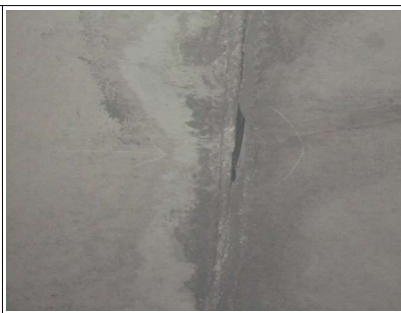
44

천단부 공동  
J47(A=0.6m\*0.4m)

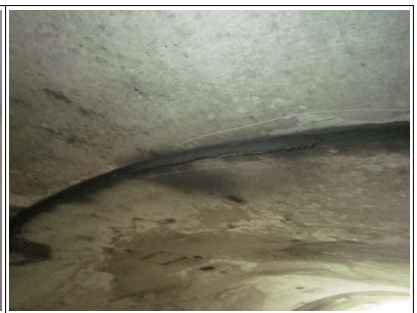
45

천단부 실란트들뜸  
J49(L=6.0m)

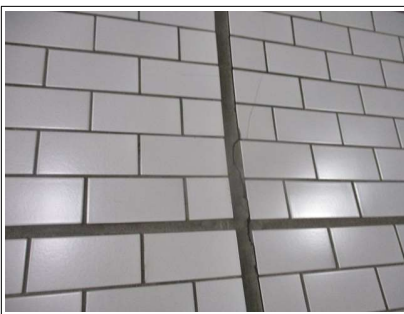
46

측벽부 파손  
J50(A=0.1m\*1.0m)

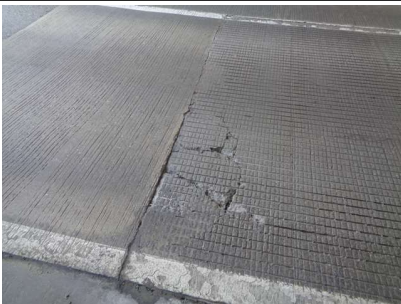
| 1 | 포장면 파손<br>SP2(A=1.0m*1.0m) | 2 | 포장면 파손<br>SP3(A=1.5m*1.0m) | 3 | 포장면 파손<br>SP5(A=1.0m*2.0m) |

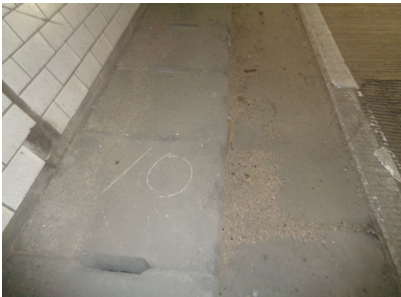
| 7 | 공동구 덮개파손<br>SP11 7EA | 8 | 포장면 파손<br>SP12(A=0.4m*1.7m) | 9 | 포장면 균열<br>SP13(L=0.9m) |

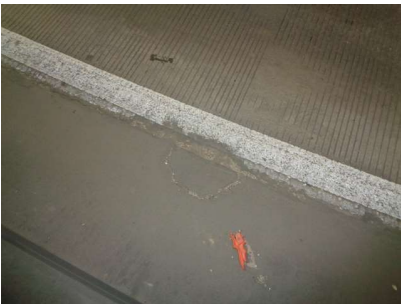
| | 24 | 포장면 파손<br>SP37(A=0.2m*0.7m) |

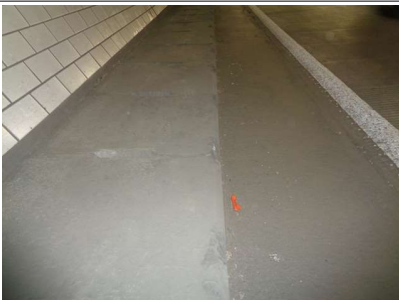
| 28 | 공동구 덮개파손<br>SP45 10EA | 29 | 공동구 덮개파손<br>SP46 8EA | 30 | 포장면 균열<br>SP49(L=3.0m) |

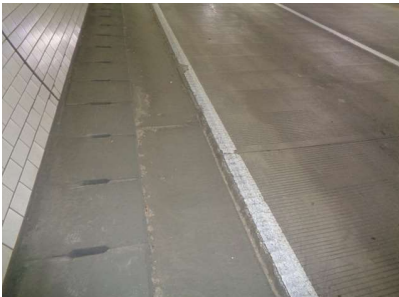
| 31 | 포장면 토사퇴적<br>SP50 보수 | 32 | 포장면 박리<br>SP50(A=0.1m*0.5m) | 33 | 포장면 파손<br>SP51(A=0.1m*1.5m) |

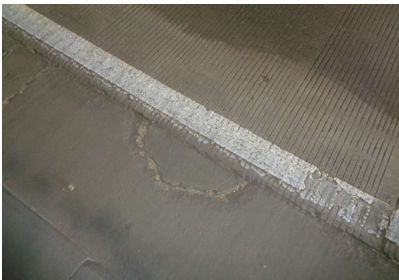
| 34 | 포장면 들뜸<br>SP52(A=0.1m*1.5m) | 35 | 포장면 파손<br>SP53(A=0.1m*0.1m) | 36 | 포장면 토사퇴적<br>SP52~54 보수 |
