## 오천터널(하) 전 경 사 진

## 1. 라이닝-1

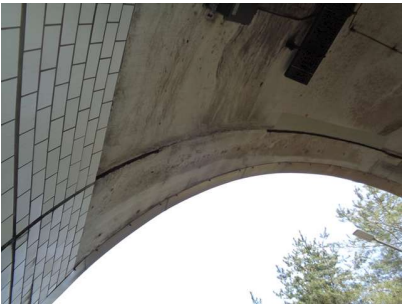
| 1 | 천단부 조인트마감불량<br>J1 (L=2.0m) | 2 | 측벽부 파손<br>J3(A=0.1m*0.3m) |

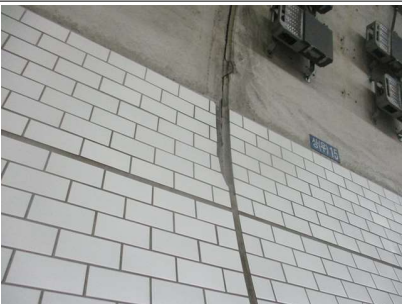
| 4 | 타일부 타일탈락<br>SP6 6EA | 5 | 타일부 타일파손<br>SP8 1EA | 6 | 측벽부 파손<br>J9(A=0.1m*1.0m) |

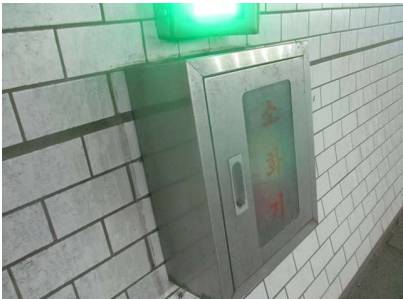
| 7 | 타일부 소화기함파손<br>SP10 보수 | 8 | 타일부 타일탈락<br>SP11 1EA | 9 | 측벽부 파손<br>J12(A=0.1m*1.5m) |

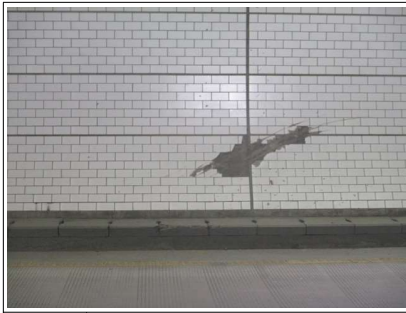
37

타일부 타일탈락  
SP35 12EA

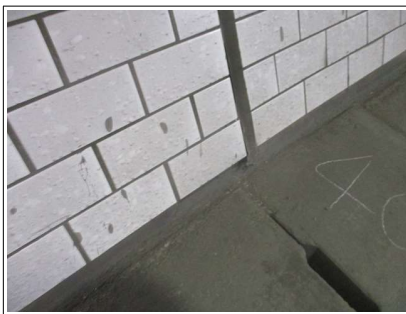
40

측벽부 몰탈탈락  
SP41(A=0.1m\*0.2m)

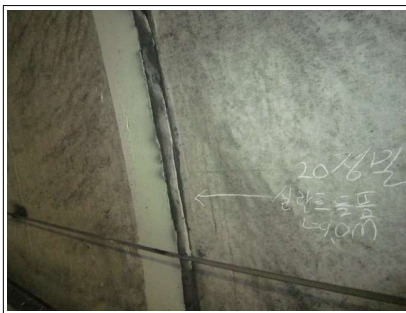
43

측벽부 실란트파손  
J46(L=9.0m)

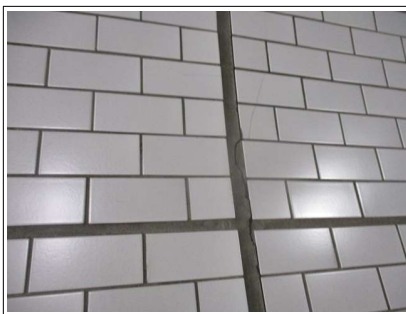
46

측벽부 파손  
J50(A=0.1m\*1.0m)
